MONITORING YEAR 5 ANNUAL REPORT

HOLMAN MILL MITIGATION SITE

Alamance County, NC
NCDEQ Contract 005795
DMS ID No. 96316
USACE Action ID Number 2015-00019
NCDWR Project Number 2014-0333

Data Collection Period: January 2020 - October 2020
Draft Submission Date: October 14, 2020
Final Submission Date: November 2, 2020

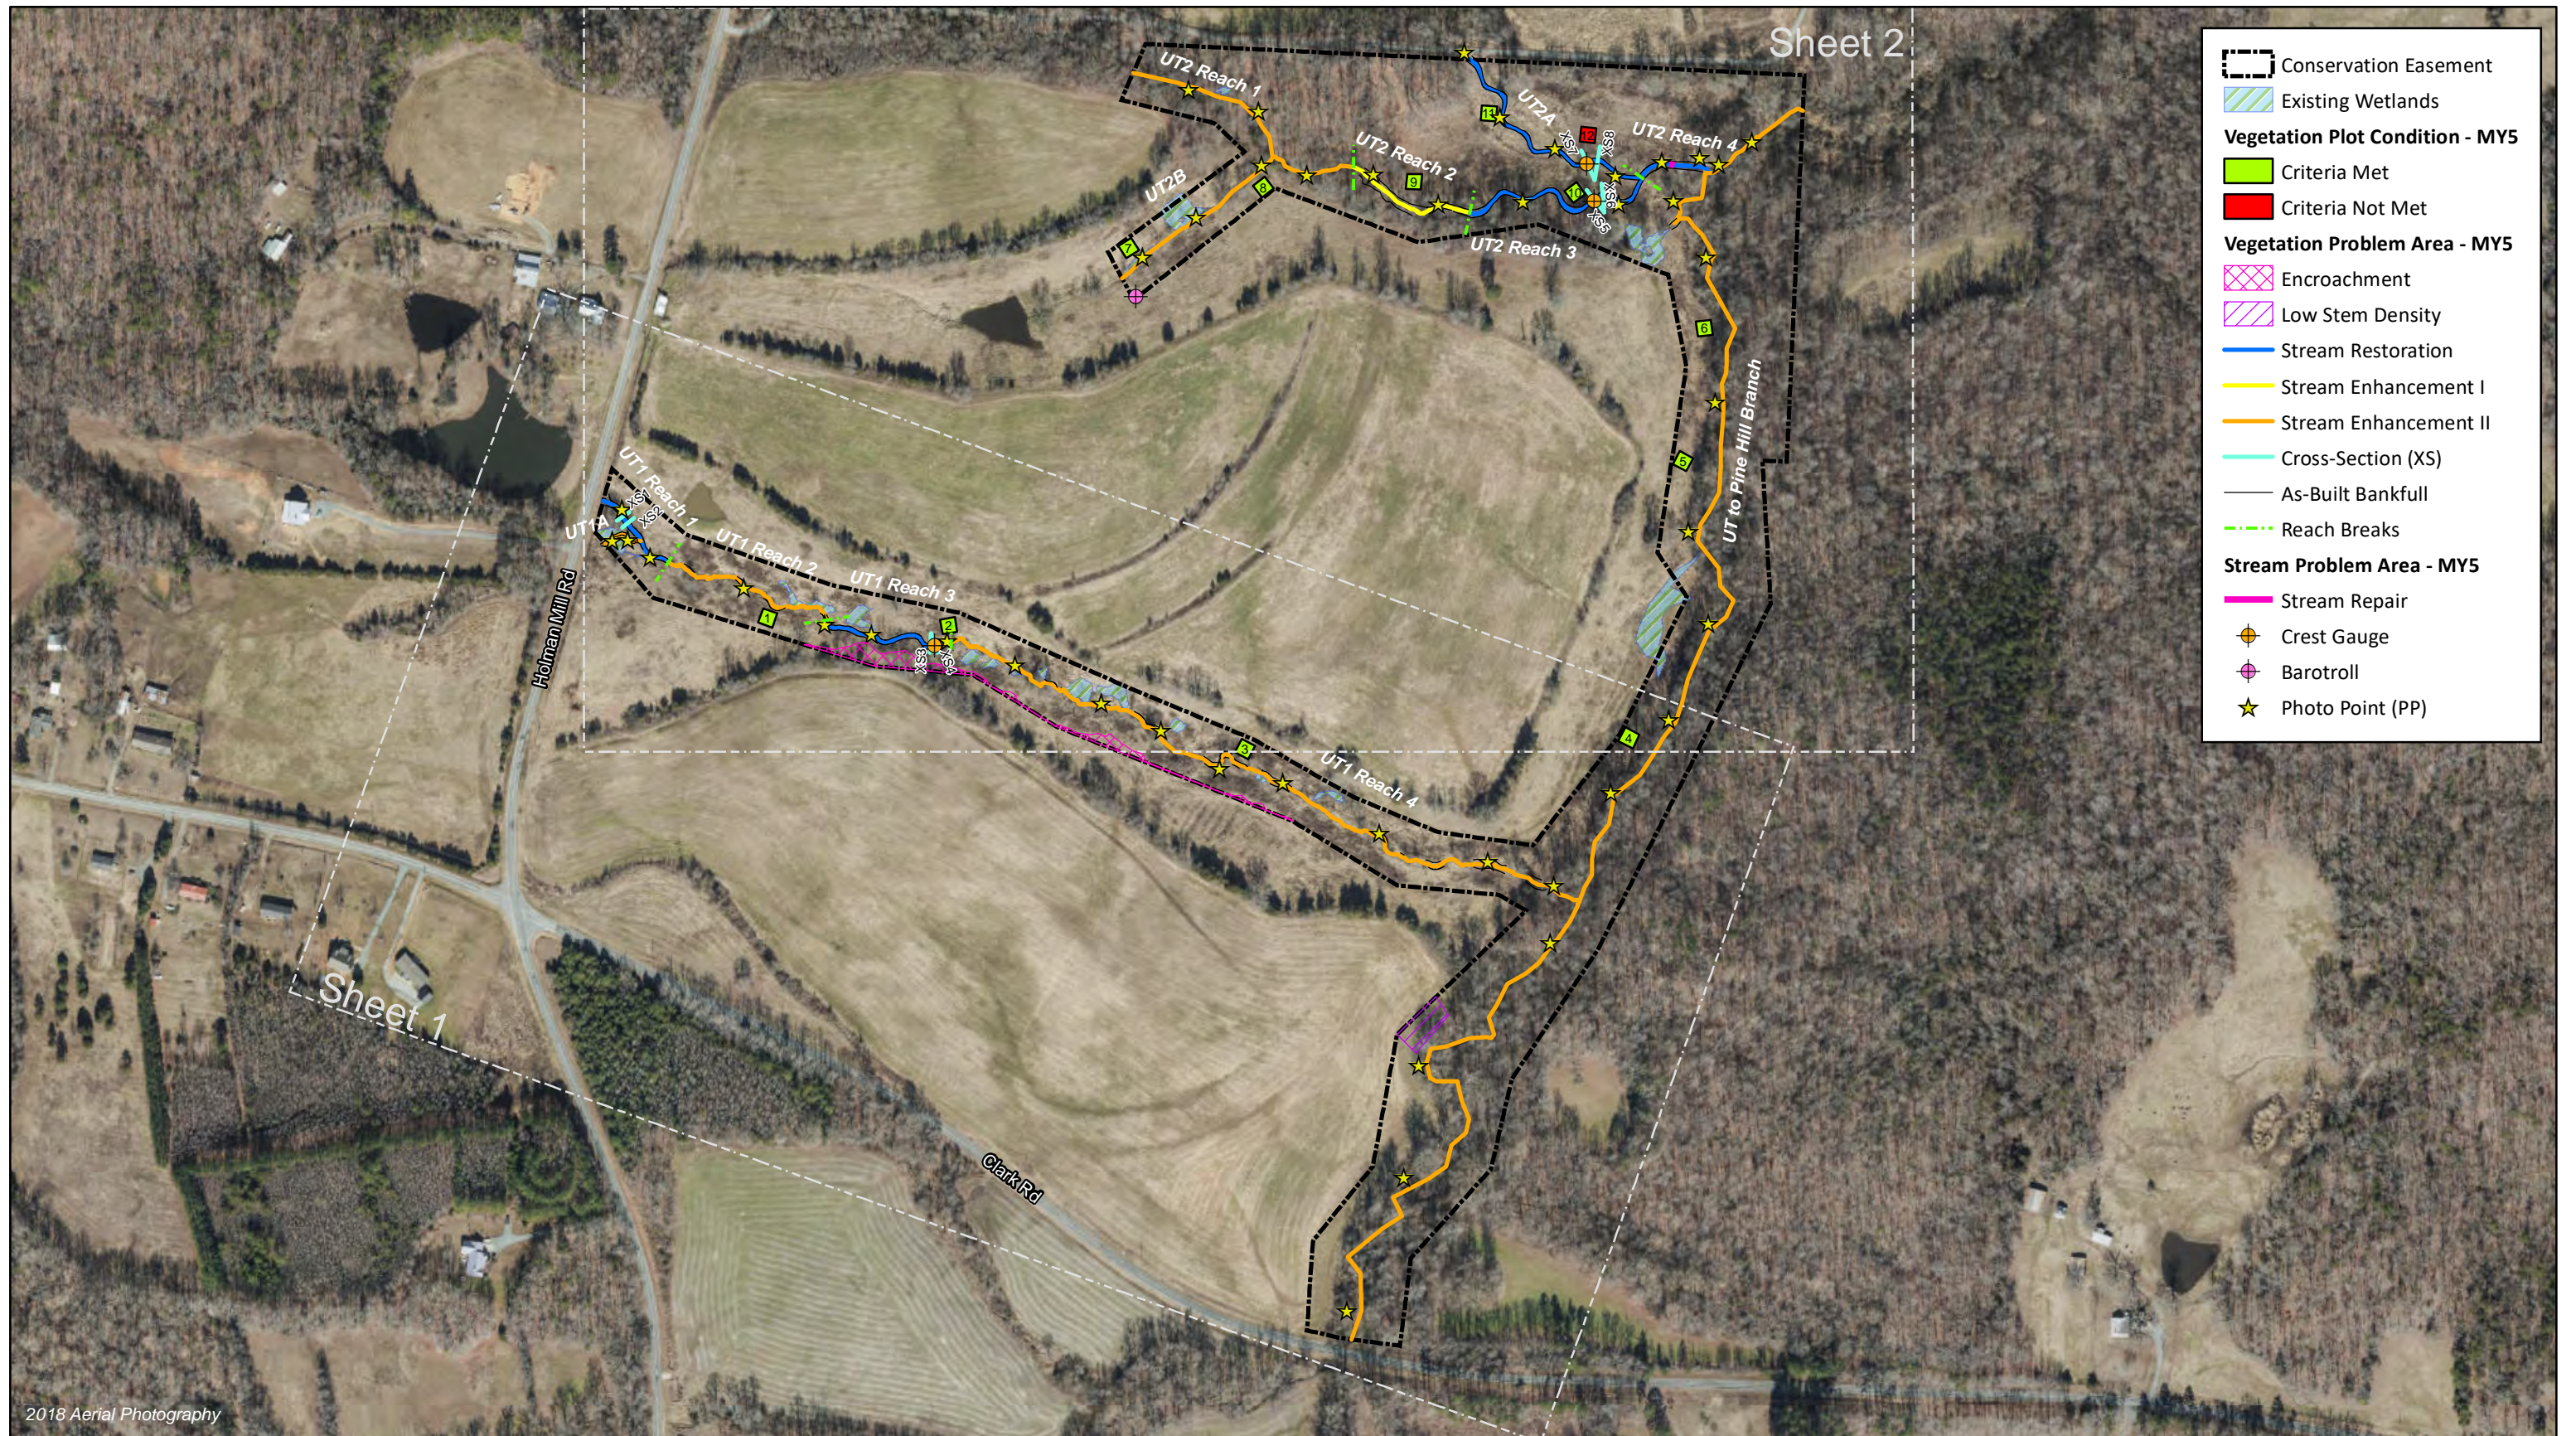
Figure 3.0 Integrated Current Condition Plan View (Key)
 Holman Mill Mitigation Site
 DMS Project No. 96316
 Monitoring Year 5 - 2020
 Alamance County, NC

An area of low stem density (Figure 3.0) was noted during MY5 for a total of 0.14 acres. Dense herbaceous vegetation has outcompeted the planted trees in the area adjacent to UT to Pine Hill

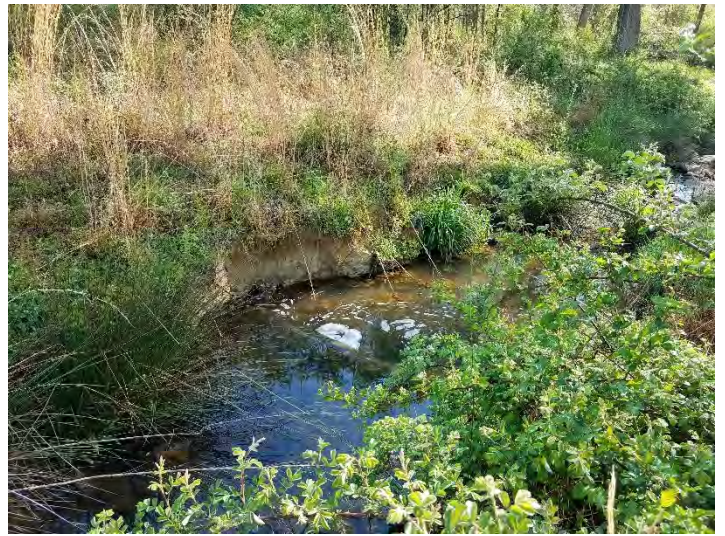
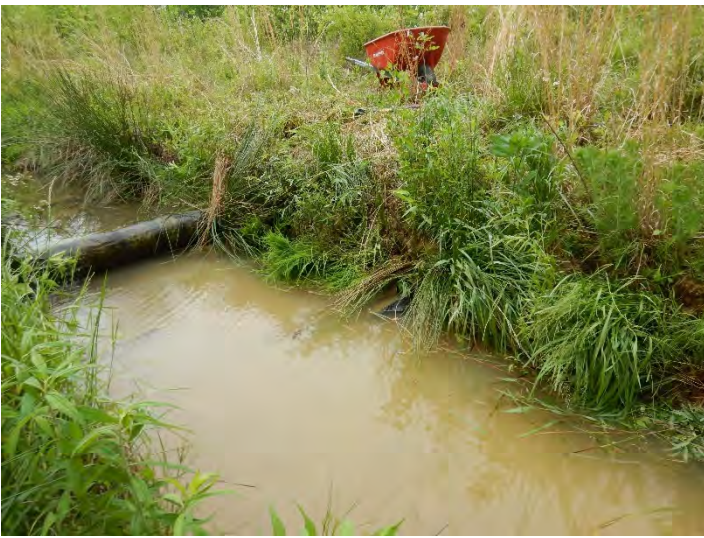
Localized erosion below a log sill on UT2 between stations 214+35 and 214+50 identified during MY4 was repaired in May 2020. The stream bank repair included installing sod mats and live stakes. See before and after photos of the area in Appendix 2. This area will continue to be monitored to determine the success of the repair work.

Before - Localized Erosion (4/7/2020)

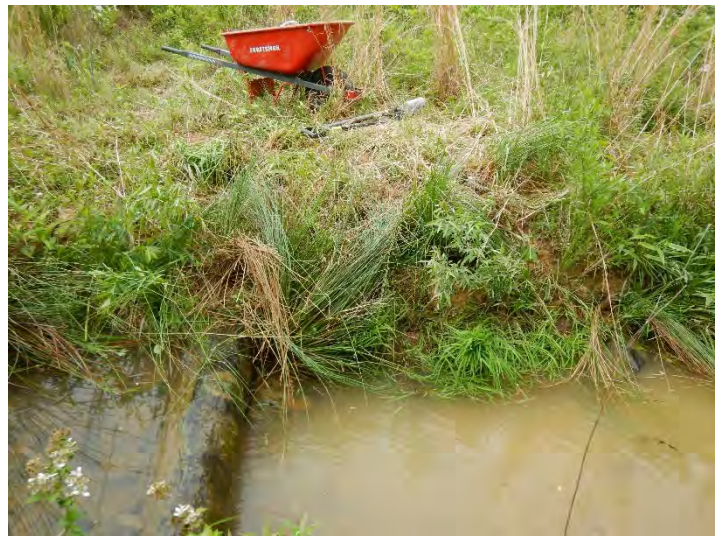
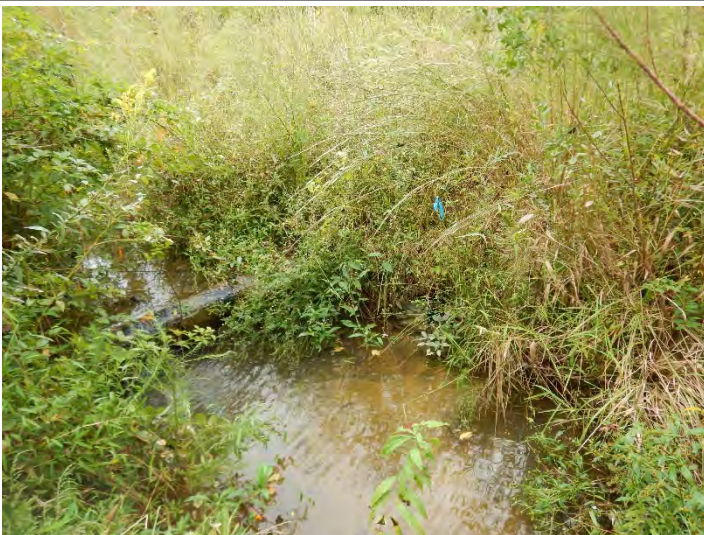
After - Repaired Localized Erosion (5/5/2020)

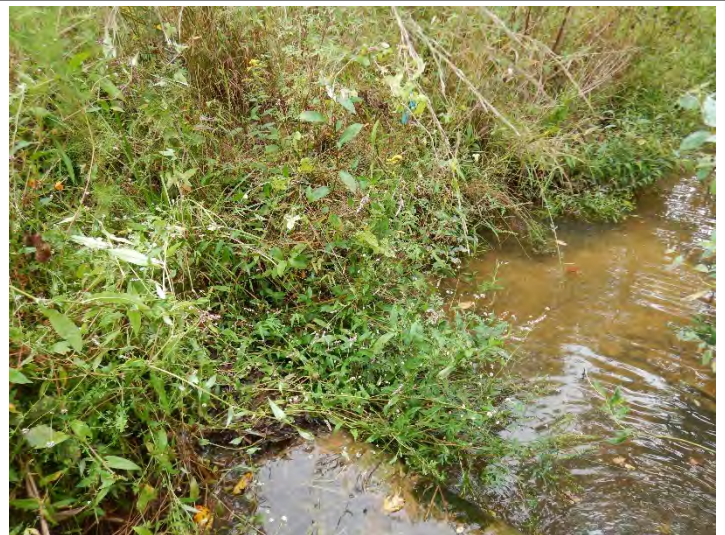
After - Repaired Localized Erosion (9/28/2020)
