# **MONITORING YEAR 7 ANNUAL REPORT FINAL**

## **HOLMAN MILL MITIGATION SITE**

Alamance County, NC

DMS Project Number 96316

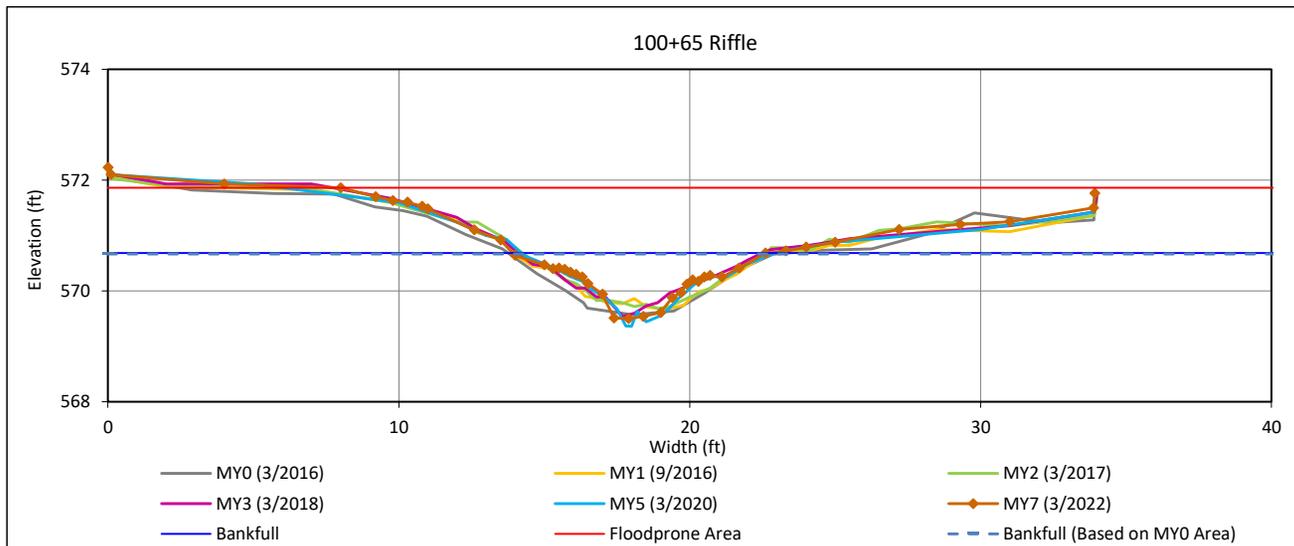
#### Cross-Section 1-UT1 Reach 1

4.8	x-section area (ft.sq.)
8.7	width (ft)
0.5	mean depth (ft)
1.2	max depth (ft)
9.2	wetted perimeter (ft)
0.5	hydraulic radius (ft)
15.8	width-depth ratio
22.0	W flood prone area (ft)
2.5	entrenchment ratio
1.0	low bank height ratio

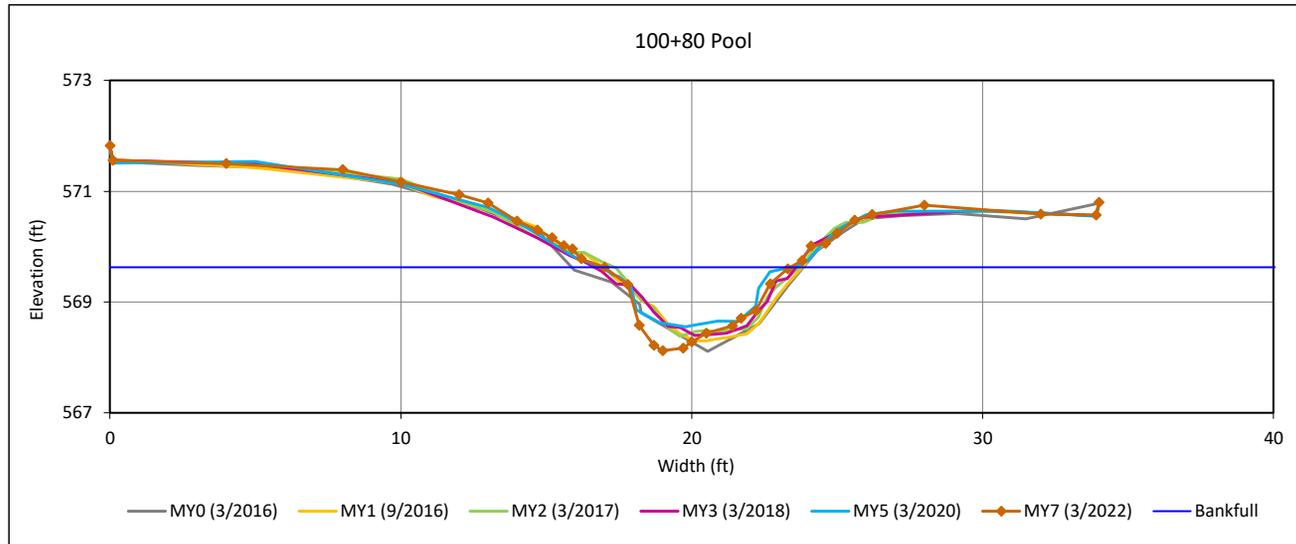
#### Cross-Section 2-UT1 Reach 1

5.7	x-section area (ft.sq.)
6.3	width (ft)
0.9	mean depth (ft)
1.5	max depth (ft)
7.3	wetted perimeter (ft)
0.8	hydraulic radius (ft)
7.0	width-depth ratio

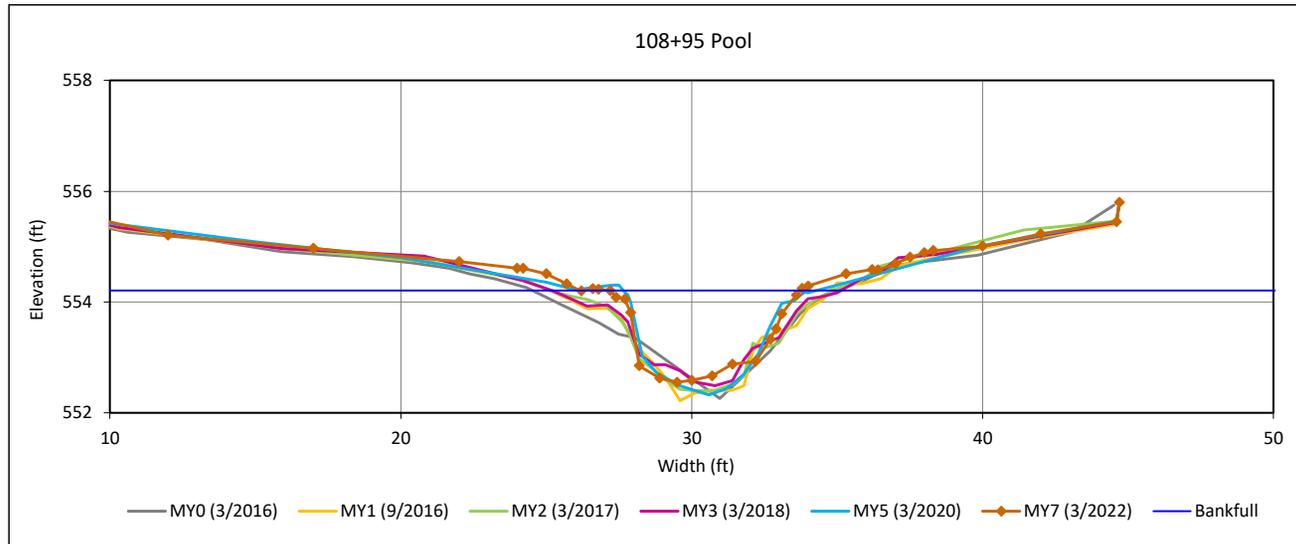
### Cross-Section 3-UT1 Reach 3

7.3	x-section area (ft.sq.)
6.5	width (ft)
1.1	mean depth (ft)
1.7	max depth (ft)
8.0	wetted perimeter (ft)
0.9	hydraulic radius (ft)
5.9	width-depth ratio

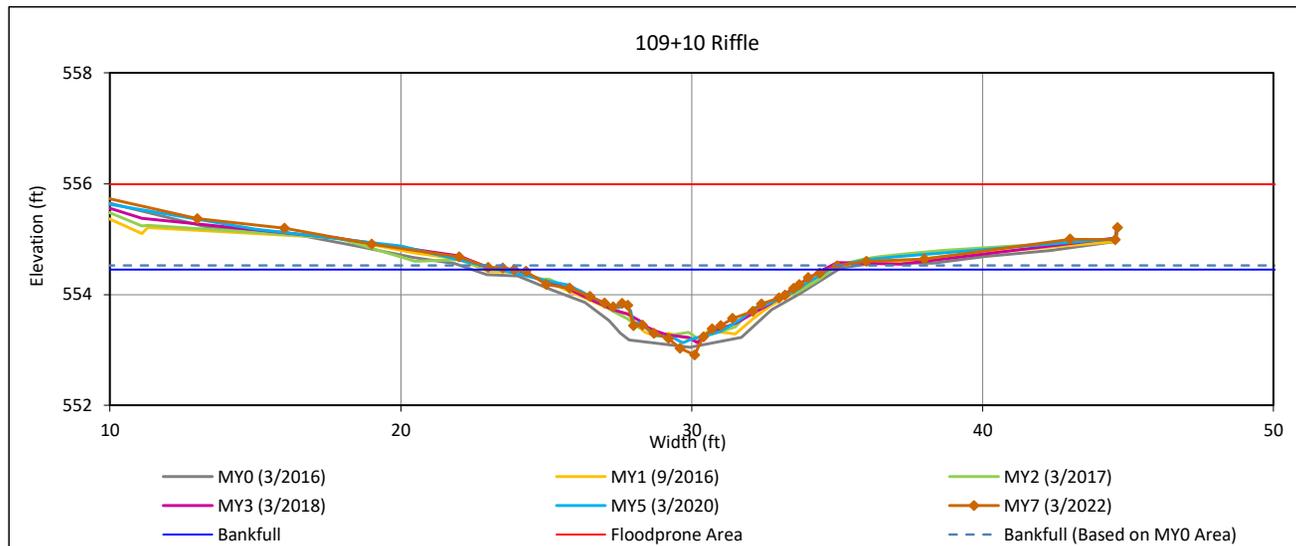
### Cross-Section 4-UT1 Reach 3

7.1	x-section area (ft.sq.)
10.5	width (ft)
0.7	mean depth (ft)
1.5	max depth (ft)
11.2	wetted perimeter (ft)
0.6	hydraulic radius (ft)
15.5	width-depth ratio
17.0	W flood prone area (ft)
1.6	entrenchment ratio
1.0	low bank height ratio

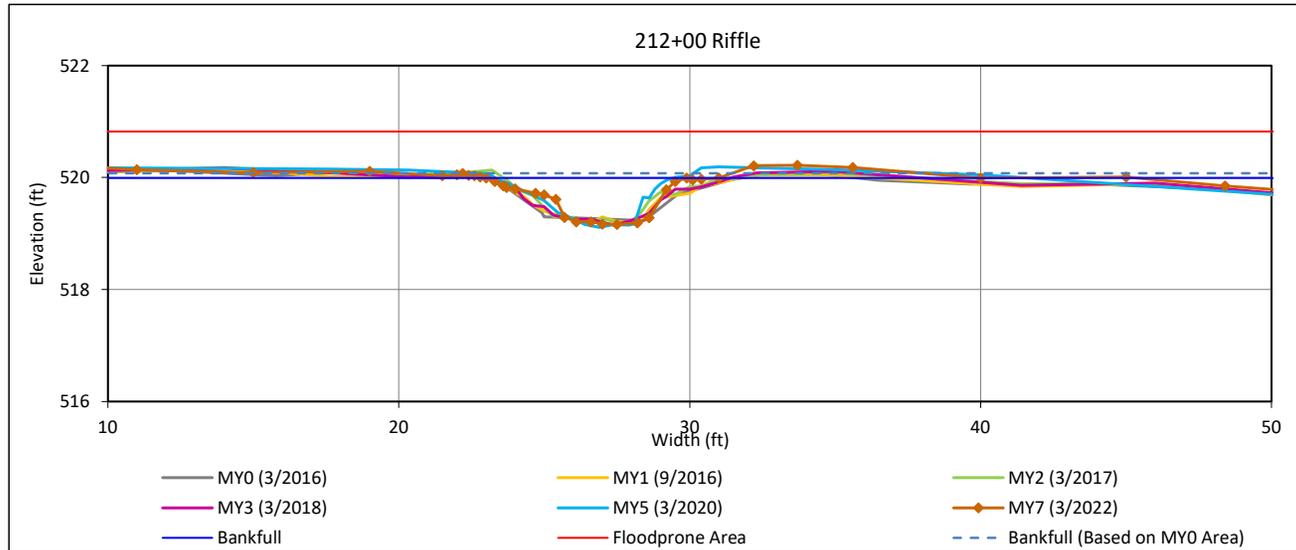
#### Cross-Section 5-UT2 Reach 3

3.3	x-section area (ft.sq.)
6.9	width (ft)
0.5	mean depth (ft)
0.8	max depth (ft)
7.3	wetted perimeter (ft)
0.4	hydraulic radius (ft)
14.5	width-depth ratio
100.0	W flood prone area (ft)
14.5	entrenchment ratio
< 1.0	low bank height ratio

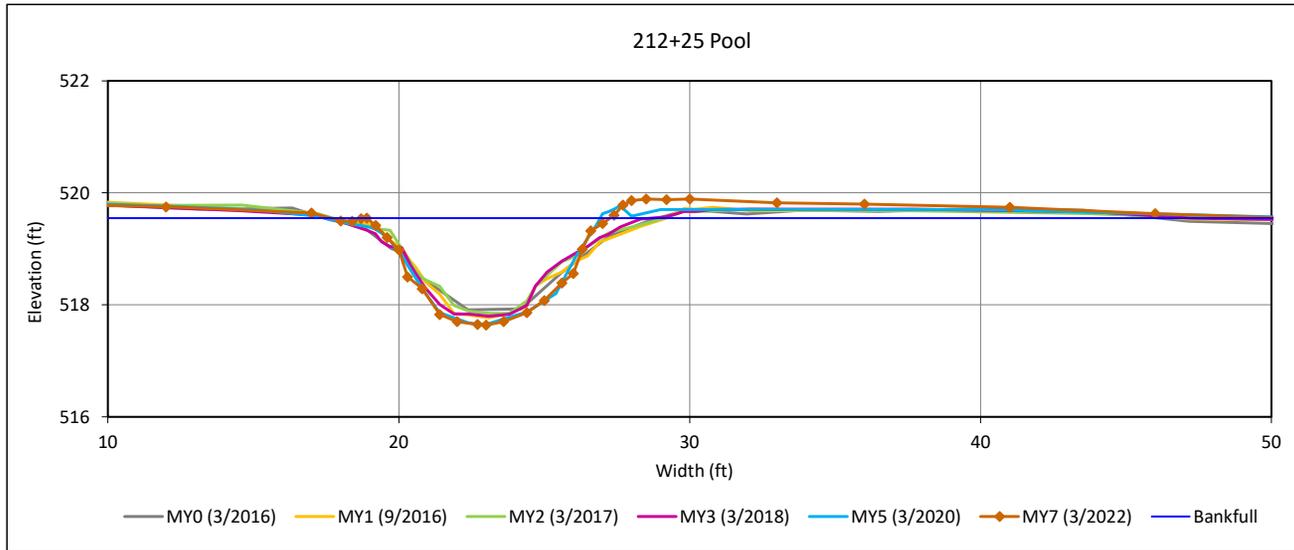
#### Cross-Section 6-UT2 Reach 3

10.1	x-section area (ft.sq.)
8.4	width (ft)
1.2	mean depth (ft)
1.9	max depth (ft)
9.6	wetted perimeter (ft)
1.1	hydraulic radius (ft)
6.9	width-depth ratio

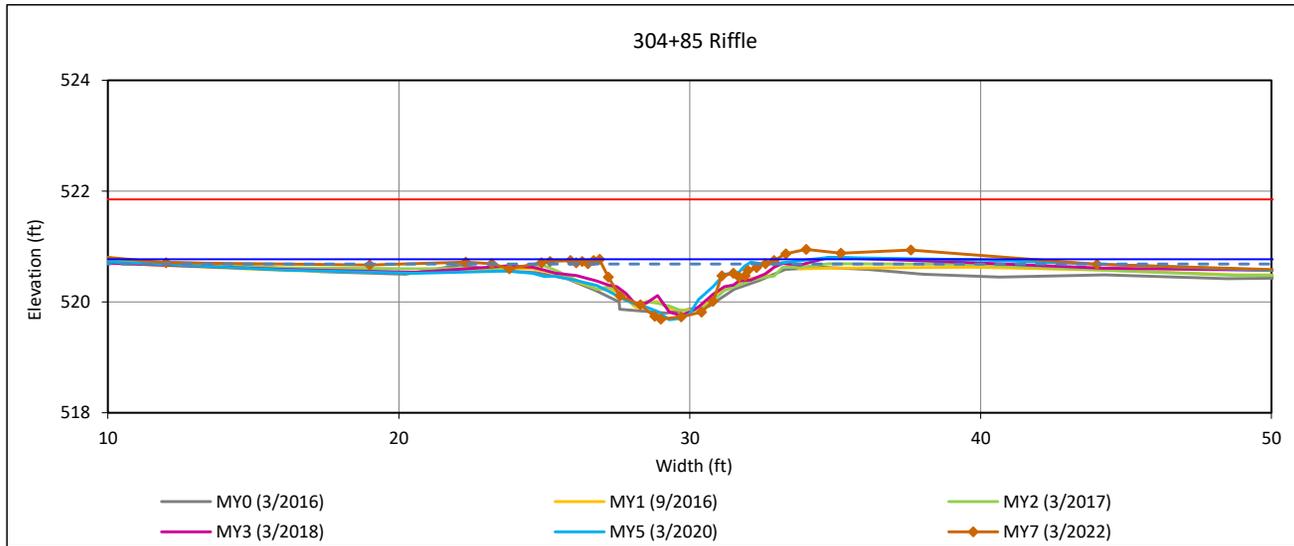
#### Cross-Section 7-UT2A

3.7	x-section area (ft.sq.)
6.1	width (ft)
0.6	mean depth (ft)
1.1	max depth (ft)
6.8	wetted perimeter (ft)
0.6	hydraulic radius (ft)
9.9	width-depth ratio
100.0	W flood prone area (ft)
16.5	entrenchment ratio
1.1	low bank height ratio

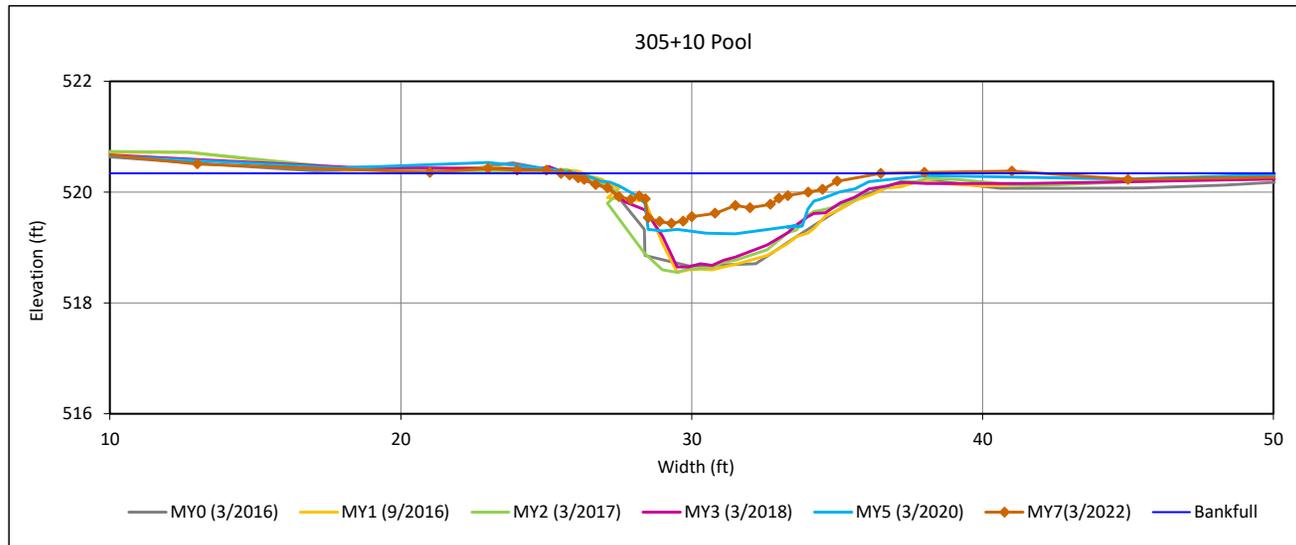
### Cross-Section 8-UT2A

4.8	x-section area (ft.sq.)
11.0	width (ft)
0.4	mean depth (ft)
0.9	max depth (ft)
11.4	wetted perimeter (ft)
0.4	hydraulic radius (ft)
25.5	width-depth ratio
