Monitoring Report
Year 1

Hominy Swamp Creek
Wilson, North Carolina

N.C. Wetlands Restoration Program
NCDENR

January 2003

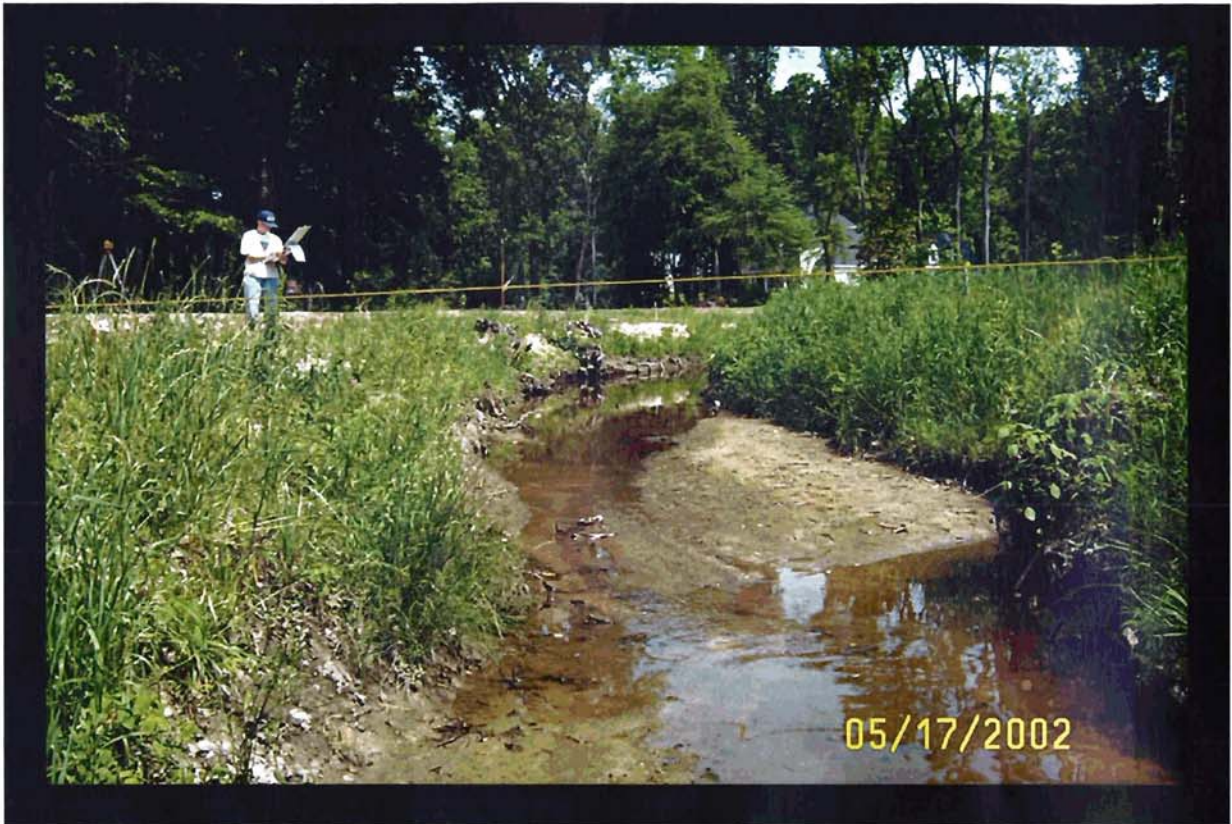
Cross-section #1

Upstream view at Cross-section #1.

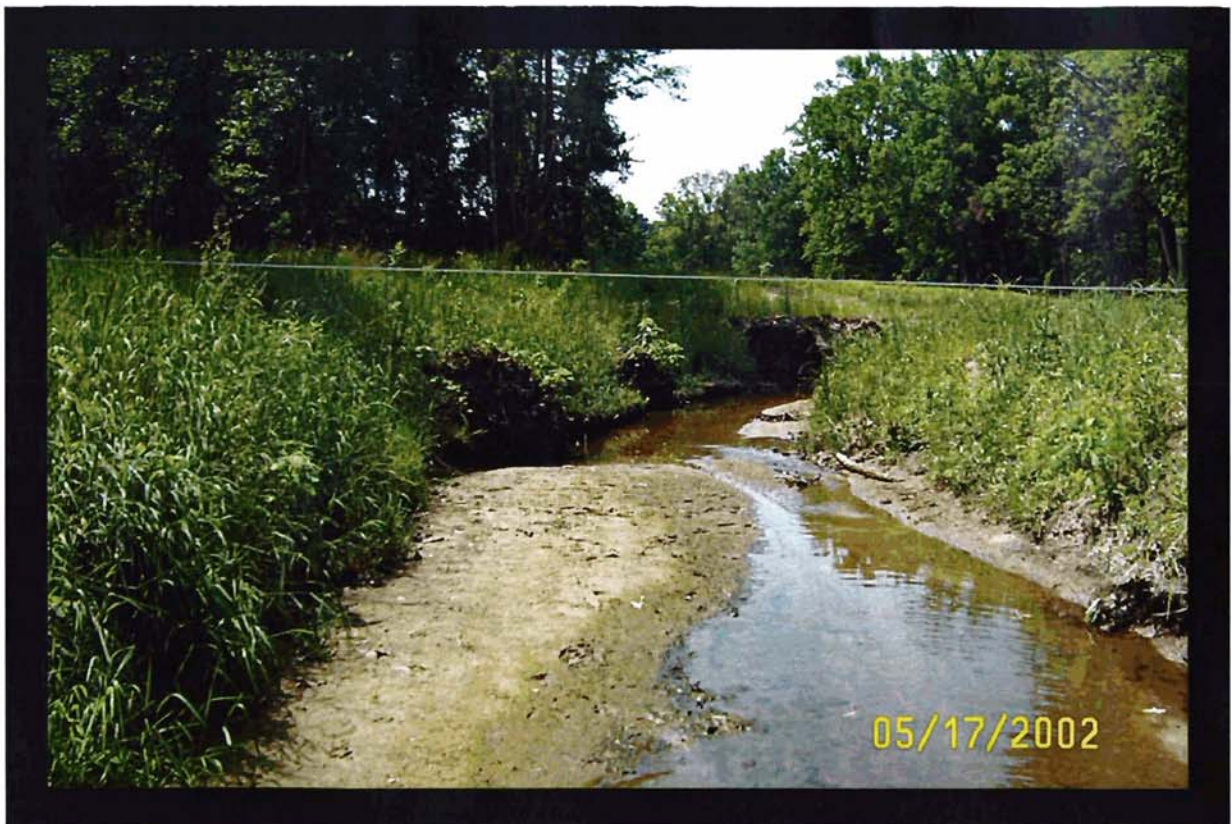
Downstream view at Cross-section #1.

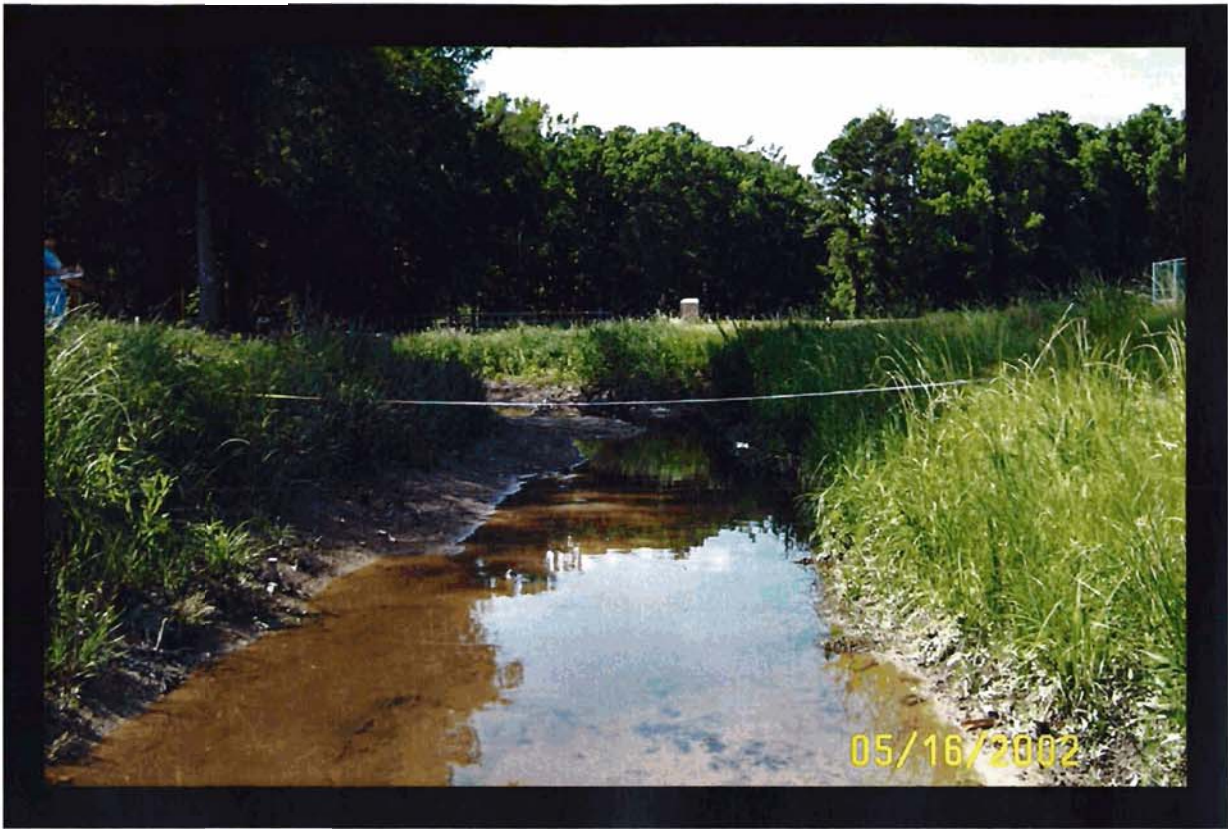
Cross-section #2

Upstream view at Cross-section #2.

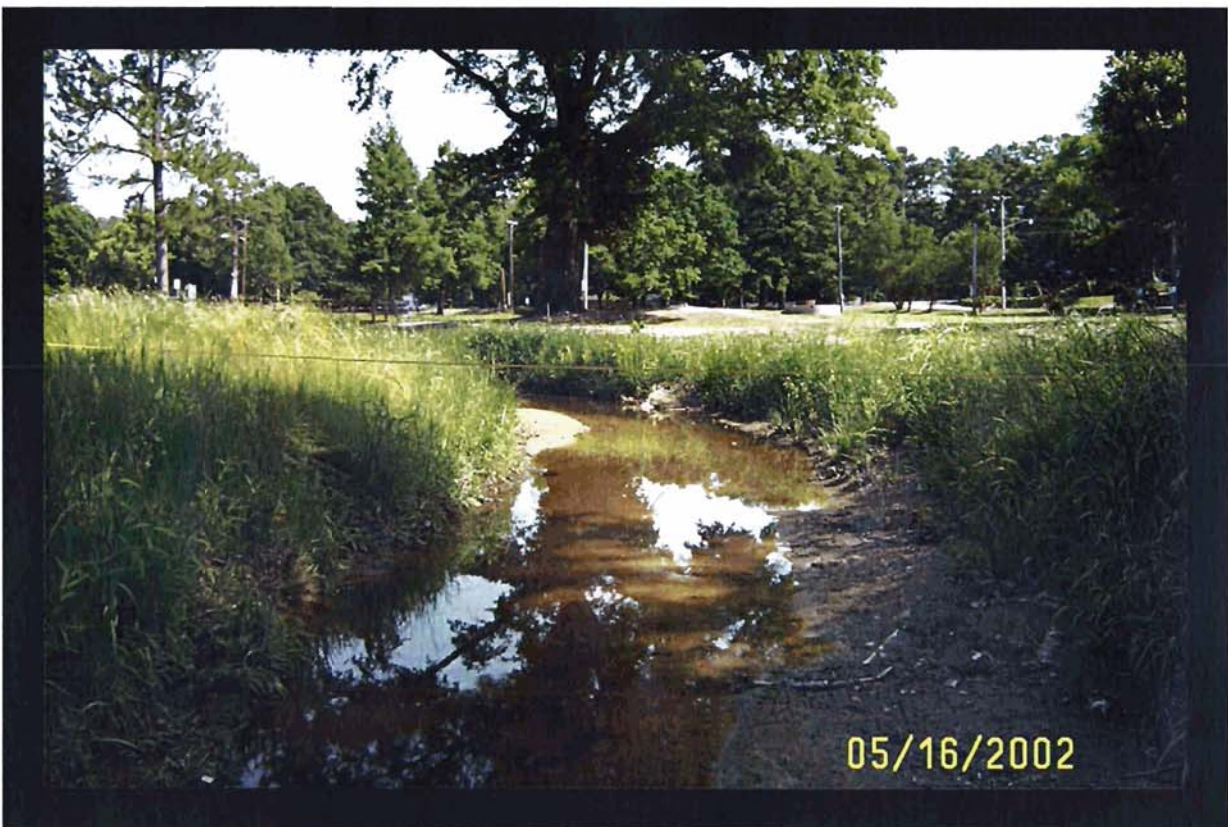
Downstream view at Cross-section #2.

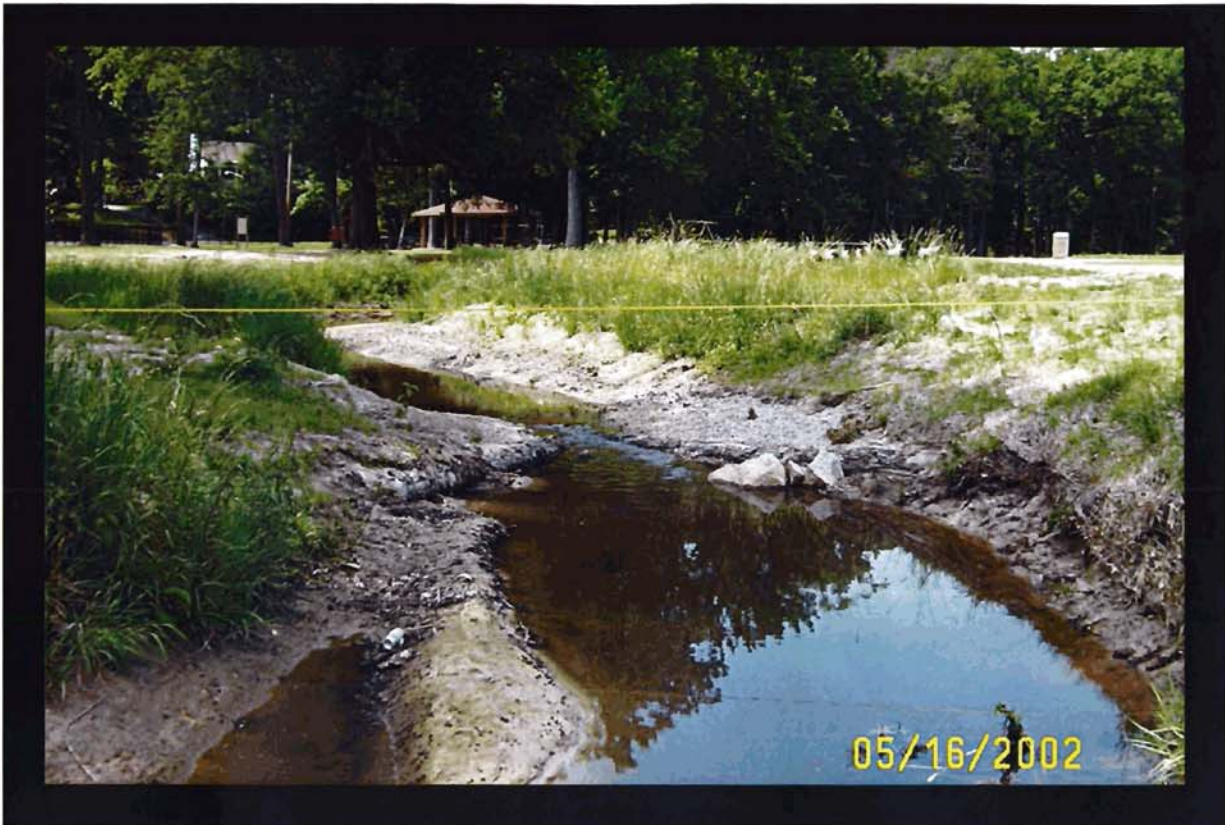
Cross-section #3

Upstream view at Cross-section #3.

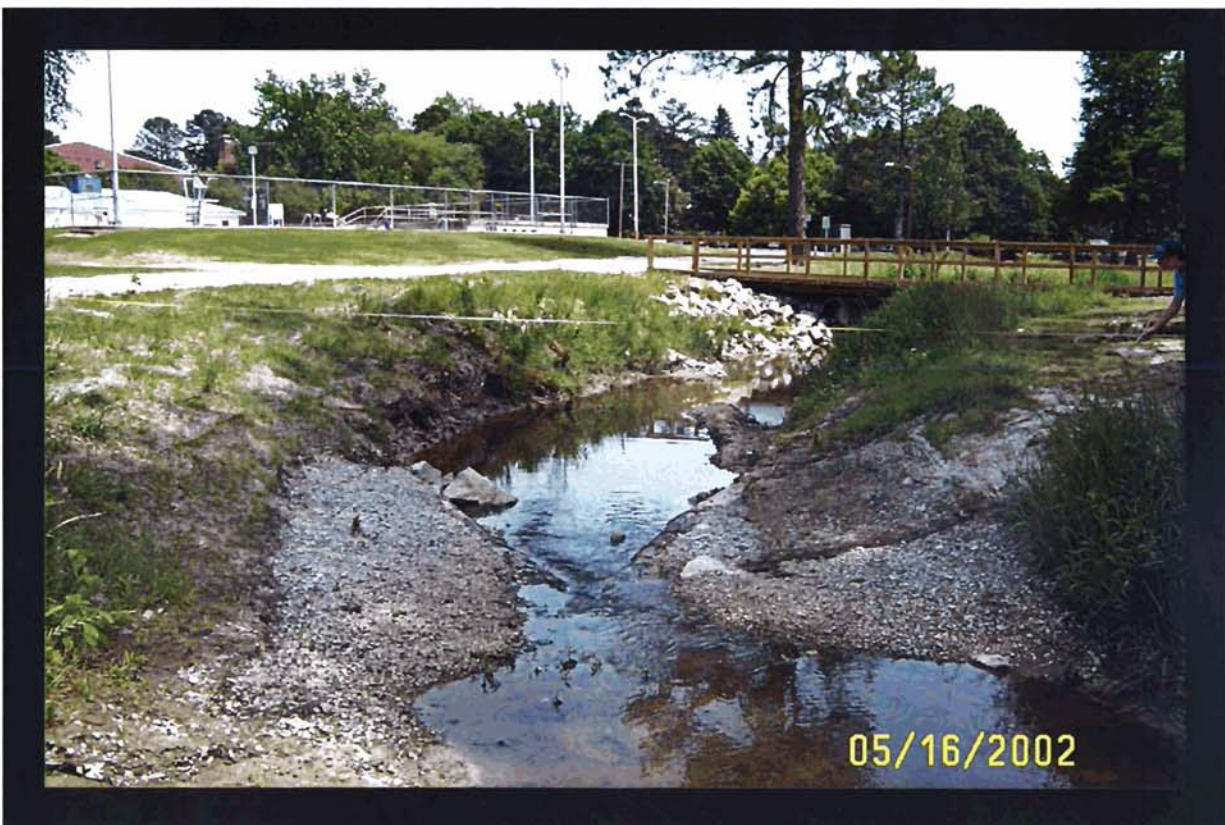
Downstream view at Cross-section #3.

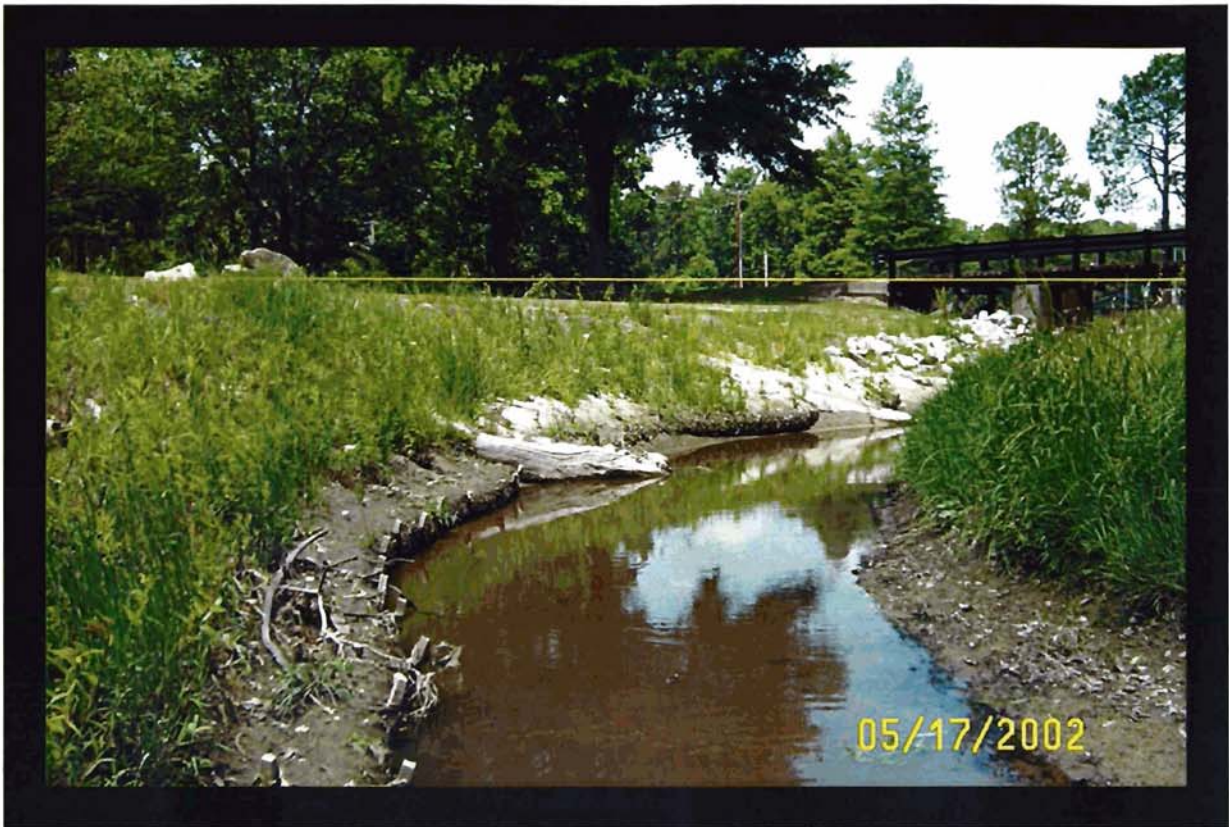
Cross-section #4

Upstream view at Cross-section #4.

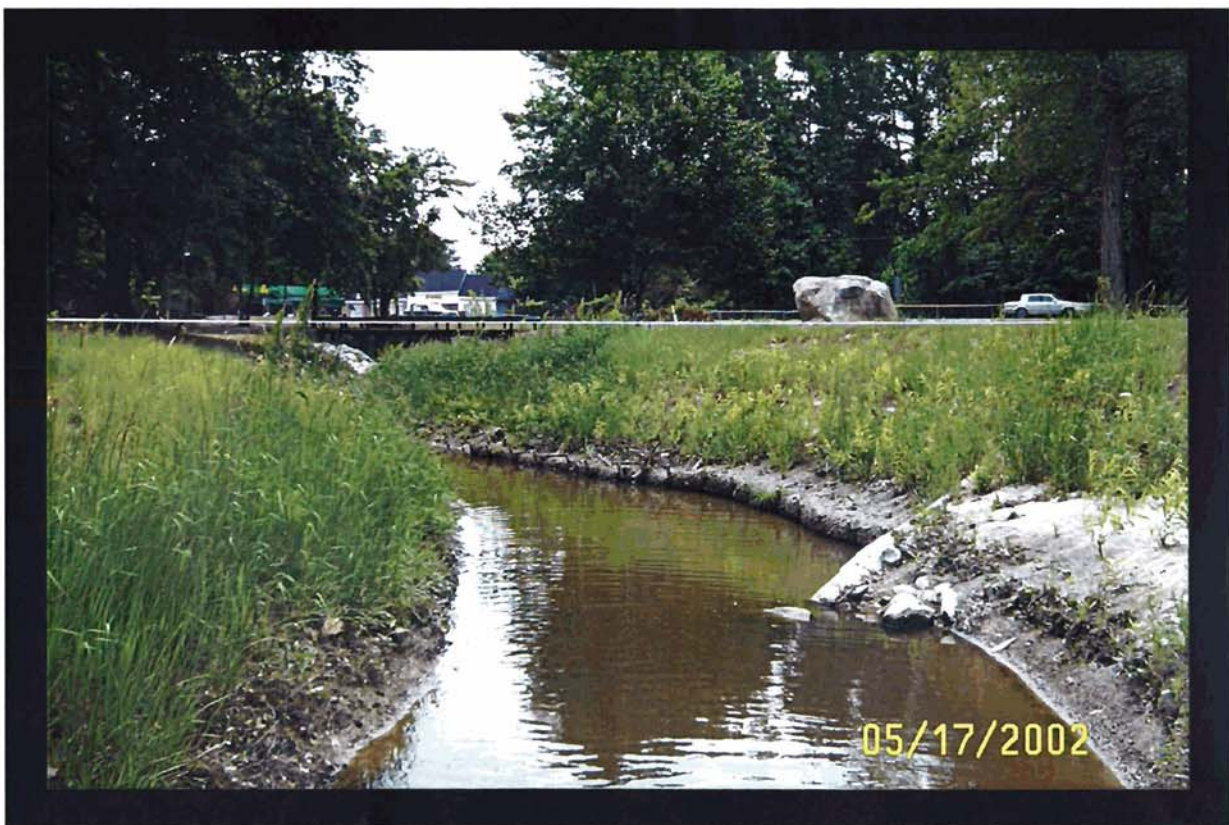
Downstream view at Cross-section #4.

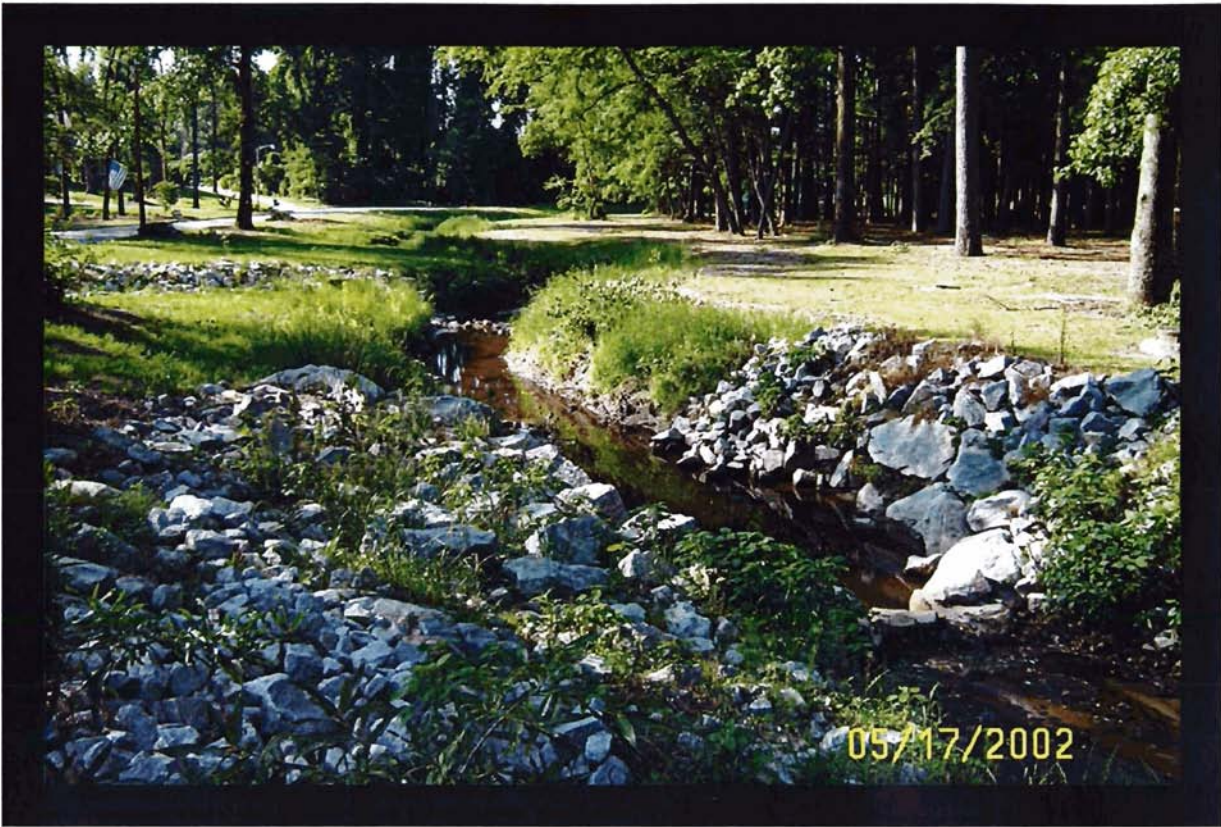
Downstream view from Photo Location #1 (Ripley Road bridge).

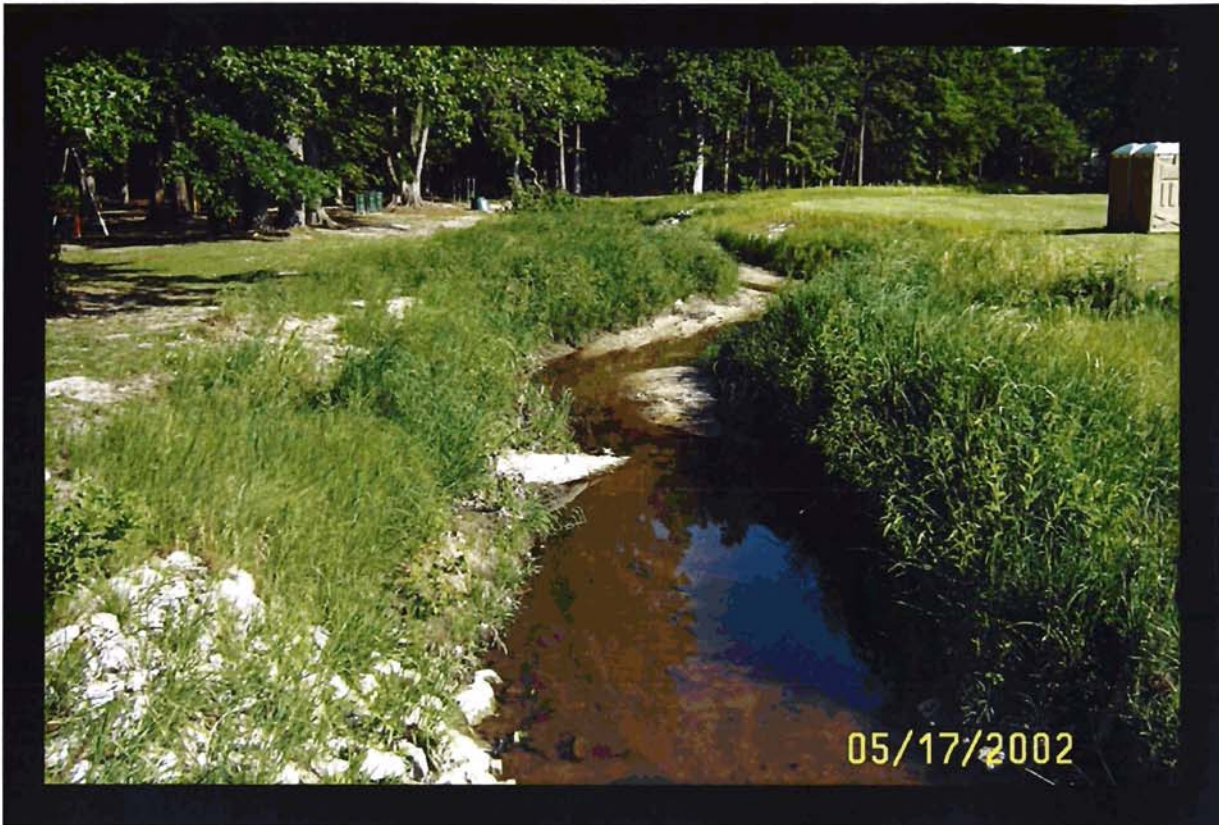
Upstream view from Photo Location #5 (center of concrete pedestrian bridge).

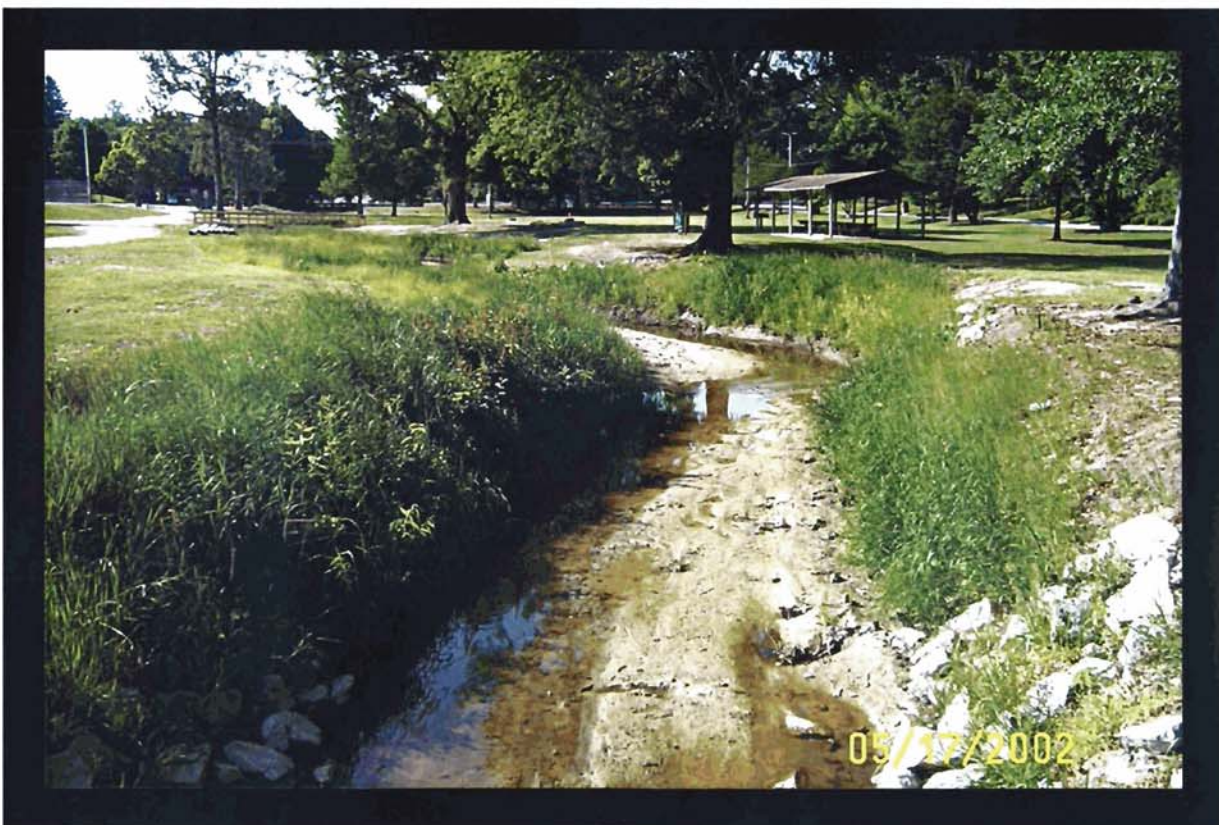
Downstream view from Photo Location #5 (center of concrete pedestrian bridge).

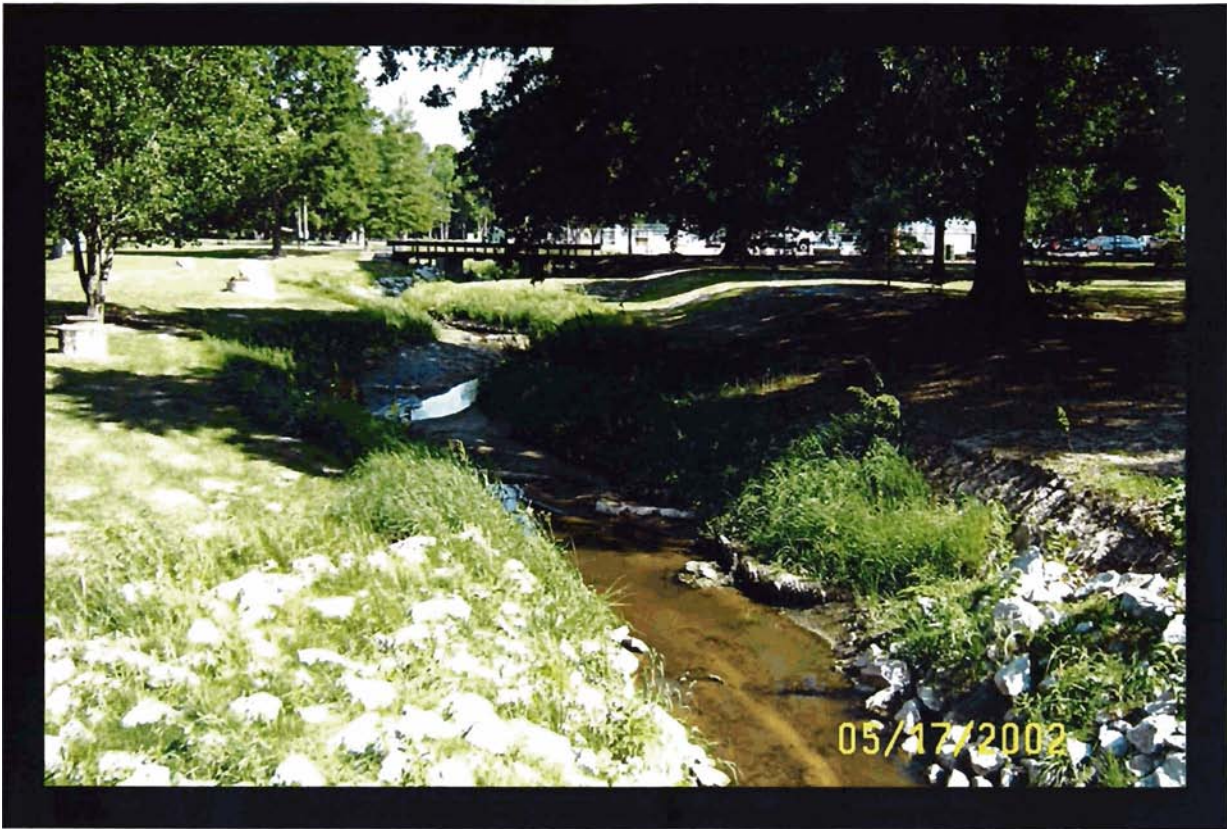
Upstream view from Photo Location #10 (on downstream railroad bridge).
