MONITORING YEAR 2 ANNUAL REPORT

HONEY MILL MITIGATION SITE

Surry County, NC
DEQ Contract No. 7619
DMS Project No. 100083

Data Collection Period: January 2022 – October 2022
FINAL Submission Date: February, 2022

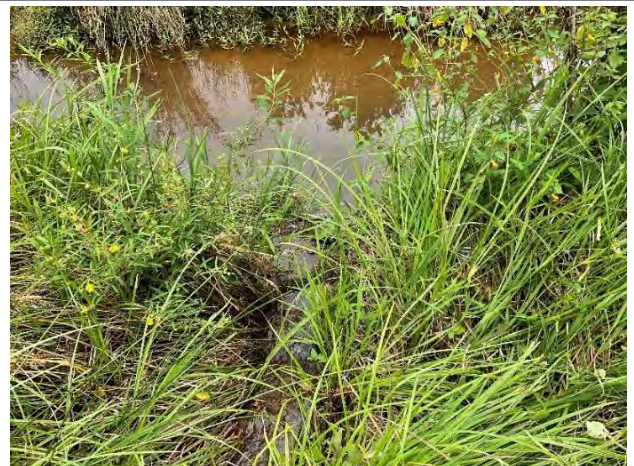
VC R3- Wetland Seep to Main Channel on right floodplain (08/16/2022)

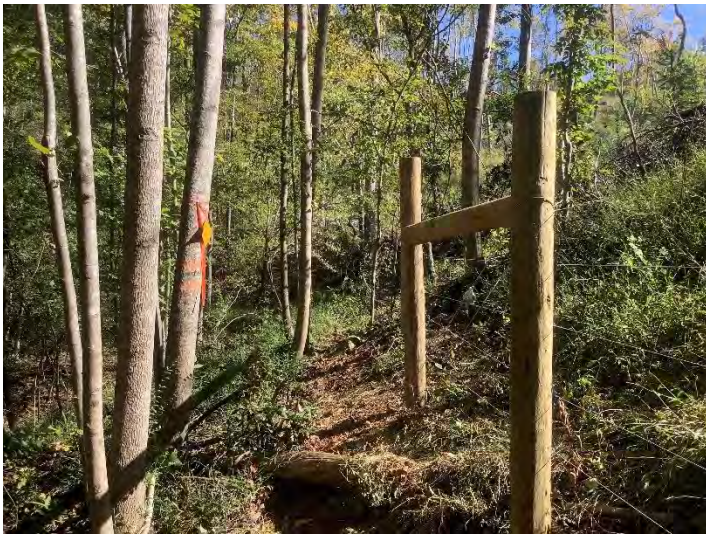
UT2 Fence Repair– (09/30/2022)

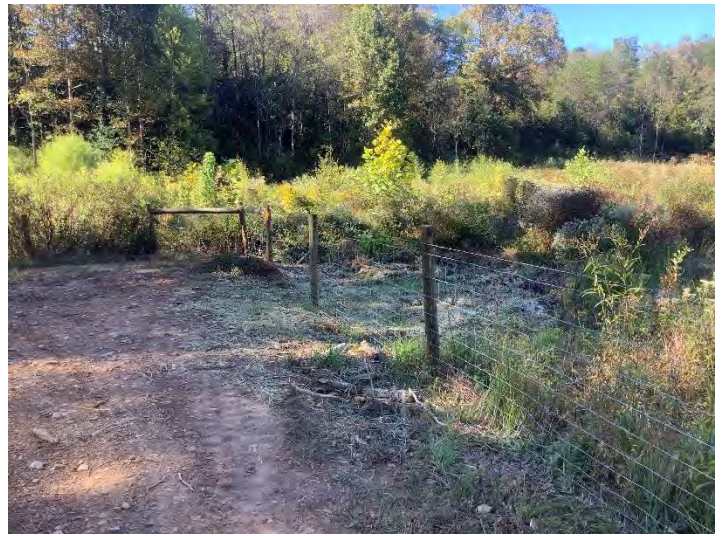
UT2 R2 Crossing and Tree Removed– (09/30/2022)

- l) Kim asked that the downed tree inside the easement on UT2 shole be moved out of the easement.
- m) Kim asked that vegetation be moved or cut back at photo points so the channel condition is obvious. She suggested that photo points at culvert crossings be taken upstream, downstream, and across the crossing. Ella replied that is how photos are typically taken at crossings and an additional photo point was added at the Ford Crossing. Photo points will be updated in the MY2 report.

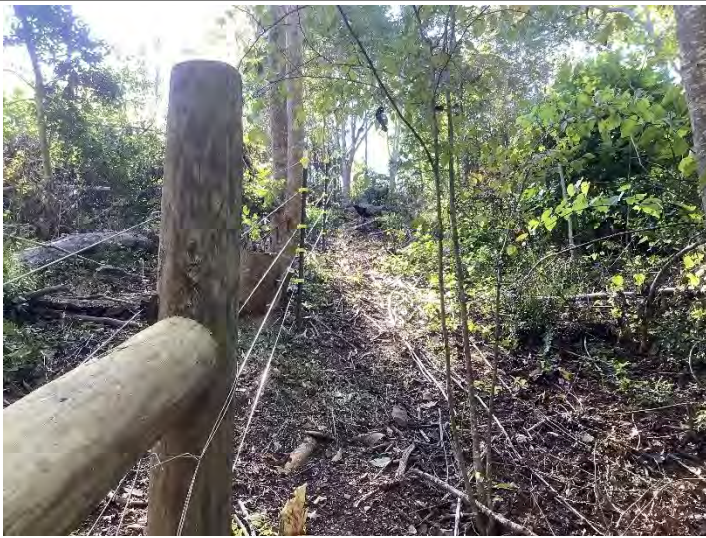
UT5 Fence Repair– (09/30/2022)

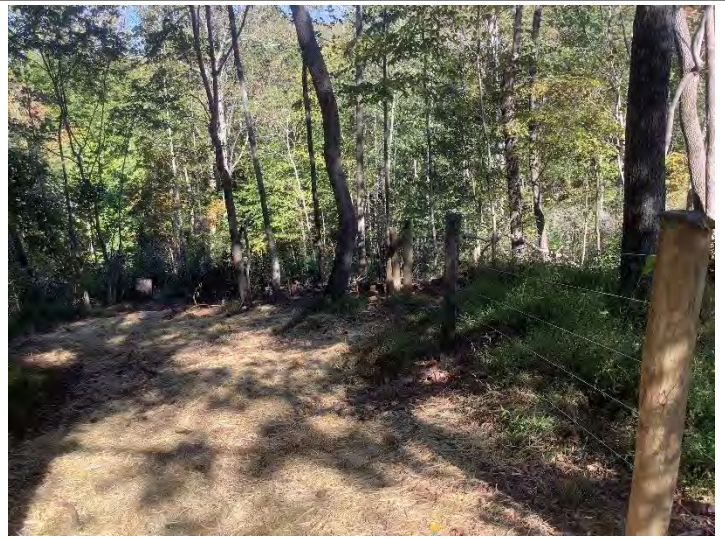
UT5 Fence Repair– (09/30/2022)

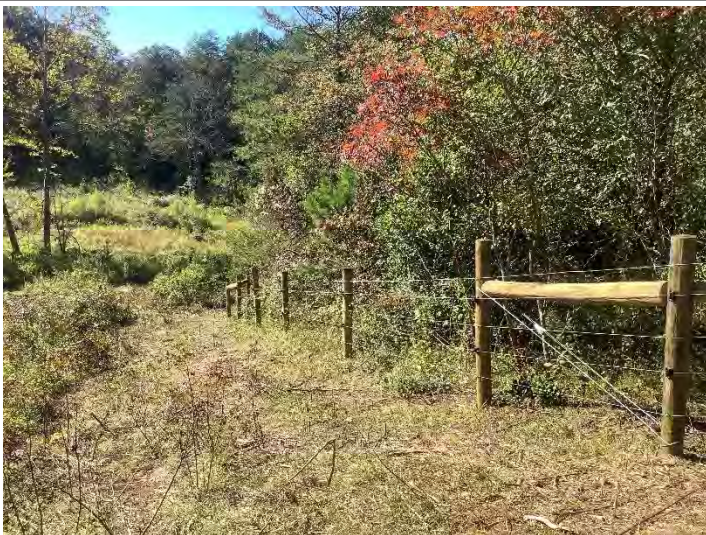
New Easement Fence Installed on Field Adjacent to Venable Creek R4– (09/30/2022)

All fencing additional installation and repairs were completed in September 2022. Approximately 910 LF of fencing was added on the eastern side of Venable Creek Reach 3 outside of the easement boundary, as cattle are being returned to the adjacent pasture. Any breaks in fencing were also repaired at the same time and a full boundary inspection was completed. All fence on the Site is intact and no encroachments were present as of October 2022. The fencing repair areas are documented in the supplemental photographs in Appendix A.

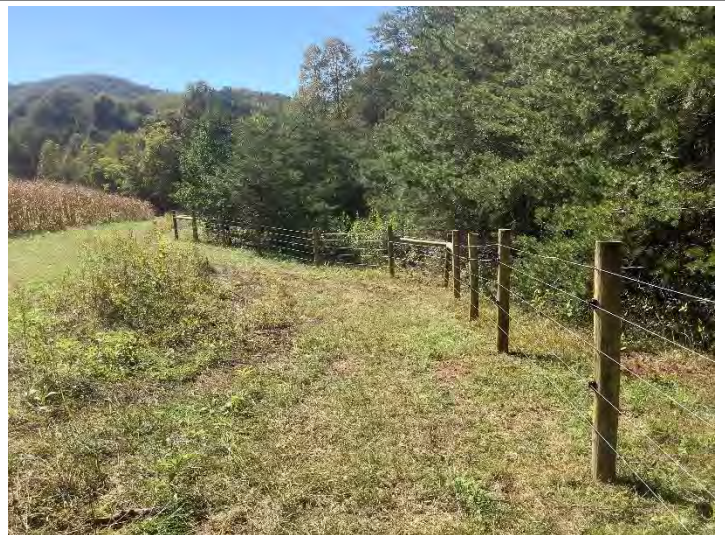
New Easement Fence Installed on Field Adjacent to Venable Creek R4– (09/30/2022)

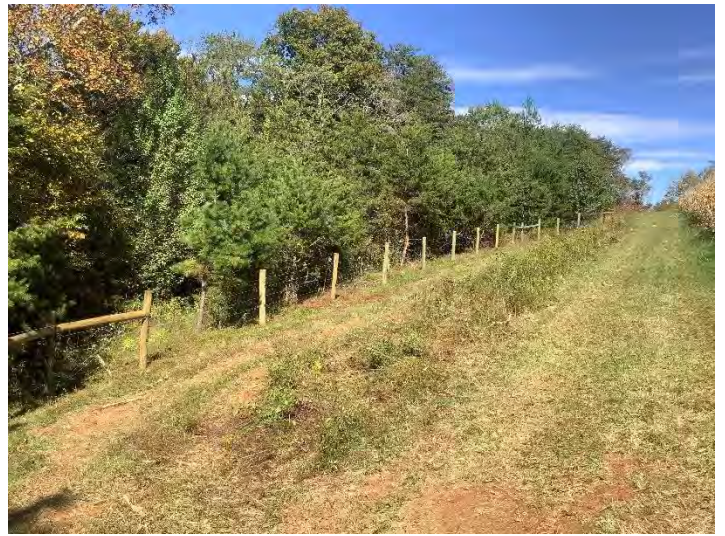
**New Easement Fence Installed on Field Adjacent to Venable
Creek R4– (09/30/2022)**
