# MONITORING YEAR 3 ANNUAL REPORT

## HONEY MILL MITIGATION SITE

Surry County, NC  
DEQ Contract No. 7619  
DMS Project No. 100083

Data Collection Period: January 2023 – October 2023  
FINAL Submission Date: January, 2024

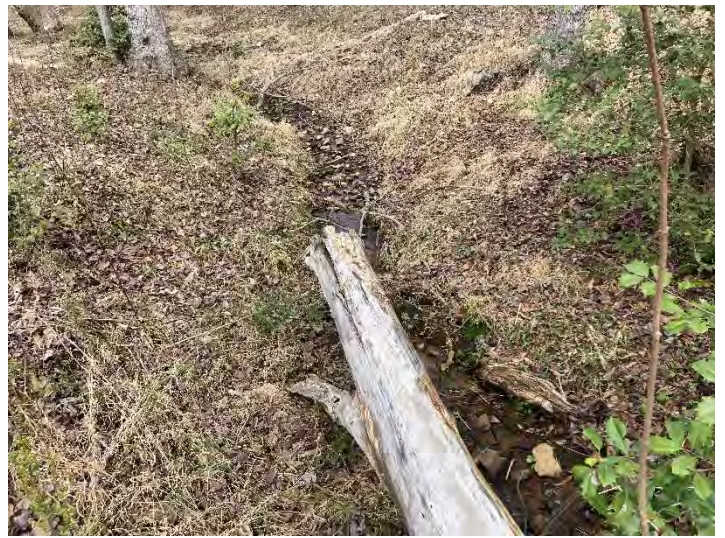
**PHOTO POINT 8 UT2 R1 Headcut – upstream (03/23/2023)**

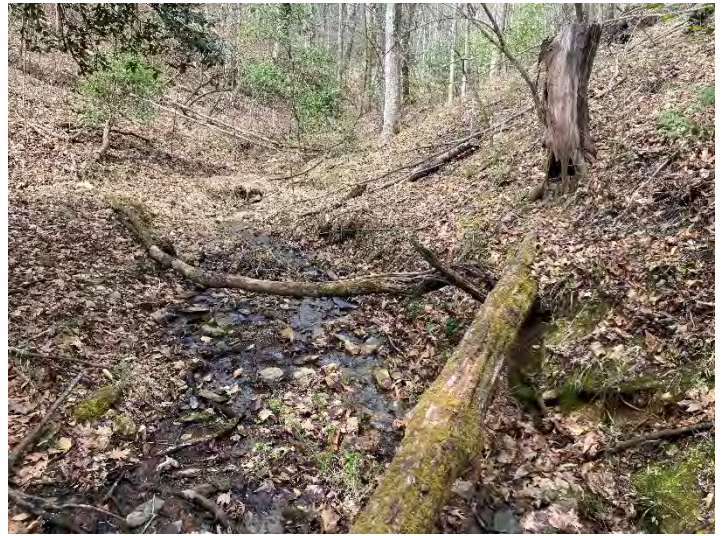
**PHOTO POINT 23 UT5 Headcut – upstream (03/23/2023)**

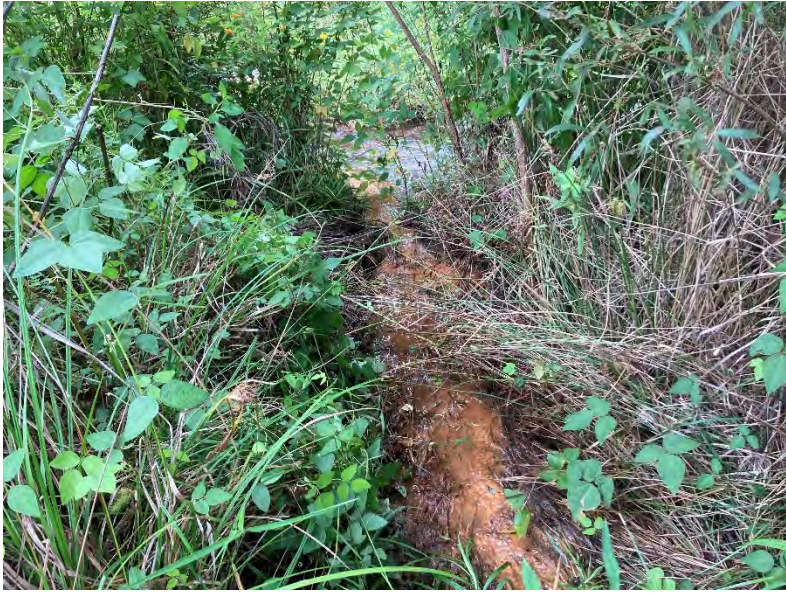
**UT2B-** channel confluence with mainstem upstream (08/30/2023)

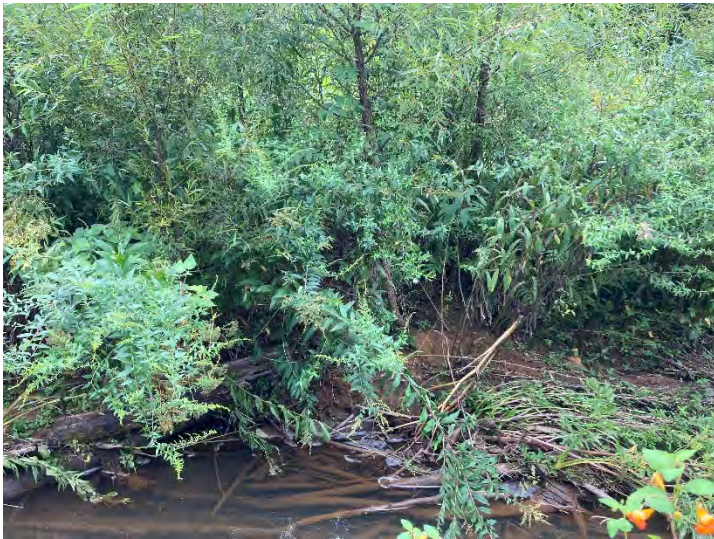
**VC R3-** Meander Bend stabilizing above UT3 confluence after live staking in winter 2022 (08/30/2023)

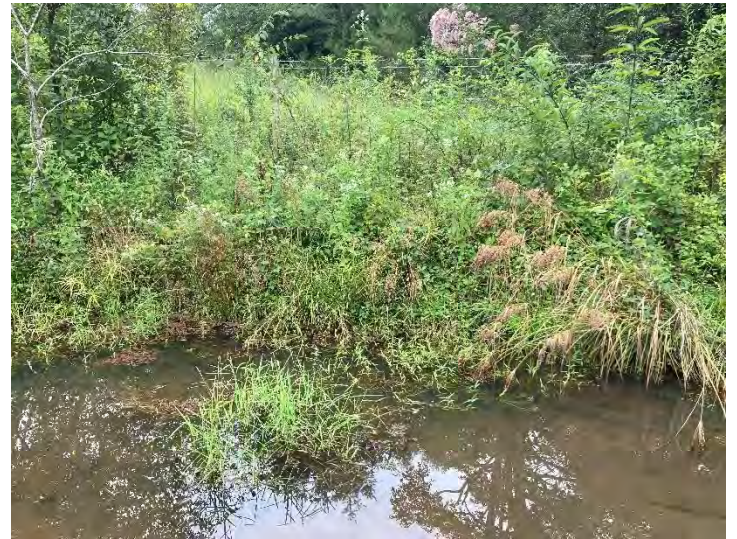
**VC R3-** Wetland seep filling in with vegetation and forming vernal pool (08/30/2023)
