MONITORING YEAR 1 ANNUAL REPORT

HOPEWELL STREAM MITIGATION SITE

Randolph County, NC
NCDEQ Contract 004642
NCDMS Project Number 95352

Data Collection Period: July 2015 - September 2015
Draft Submission Date: November 13, 2015
Final Submission Date: December 18, 2015

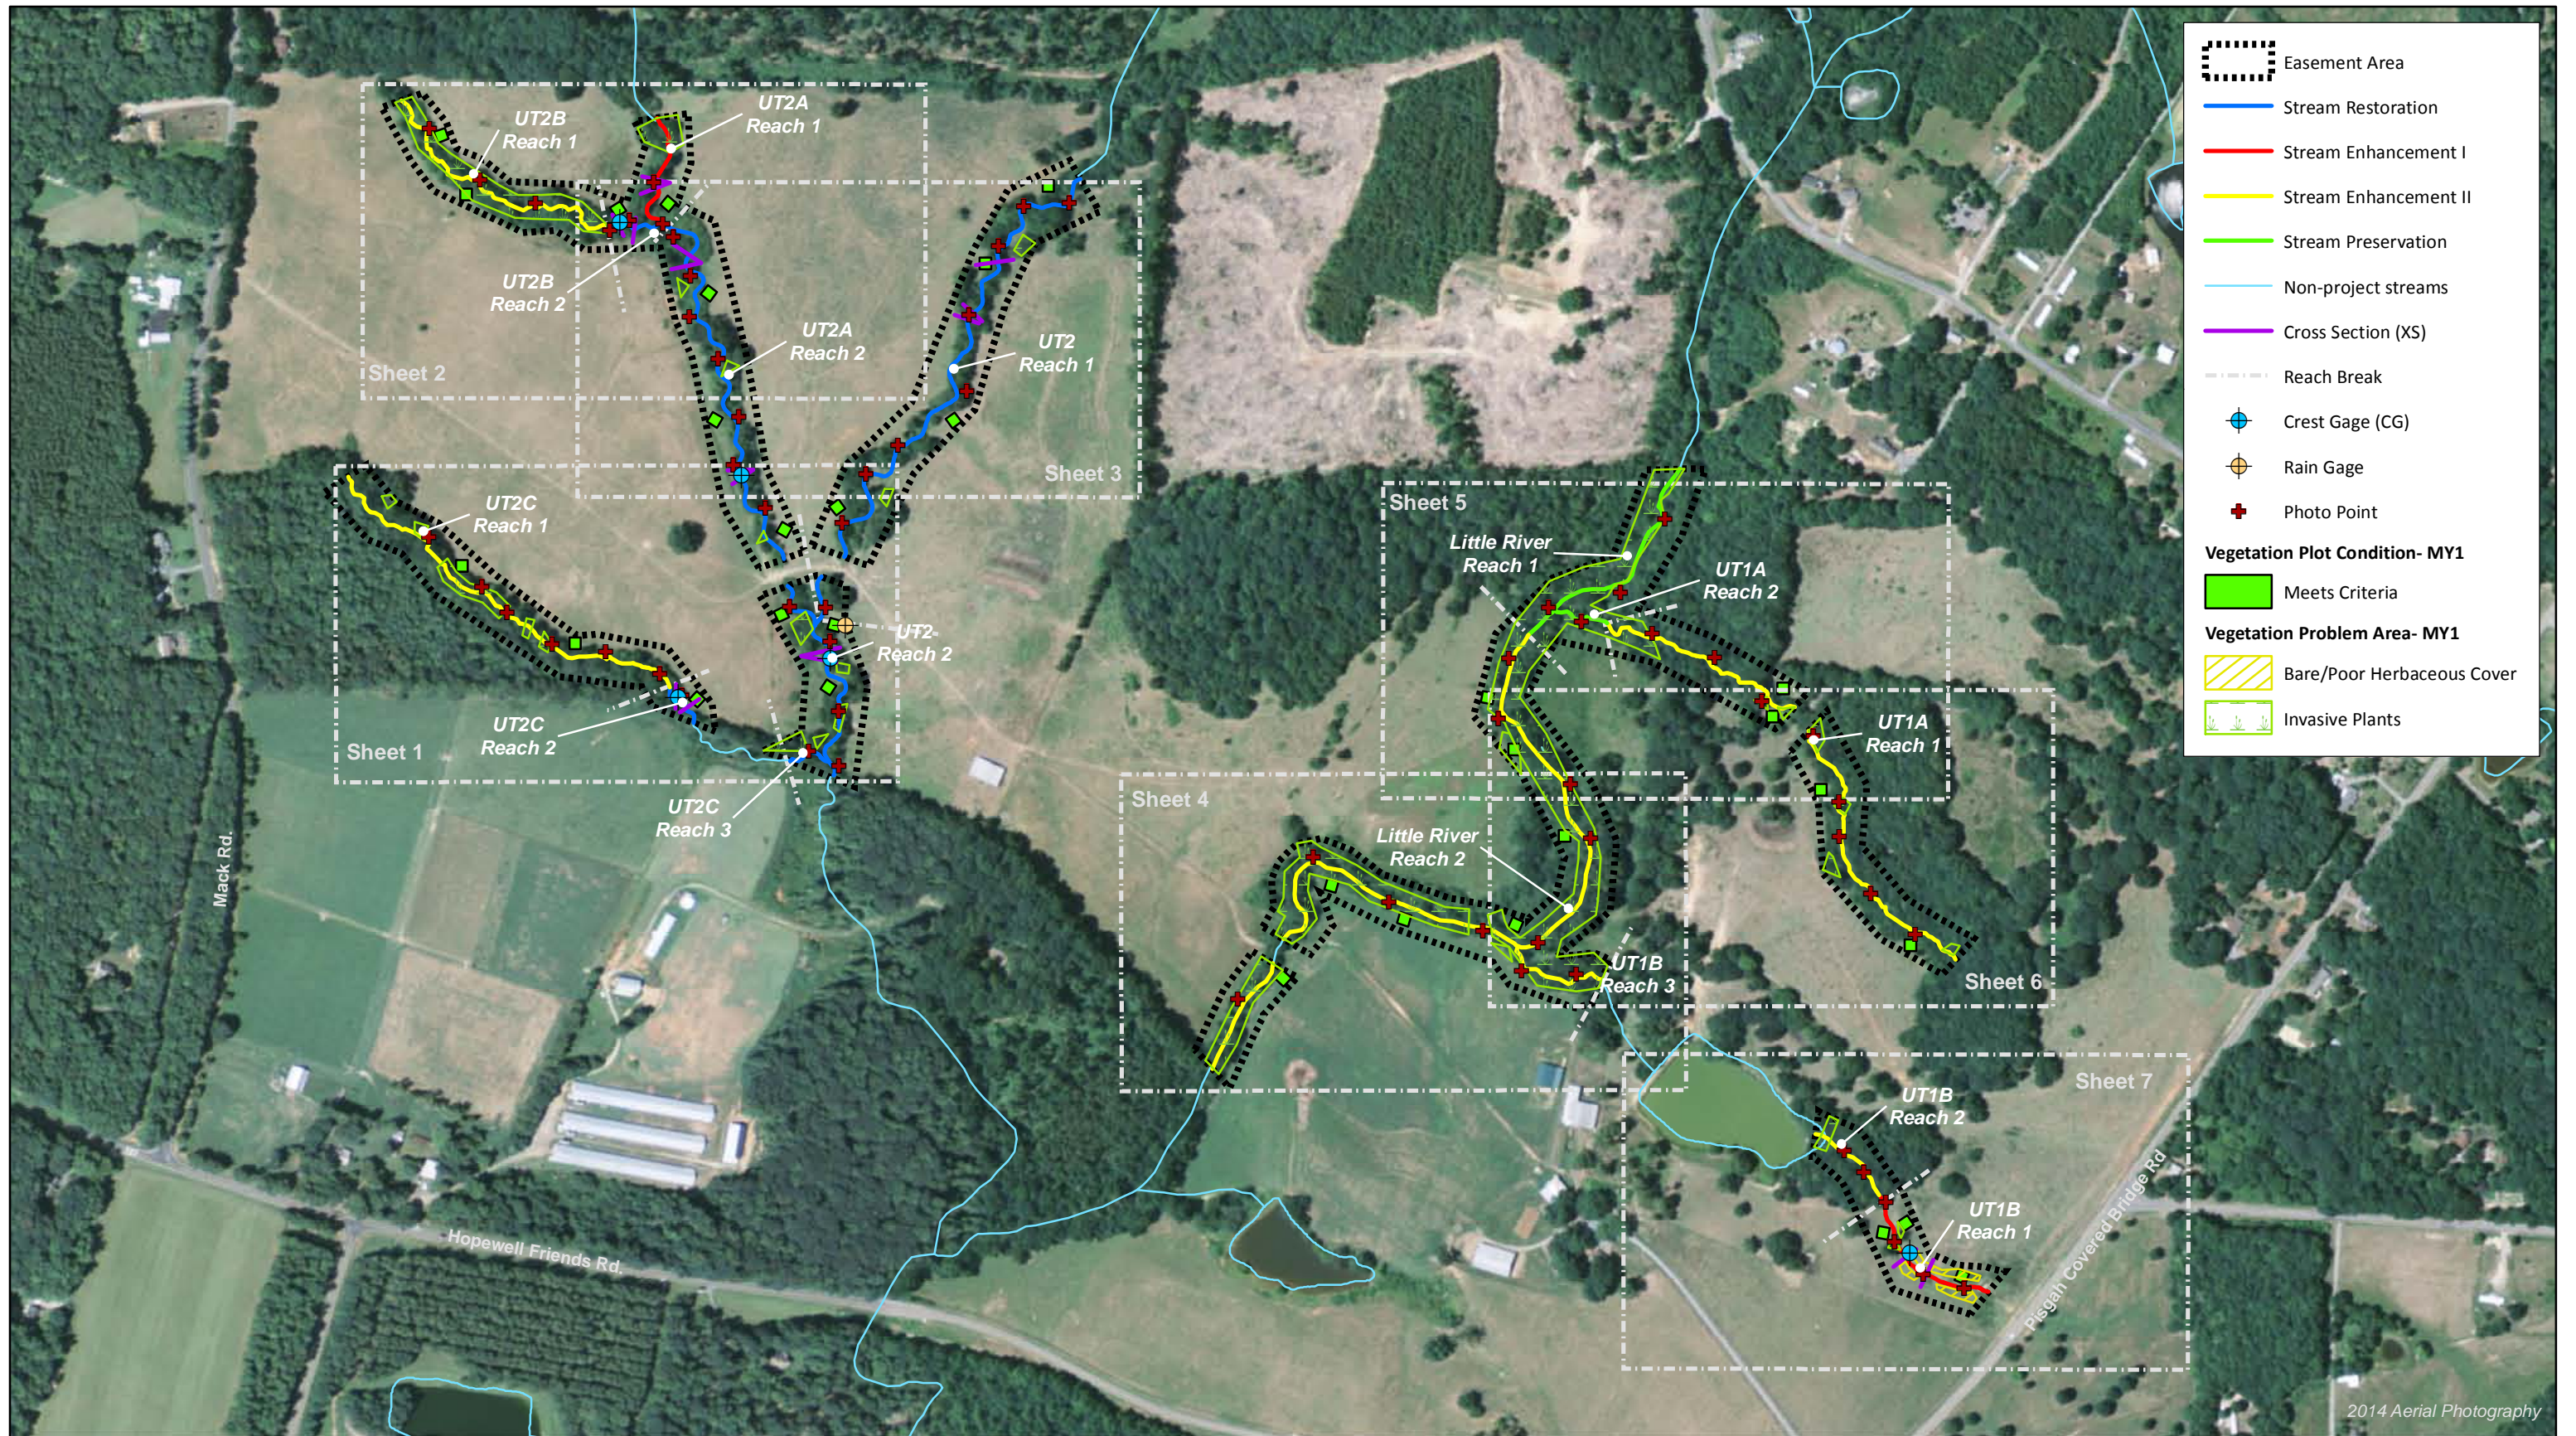
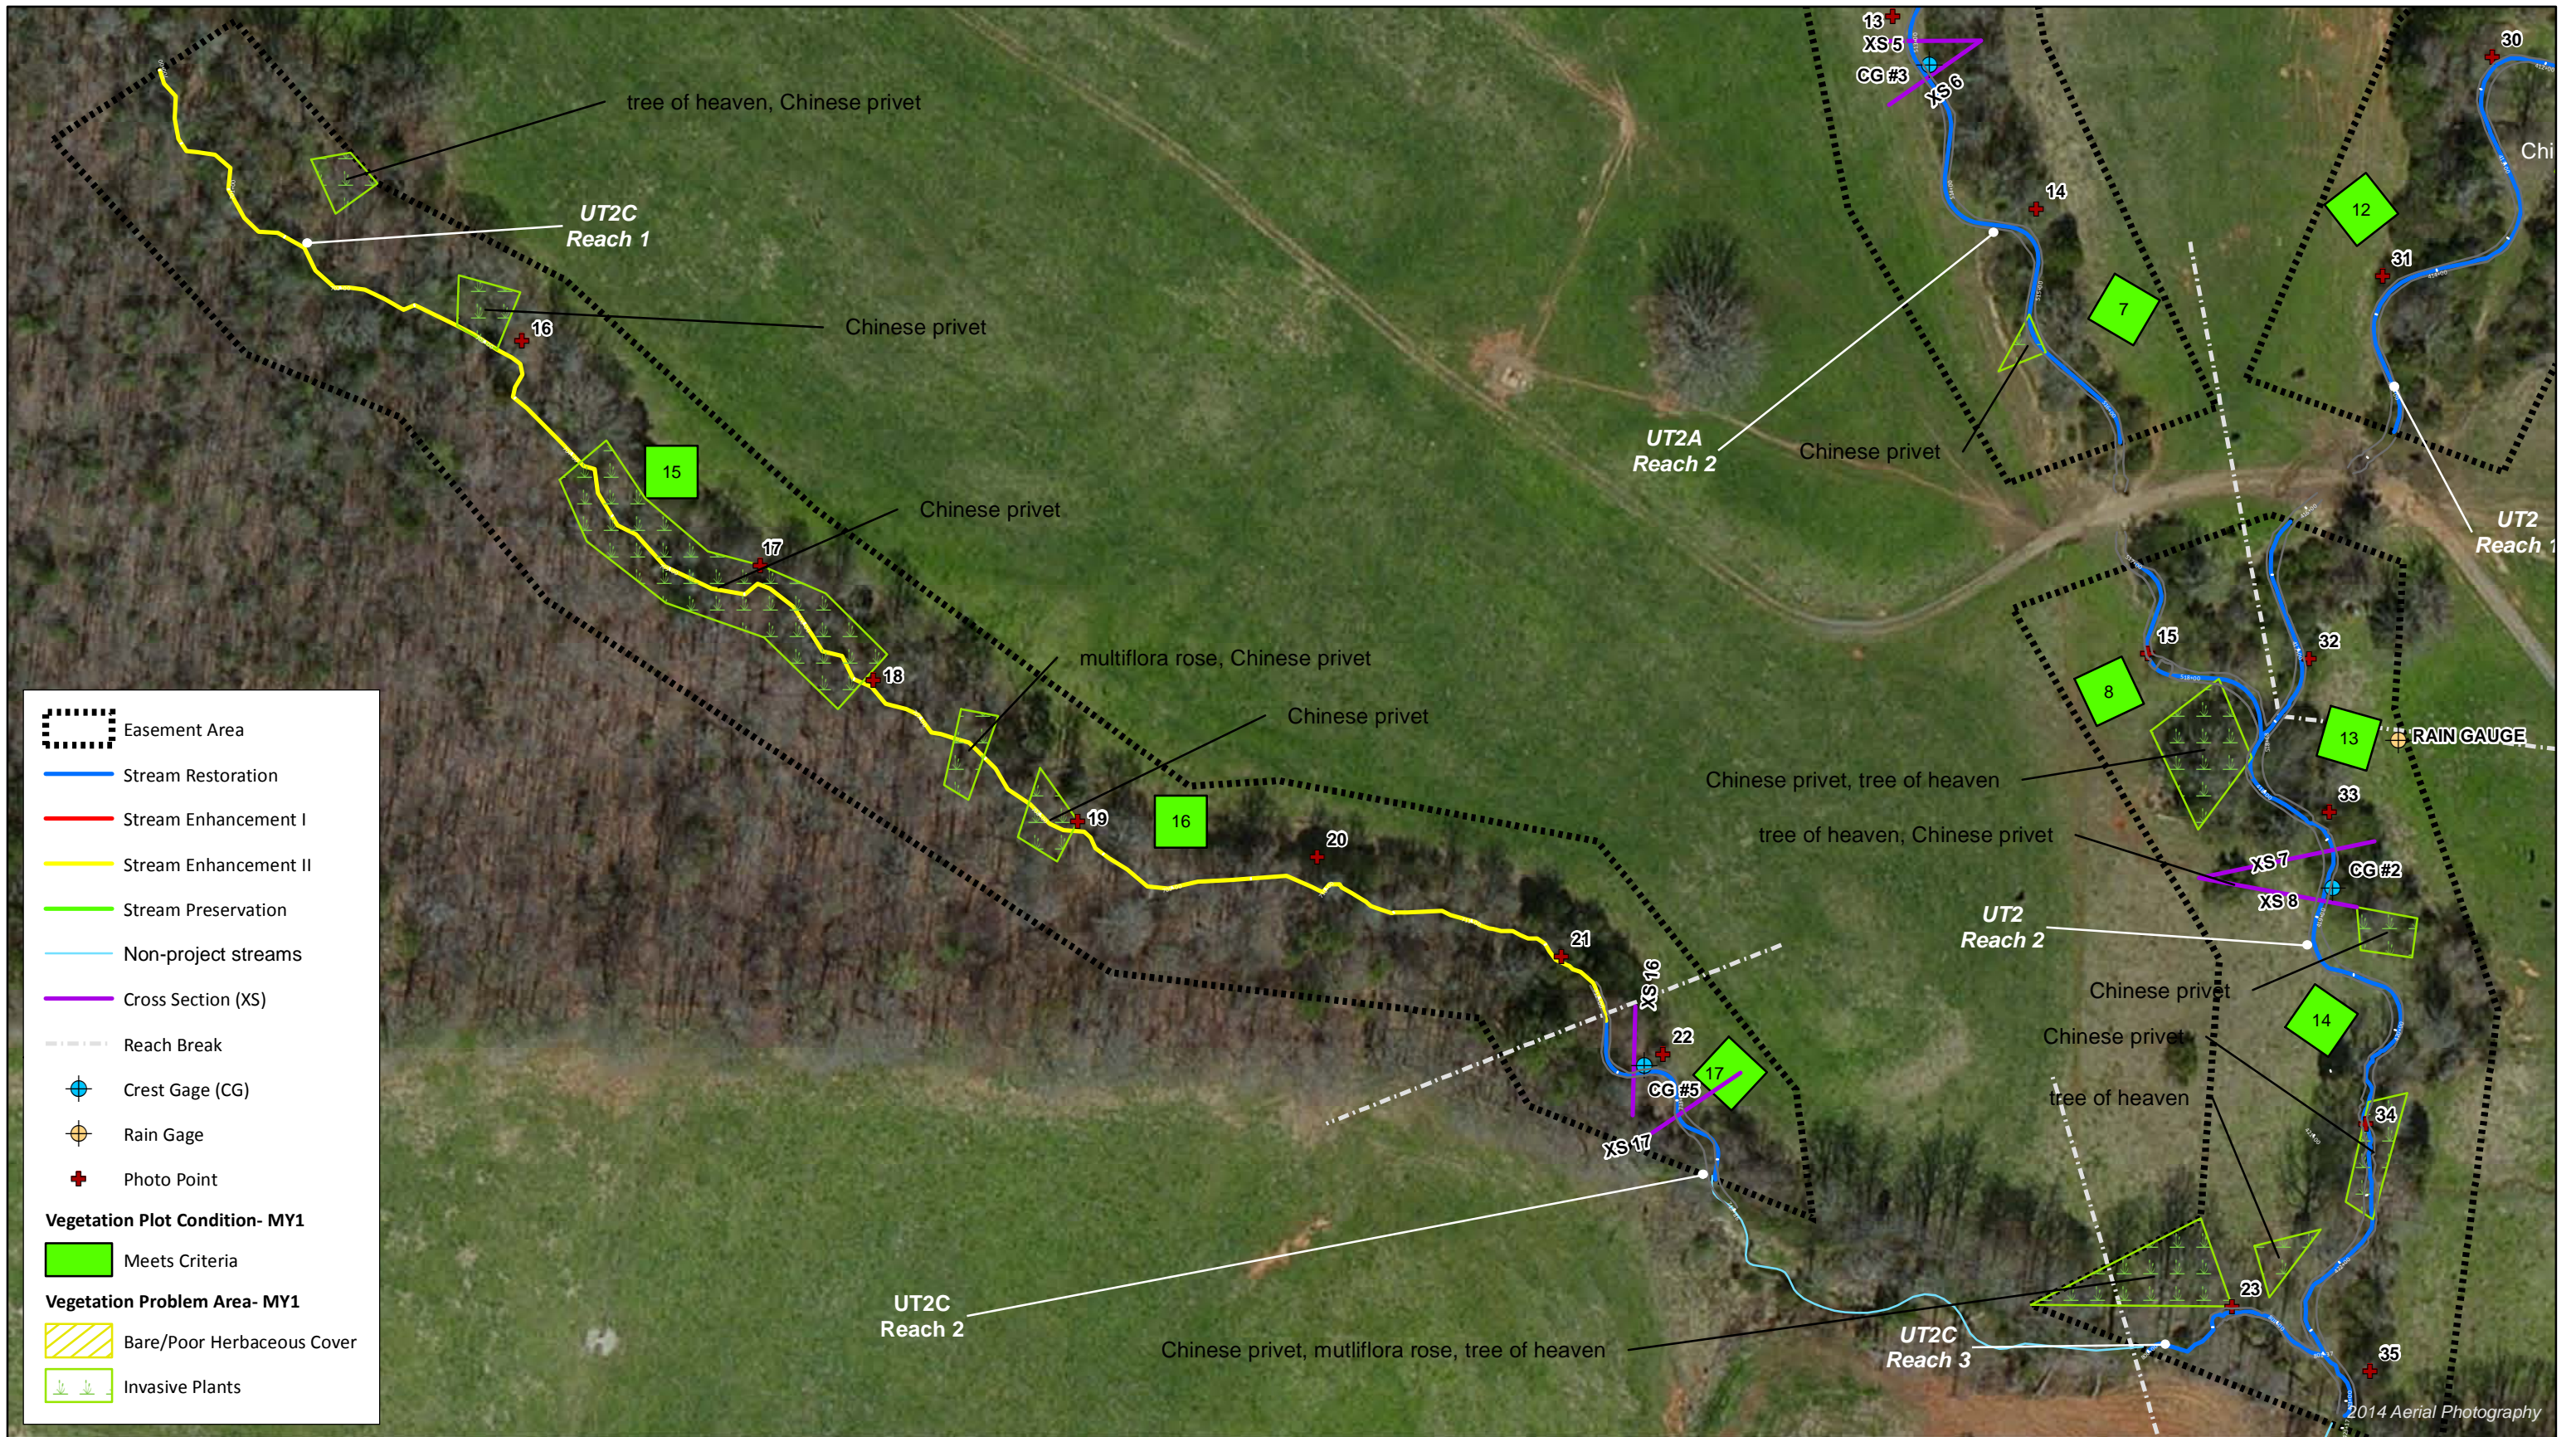
Figure 3.1 Integrated Current Condition Plan View (Sheet 1 of 7)
 Hopewell Stream Mitigation Site
 DMS Project Number 95352
 Monitoring Year 1 - 2015
 Randolph County

Along the upper section of UT1B Reach 1 there are several, small bare areas (<1% of the planted acreage). In these bare areas the planted trees appear healthy, but the herbaceous layer is not well established. Refer to Appendix 2 for the vegetation condition assessment table, Integrated Current Condition Plan View (CCPV), and reference photographs.

Wildlands plans to incorporate lime into the soil at those areas along UT1B Reach 1 that were noted with poor herbaceous growth. Incorporation of lime in these areas is expected to result in a decrease in the soil pH therefor promoting improved herbaceous growing conditions. This area will be monitored, and any additional actions deemed necessary to promote herbaceous plant growth will be taken.
