## **MONITORING YEAR 2 ANNUAL REPORT**

### **HOPEWELL STREAM MITIGATION SITE**

Randolph County, NC

NCDMS Project Number 95352

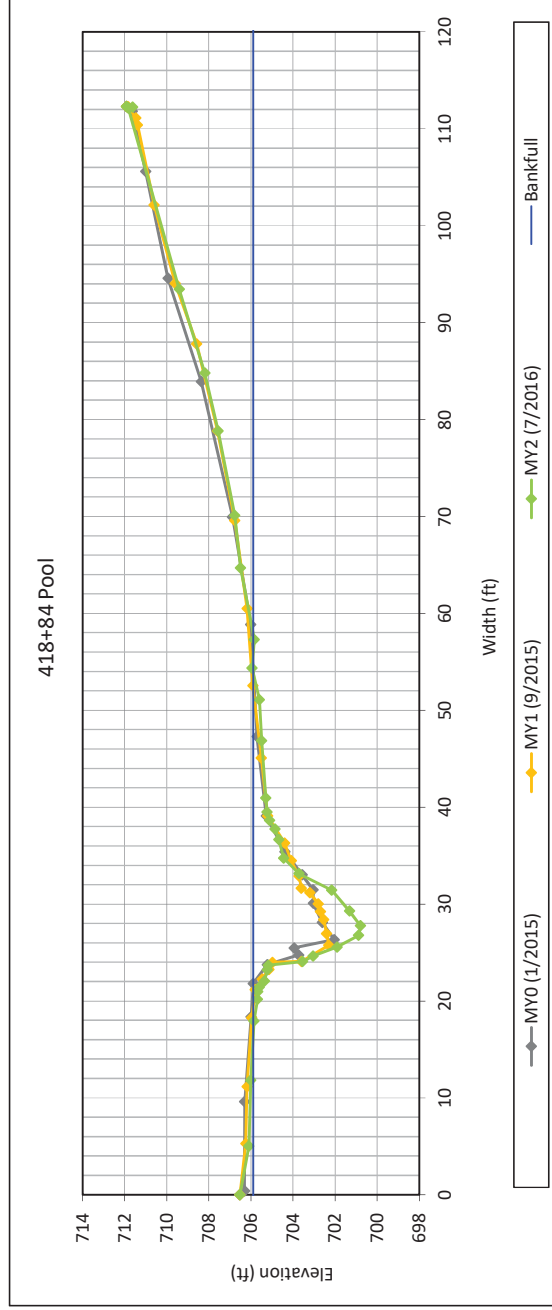
**Cross Section 7, UT2 R2**

In general, cross sections for UT2, UT2A, UT2B, UT2C, and UT1B show little to no change in the bankfull area, maximum depth ratio, or width-to-depth ratio. Changes observed at cross section 7 (UT2 - Reach - 2) were the result of pool scouring at this one location. Willow root mats are growing into the channel at cross section 17 (UT2C - Reach 2) resulting in a decreased bankfull area and depth in MY2.

The decrease in cross sectional area and depth noted on UT2C - Reach 2 will continue to be monitored during subsequent years for signs of instability and a maintenance plan will be established if deemed necessary. The increased pool depth at one location on UT2 does not constitute a problem as long as the stream is otherwise stable.
