MONITORING YEAR 3 ANNUAL REPORT

HOPEWELL STREAM MITIGATION SITE

Randolph County, NC
NCDEQ Contract 004642
NCDMS Project Number 95352

Data Collection Period: February 2017 - September 2017
Final Submission Date: December 20, 2017

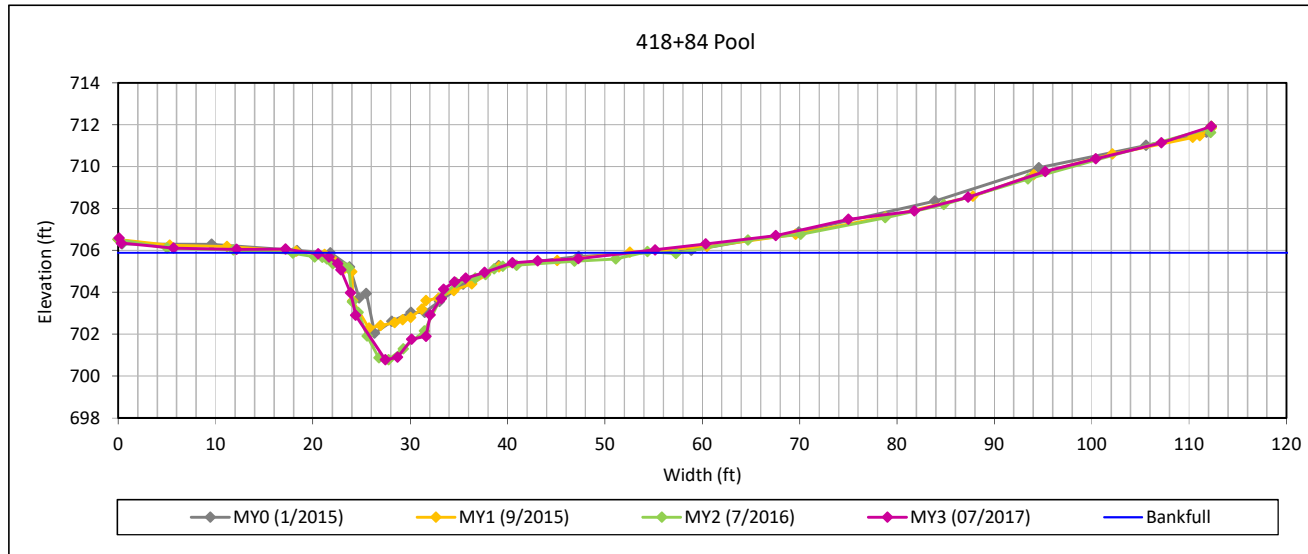
Cross Section 7, UT2 R2

In general, cross sections for UT2, UT2A, UT2B, UT2C, and UT1B show little to no change in the bankfull area, maximum depth ratio, or width-to-depth ratio. Changes observed at cross section 7 (UT2 - Reach 2) between MY1 and MY2 were the result of pool scouring at this one location. No additional scouring was observed during MY3. Some minor riffle scour was observed at cross section 9 (UT2B – Reach 2) which will continue to be monitored during subsequent years. Vegetation root mat growth within the channel at cross section 14 (UT1B – Reach 1) has resulted in a decreased bankfull area and depth in MY3. The decreased bankfull area and depth observed in MY2 at cross section 17 (UT2C - Reach 2) associated with willow root mats within the channel appears to have stabilized.

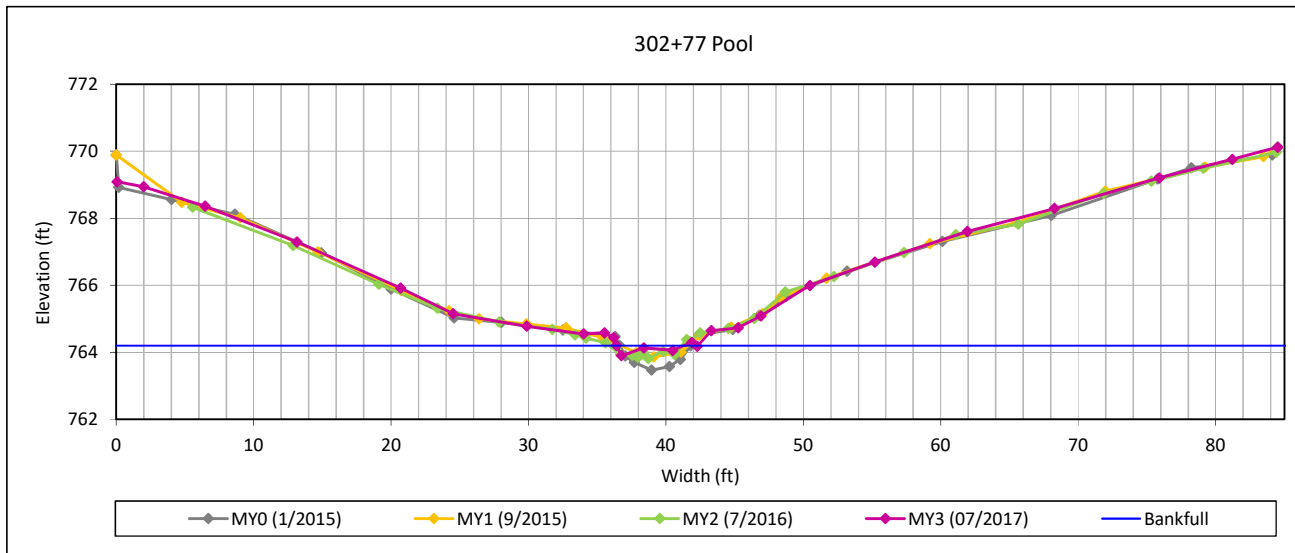
Cross Section 14, UT1B R1

The changes in cross sectional area and depth noted for cross sections 14 and 17 will continue to be monitored during subsequent years for signs of instability and a maintenance plan will be established if deemed necessary. The increased pool depth at one location on UT2 does not constitute a problem as long as the stream is otherwise stable.
