MONITORING YEAR 4 ANNUAL REPORT

HOPEWELL STREAM MITIGATION SITE

Randolph County, NC
DEQ Contract No. 004642
DMS Project N 95352

Data Collection Period: February – October 2018
Submission Date: December 13, 2018

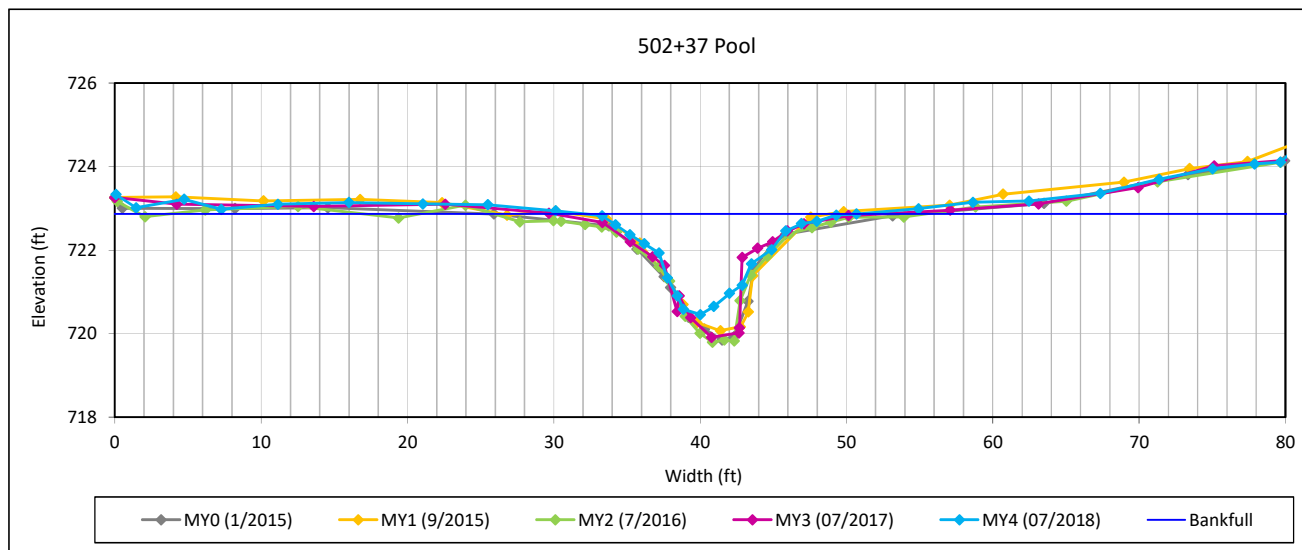
Cross-Section 1, UT2A Reach 1

In general, cross sections for UT2, UT2A, UT2B, UT2C, and UT1B show little to no change in the bankfull area, maximum depth ratio, or width-to-depth ratio. During MY4, minor aggradation was documented at cross sections 1 and 2 (UT2A – Reach 1). The slight adjustment in channel dimension will be monitored in subsequent years and currently doesn't indicate instability. Changes observed at cross section 7 (UT2 - Reach 2) between MY1 and MY2 were the result of pool scouring at this location. No additional scouring was observed in MY3 or MY4. Minor riffle scour observed in MY3 at cross section 9 (UT2B – Reach 2) wasn't documented during the MY4 survey suggesting the channel has adjusted back towards the design bed elevation. During MY4 the bankfull stage was adjusted at cross section 9 because the bankfull elevation appears to have been set slightly below top of bank during the baseline assessment. As a result, bankfull area and depth increased at this cross section.

The changes in cross sectional area and depth noted for cross sections 1, 2, and 14 will continue to be monitored during subsequent years for signs of instability and a maintenance plan will be established if deemed necessary.

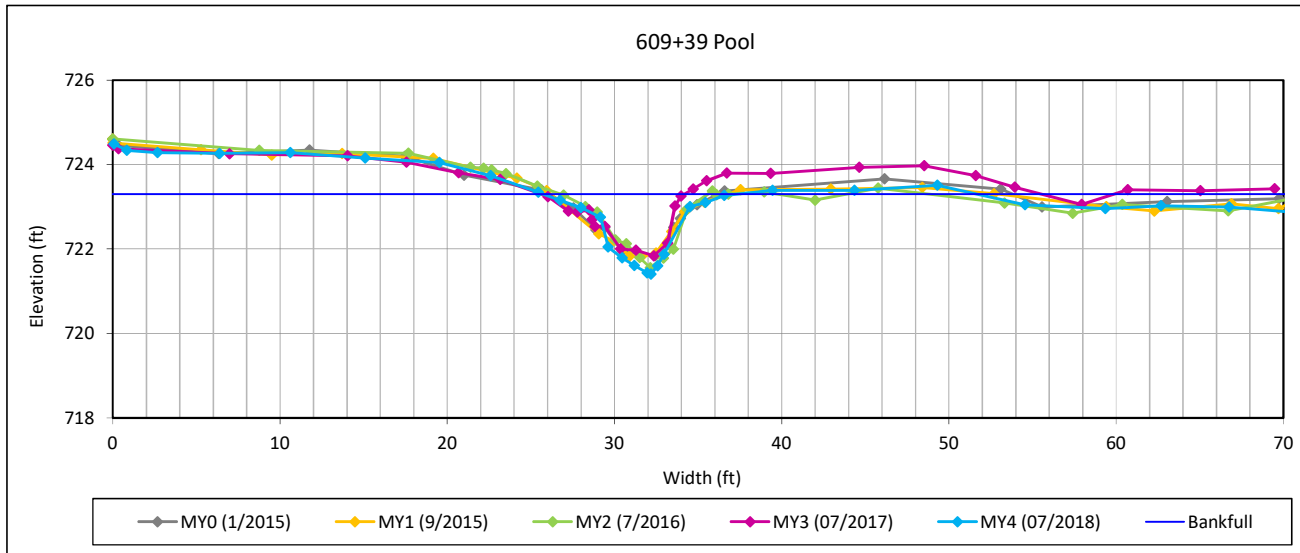
Cross-Section 10, UT2B R2

Pool scouring at cross section 10 (UT2B – Reach 2) has resulted in an increase in bankfull depth. Vegetation root mat growth has continued within the channel at cross section 14 (UT1B – Reach 1) which has resulted in an increase in the bankfull elevation. Decreased bankfull area and depth observed in MY2 at cross section 17 (UT2C - Reach 2) associated with willow root mats within the channel appears to have stabilized.
