MONITORING YEAR 5 ANNUAL REPORT Final

HOPEWELL STREAM MITIGATION SITE

Randolph County, NC

DMS Project N 95352

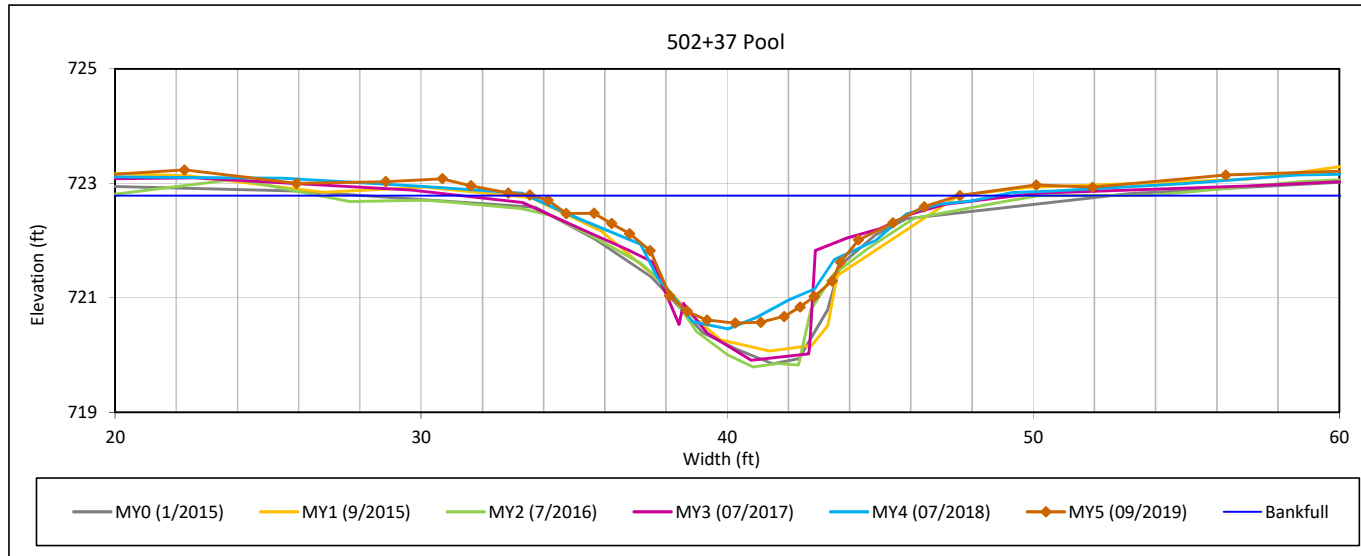
Cross Section 1, UT2A Reach 1

In general, cross-sections for UT2, UT2A, UT2B, UT2C, and UT1B show little to no change in the bankfull area, maximum depth ratio, or width-to-depth ratio. In MY5, the minor aggradation documented during MY4 at cross-sections 1 and 2 (UT2A – Reach 1) hasn't changed indicating that they are stable. During MY5, aggradation was recorded at cross-sections 16 and 17 (UT2C – Reach 2). The adjustments in channel dimension will be monitored in subsequent years and currently don't indicate instability. Changes observed at cross-section 7 (UT2 - Reach 2) between MY1 and MY2 were the result of pool scouring at this location. No additional scouring was observed in MY3, MY4, or MY5. Minor riffle scour observed in MY3 at cross-section 9 (UT2B – Reach 2) wasn't documented during the MY4 or MY5 survey suggesting the channel has adjusted back towards the design bed elevation. During MY4 the bankfull stage was adjusted at cross-section 9 because the bankfull elevation appeared to have been set slightly below top of bank during the baseline assessment.

15.3	x-section area (ft.sq.)
14.0	width (ft)
1.1	mean depth (ft)
2.2	max depth (ft)
15.1	wetted perimeter (ft)
1.0	hyd radi (ft)
12.8	width-depth ratio

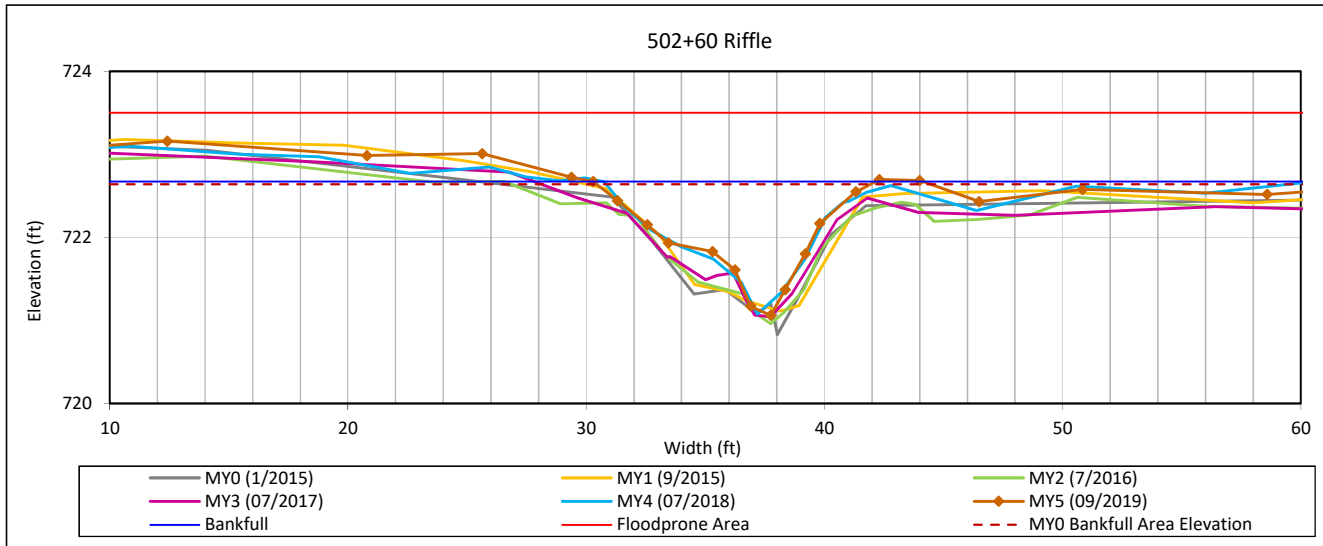
Cross-Section 2, UT2A Reach 1

8.4	x-section area (ft.sq.)
11.8	width (ft)
0.7	mean depth (ft)
1.6	max depth (ft)
12.4	wetted perimeter (ft)
0.7	hyd radi (ft)
16.7	width-depth ratio
87.4	W flood prone area (ft)
7.4	entrenchment ratio
1.0	low bank height ratio

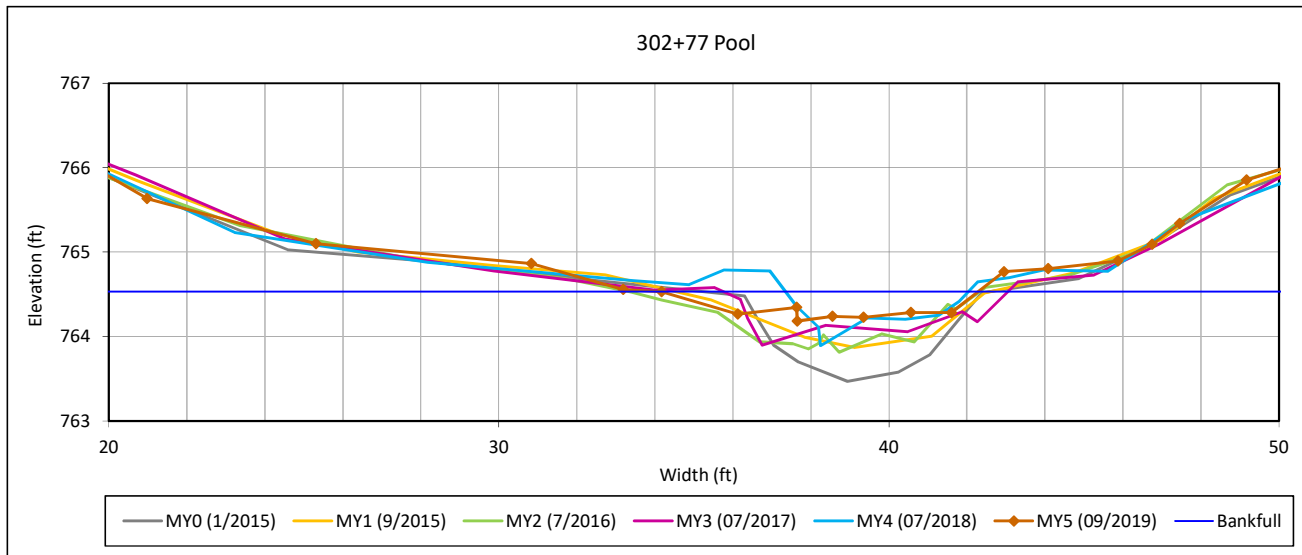
Cross-Section 14, UT1B R1

The changes in cross-sectional area and depth noted for cross-sections 14, 16, and 17 will continue to be monitored during subsequent years for signs of instability and a maintenance plan will be established if deemed necessary.

1.8	x-section area (ft.sq.)
8.1	width (ft)
0.2	mean depth (ft)
0.3	max depth (ft)
8.3	wetted parimeter (ft)
0.2	hyd radi (ft)
36.6	width-depth ratio

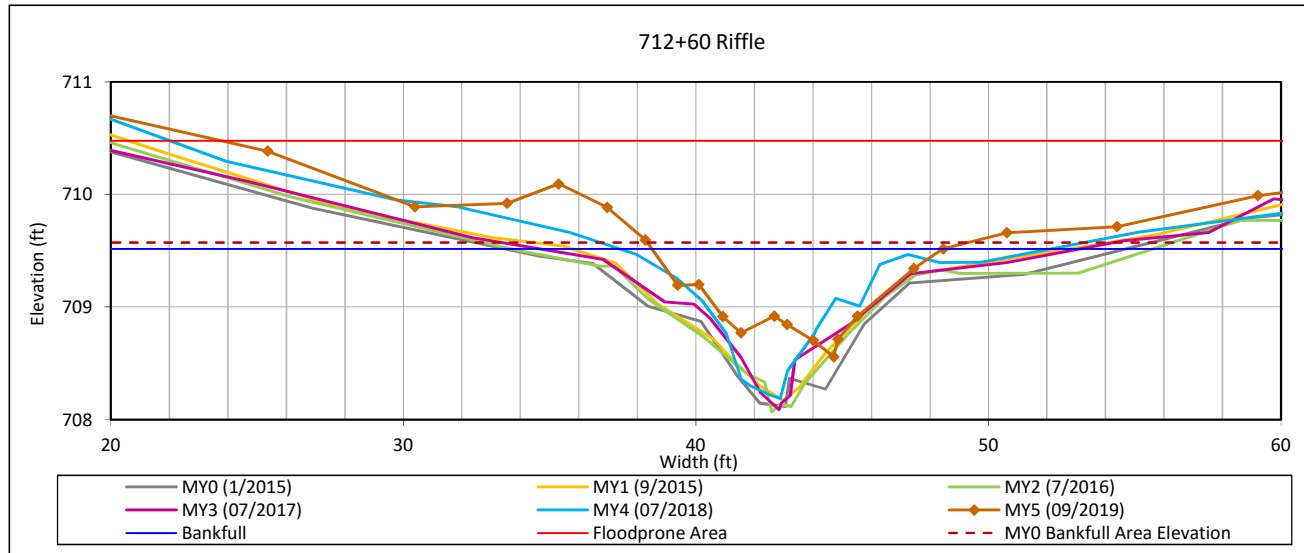
Cross-Section 16, UT2C R2

4.9	x-section area (ft.sq.)
10.0	width (ft)
0.5	mean depth (ft)
1.0	max depth (ft)
10.3	wetted perimeter (ft)
0.5	hyd radi (ft)
20.2	width-depth ratio
44.5	W flood prone area (ft)
4.5	entrenchment ratio
0.9	low bank height ratio

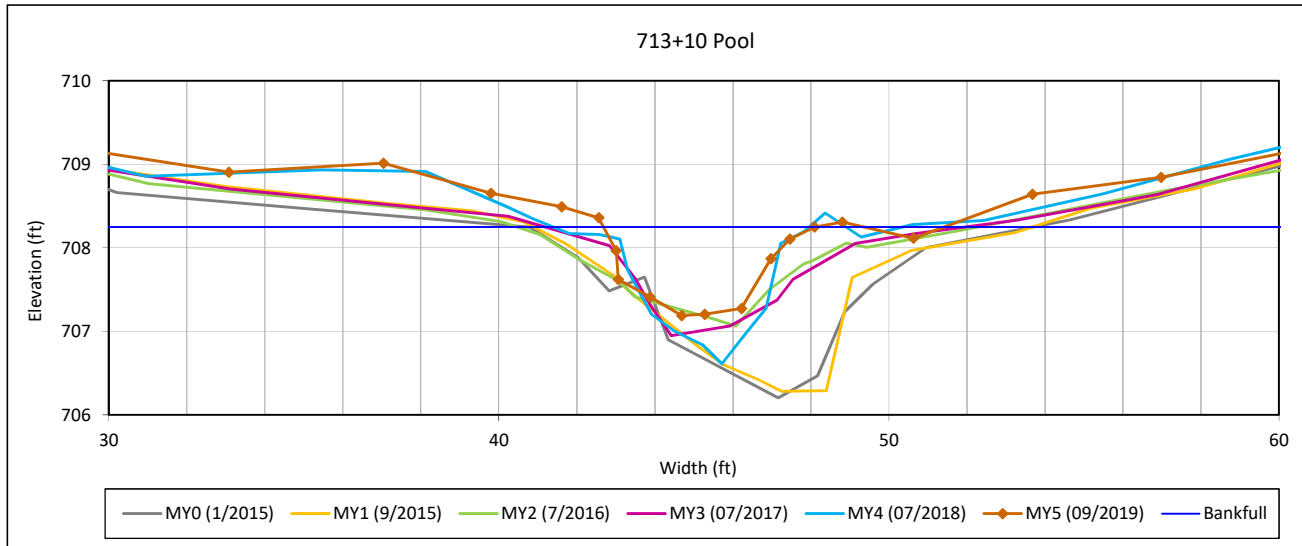
Cross-Section 17, UT2C R2

3.7	x-section area (ft.sq.)
5.4	width (ft)
0.7	mean depth (ft)
1.1	max depth (ft)
6.1	wetted perimeter (ft)
0.6	hyd radi (ft)
7.9	width-depth ratio
