MONITORING YEAR 6 ANNUAL REPORT Final

HOPEWELL STREAM MITIGATION SITE

Randolph County, NC

DMS Project No. 95352

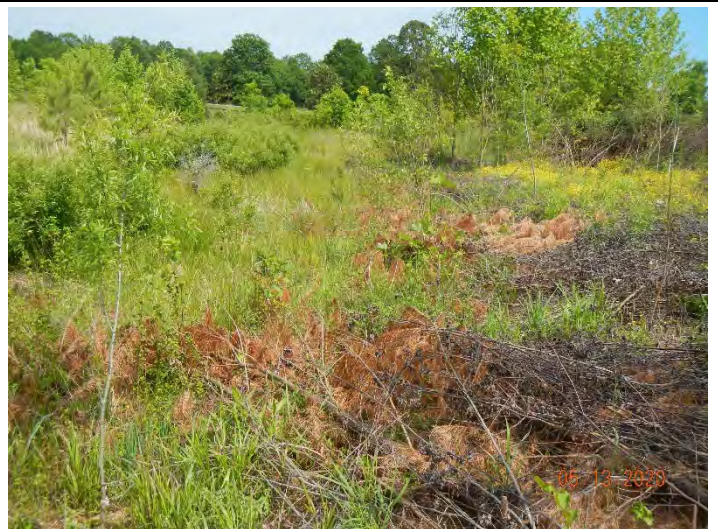
Small bare areas noted during previous monitoring years along the upper section of UT1B Reach 1 have established herbaceous cover because of re-seeding, liming, and fertilizing. No bare areas were noted in MY6. Pockets of dense sweetgum (*Liquidambar styraciflua*) volunteers were treated in late 2019 and early 2020 in the upper section of UT1B Reach 1 and UT2C Reach 2. In February 2020, 75 containerized trees were planted in the larger sweetgum treatment area on UT1B Reach 1 as discussed during the IRT/DMS site meeting in May 2019. Refer to Appendix 6 for IRT/DMS meeting minutes and Appendix 7 for photographs of sweetgum treatment and containerized tree planting areas taken in May 2020.

Left hillside at Station 303+50 – sweetgum treatment / plantings (05/13/2020)

Left hillside at Station 303+50 – looking upstream (05/13/2020)
