FINAL MONITORING REPORT (MY7) / CLOSEOUT REPORT

HOPEWELL STREAM MITIGATION SITE

Randolph County, NC

DMS Project No. 95352

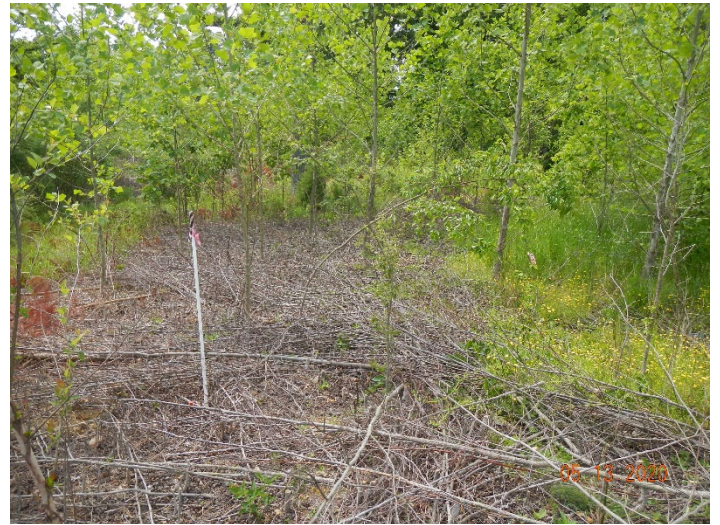
Right hillside at Station 303+50 – sweetgum treatment / plantings (05/13/2020)

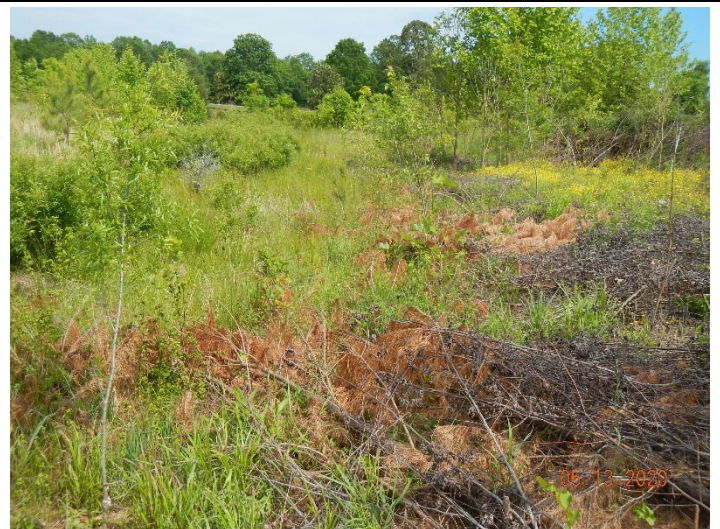
Left hillside at Station 303+50 – looking upstream (05/13/2020)

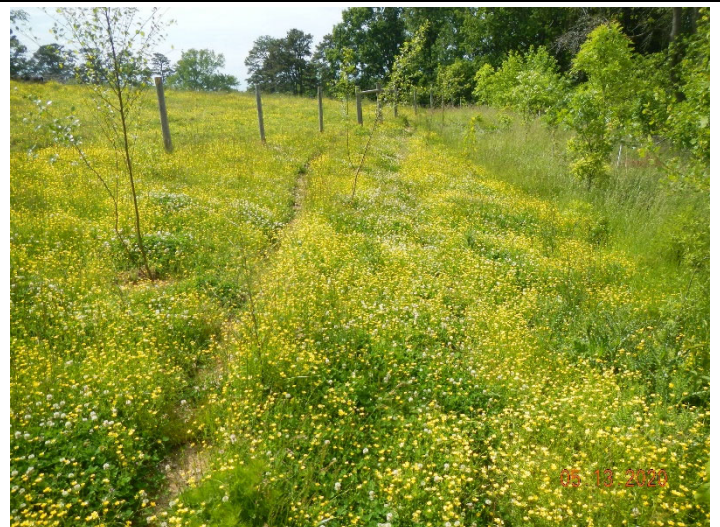
Left easement corner at Station 303+50 – new fencing / plantings (05/13/2020)
