South Muddy Creek Stream Restoration Project Final Baseline Monitoring Document and As-Built Baseline Report

McDowell County, North Carolina

NCEEP Project Numbers - 737 and 92251

Submission Date: June 30, 2011

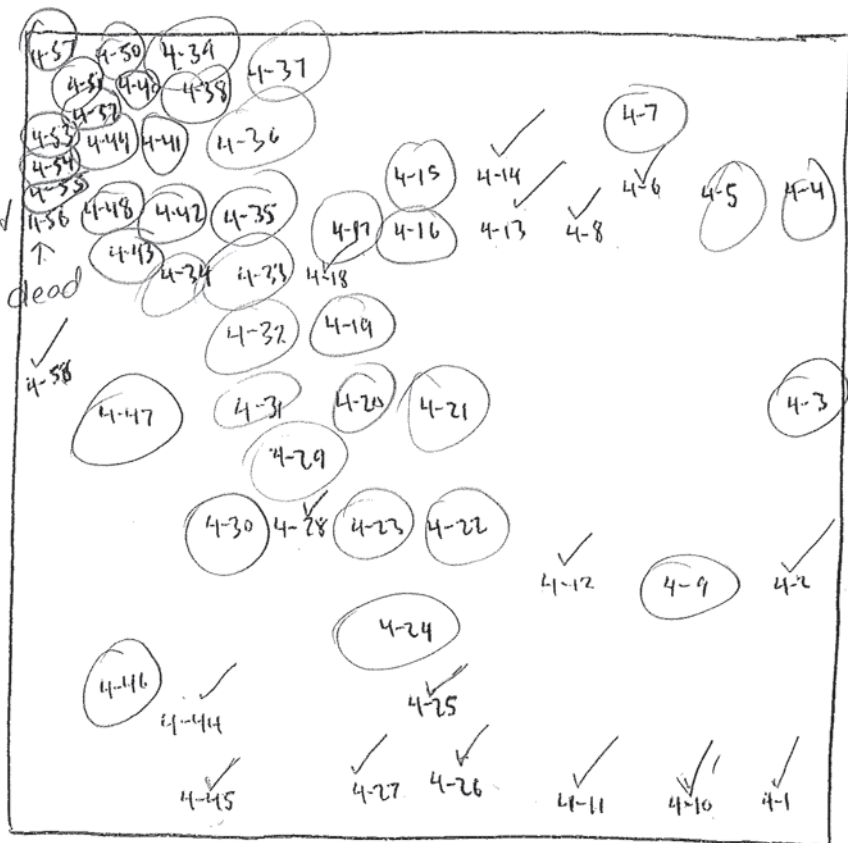
Unusual cluster of stems in this corner →

Perhaps due to reconstruction of meander - replanting?
