Hoppers Creek-Melton Farm Stream Restoration Project

Year 1 Monitoring Report

McDowell County, North Carolina

NCEEP Project Number – 92251

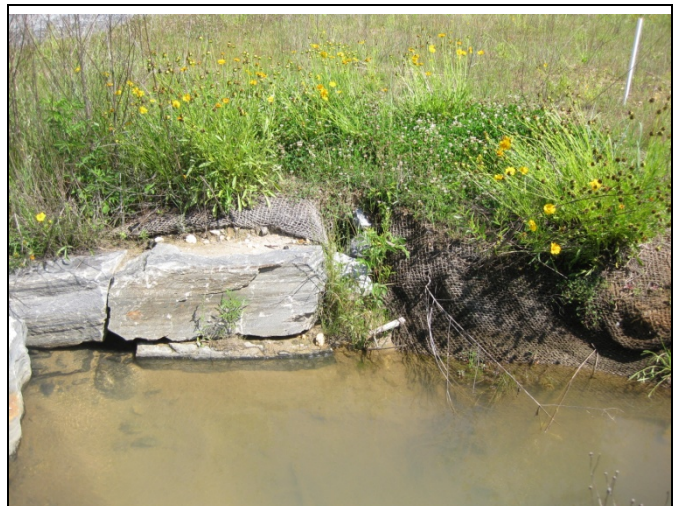
SPA3 and SPA4 involve the piping of flow and bank scour, respectively, observed at the cross vane located downstream of the easement crossing in SFHC Reach 2. Since construction, flow has continued to pipe (SPA3) under the downstream sill and through both cross vane arms as a possible result of poor soil compaction, inadequate silting, and/or failing filter fabric. The piping of flow through the vane arms may have become exacerbated by the bank scour and recent exposure of macropores reported along the back of the right vane arm for SPA4. Bankfull events appear to be diverting excess flow into the left and right floodplains, and scouring the back of the right (and end of the left) vane arm due to the transition of expanded flow from the (wide) upstream easement crossing area to a narrower cross-sectional area downstream. Scoured areas around both vane arms should be stabilized to prevent additional piping that could potentially lead to the compromising of structural integrity over time.

SPA3 – SFHC Reach 2 Piping of cross vane

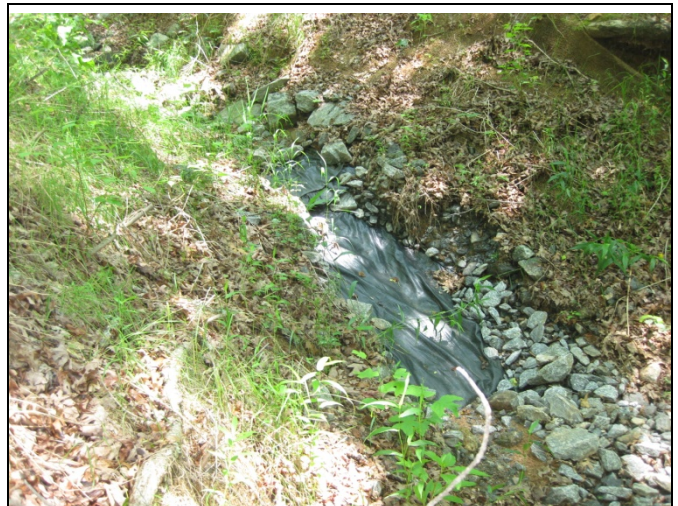
SPA5 – UT2 Reach A Piping within riffle cascade around log sill

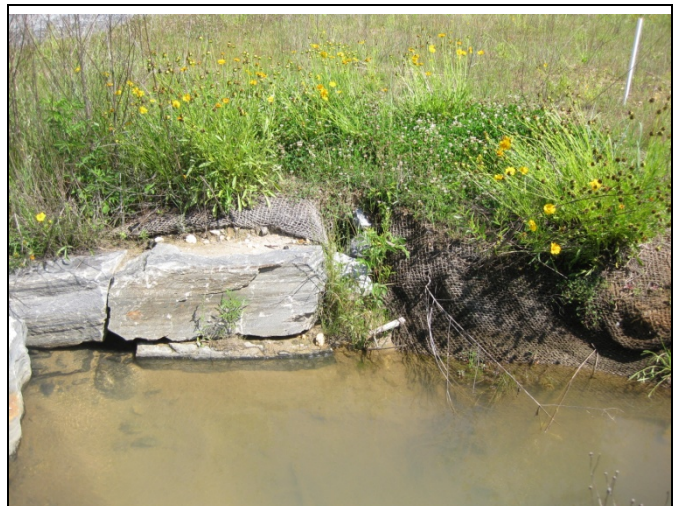
SPA3 – SFHC Reach 2 Piping of cross vane

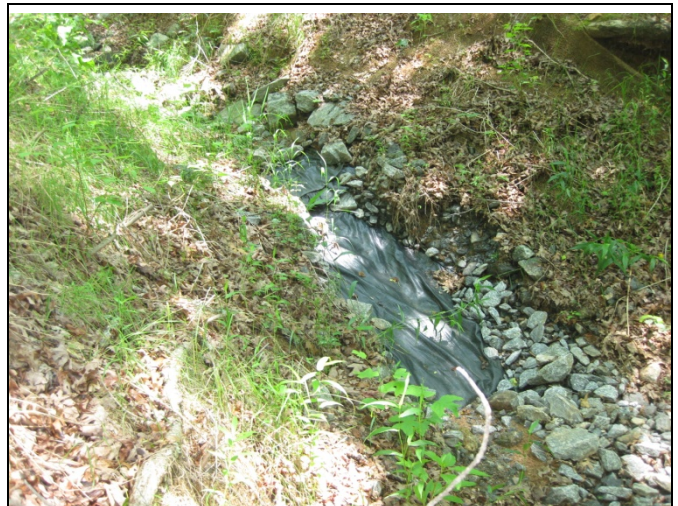
SPA5 – UT2 Reach A Piping within riffle cascade around log sill
