# Hoppers Creek-Melton Farm Stream Restoration Project

## Year 2 Monitoring Report

**NCEEP Project Number – 92251**

# **Site Assessment Report – Monitoring Year 2**

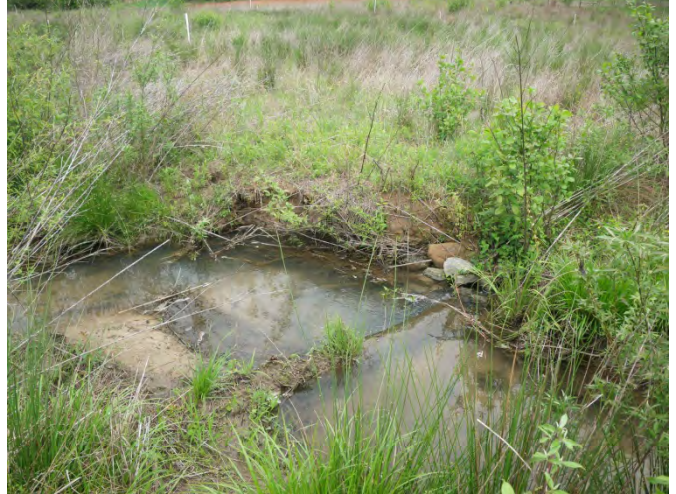
SPA1-2 – SFHC Reach 1 Right bank scour

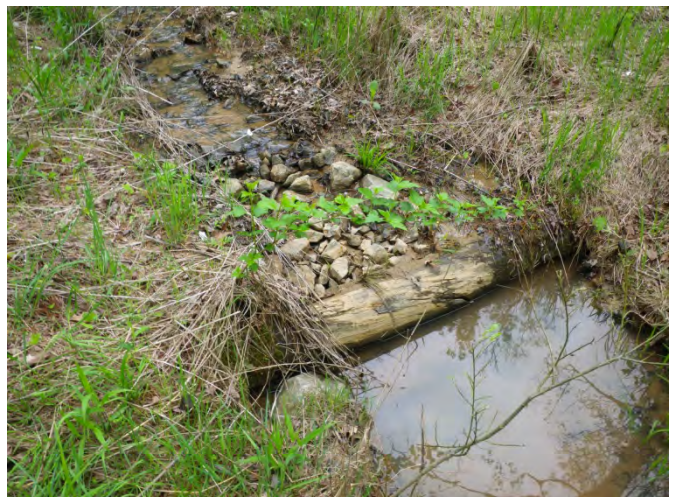
SPA1-5 – UT2 Reach A Piping within riffle cascade around log sill

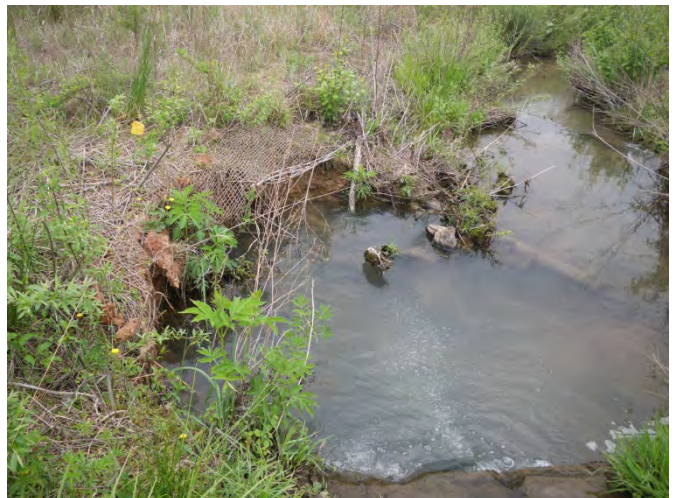
The two newly identified SPAs discovered on SFHC Reach 1, SPA2-1 and SPA2-2, are located in close proximity to each other on opposite banks downstream of a meander bend between stations 15+95 and 16+32. SPA2-1 is characterized by a failing rootwad associated with the erosion and undercutting of the left bank located immediately downstream of a log sill around station 16+25. The invert along the upstream log sill is sloped to one side (slanted toward the left bank) and is oriented within the channel such that flow is being directed toward the left bank immediately downstream of where the log sill ties into the bank, causing bank erosion. Erosion along the left bank appears to have migrated further downstream over time, scouring the upstream portion of the rootwad and the channel toe beneath it, eventually undermining the structure. The rootwad has separated from the left bank, has slumped into the channel, and is no longer affording erosion protection of the left bank.

SPA2-1 – SFHC Reach 1 Rootwad failure along left bank due to undercutting along bank

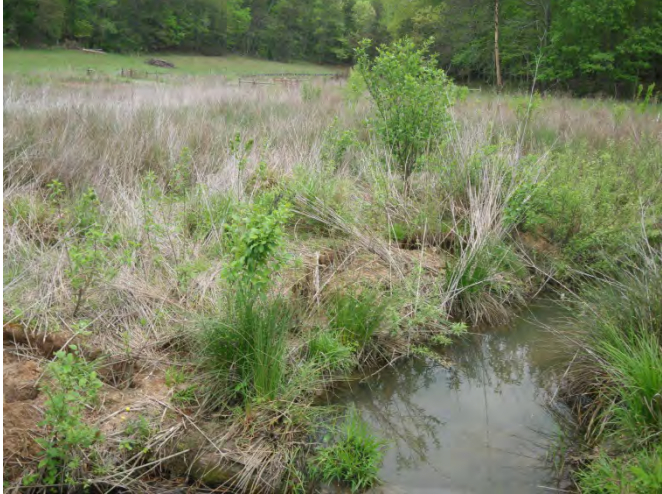
SPA2-2 – SFHC Reach 1 Right bank slumping

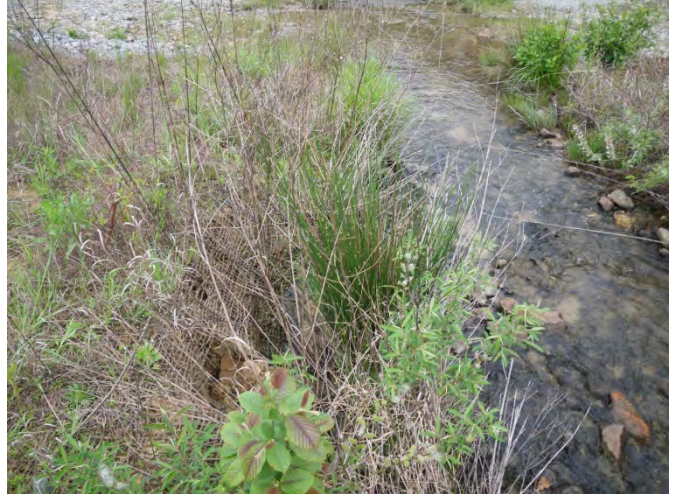
SPA2-3 involves localized scour along the left bank of a riffle located upstream of the easement crossing between stations 18+75 and 18+87. Flow has wallowed out and eroded a small portion of the left bank behind a cluster of well rooted, native vegetation that is thriving at the channel toe of the bank. The vegetation is comprised primarily of Willow Oak, Tag Alder, and Soft Rush. Matting along the bank is generally intact but has separated from the bank in areas due erosion over time that has caused the bank to recede. The left bank is vertical, exposed, and devoid of vegetation and surface protection. The thalweg along the riffle where SPA2-3 is located appears to be centered; but velocity vectors, and thus flow, may have been temporarily redirected toward the left bank during past storm events from slight temporal shifts in aggraded riffle material within the riffle, thereby increasing stress along the near bank and making the bank more highly susceptible to subsequent erosion.

SPA2-3 – SFHC Reach 2 Left bank scour

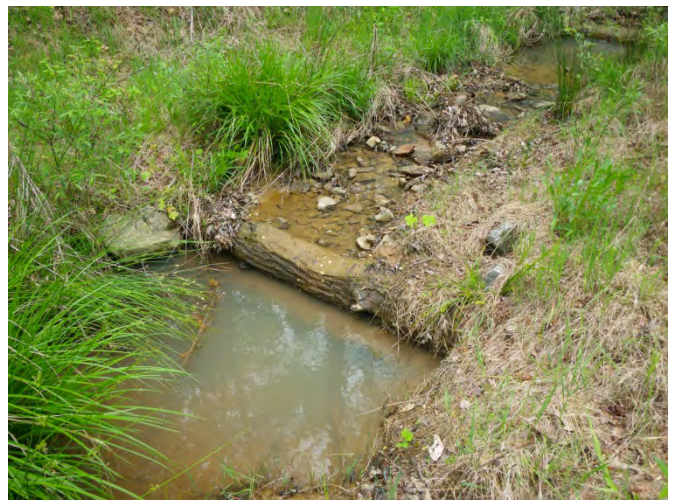
SPA2-5 – UT2 Reach A Piping within riffle cascade  
around log sill

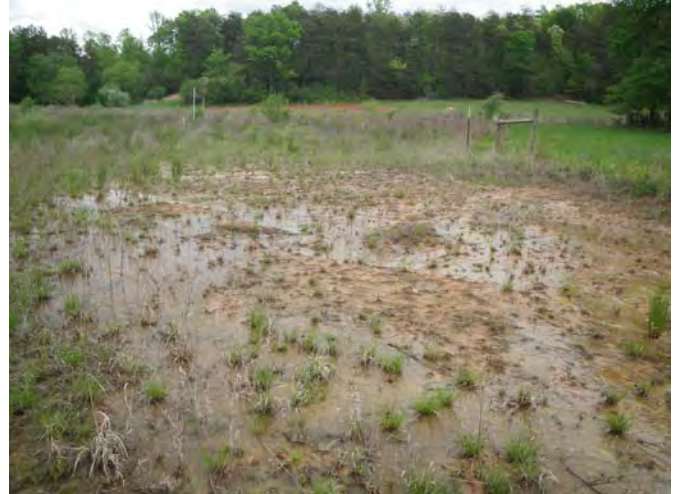
VPA1-2 – UT2 Reach 1 Bare Floodplain Area

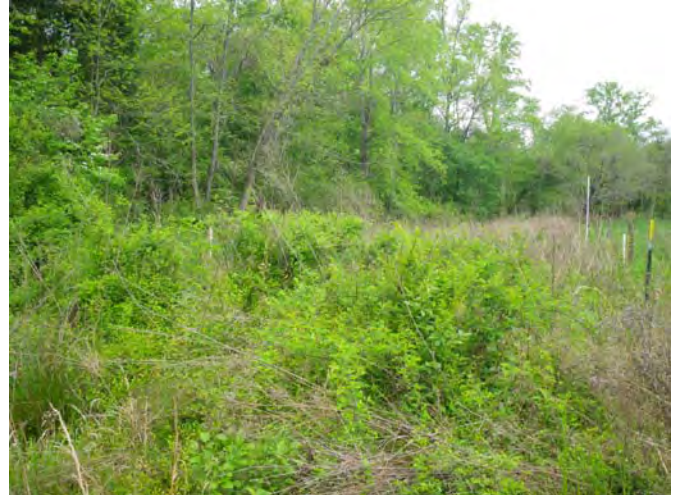
VPA1-4 – UT2 Reach B Multiflora Rose, Chinese Privet, Japanese Stilt Grass

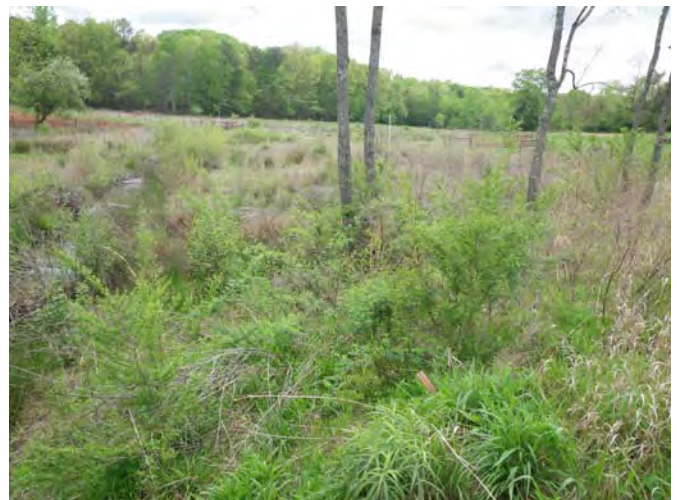
VPA2-2 – SFHC Reach 2 Multiflora Rose and Chinese Privet

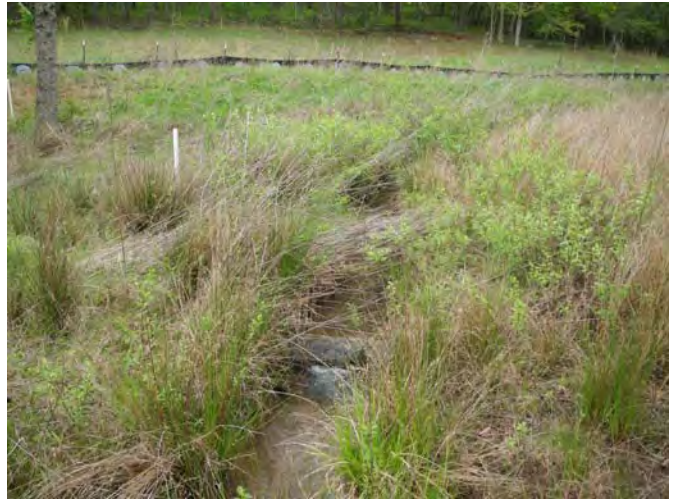
VPA2-4 – UT1B Multiflora Rose and Japanese Honeysuckle

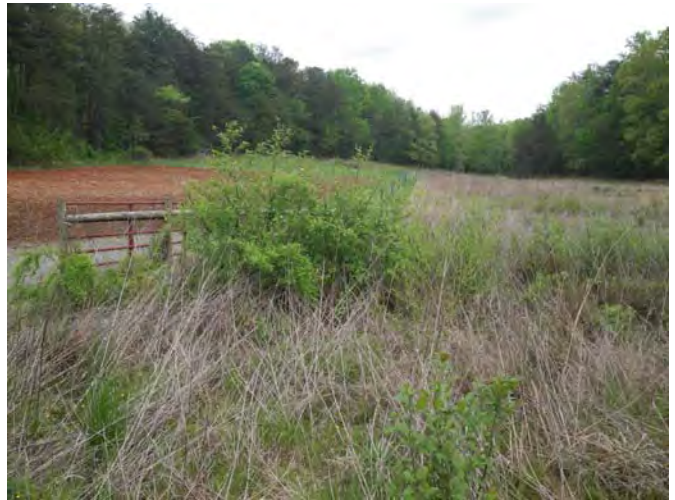
VPA2-6 – UT1B Multiflora Rose
