Hoppers Creek-Melton Farm Stream Restoration Project

Year 3 Monitoring Report

McDowell County, North Carolina

NCEEP Project Number – 92251

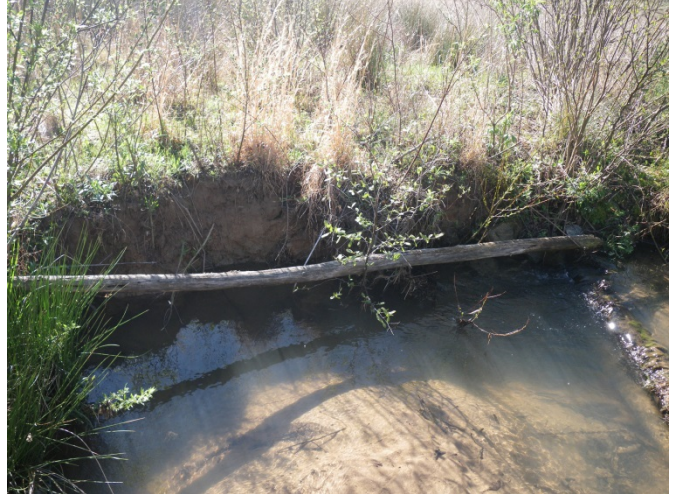
SPA1-2 – SFHC Reach 1 Right bank scour

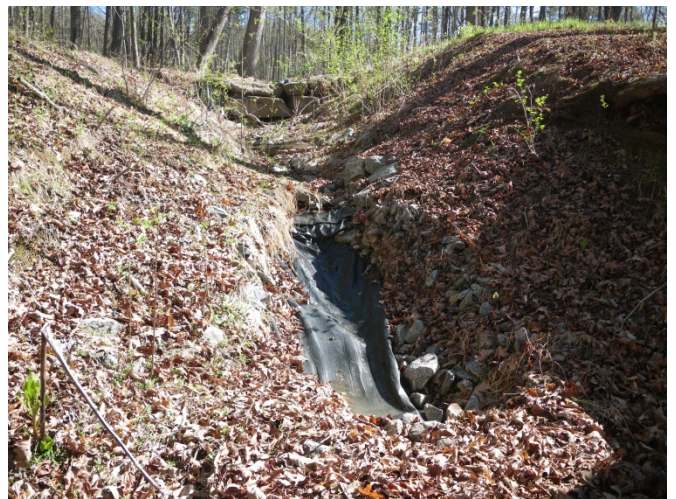
SPA1-6 – Ephemeral drainage channel bed erosion

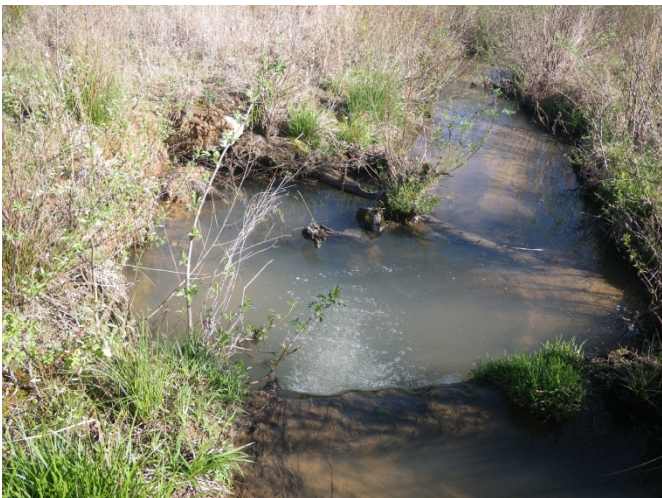
SPA2-1 and SPA2-2 are located in close proximity to each other on opposite banks downstream of a meander bend between stations 15+95 and 16+32 on SFHC Reach 1. SPA2-1 is characterized by a failing rootwad associated with the erosion and undercutting of the left bank located immediately downstream of a log sill around station 16+25. The invert along the upstream log sill is sloped to one side (slanted toward the left bank) and is oriented within the channel such that flow is being directed toward the left bank immediately downstream of where the log sill ties into the bank, causing bank erosion. Erosion along the left bank appears to have migrated further downstream over time, scouring the upstream portion of the rootwad and the channel toe beneath it, eventually undermining the structure. The rootwad has separated from the left bank, has slumped into the channel, and is no longer affording erosion protection of the left bank.

SPA2-1 – SFHC Reach 1 Rootwad failure along left bank due to undercutting along bank

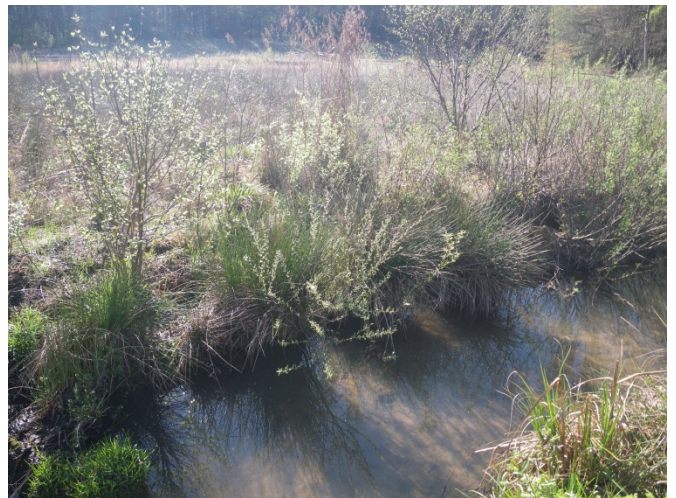
The 15 LF section of calved right bank has separated but not yet slumped into the channel. Flow behind the separated bank threatens to continue to erode and expose the parent bank which is vertical and devoid of stabilizing vegetation. Bank slumping of SPA2-2 may be a result of poor soil compaction during construction and/or the unconsolidated nature of the soil matrix within the bank, which without adequate vegetation to help reinforce or stabilize the bank is easily eroded. This is evident as the mass wasting along the right bank extends about 15 LF downstream along one continuous fissure to the log sill associated with SPA2-1. The tie-in of the log sill along the right bank around station 16+10 is slightly exposed as a result; the sill appears to be fully functional as grade control, but may become structurally compromised if scour behind the slumped bank material extends over time.

SPA2-2 – SFHC Reach 1 Right bank slumping

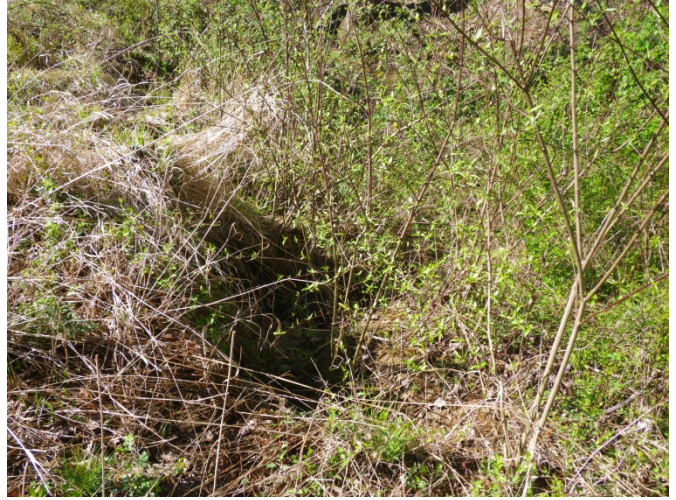
SPA2-4 is located on UT2 Reach B and is a steep portion of left bank located across from vegetation plot 13 that is slumping and separating from the top of terrace. This bank was originally stabilized during construction by a combination of bank grading, temporary/permanent seeding, the installation of staked matting, and the planting of live-stake vegetation. The graded bank began to slump before construction was completed and was re-stabilized before demobilization and project closeout. The cause of the recurrent bank instability at SPA2-4 may potentially be a result of poor soil compaction and overland storm flow seepage that appears to be occurring at the top of terrace which may be undermining the re-graded bank.

SPA2-4 – UT2 Reach B Left bank slumping

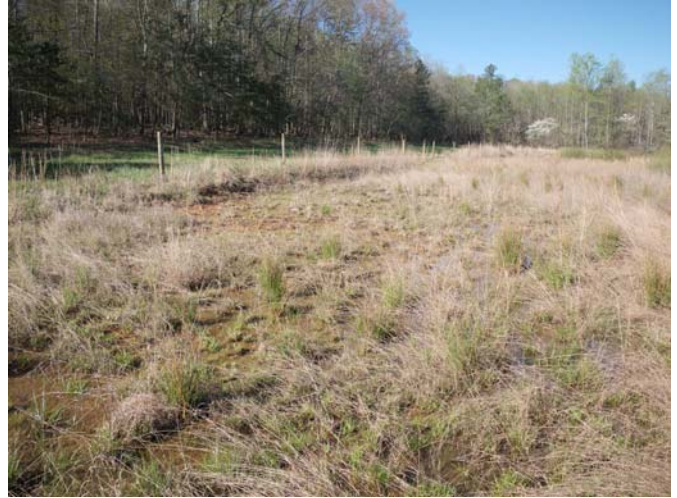
VPA1-2 – UT2 Reach 1 Bare Floodplain Area

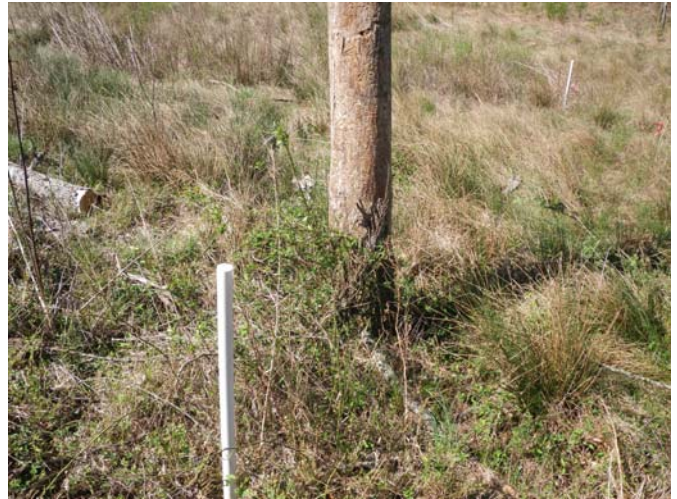
VPA2-4 – UT1B Multiflora Rose and Japanese Honeysuckle

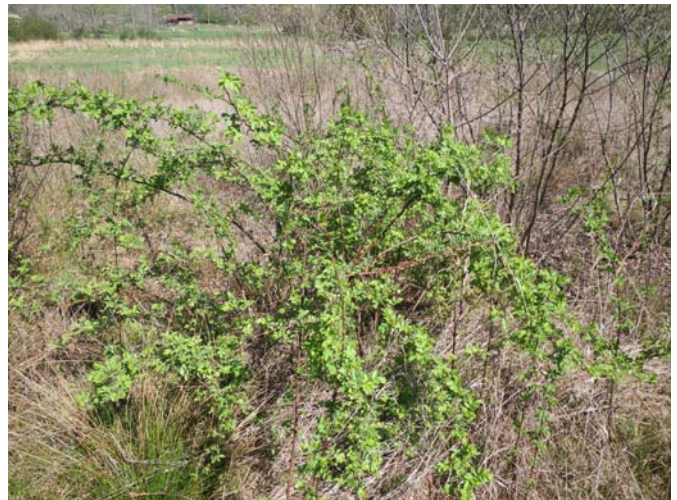
VPA2-6 – UT1B Multiflora Rose
