South Fork Hoppers Creek - Melton Farm Stream Restoration Project Year 4 Monitoring Report

NCDMS Project Number – 92251

FINAL

Report Prepared and Submitted by Michael Baker Engineering, Inc.

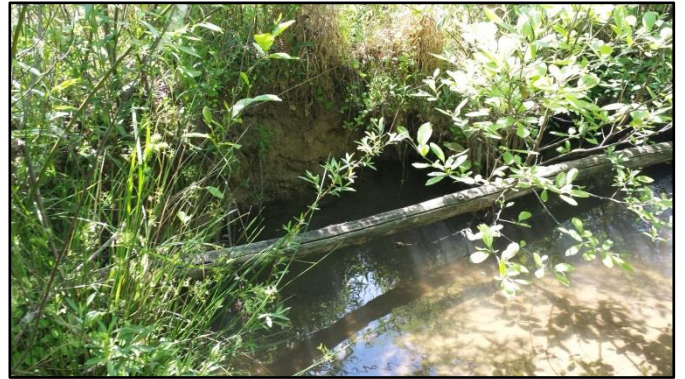
SPA1-1 – SFHC Reach 1: Left bank scour.

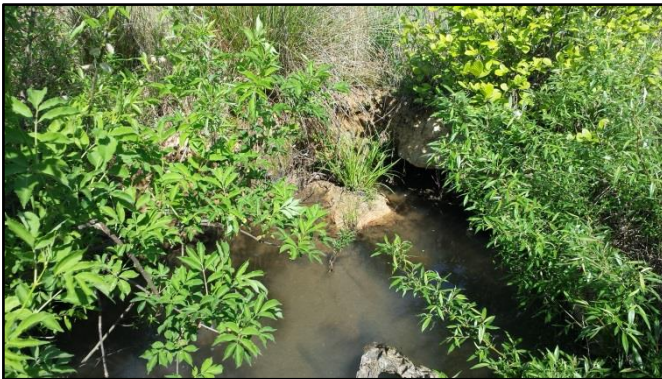
SPA1-2 – SFHC Reach 1: Right bank scour.

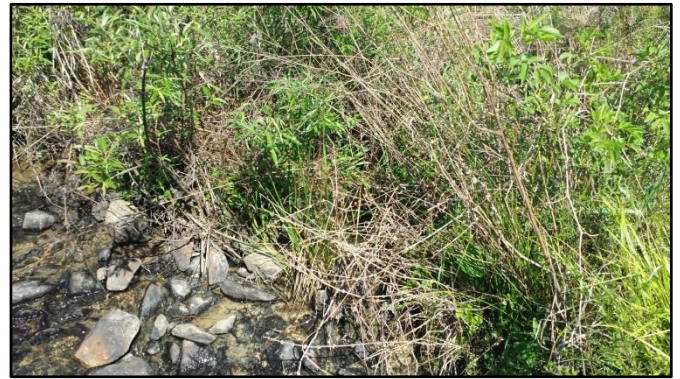
SPA2-1 is located downstream of a meander bend between stations 15+95 and 16+32 on SFHC Reach 1. SPA2-1 is characterized by a failing rootwad associated with the erosion and undercutting of the left bank located immediately downstream of a log sill around station 16+25. The invert along the upstream log sill is sloped to one side (slanted toward the left bank) and is oriented within the channel such that flow is being directed toward the left bank immediately downstream of where the log sill ties into the bank, causing bank erosion. Erosion along the left bank appears to have subsided, but has scoured the upstream portion of the rootwad and the channel toe beneath it, undermining the structure. The rootwad has separated from the left bank, has slumped into the channel, and is no longer affording erosion protection of the left bank. Native herbaceous and woody vegetation are starting to colonize the problem area. This area should be continually monitored to document and prevent any further bank degradation.

Matting along the bank is generally intact but has separated from the bank in areas due to erosion over time that has caused the bank to recede. The left bank is vertical and exposed, but vegetation is starting to provide surface protection. The thalweg along the riffle where SPA2-3 is located appears to be centered, but velocity vectors, and thus flow, may have been temporarily redirected toward the left bank during past storm events from slight temporal shifts in aggraded riffle material within the riffle, thereby increasing stress along the left bank and making the bank more susceptible to subsequent erosion.

SPA2-1 – SFHC Reach 1: Rootwad failure along left bank due to undercutting along bank.

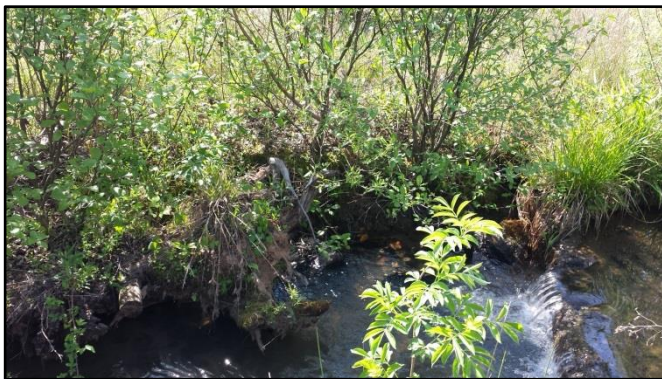
SPA2-3 – SFHC Reach 2: Left bank scour.

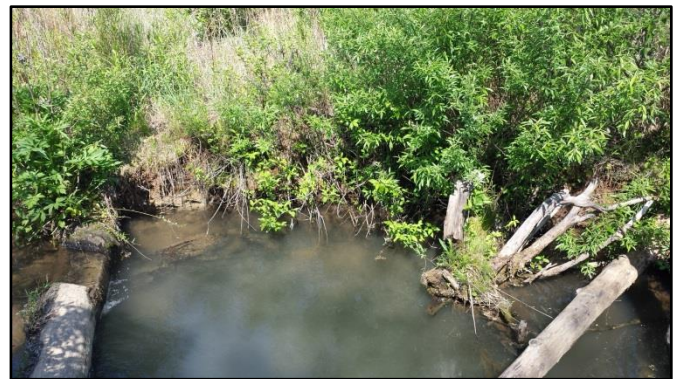
SPA4-1 is located downstream of a log step on SFHC Reach 1. SPA4-1 is characterized by a failing rootwad associated with the erosion and undercutting of the right bank located immediately downstream of a log sill around station 16+25. The invert along the upstream log sill is sloped to one side (slanted toward the right bank) and is oriented within the channel such that flow is being directed toward the right bank immediately downstream of where the log sill ties into the bank, causing bank erosion. The rootwad has separated from the right bank, has slumped into the channel, but is still providing erosion protection of the right bank. Native herbaceous and woody vegetation are present and are providing some stability to the bank. This area should be continually monitored to document and prevent any further bank degradation.

SPA4-1– SFHC Reach 2: Rootwad failure along right bank due to undercutting along bank.

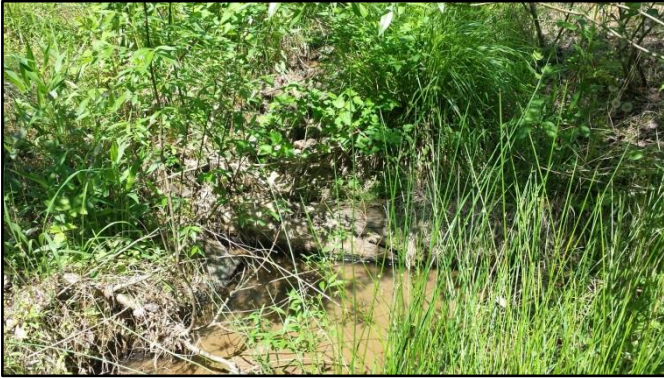
SPA4-2 is located downstream of a log step on SFHC Reach 1. SPA4-2 is characterized by a failing rootwad associated with the erosion and undercutting of the left bank located immediately downstream of a log sill around station 20+75. The invert along the upstream log sill is sloped to one side (slanted toward the left bank) and is oriented within the channel such that flow is being directed toward the left bank immediately downstream of where the log sill ties into the bank, causing bank erosion. There is erosion immediately upstream of the rootwad potentially compromising the structure, but the rootwad is still providing some bank protection. Native herbaceous and woody vegetation are present and are providing some stability to the bank. This area should be continually monitored to document and prevent any further bank degradation.

SPA4-2– SFHC Reach 2: Rootwad failure along left bank due to undercutting along bank.

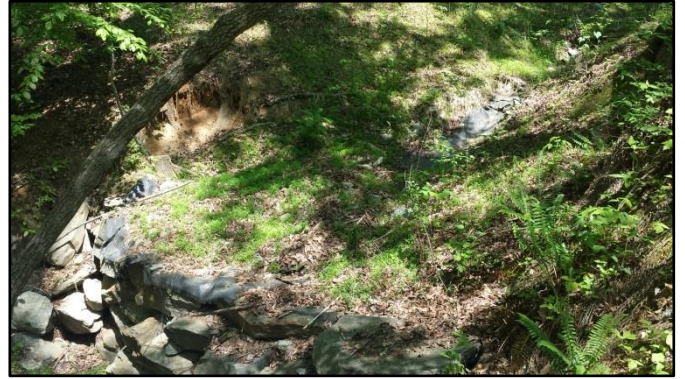
SPA1-5 – UT2 Reach A: Piping within riffle cascade around log sill.

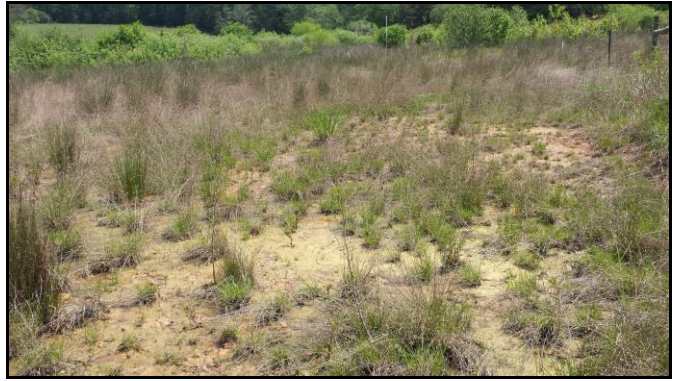
VPA1-1 – SFHC Reach 1: Bare floodplain area

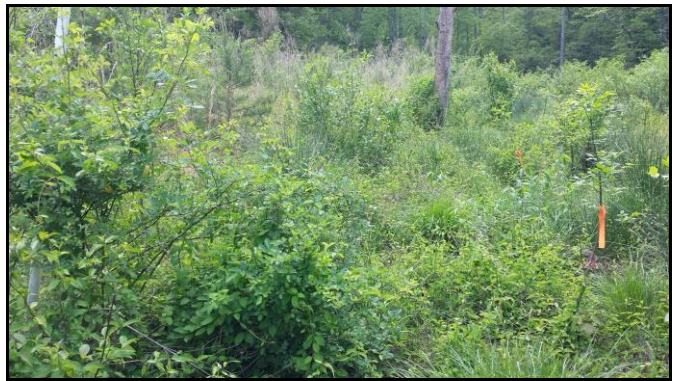
VPA2-2 – SFHC Reach 2: Multiflora rose

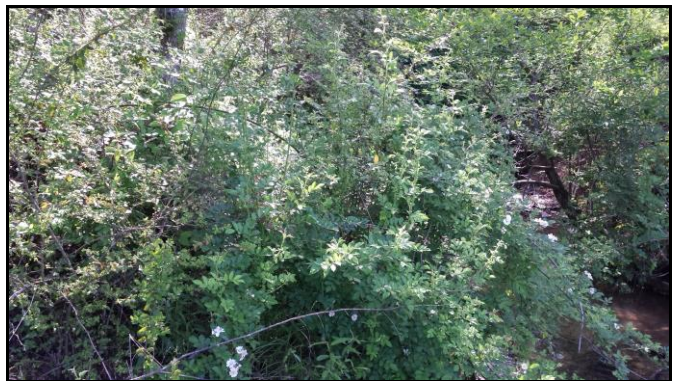
VPA2-5 – UT1B: Multiflora rose and Japanese honeysuckle

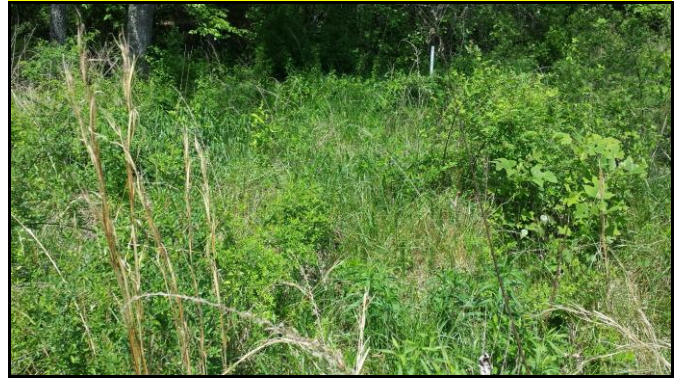
VPA4-2 – SFHC Reach 2: Japanese honeysuckle

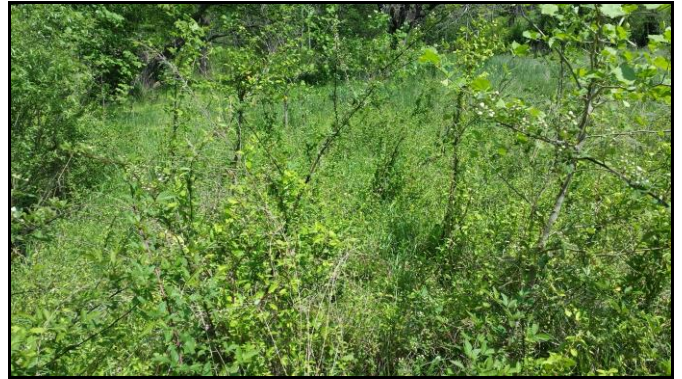
VPA4-4 – UT2: Multiflora rose on RTB

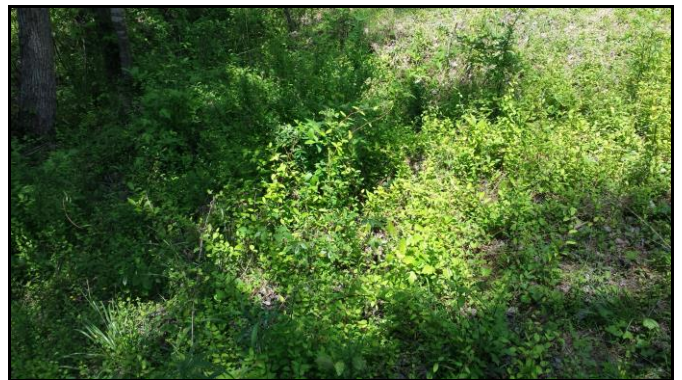
VPA4-6 – UT2: Japanese honeysuckle in left floodplain

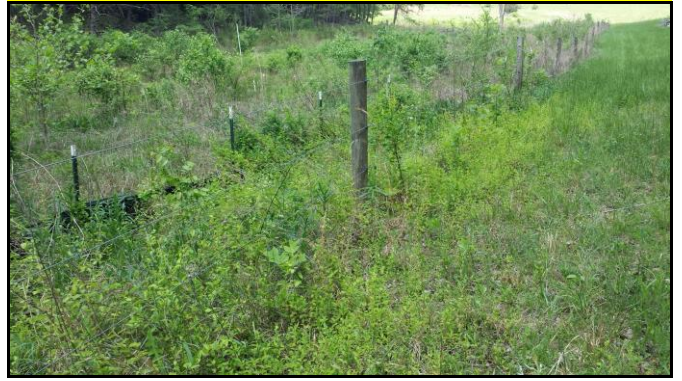
VPA4-8 – UT2: Multiflora rose in left floodplain
