Monitoring Report
FINAL VERSION
Horne Creek Tributaries Mitigation Project
Monitoring Year 3
Calendar Year of Data Collection: 2022

NCDEQ DMS Project Identification # 100026
NCDEQ DMS Contract # 7181
Yadkin River Basin (Cataloging Unit 03040101)
USACE Action ID Number: SAW-2017-01510
NCDEQ DWR Project # 2017-1156
Surry County, NC
Contracted Under RFP # 16-006993, Date of Issue: August 16, 2016
Data Collection Period: July - October 2022
Submission Date: November 2022

RE: WLS Responses to NCDEQ DMS Review Comments for Task 9 Submittal, Monitoring Year 3 Report for the Horne Creek Tributaries Mitigation Project, DMS Full-Delivery Project ID #100026, Contract #7181, Yadkin River Basin, Cataloging Unit 03040101, Surry County, NC

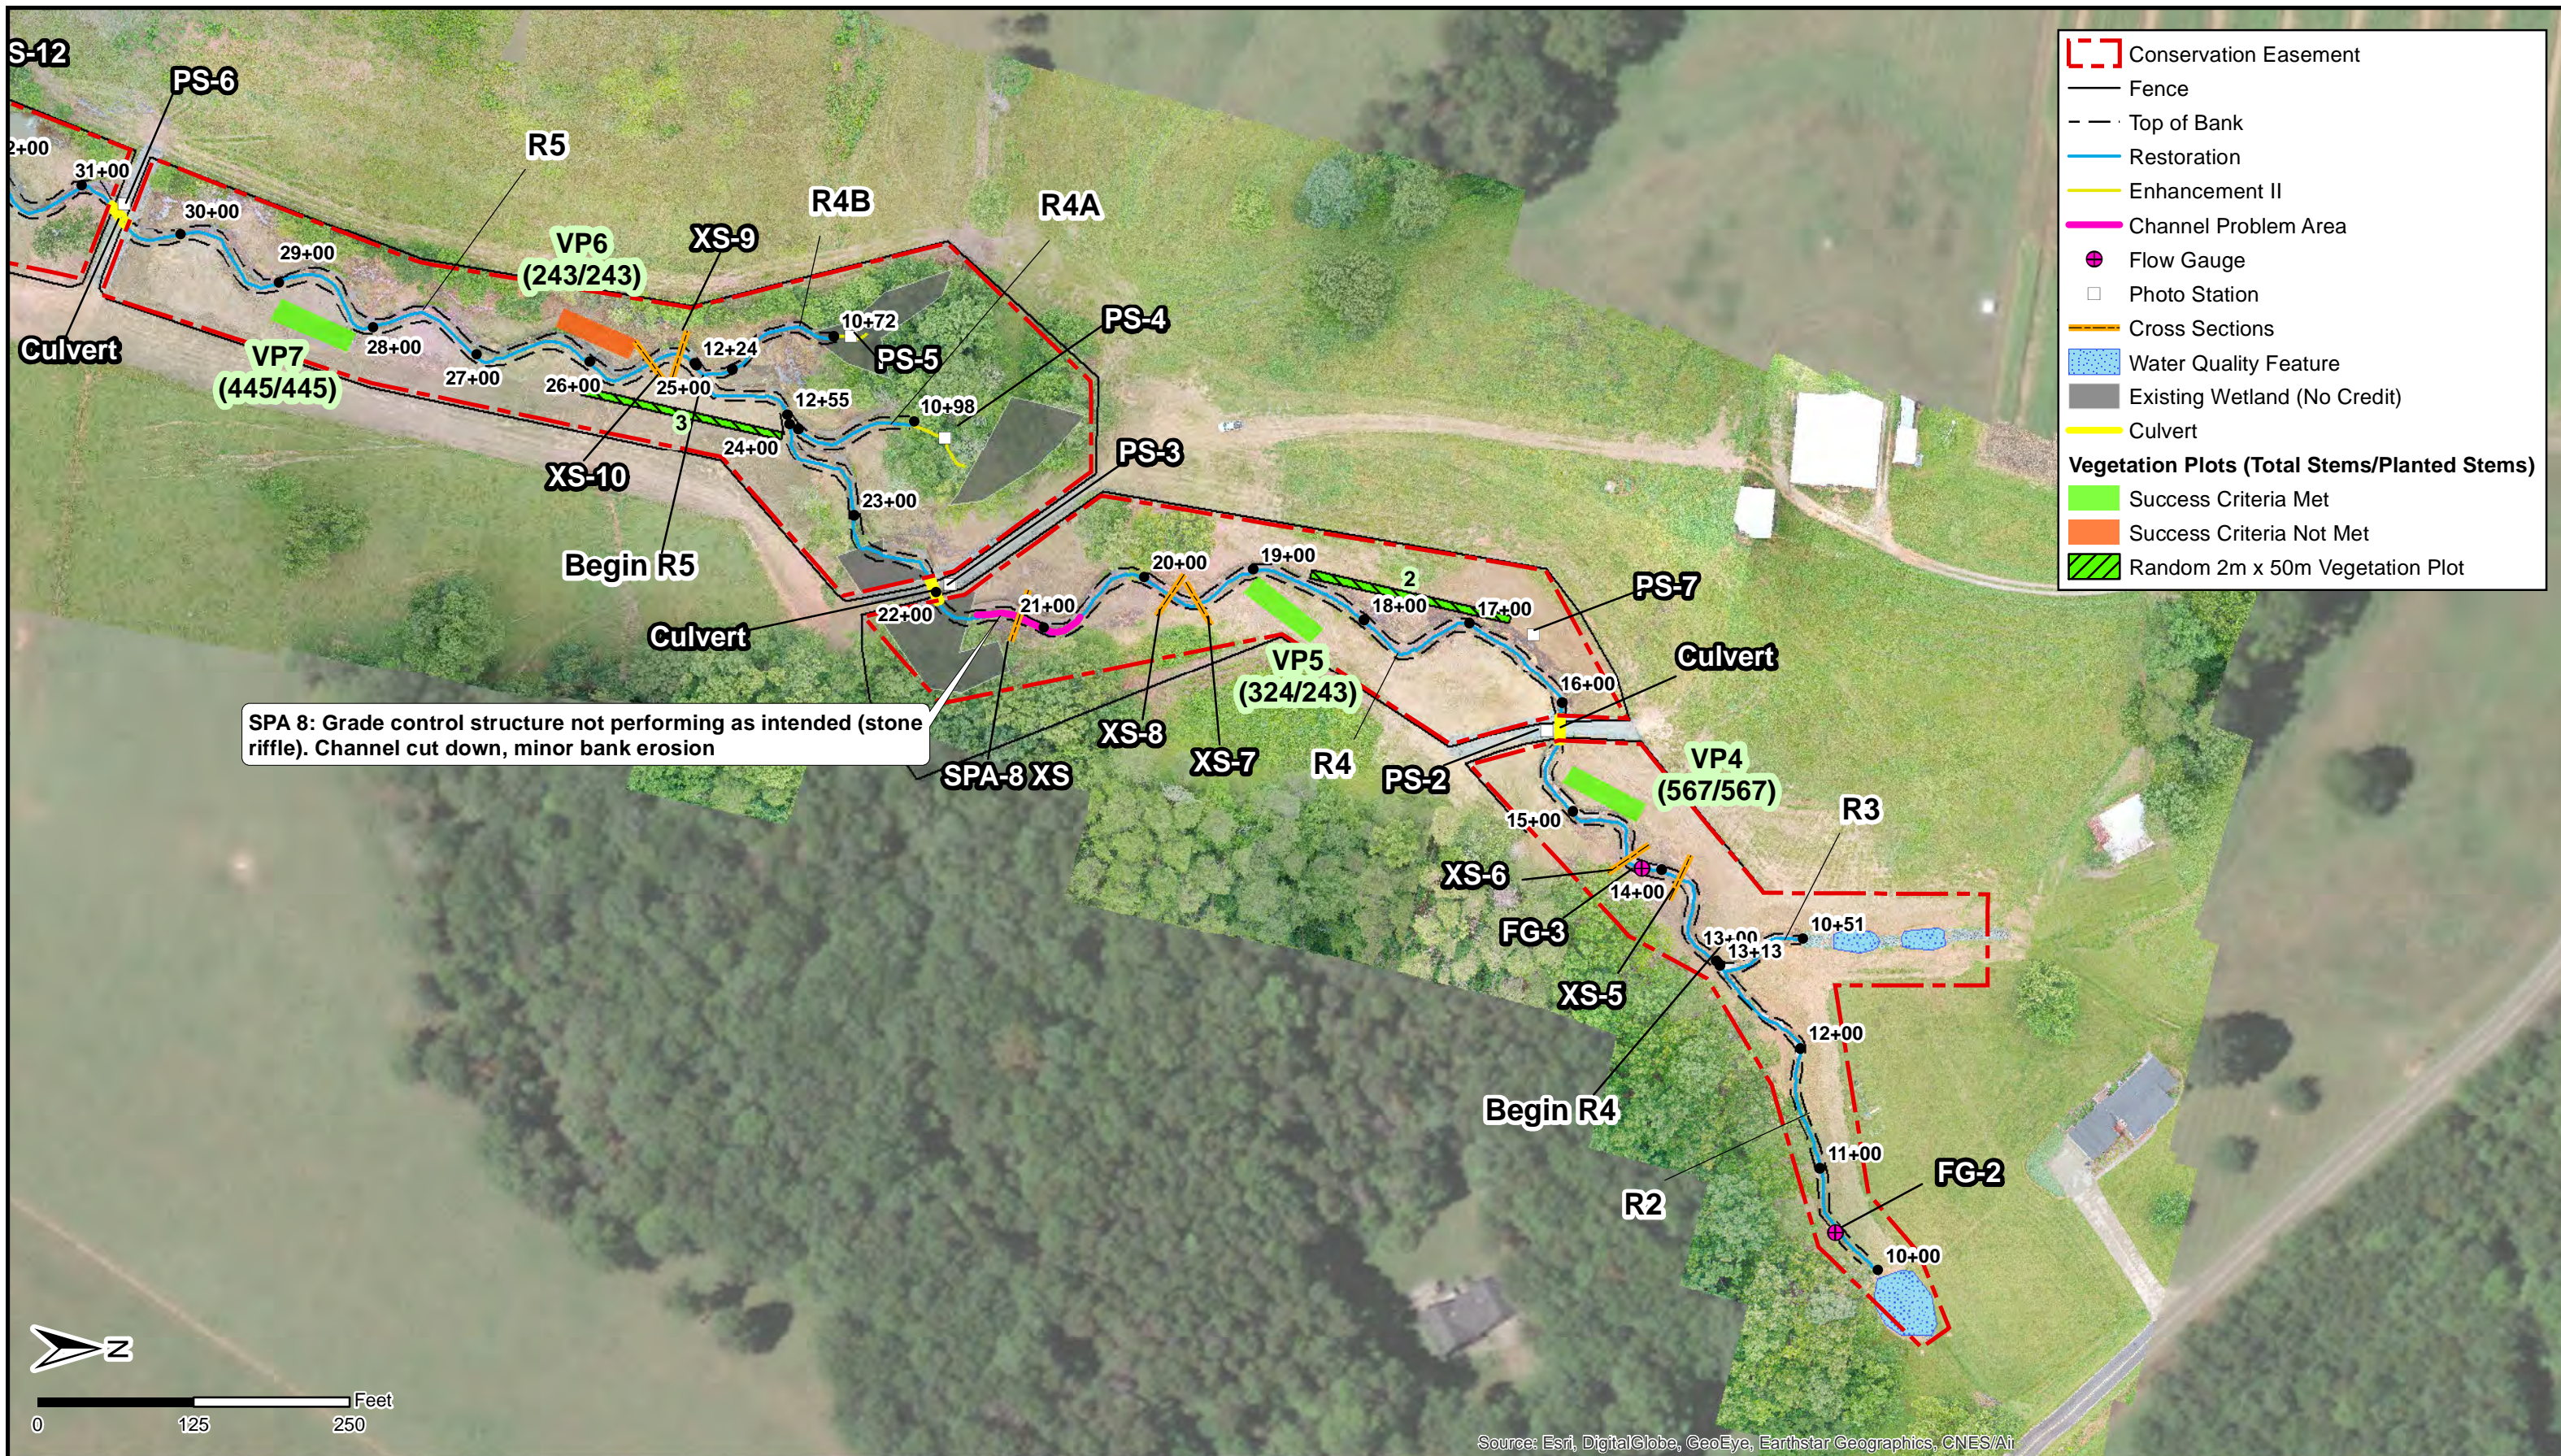
FIGURE
1a

SPA 8: Grade control structure not performing as intended (stone riffle). Channel cut down, minor bank erosion

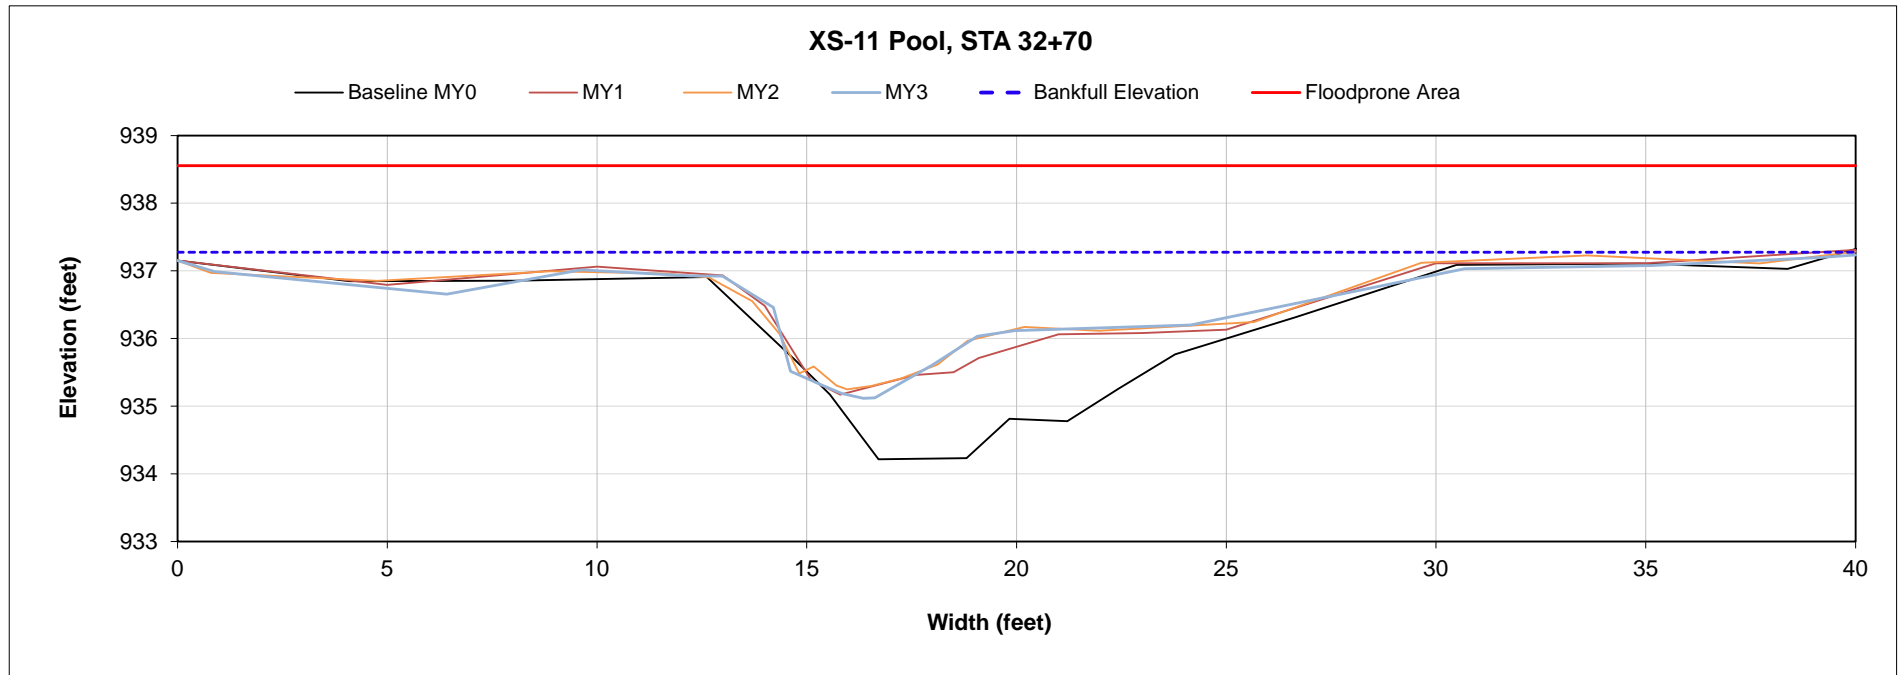
The MY3 channel dimensions generally match the design parameters and are within acceptable and stable ranges of tolerance. Data for the 16 cross-sections (eight riffle and eight pool) can be found in Appendix D. It is expected over time that some pools may accumulate fine sediment and organic matter, however, this is not an indicator of channel instability. Maximum riffle depths are also expected to fluctuate throughout the monitoring period as the channels adjust to the new flow regime. Of the eight riffle cross-sections, four experienced minor changes in bank height ratio (BHR) from MY0 to MY3. Two of the eight riffle cross-sections (XS-10 and XS-12) have decreased BHRs from MY2, but still have BHRs above 1.2. One riffle cross-section, XS-15 on R5, experienced minor aggradation due to sediment migration and thick herbaceous vegetation occurring during MY3. The cross-section is stable and shows minimal change from MY1. Three riffle cross sections, XS-10, XS-12, and XS-14 on R5, experienced degradation. XS-10 and XS-12 on R5, experienced degradation due to bed material entrainment from the riffles during MY2 storm events. Both riffles adjusted to be shorter and migrated slightly downstream, resulting in apparent degradation. R5 is stable above and below both cross-sections. XS-10 and XS-12 were re-surveyed in

Spring 2022 during visual assessments for MY3 and the cross-section data showed no major changes from MY2. XS-14 is stable and shows minimal changes from MY1. Visual surveys indicate the areas affected through aggradation and degradation are functioning and stable. WLS will closely monitor any changes to all stream reaches during MY4.

Dimension Data Summary: MY3 2022	
Bankfull Elevation (ft)	935.9
Low Bank Height Elevation (ft)	936.3
Bankfull Max Depth (ft)	1.3
Low Bank Height (ft)	1.7
Bank Height Ratio	1.31
Bankfull X-section Area (ft²)	4.5
% Change Bank Height Ratio	31.0%

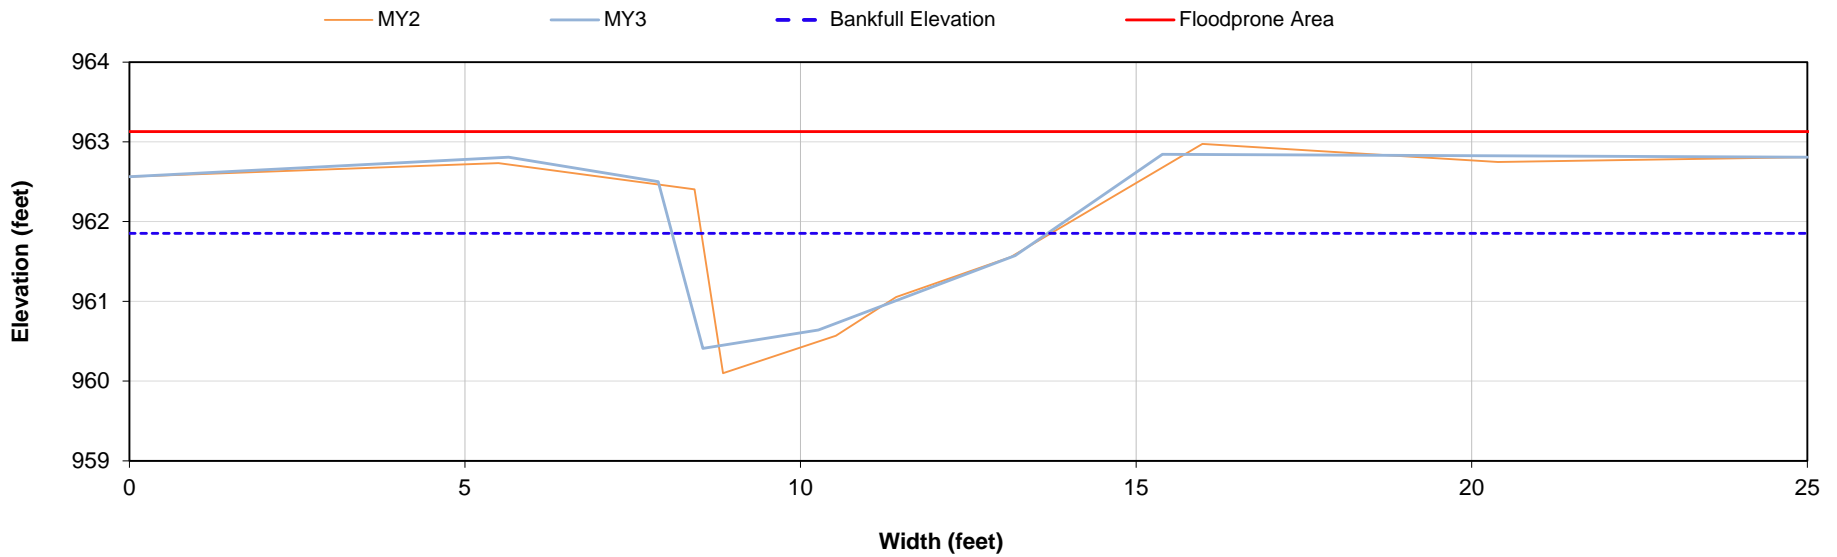
SPA-8 (Riffle), STA 21+15

Dimension Data Summary: MY3 2022	
Bankfull Elevation (ft)	961.9
Low Bank Height Elevation (ft)	962.5
Bankfull Max Depth (ft)	1.4
Low Bank Height (ft)	2.1
Bank Height Ratio	1.45
Bankfull X-section Area (ft²)	*4.9
