Monitoring Report
FINAL VERSION
Horne Creek Tributaries Mitigation Project
Monitoring Year 4
Calendar Year of Data Collection: 2023

NCDEQ DMS Project Identification # 100026
NCDEQ DMS Contract # 7181
Yadkin River Basin (Cataloging Unit 03040101)
USACE Action ID Number: SAW-2017-01510
NCDEQ DWR Project # 2017-1156
Surry County, NC
Contracted Under RFP # 16-006993, Date of Issue: September 16, 2016
Data Collection Period: April and October 2023
Submission Date: November 2023

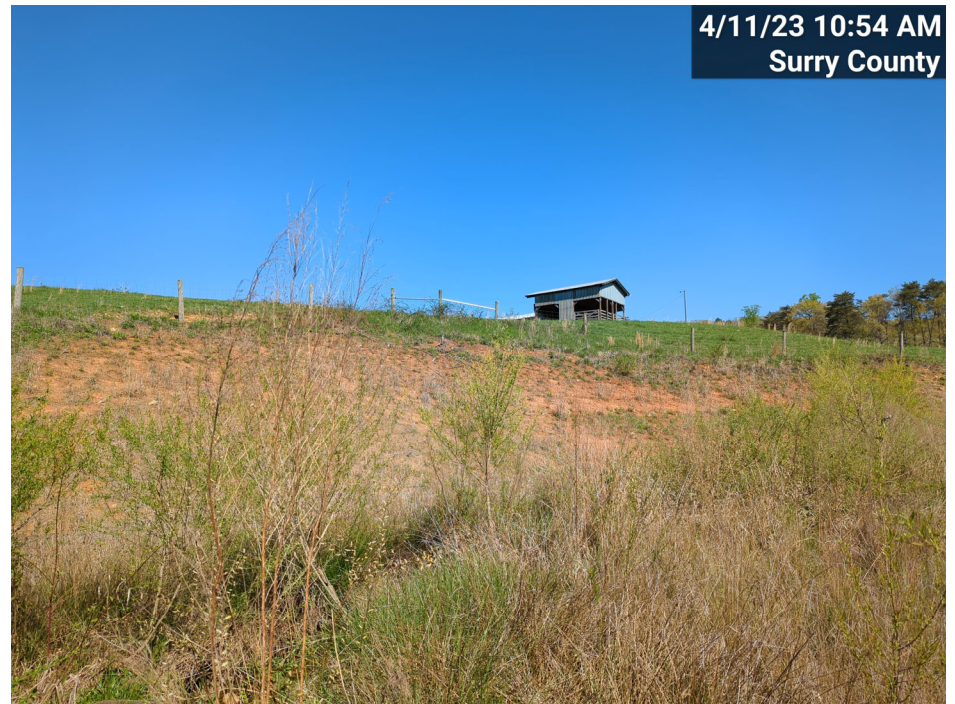
PS-7, R4, Right Floodplain Slope (MY-04)

- **The right floodplain slope shown in photo point 7 appears to have little herbaceous vegetation. Has WLS conducted any additional efforts to increase the slope stability? Are any efforts planned?** WLS Response: WLS did reseed the affected area in MY2 to improve herbaceous cover on the slope. No areas of rilling or slumping were noted during MY4 and tree and herbaceous vegetation is establishing on the slope. This area will continue to be monitored in MY5.

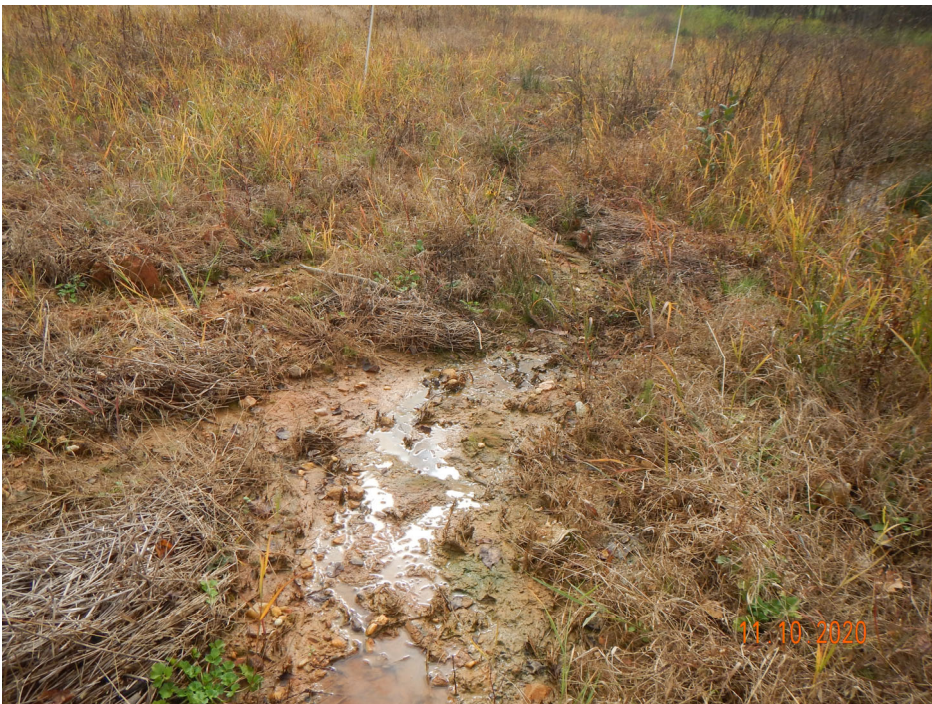
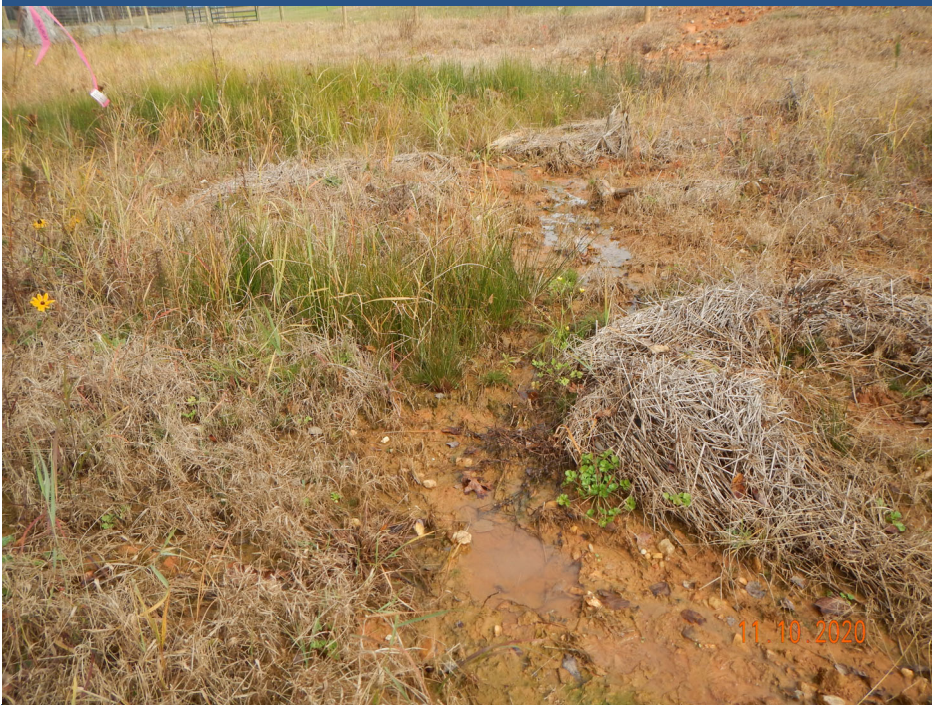
- **SPA5-** On R5, in the left floodplain area: minor deposition and erosion is occurring adjacent to station 32+60 because of erosion outside of the easement.

SPA5, R5 Left Floodplain, R5 Side Slope, Minor deposition and erosion as a result of erosion outside of the easement (MY-01)

- **MY3 Action:** No action was taken during MY3.
 - **MY4 Action:** Grading activities outside of the conservation easement stabilized the erosion occurring in the pasture. The work was completed using a small excavator in July 2023. Matting and coir wattles were installed to stabilize soil and slow water flow. The area was seeded and mulched. Only minor hand work was completed within the easement to add seed to areas of sediment deposition. Herbaceous cover is establishing well within the easement and no additional erosion was observed outside the easement. WLS will continue to monitor the repair during MY5.

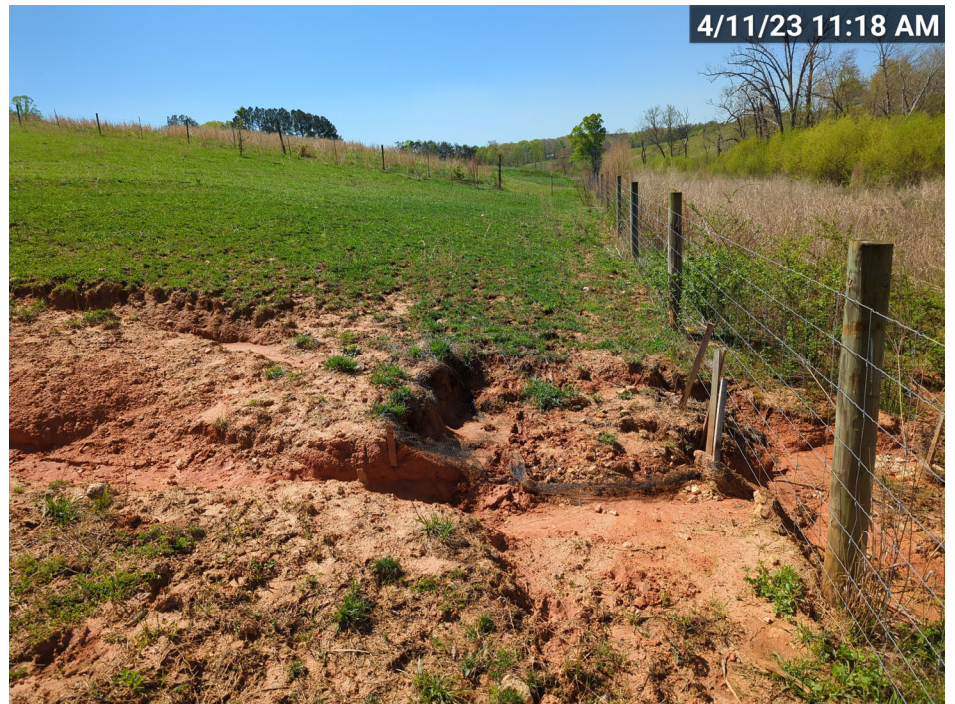
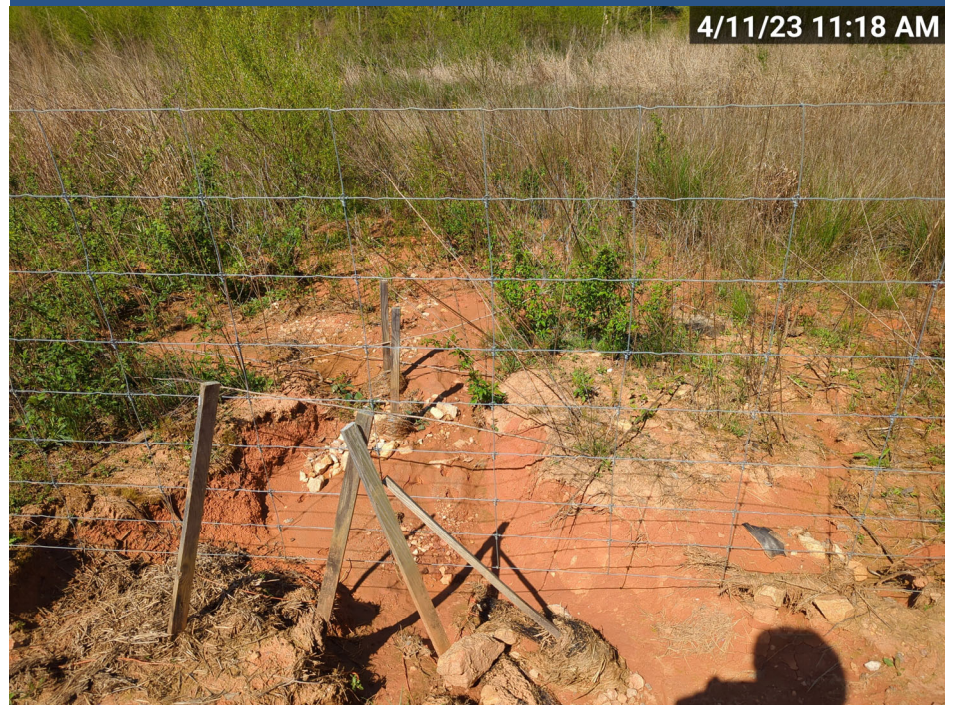
SPA5, R5 Side Slope, Minor deposition and erosion as a result of erosion outside of the easement (MY-04)

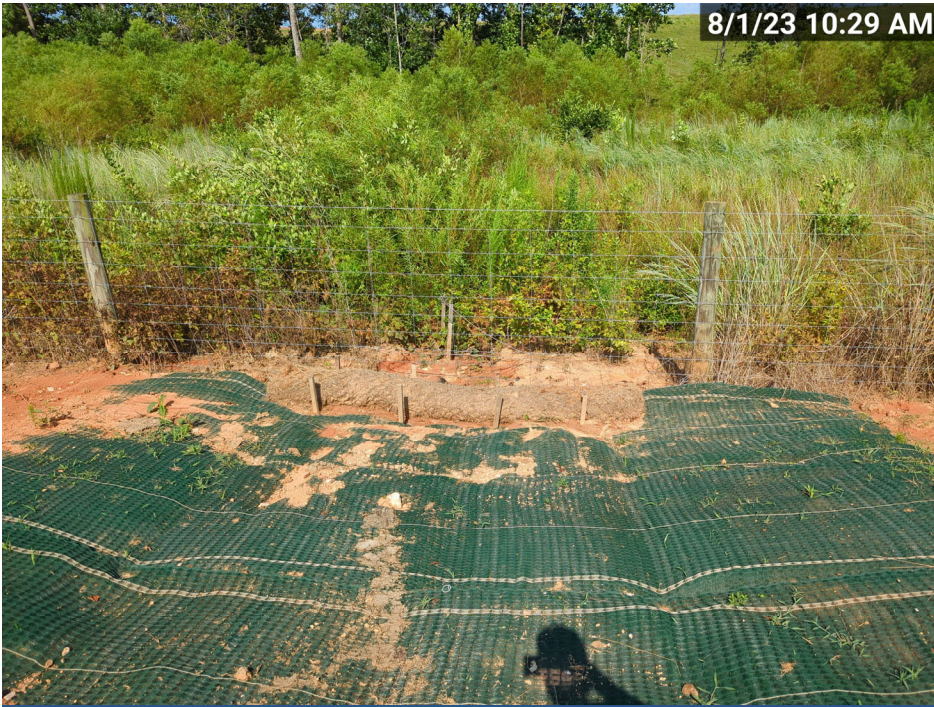
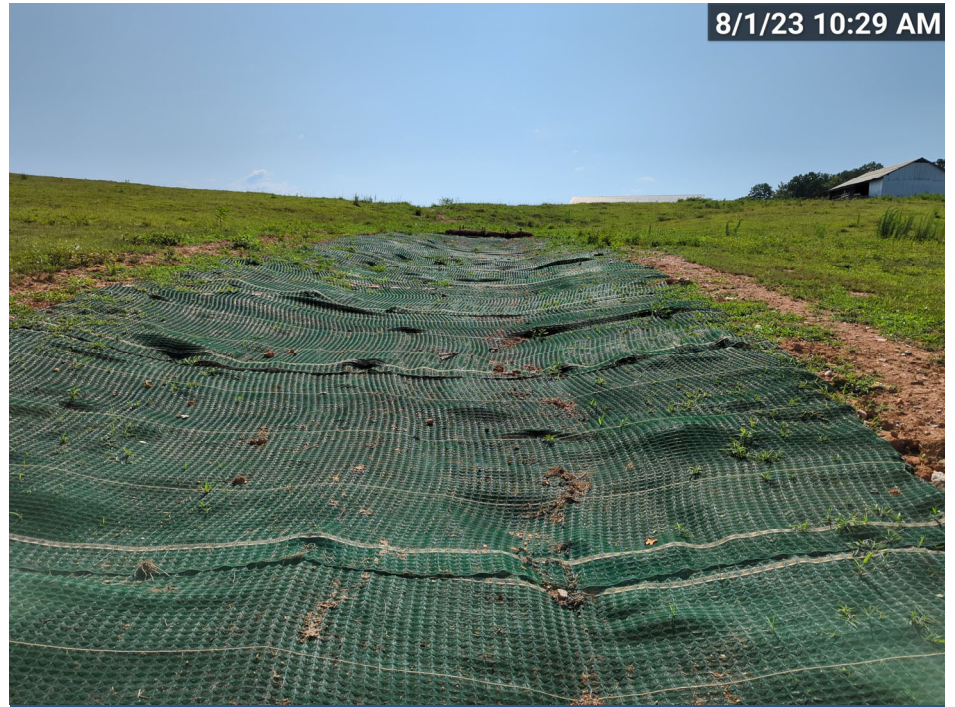
SPA 5: Erosion outside easement graded, with matting and coir wattle installed. Seeded inside easement boundary.

SPA5, R5 Side Slope, After repair (MY-04)

- **Thanks for including pictures of SPA5 repair. Please include update and photos in MY5 report.** WLS Response: WLS will include photos of SPA5 during MY5 to document stabilization of the repair area.

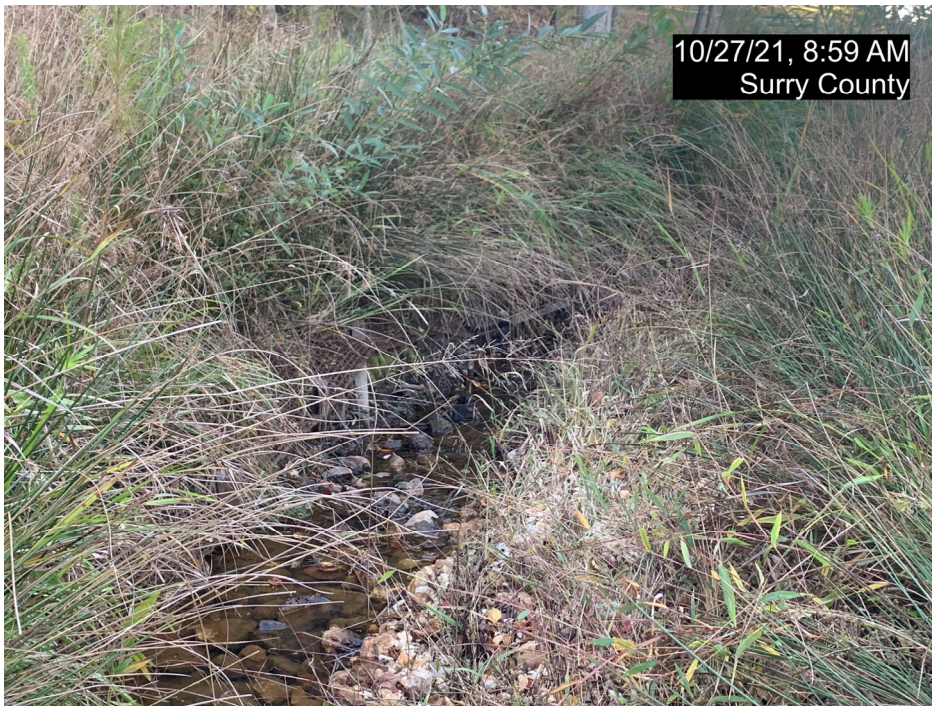
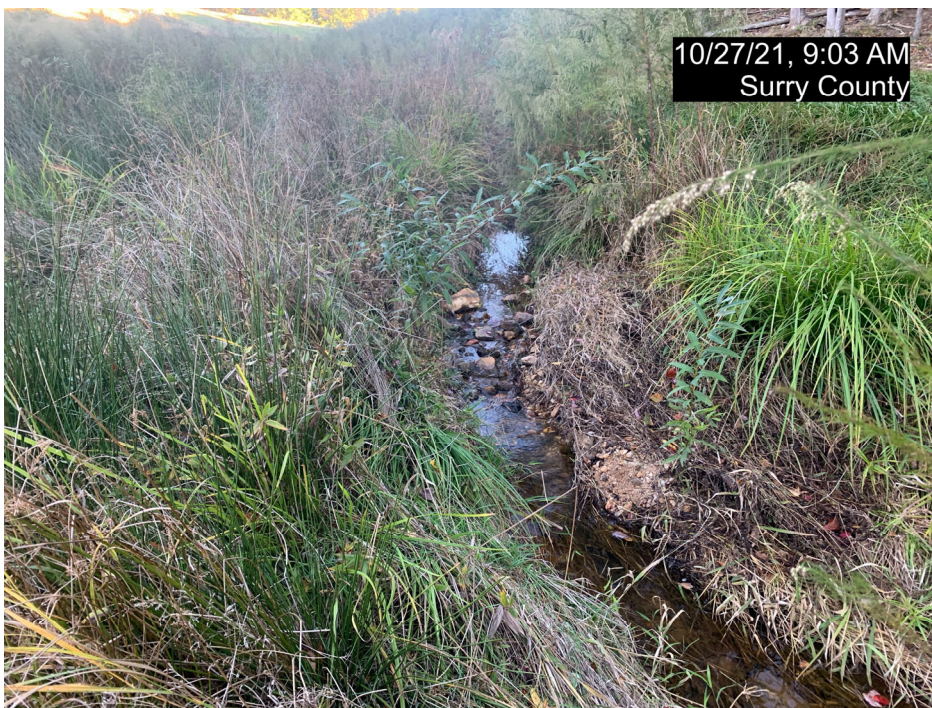
- **SPA8-** On R4, just below two log vanes from approximate station 20+75 to 21+75, an area of the stream has dropped elevation due to migrating riffle material causing stream incision. Coarse riffle substrate is still present, the log vanes directly upstream are stable and functional, and the culvert immediately downstream is holding grade. No additional incision was observed in MY4, and no remedial action is required. This area will continue to be monitored closely in MY5. Cross-section data will be completed again in MY5, and the area will be removed from the problem area list if it is stable.

SPA8, R4, STA 20+75, Channel Bed Incision (MY-02)

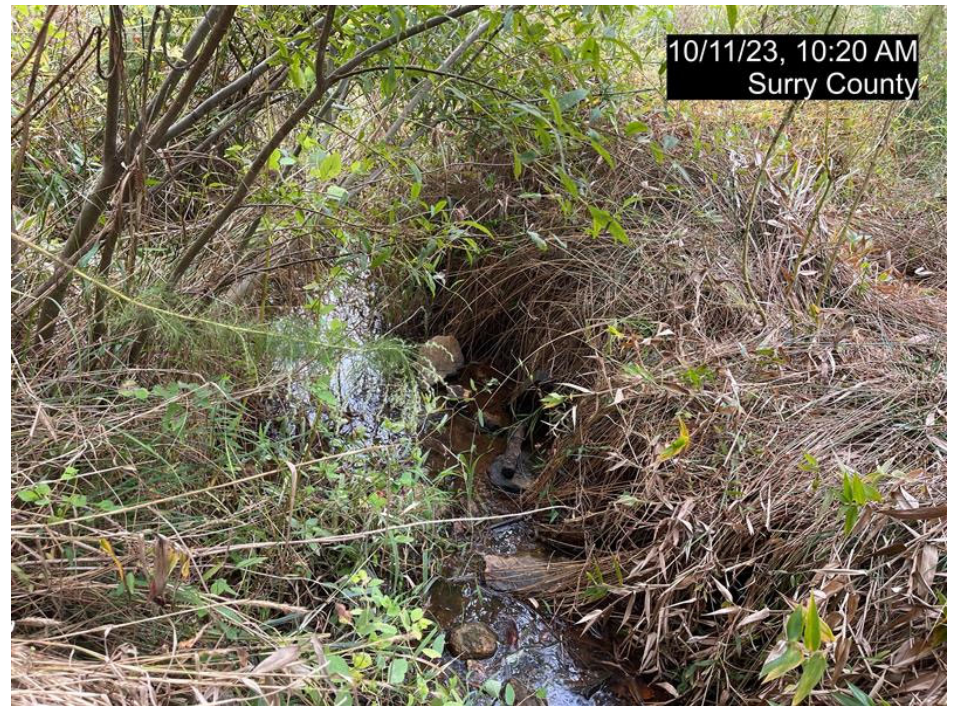
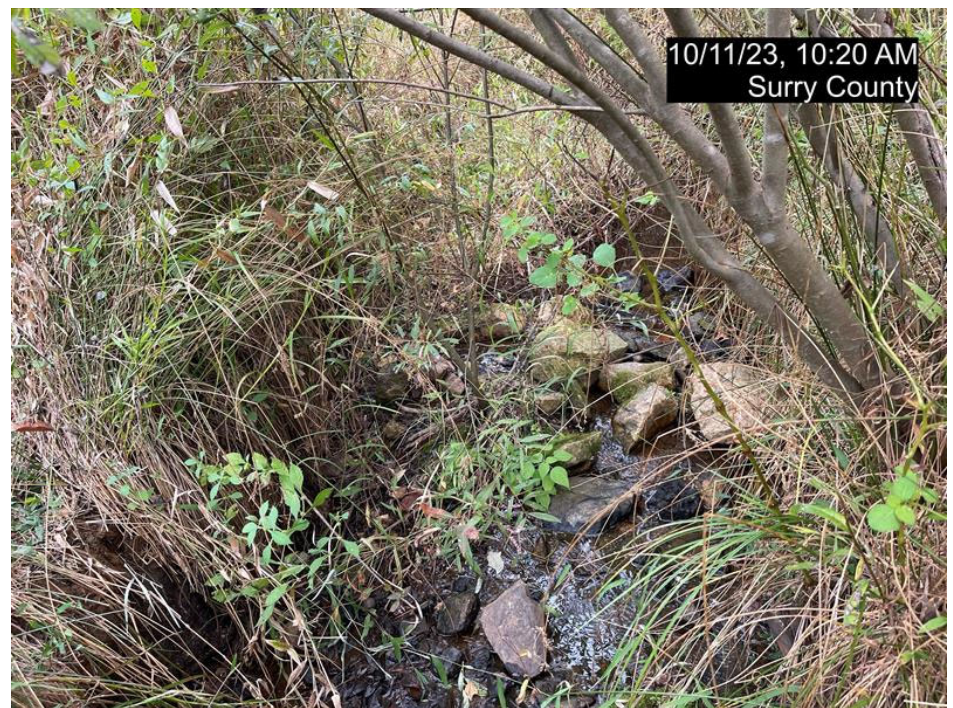
SPA8, R4, STA 20+75, Channel Bed Incision (MY-04)

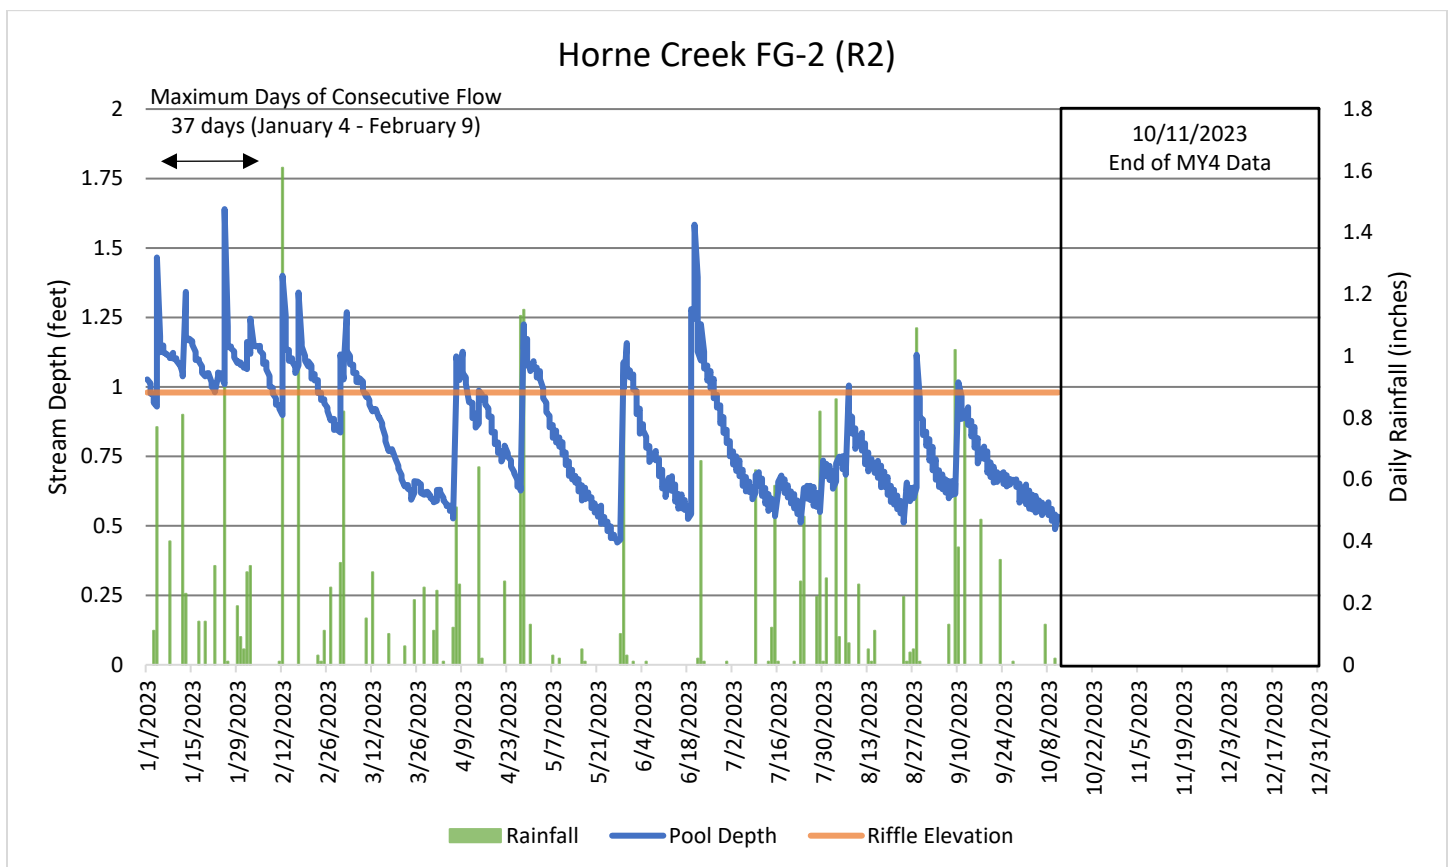
- **80 days of cumulative flow, 204 days of no flow.**

- **Does R3 have documented stream flow in the channel? Recommend adding a camera and/or gauge to document stream flow on this reach to prevent credits from being at risk.** WLS Response: R3 does not have any monitoring devices on the reach but is visually monitored during quarterly site visits. WLS is confident that the reach is performing as intended and has no concern about the 76 stream credits being at risk. WLS will provide additional photos and video during quarterly MY5 site visits to provide flow documentation.
