Monitoring Report
FINAL VERSION
Horne Creek Tributaries Mitigation Project
Monitoring Year 1
Calendar Year of Data Collection: 2020

NCDEQ DMS Project Identification # 100026
NCDEQ DMS Contract # 7181
Yadkin River Basin (Cataloging Unit 03040101)
USACE Action ID Number: SAW-2017-01510
NCDEQ DWR Project # 2017-1156
Surry County, NC
Contracted Under RFP # 16-006993
Data Collection Period: November 2020
Submission Date: December 2020

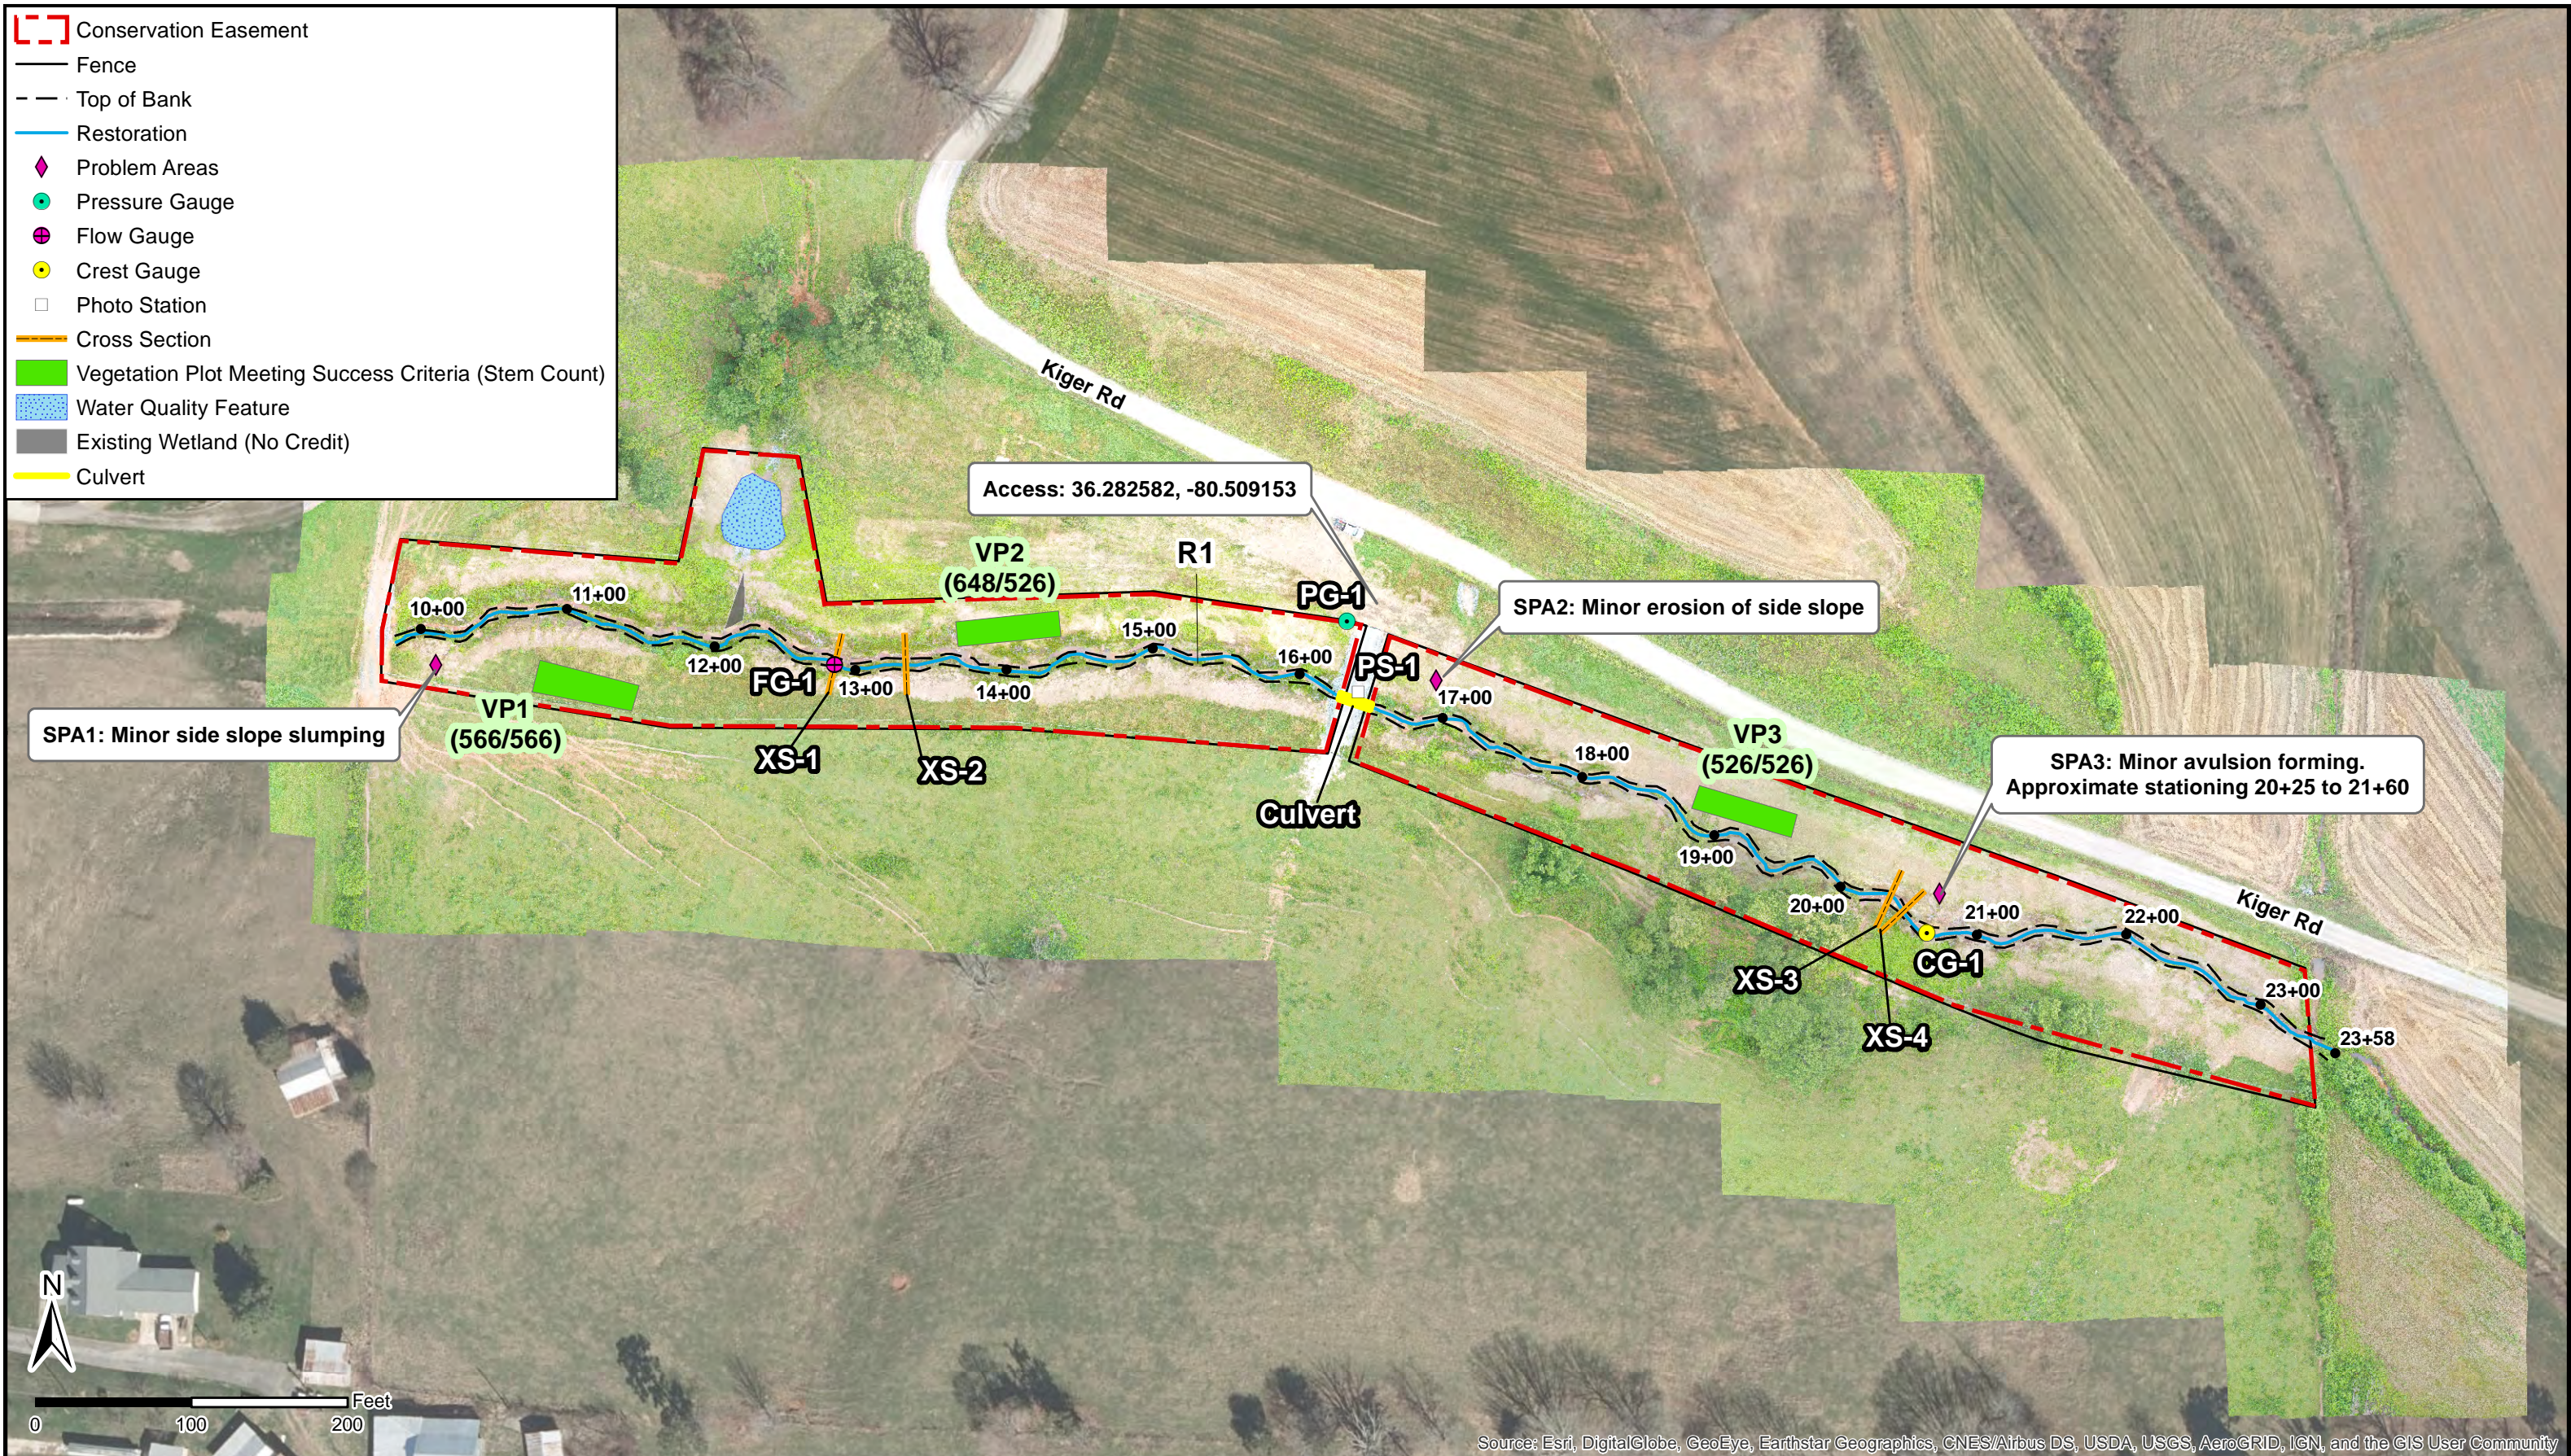
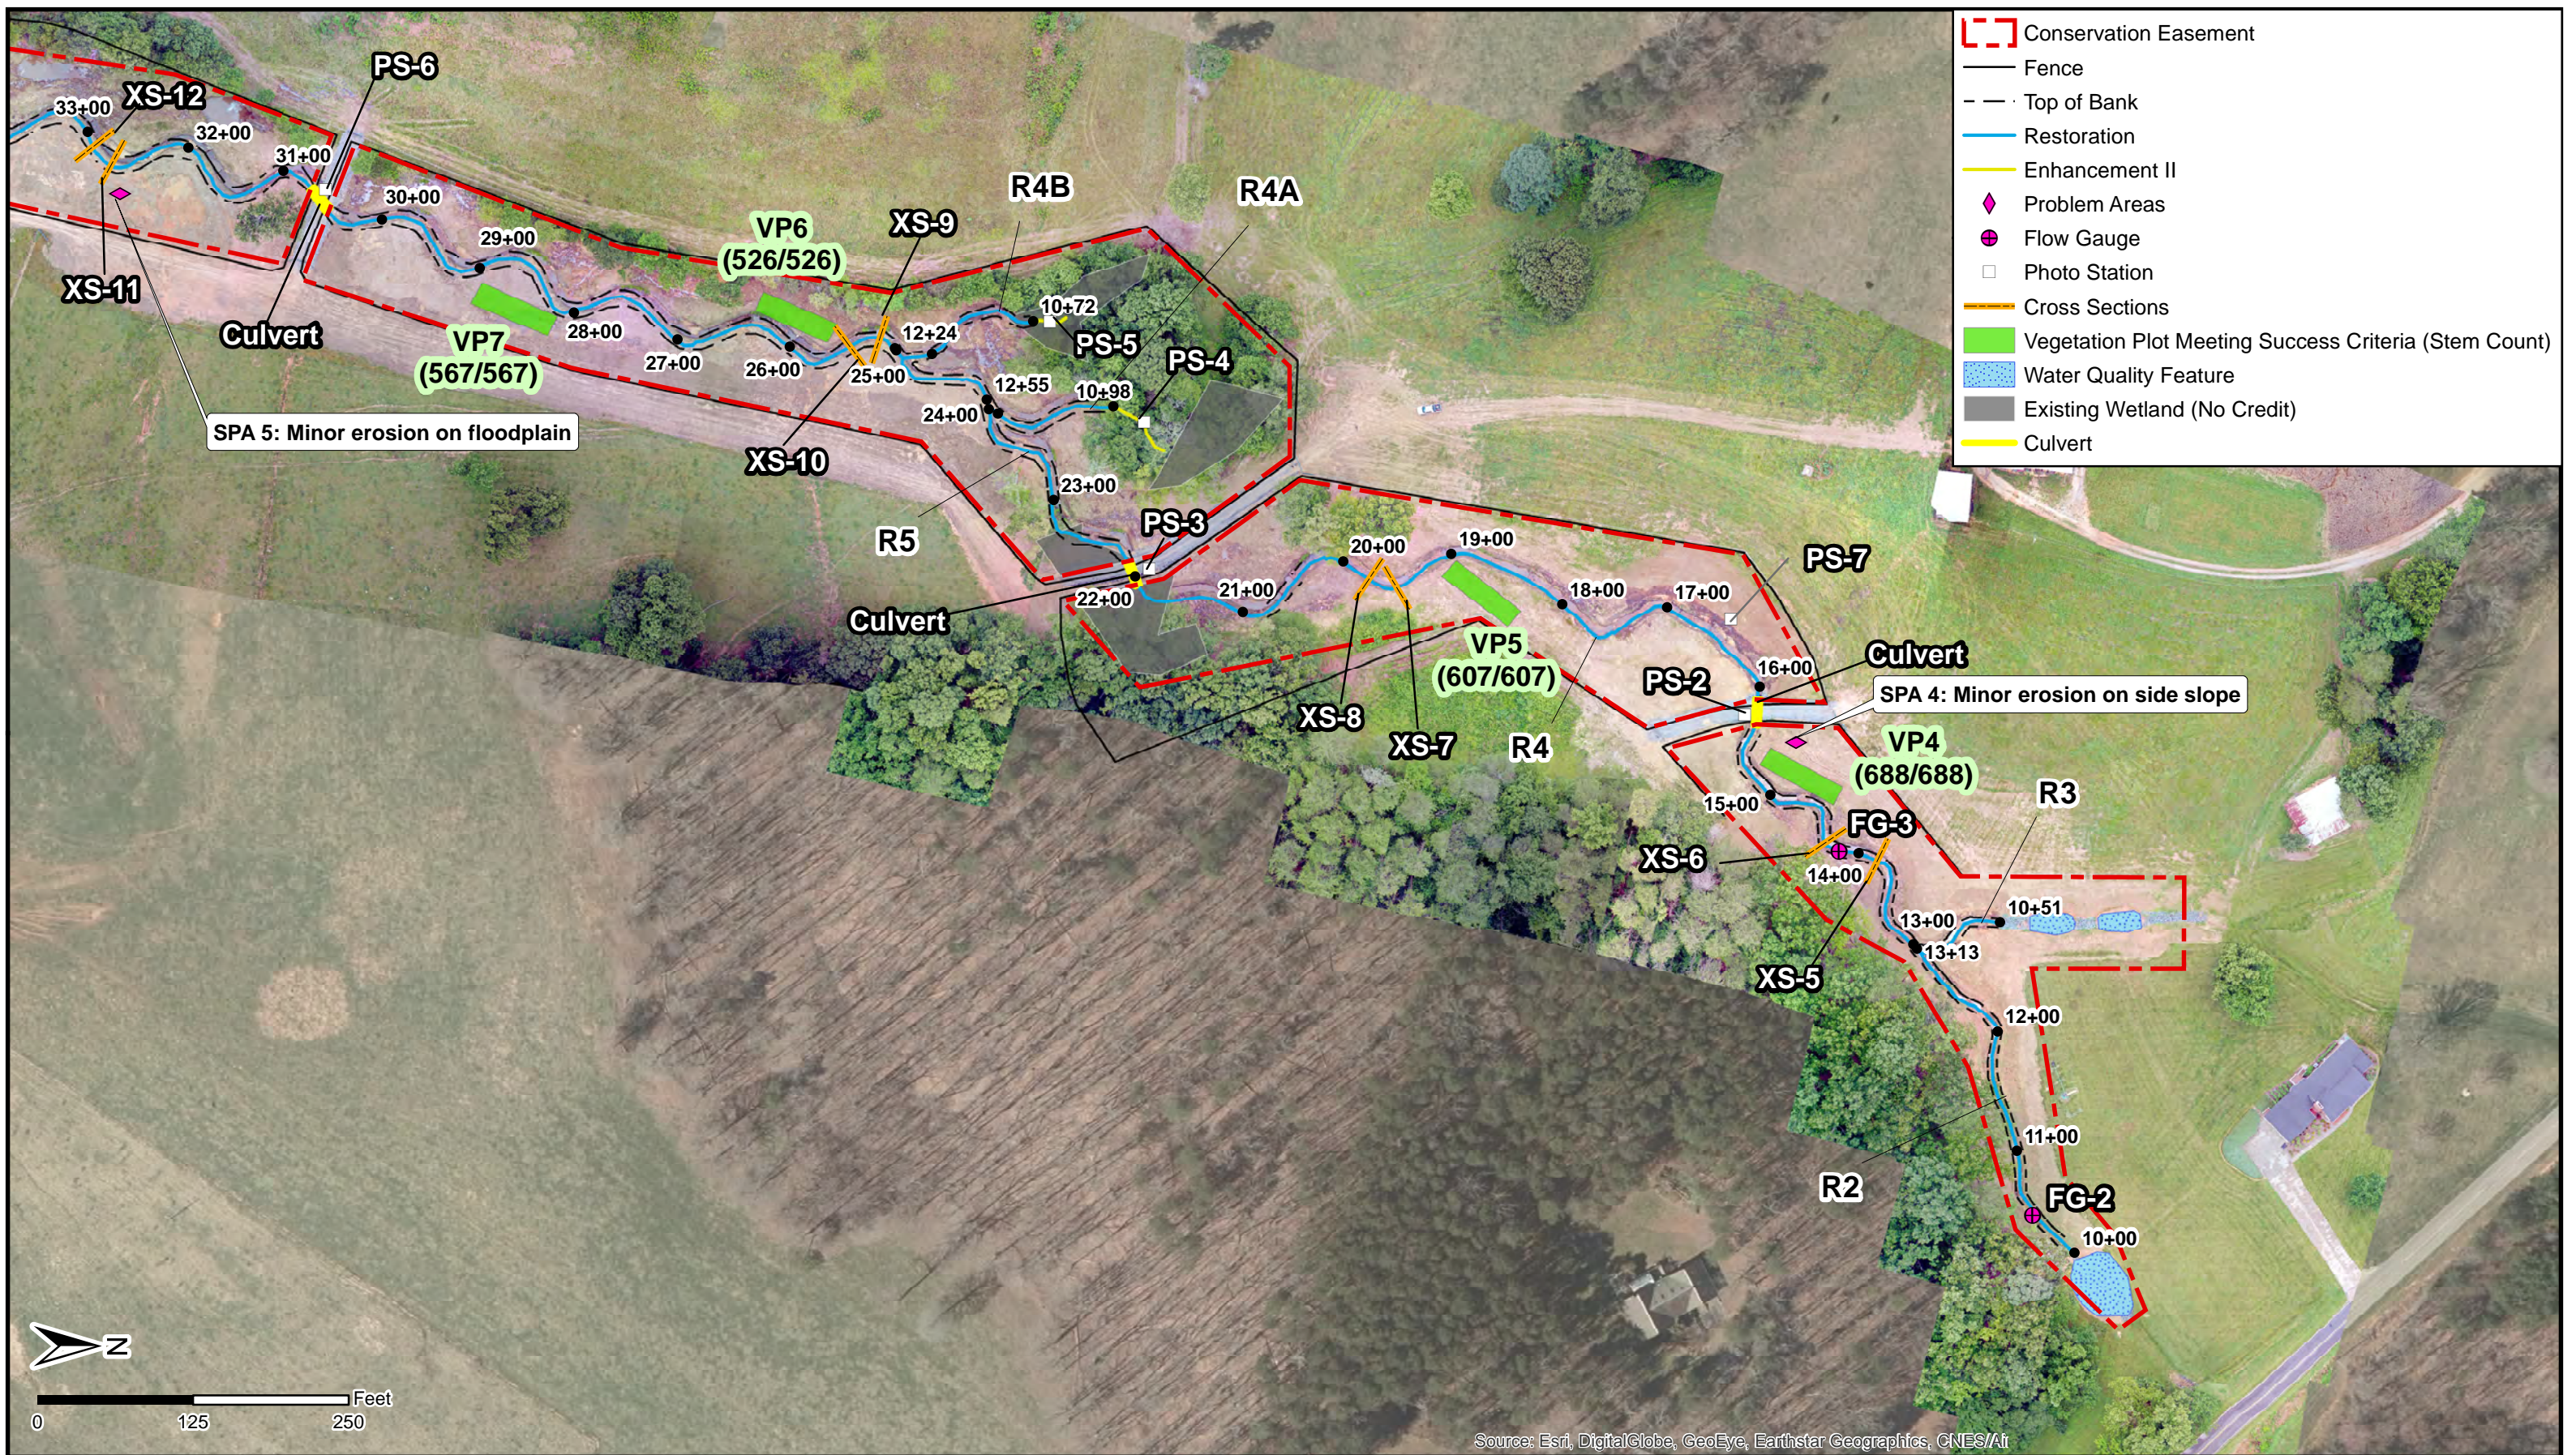
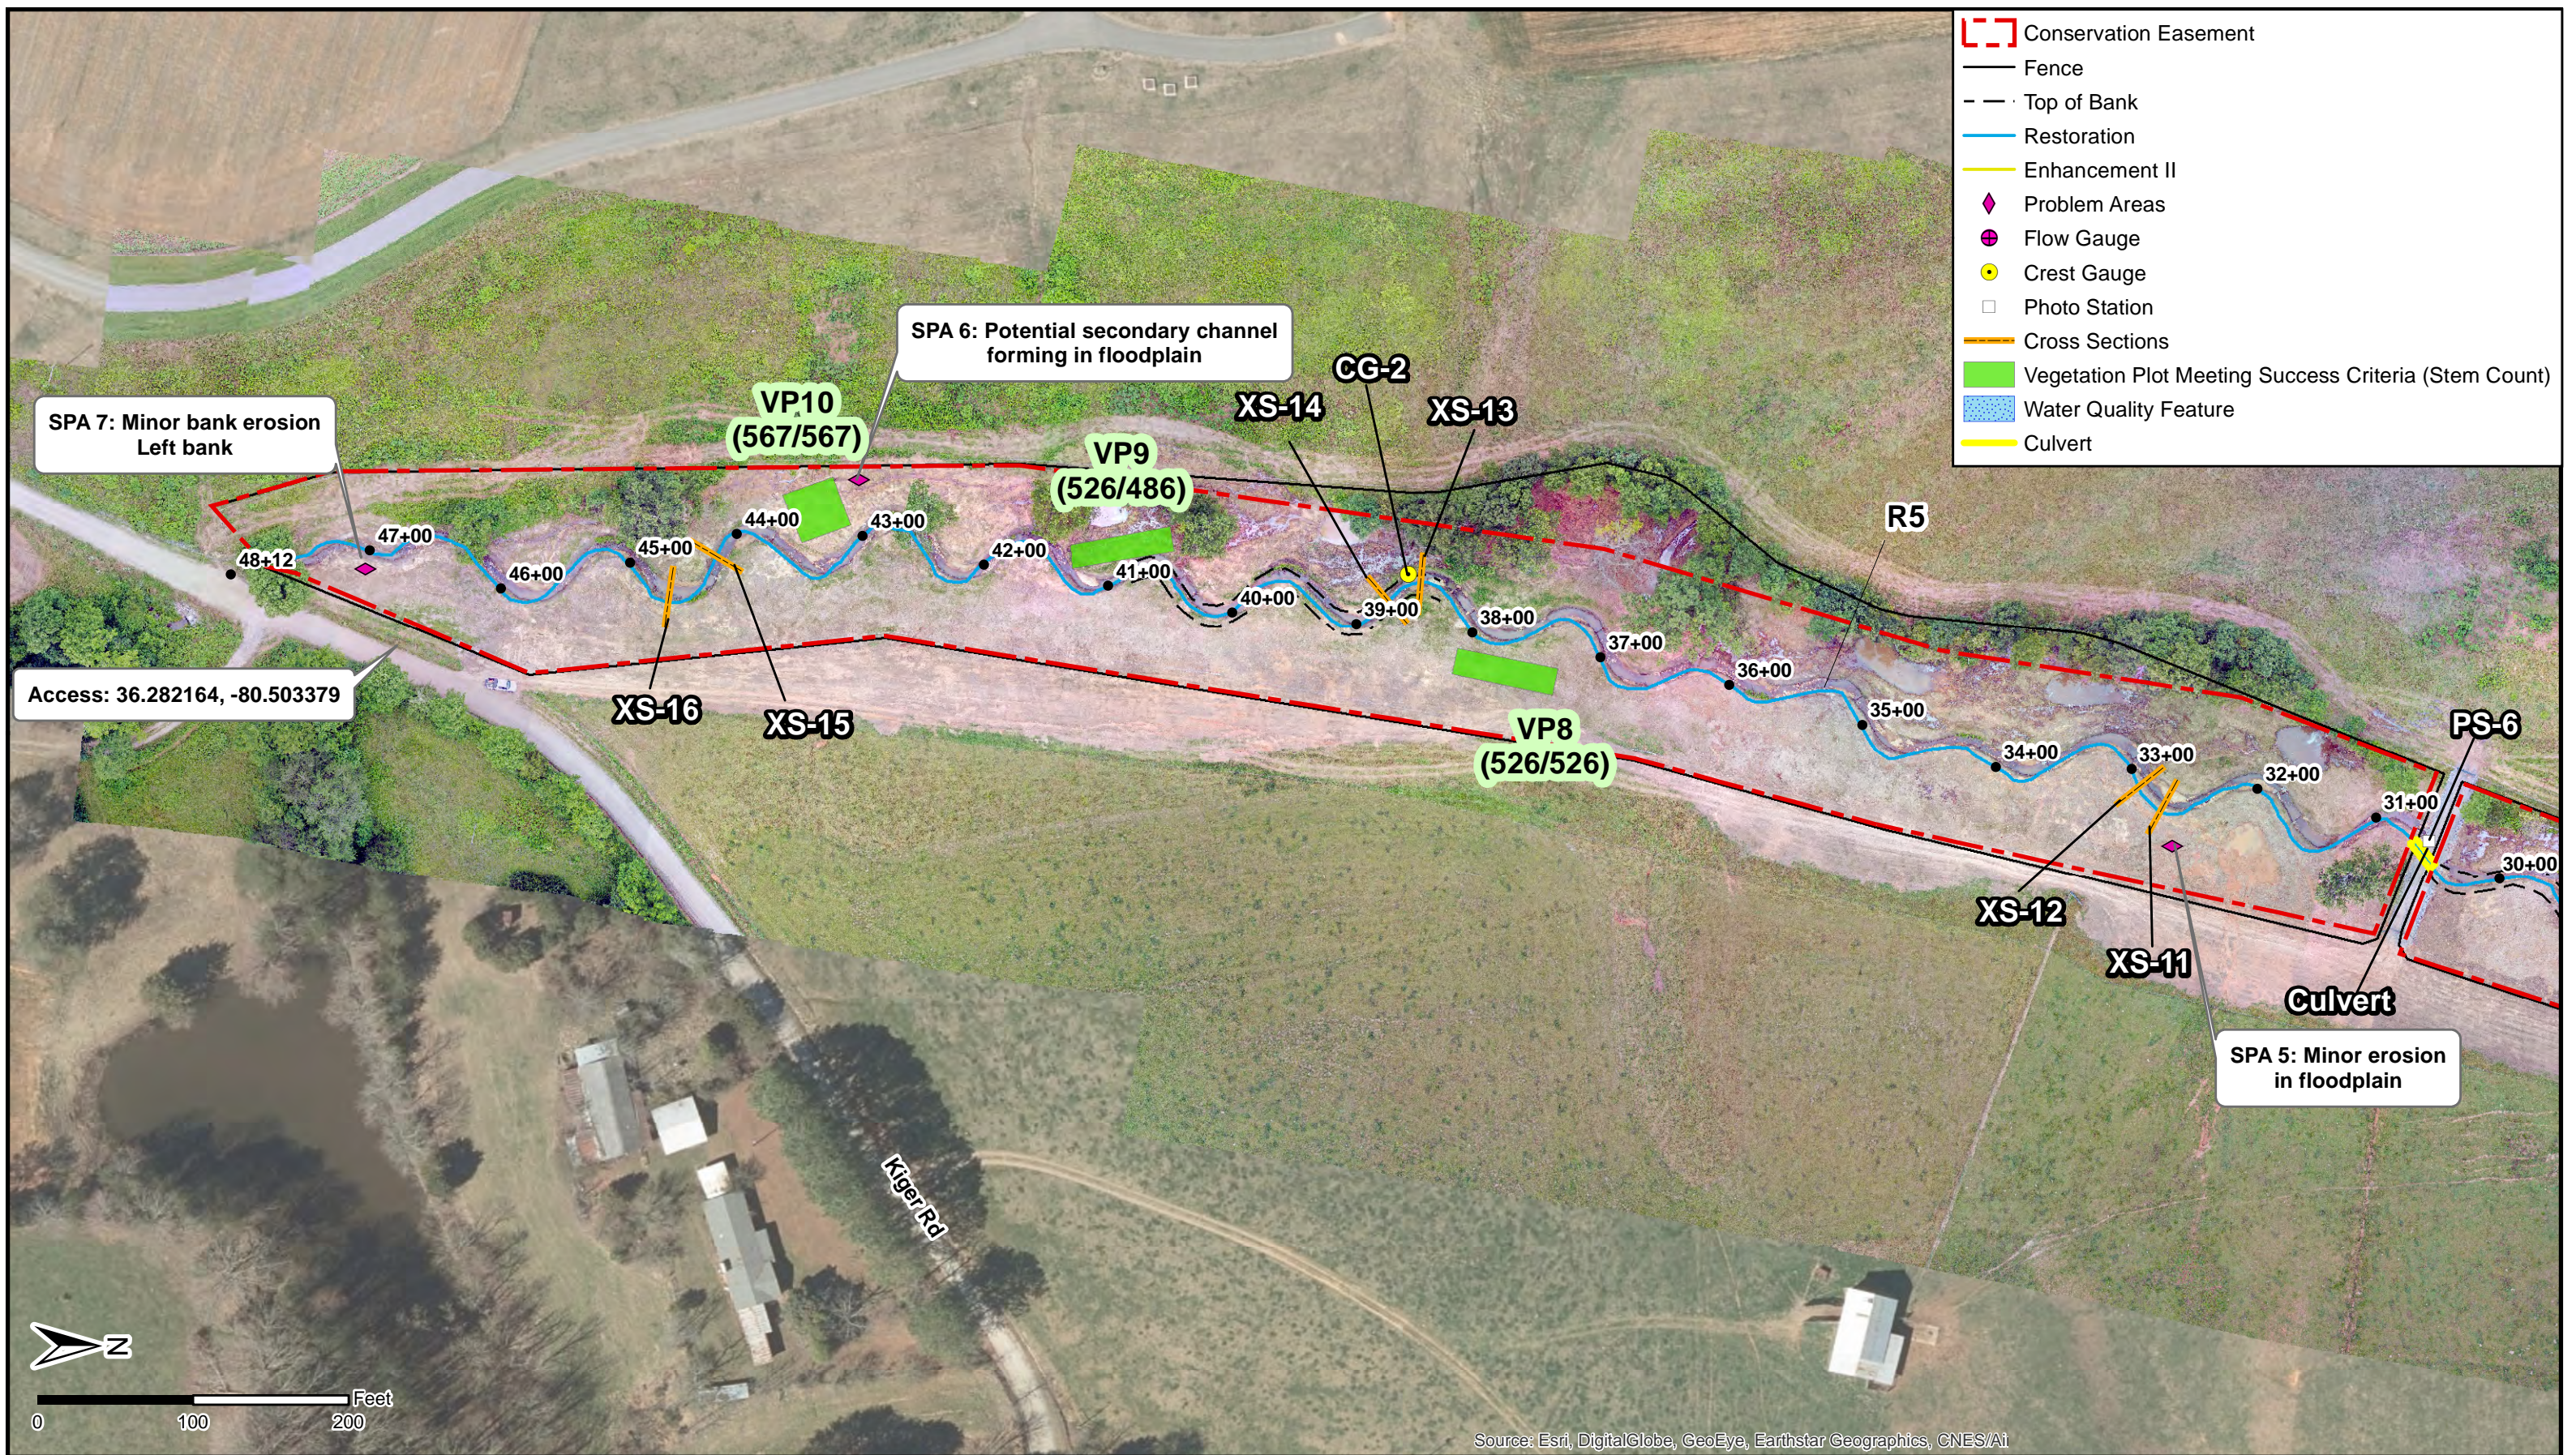
FIGURE
1a

During the fall visual assessment for MY1, WLS staff noted seven potential problem areas outside the channel. These areas are called out on the CCPV (Figure 1a-1c) and photos can be found in Appendix B and the E-Data Submission included with this report.

- **SPA4-** On R4, minor erosion was observed on both the right and left bank side slopes at approximate station 15+75, above the culvert crossing. This area will be closely monitored during MY2.
- **SPA5-** On R5, in the left floodplain area: minor erosion is occurring adjacent to station 32+60. WLS will monitor this area during MY2.
- **SPA6-** On R5, adjacent to vegetation plot 10 near station 43+50: a small secondary channel has formed in the right floodplain between the floodplain depressions. This area and drainage pattern will be closely monitored during MY2.
- **SPA7-** On R5, at the meander bend located at station 47+00: the left bank is at risk of eroding. The bank is currently functioning, but WLS will install additional live stakes in the meander to ensure stability in MY2. Any remedial action taken during MY2 will be photographed and documented in the MY2 report.

- **Please continue monitoring the seven stream problem areas that were identified during MY1 and document any remedial actions taken in the MY2 report.** WLS Response: The seven stream problem areas will continue to be monitored and remedial actions will be noted in the MY2 Report.
- **3.1.2 Stream Horizontal Dimension: The report indicates that four cross-sections (XS-2, XS-4, XS-5, and XS-15) are experiencing minor aggradation. With the exception of XS-15, the cross-section graphs do not support this claim. XS-2, 4 and 5 graphs indicate areas of degradation. Please review and revise as necessary.** WLS Response: WLS has revised 3.1.2 to indicate XS-2, XS-4, and XS-5 are experiencing minor degradation and XS-15 is experiencing minor aggradation. WLS staff noted that XS-2, XS-4, XS-5, and XS-15 are functioning and stable. WLS will continue to monitor all cross sections closely in MY2.

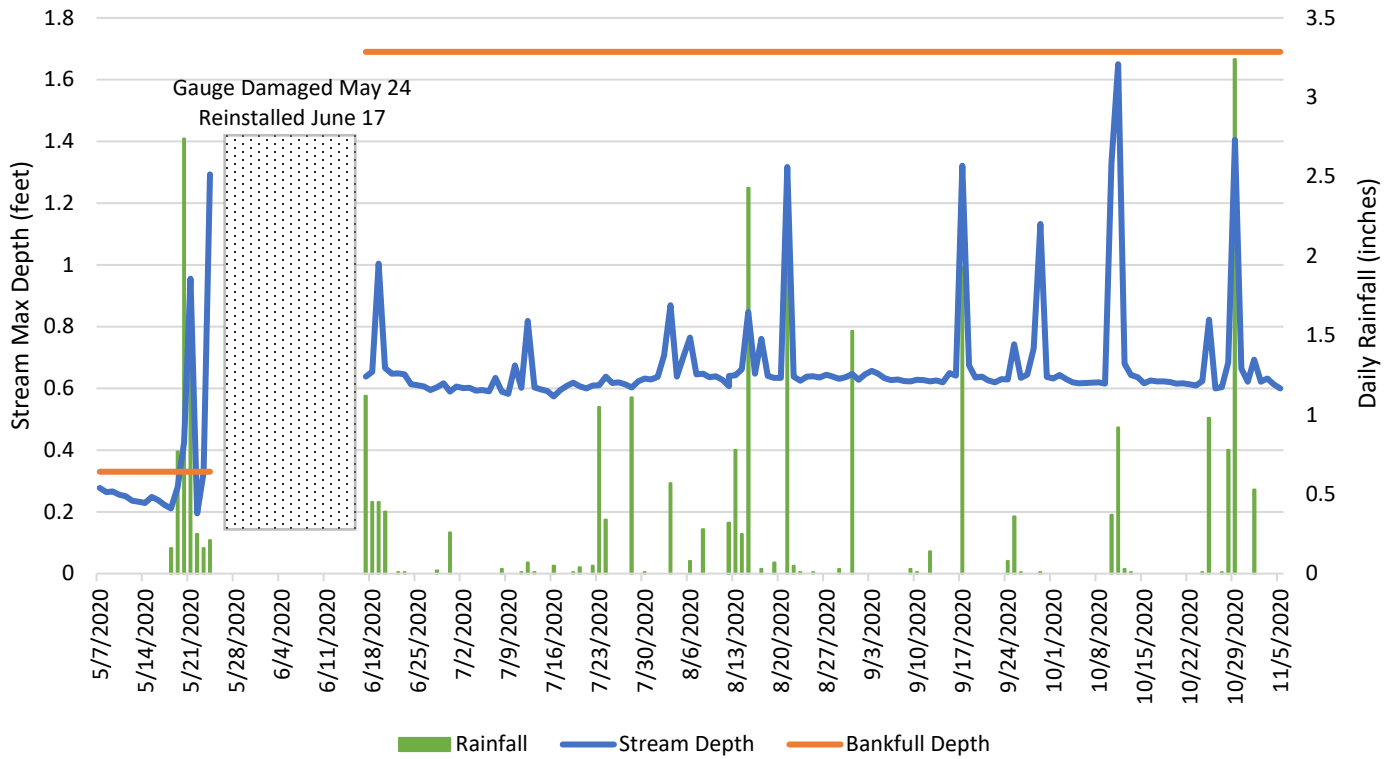
Horne Creek Tribs - Crest Gauge CG-2 (R5)

maximum event of 0.96' above bankfull. CG-2 was subsequently damaged by a storm event on May 24th, 2020. WLS reinstalled the gauge on June 17th, 2020. Additionally, the cork crest gauge located adjacent to CG-1 on R1 recorded two bankfull events. The associated data and photographs are located in Appendix E.

*R5 Crest Gauge was damaged during a storm event on 5/24 and was repaired and reinstalled by WLS staff on 6/17

** CG-2 was re-surveyed in its new location after reinstallation with new bankfull depth of 1.69'

- **3.22 Bankfull Events: CG-2 recorded two events during MY1. The two events were recorded prior to the gauge being damaged and moved. The new reinstalled location has a new bankfull depth as shown on Figure 4. The new location did not record a bankfull event despite several 2.5-3" rain events. Is WLS confident that the location and calibration of CG- 2 is capturing bankfull events in the new location?** WLS Response: WLS is confident in the location of CG-2. WLS re-surveyed CG-2 on December 7th, 2020 and adjusted the re-installed bankfull height to 1.69'. Since the submittal of the draft monitoring report, CG-2 has recorded a bankfull event. Figure 4 in Appendix E has been updated with the corrected bankfull depth of 1.69'.
