MY1 FINAL MONITORING REPORT
Hornpipe Branch Tributaries Mitigation Project
Lenoir County
Neuse River Basin
CU 03020202

DMS Project # 100076
DMS Contract # 7605
Contracted RFP # 16-007401
USACE Action ID Number: SAW-2018-01762
DWR Project # 2018-1155

Calendar Year of Data Collection: 2021

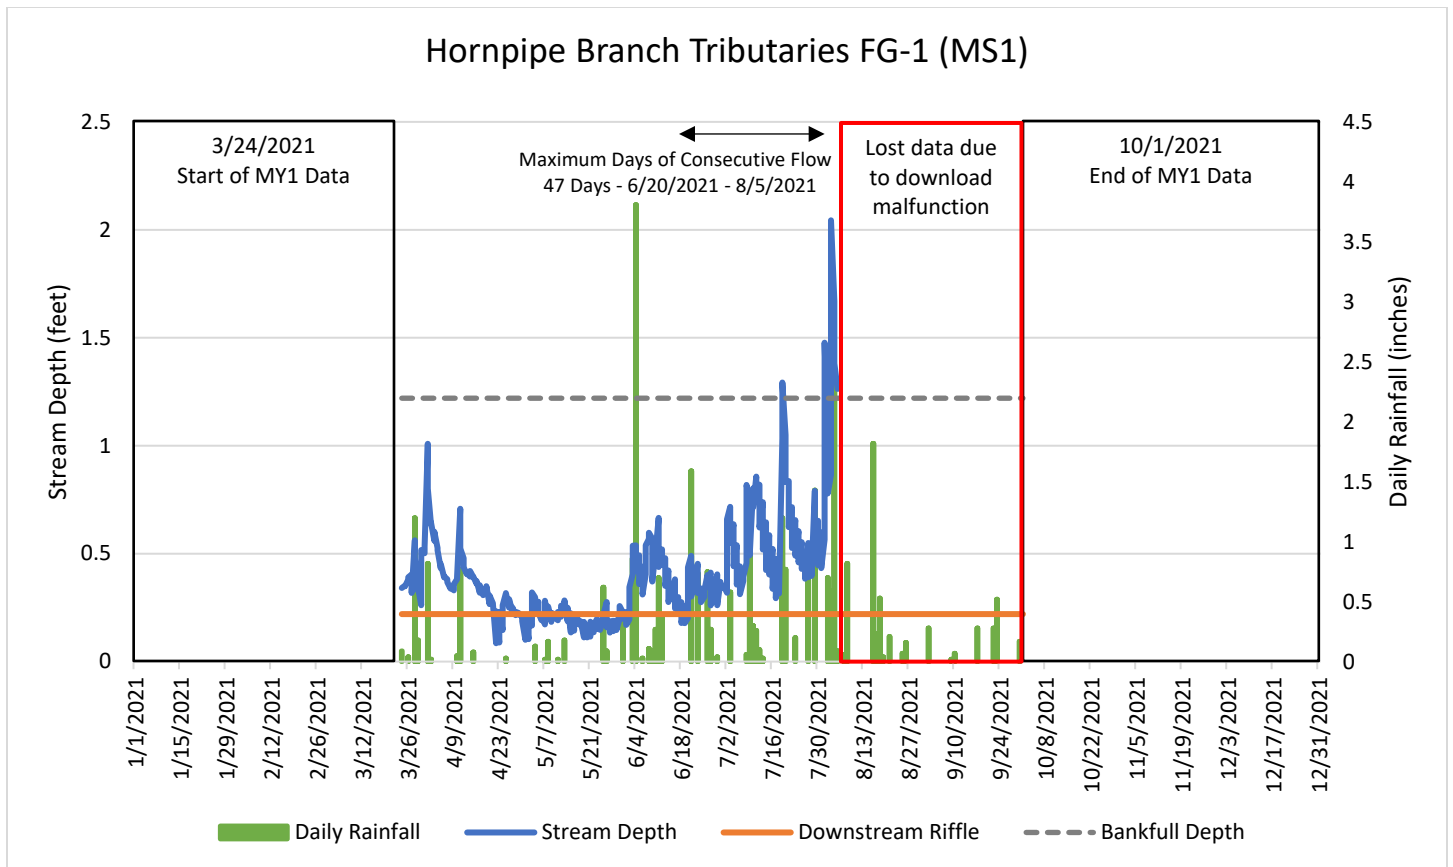
*106 days of cumulative flow in MY1, 29 days of no recorded flow in MY1

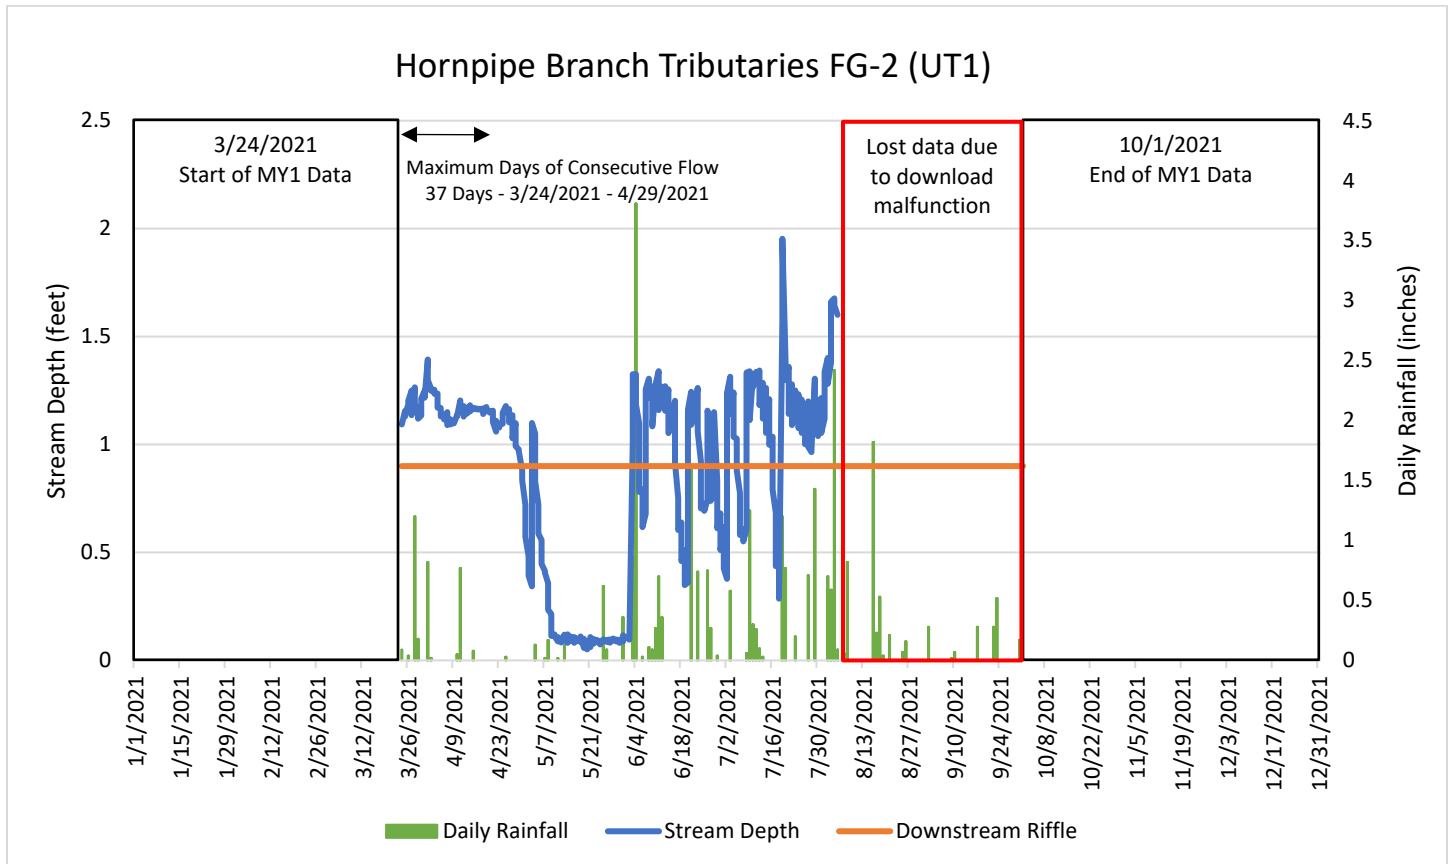
*84 days of cumulative flow in MY1, 51 days of no recorded flow in MY1

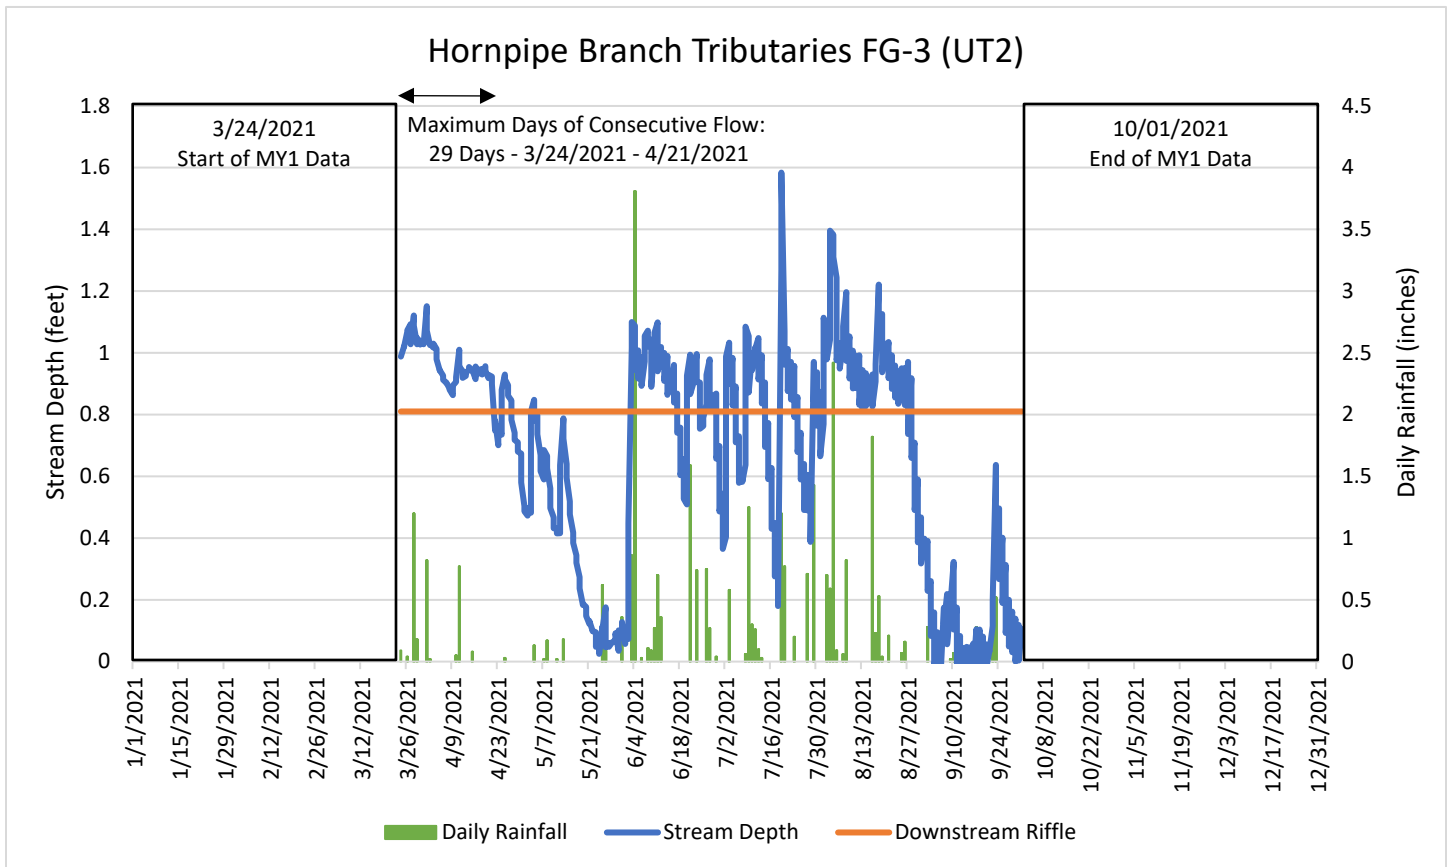
*97 days of cumulative flow in MY1, 95 days of no recorded flow in MY1

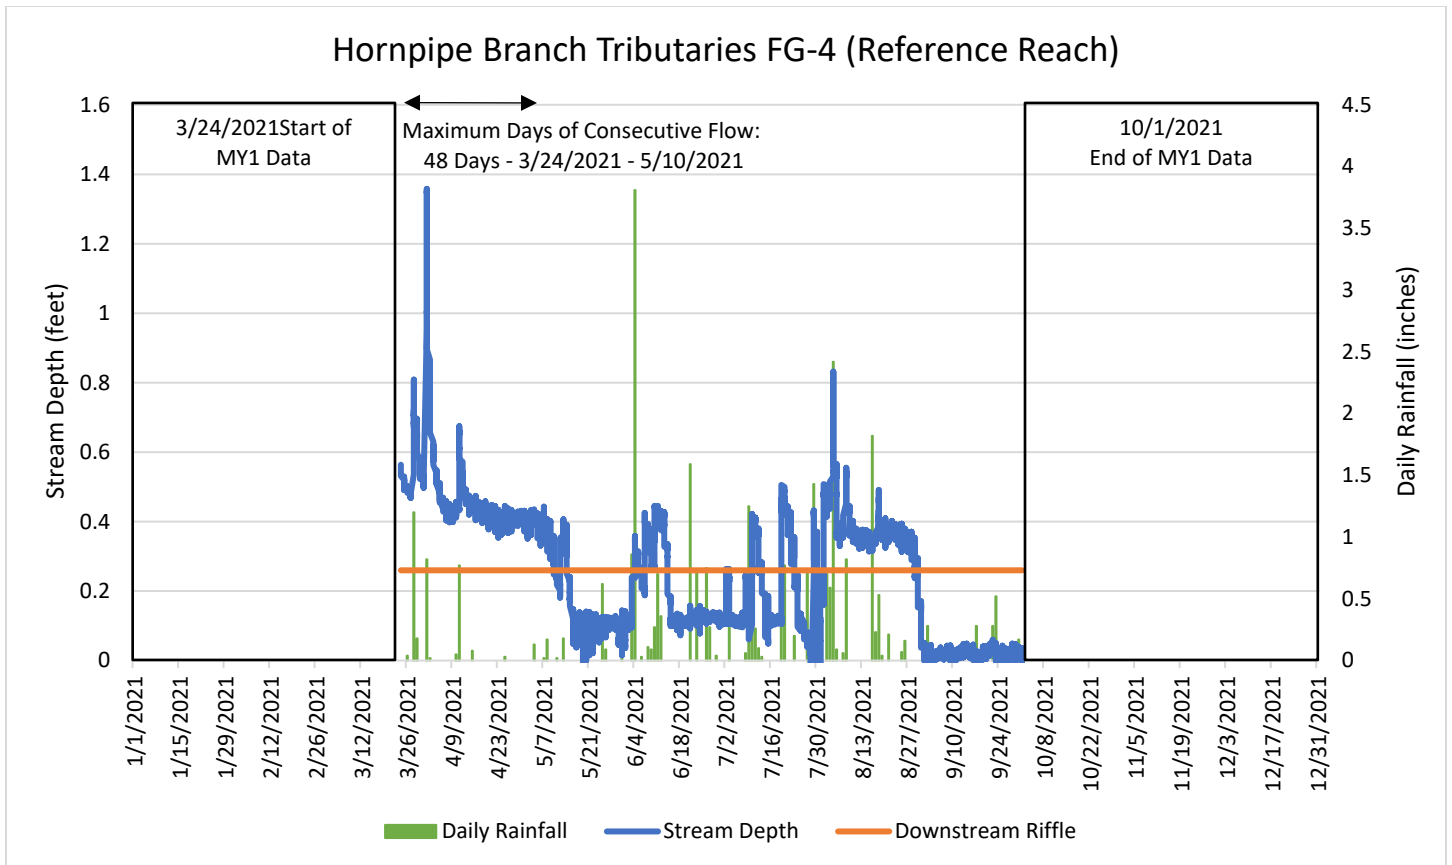
*96 days of cumulative flow in MY1, 96 days of no recorded flow in MY1

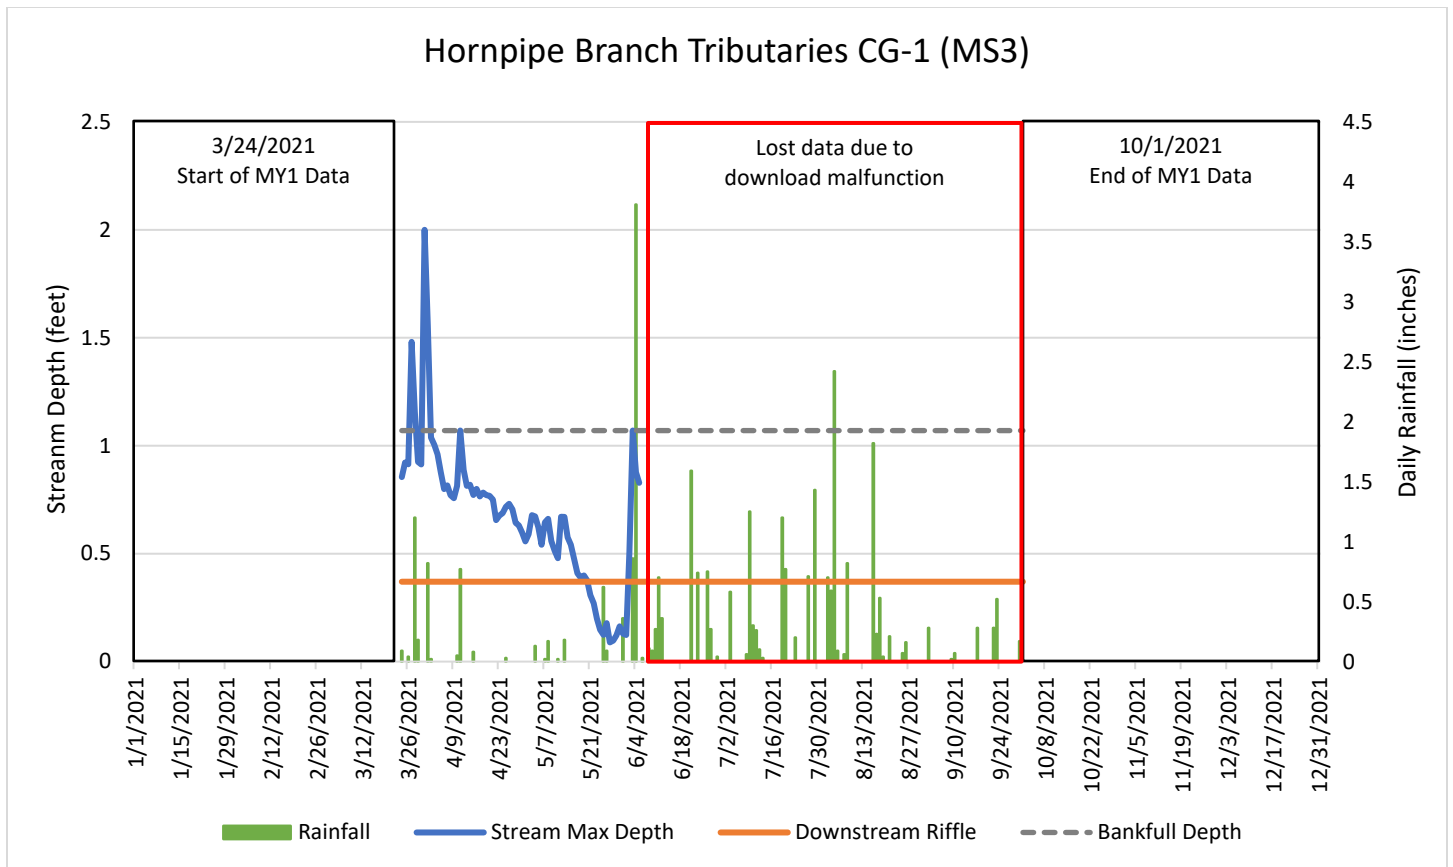
Crest Gauge Data – Hornpipe Branch Tributaries MY1

During MY1, bankfull events were recorded on the pressure transducer crest gauge. CG-1 recorded 2 events with a maximum event of 0.488' above bankfull on April 1, 2021. The CG-1 pressure transducer malfunctioned on June 6, 2021 and was replaced during MY1 activities on October 19, 2021. Additionally, the cork crest gauge located adjacent to CG-1 recorded 2 bankfull events with a maximum event of 0.85' above bankfull. Associated data and photographs are located in Appendix D.

*Data lost due to a pressure transducer malfunction from 6/6/2021 - 10/19/2021
