MY2 FINAL MONITORING REPORT
Hornpipe Branch Tributaries Mitigation Project
Lenoir County
Neuse River Basin
CU 03020202

DMS Project # 100076
DMS Contract # 7605
Contracted RFP # 16-007401
USACE Action ID Number: SAW-2018-01762
DWR Project # 2018-1155

Calendar Year of Data Collection: 2022

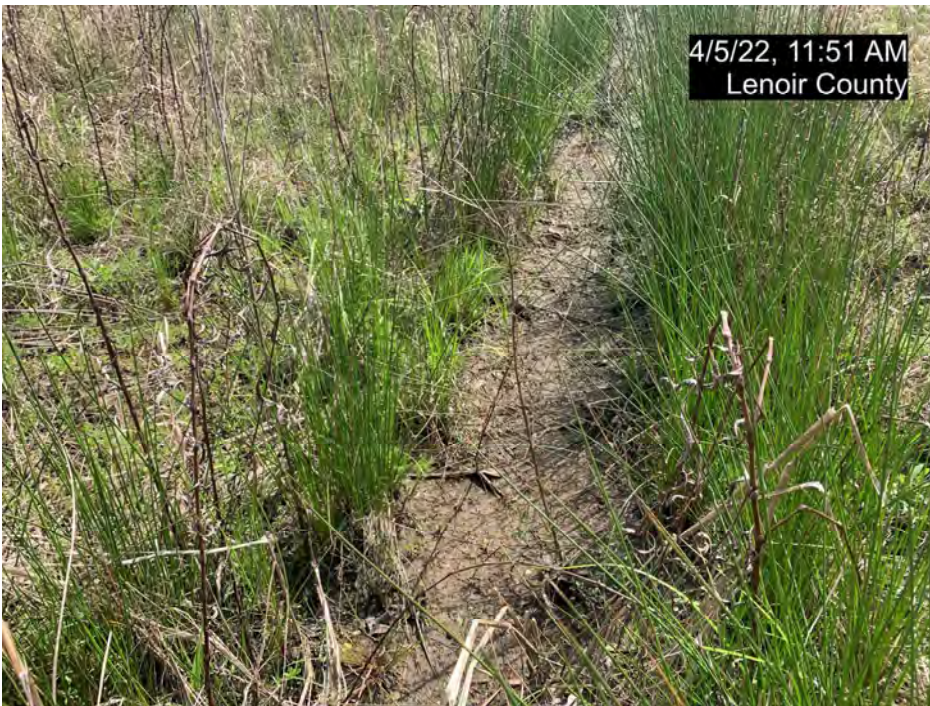
UT1, absent leaf litter in channel

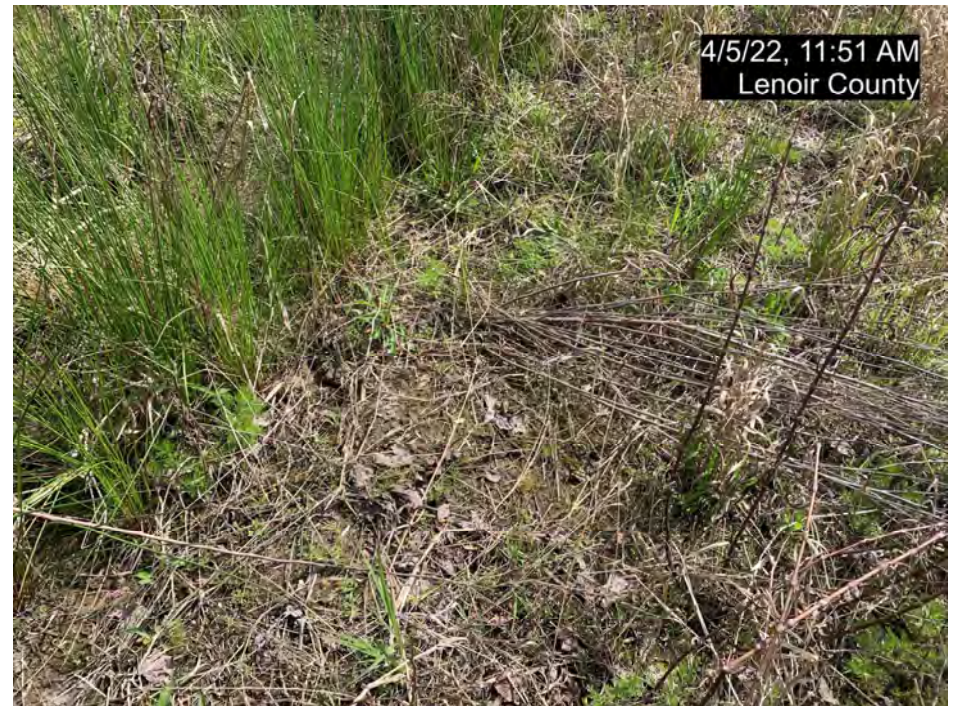
UT1, leaf litter outside of channel

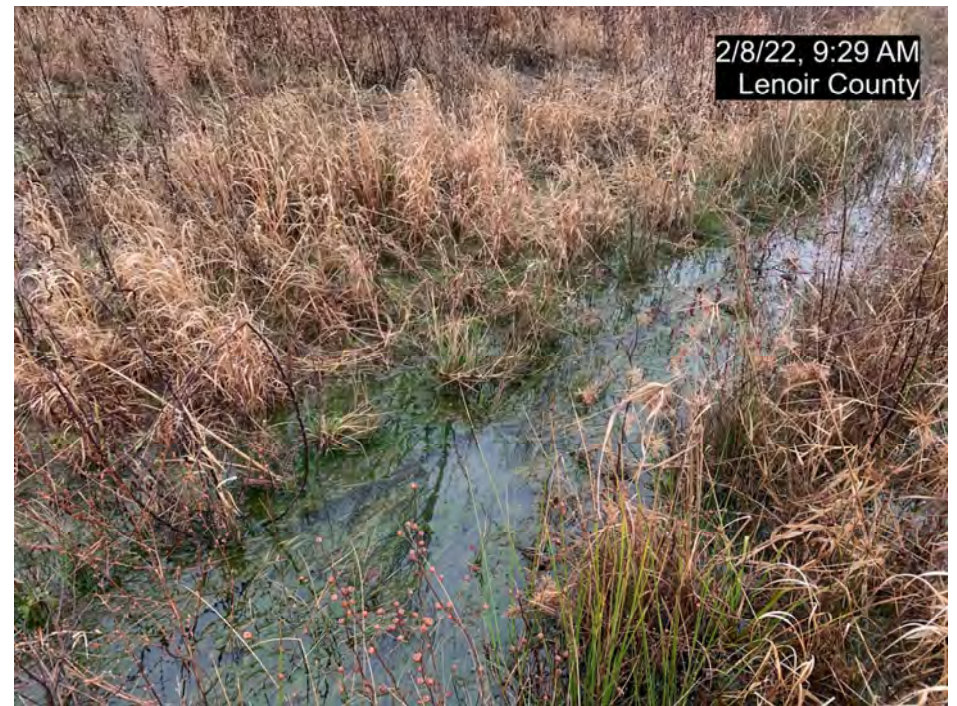
UT1, wrack line

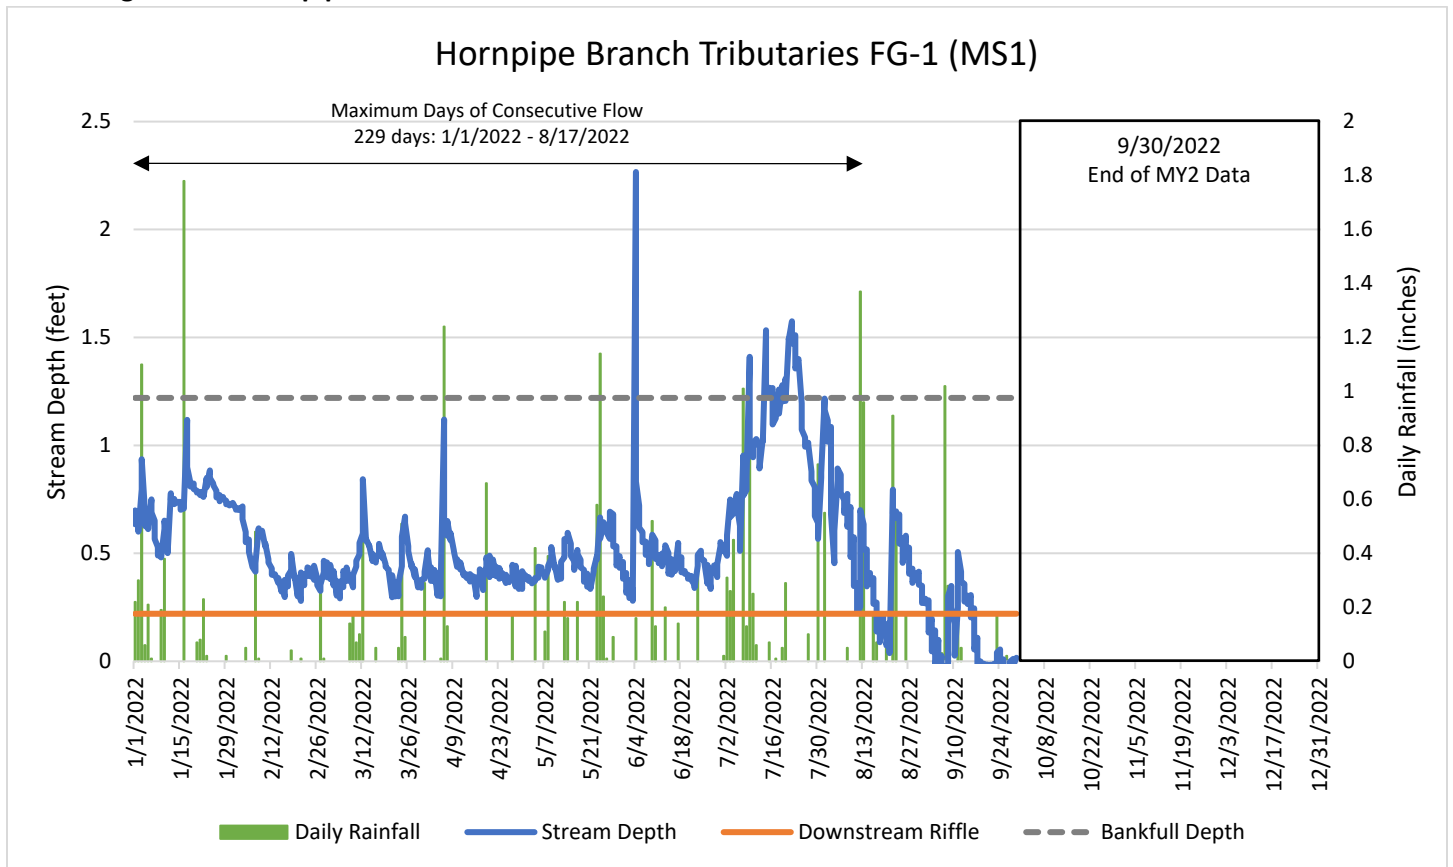
*247 days of cumulative flow in MY2, 25 days of cumulative no flow in MY2

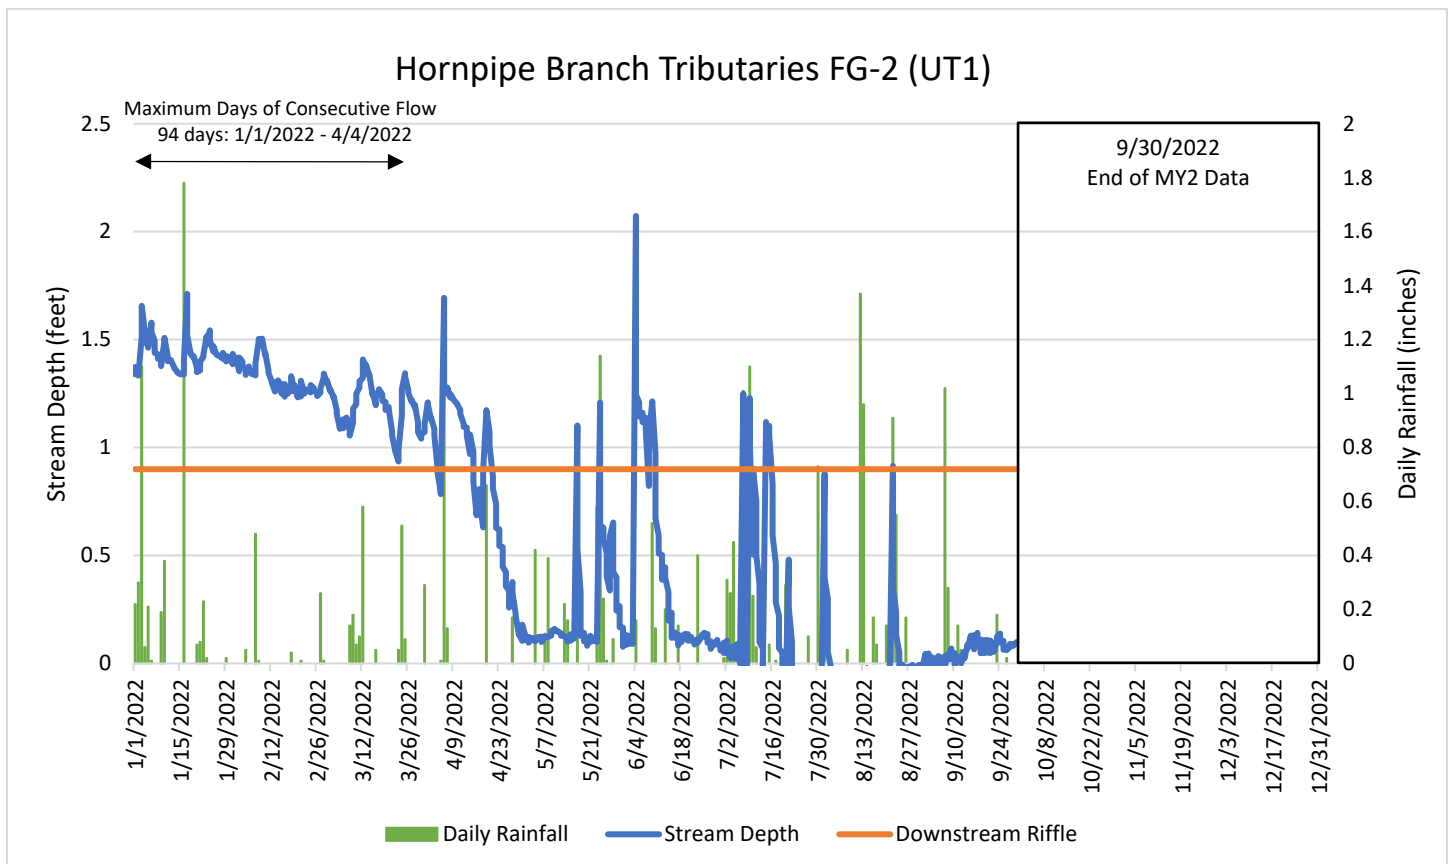
*117 days of cumulative flow in MY2, 155 days of cumulative no flow in MY2

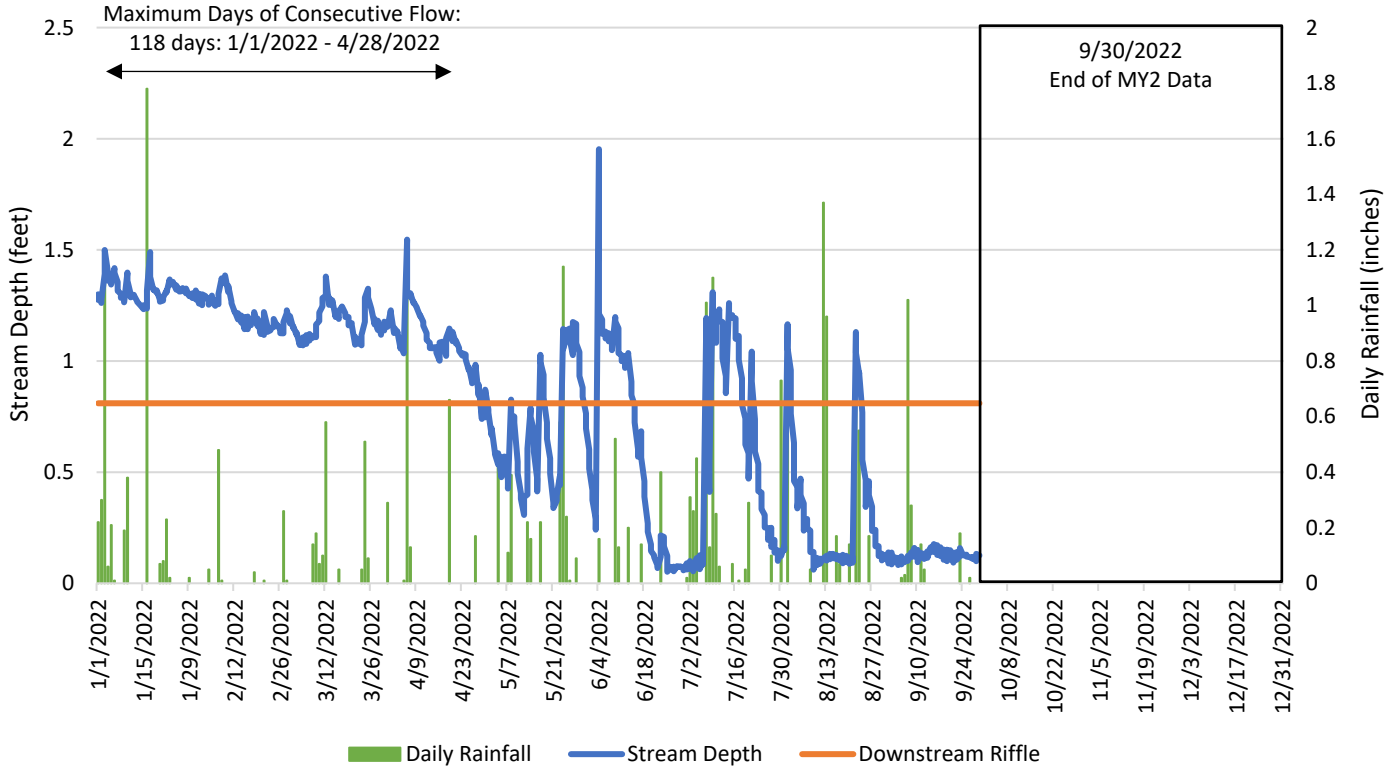
Hornpipe Branch Tributaries FG-3 (UT2)

*154 days of cumulative flow in MY2, 118 days of cumulative no flow in MY2

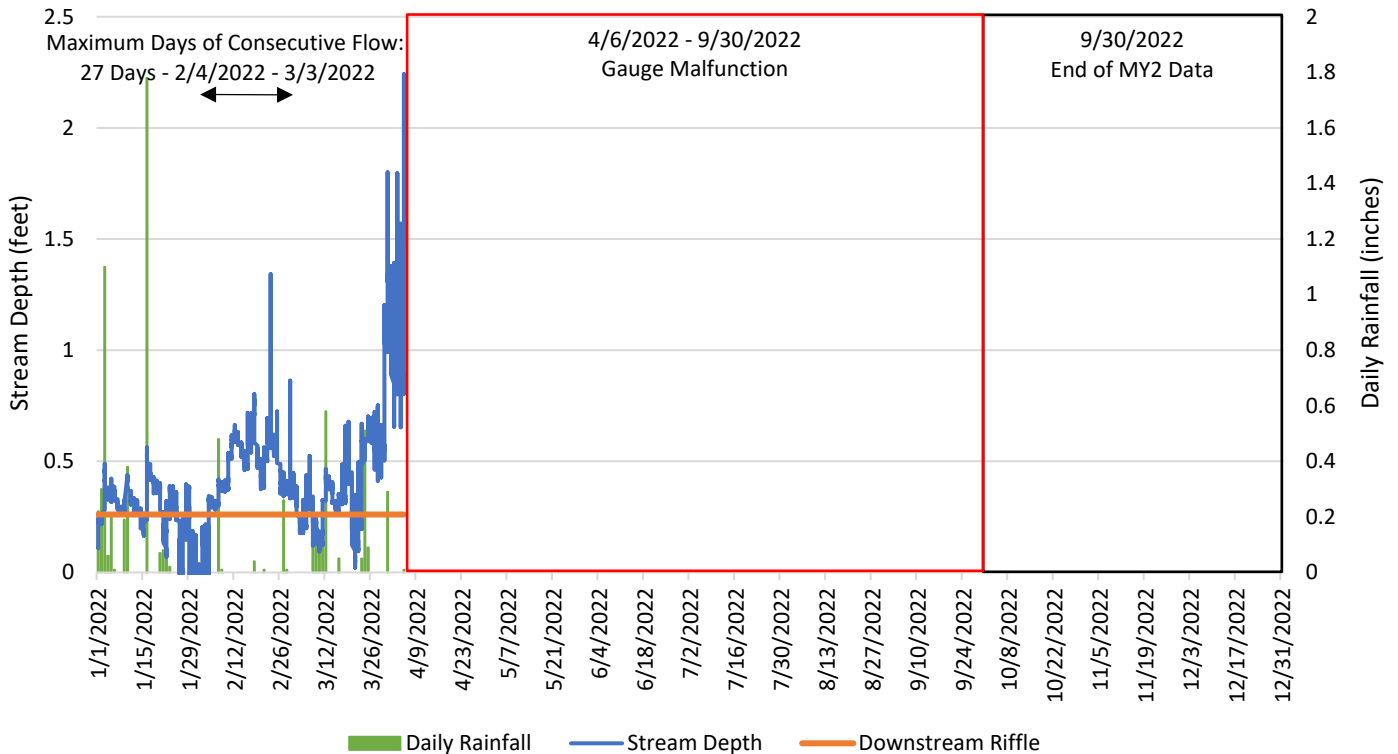
Hornpipe Branch Tributaries FG-4 (Reference Reach)

*65 days of cumulative flow in MY2, 29 days of cumulative no flow in MY2

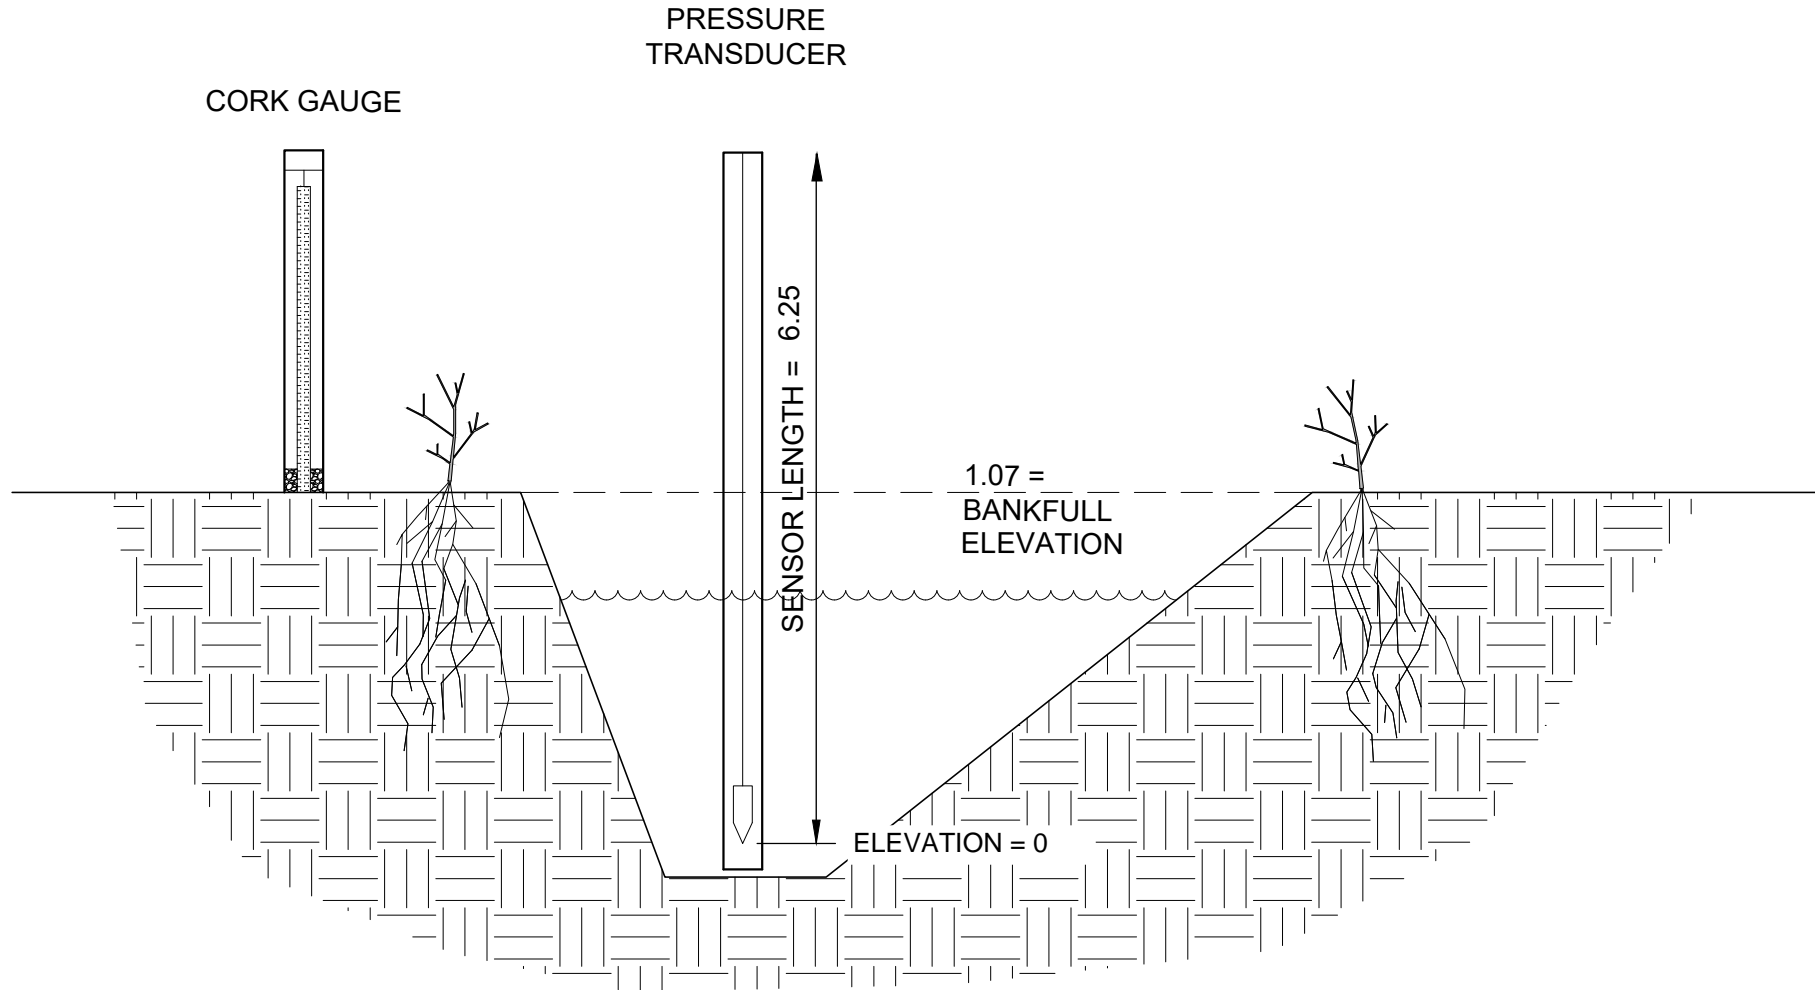
Crest Gauge CG-1 (MS-3)

Bankfull Event Depth = 1.07 feet
