MY3 FINAL MONITORING REPORT
Hornpipe Branch Tributaries Mitigation Project
Lenoir County
Neuse River Basin
CU 03020202

DMS Project # 100076
DMS Contract # 7605
Contracted RFP # 16-007401
USACE Action ID Number: SAW-2018-01762
DWR Project # 2018-1155

Calendar Year of Data Collection: 2023

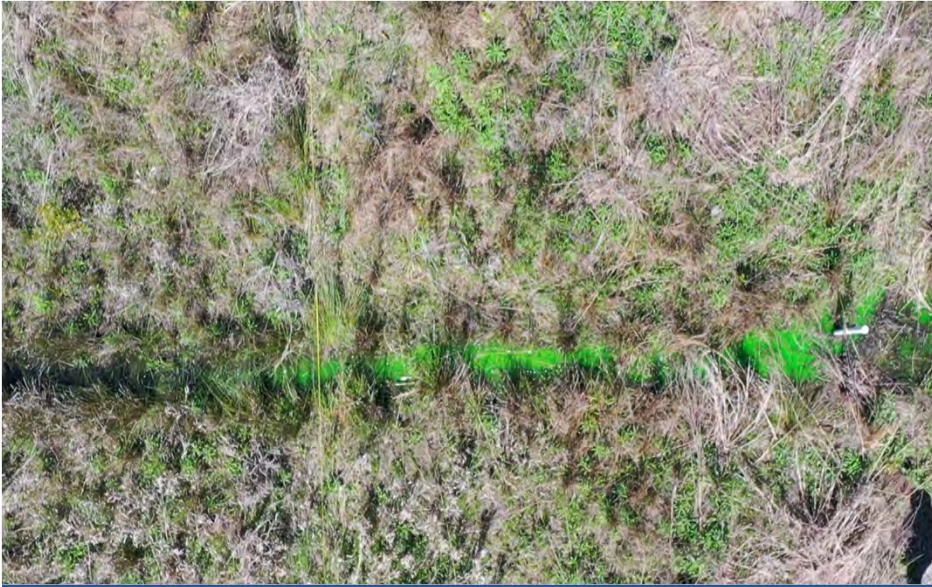
UT1, flow documentation – dye test, 4/12/2023 (MY-03)
