# **As-Built Baseline Monitoring Report FINAL**

## **Hudson Property**

DMS Project ID #: 95361

### **Submitted: August 2016**

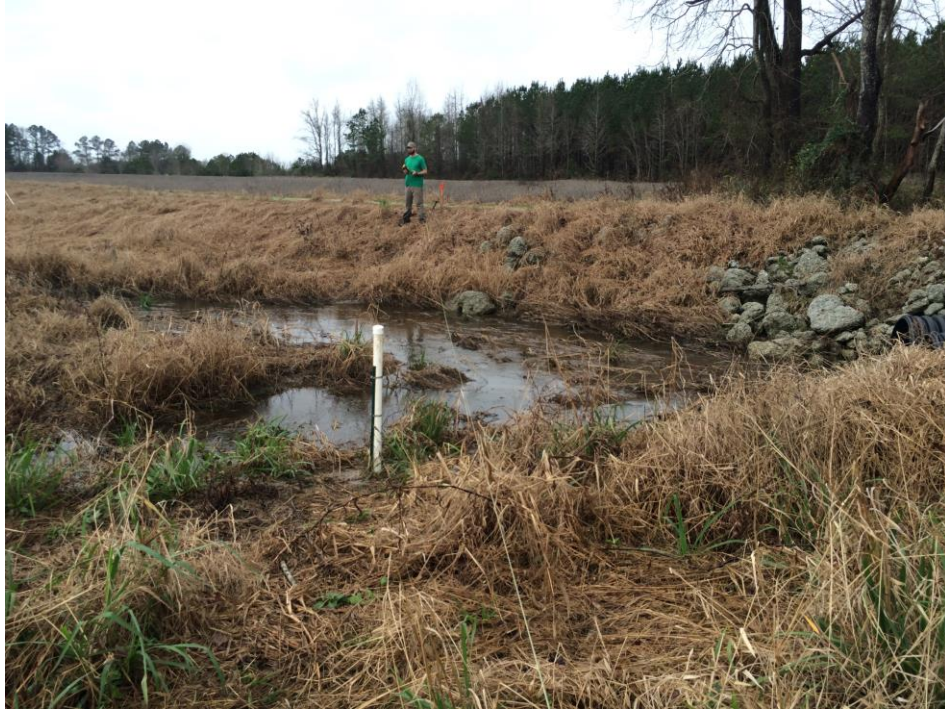
Photo 1: Cross section near culvert at convergence of Reach 1&2

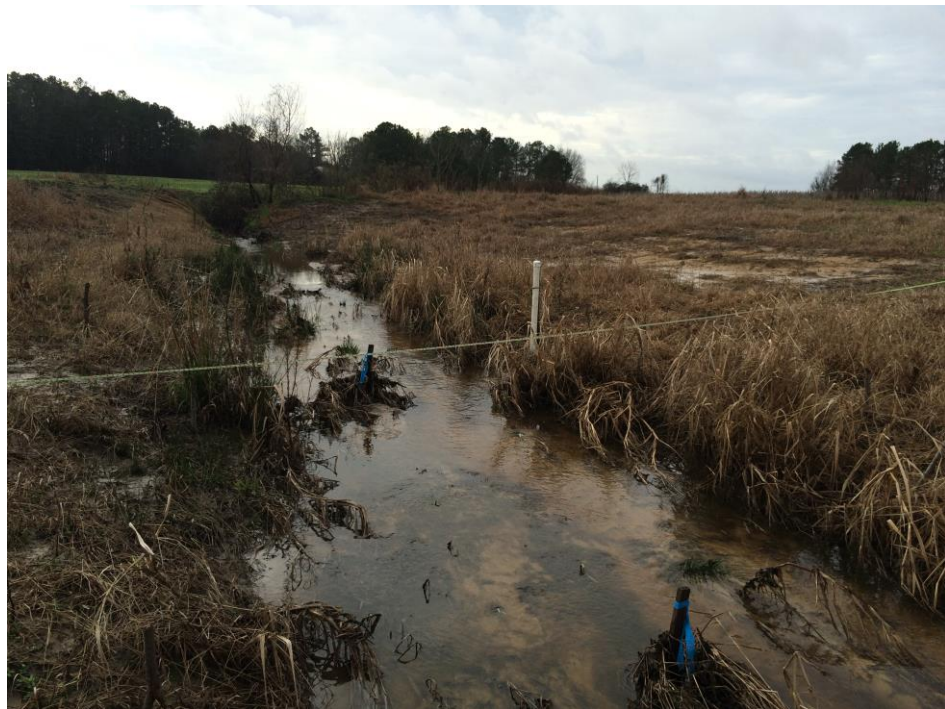
Photo 2: As-Built cross section on Reach 2

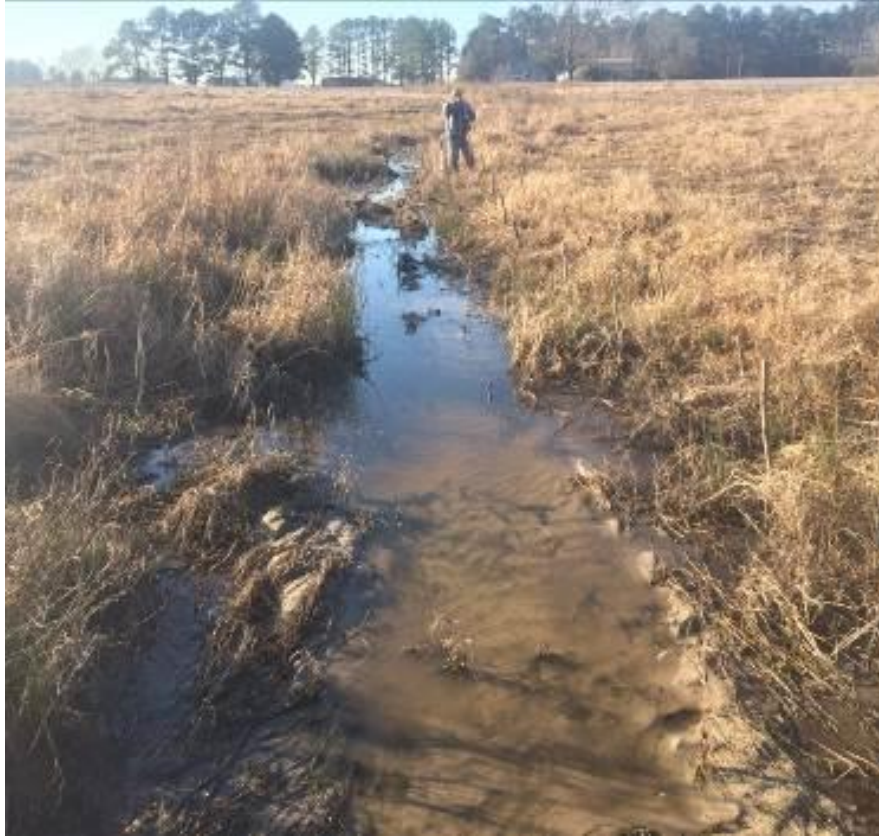
Photo 3: View South along Reach 3

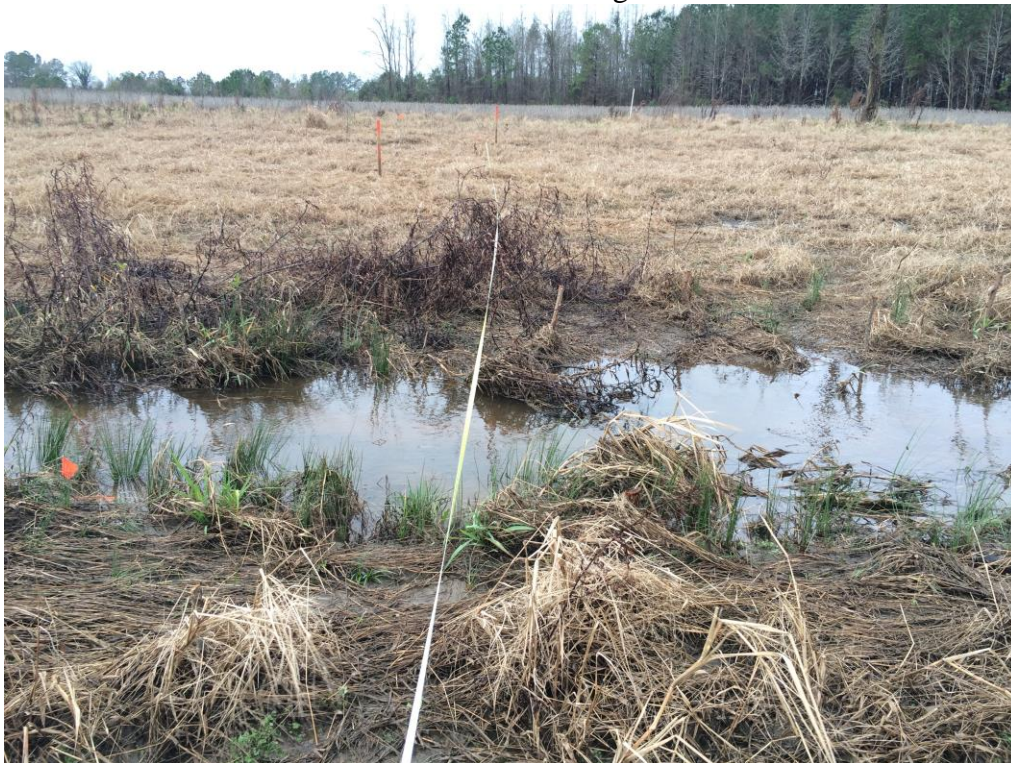
Photo 4: Cross section on Reach 4

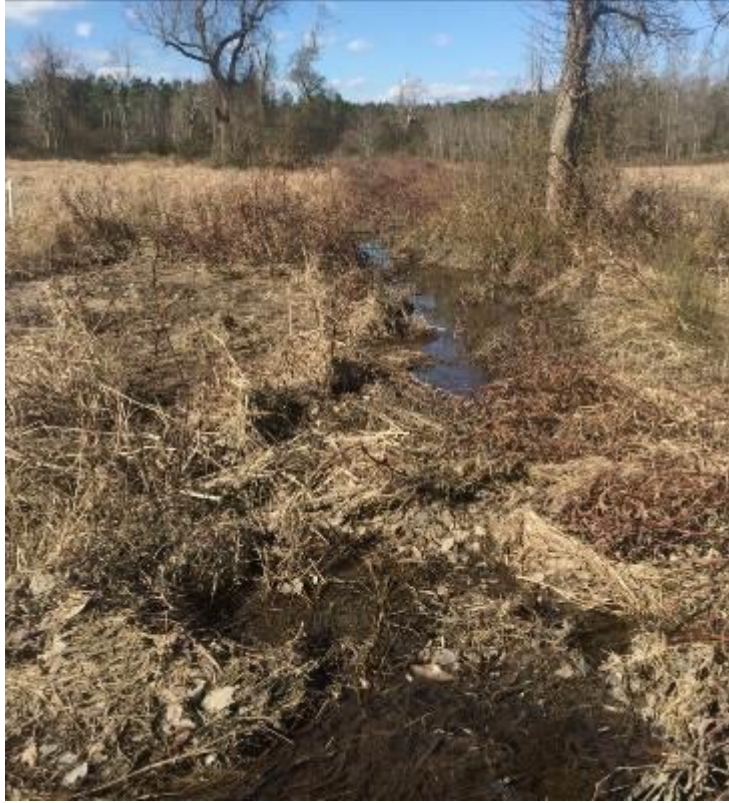
Photo 5: View northwest on Reach 5

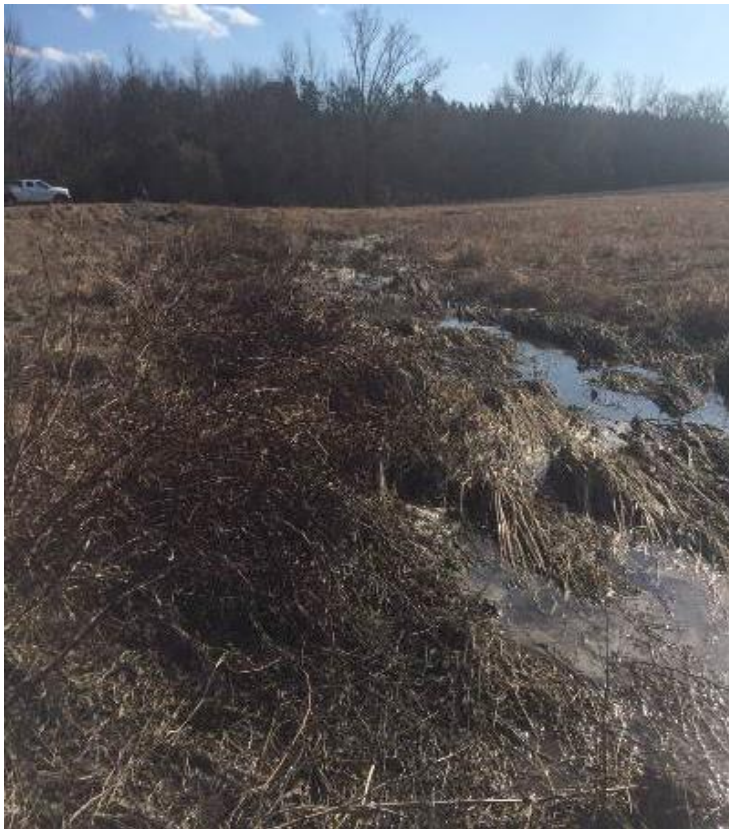
Photos 6: View southeast on Reach 5
