Year 1 Monitoring Report FINAL

Hudson Property

DMS Project ID #: 95361

Beaufort County, North Carolina

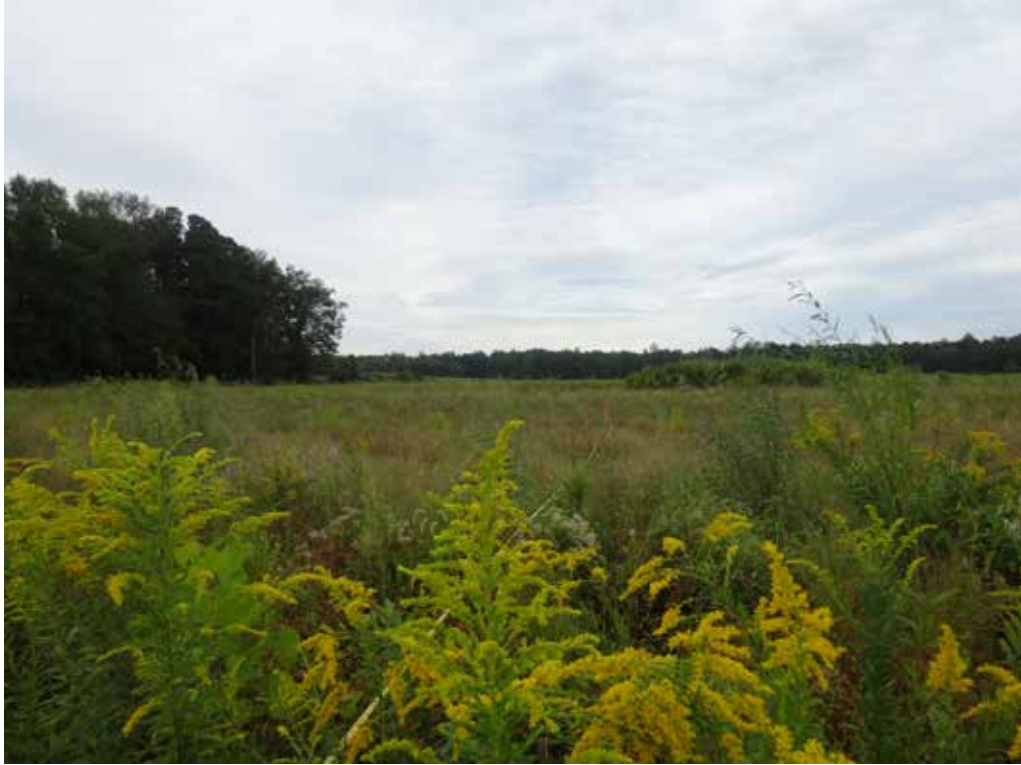
Photo 1: Highly vegetated restoration area along Reach 4 - View North

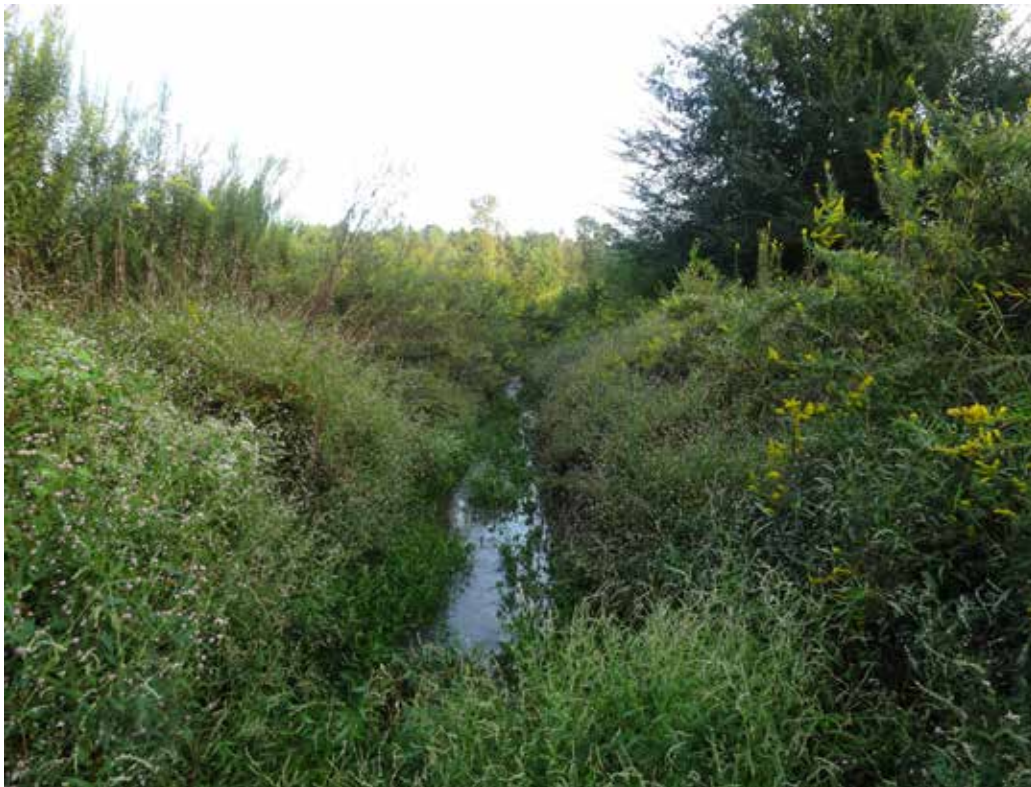
Photo 2: View Upstream on Reach 5

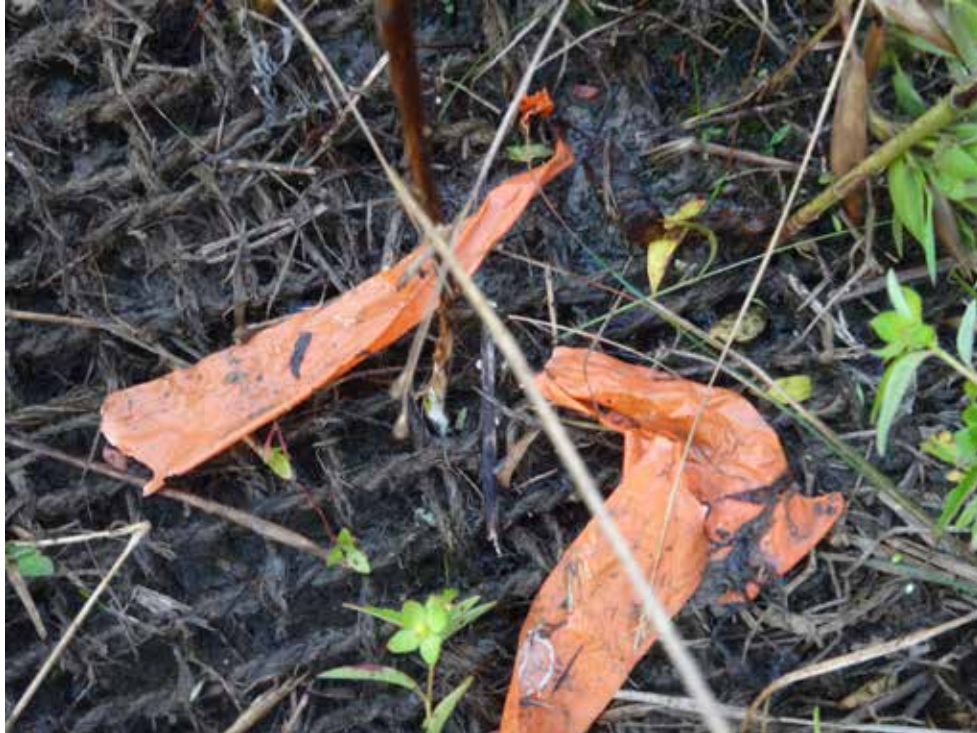
Photo 3: Bank Pin Array 2 – minimal exposure

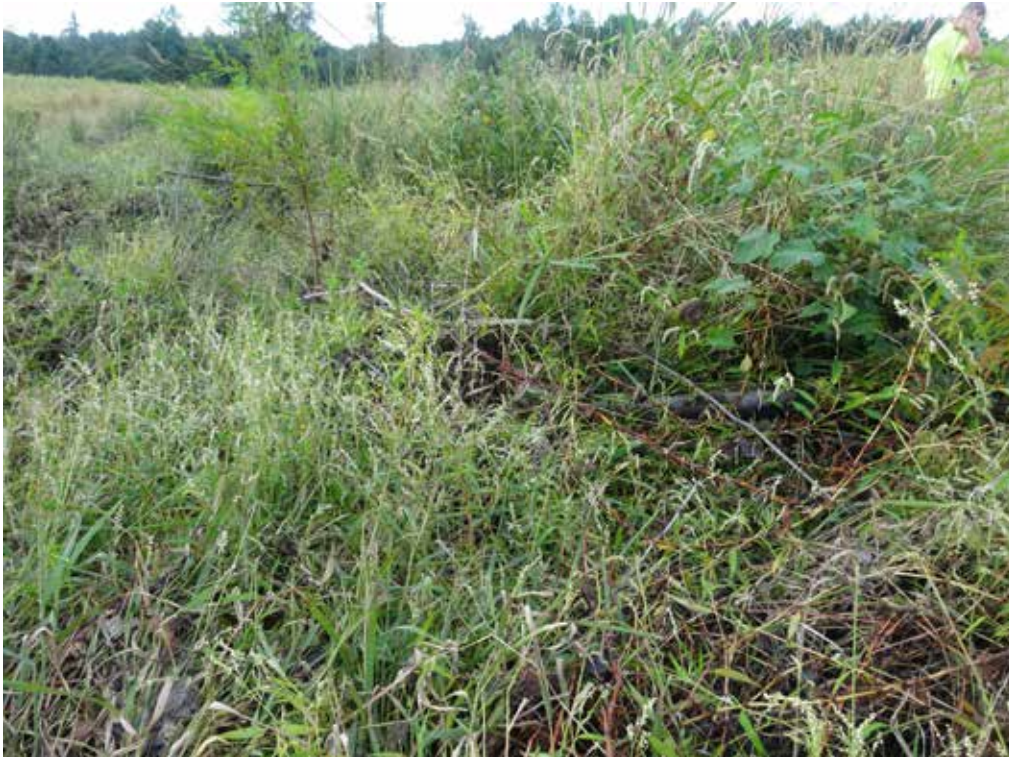
Photo 4: Debris deposited above bankfull - Reach 5

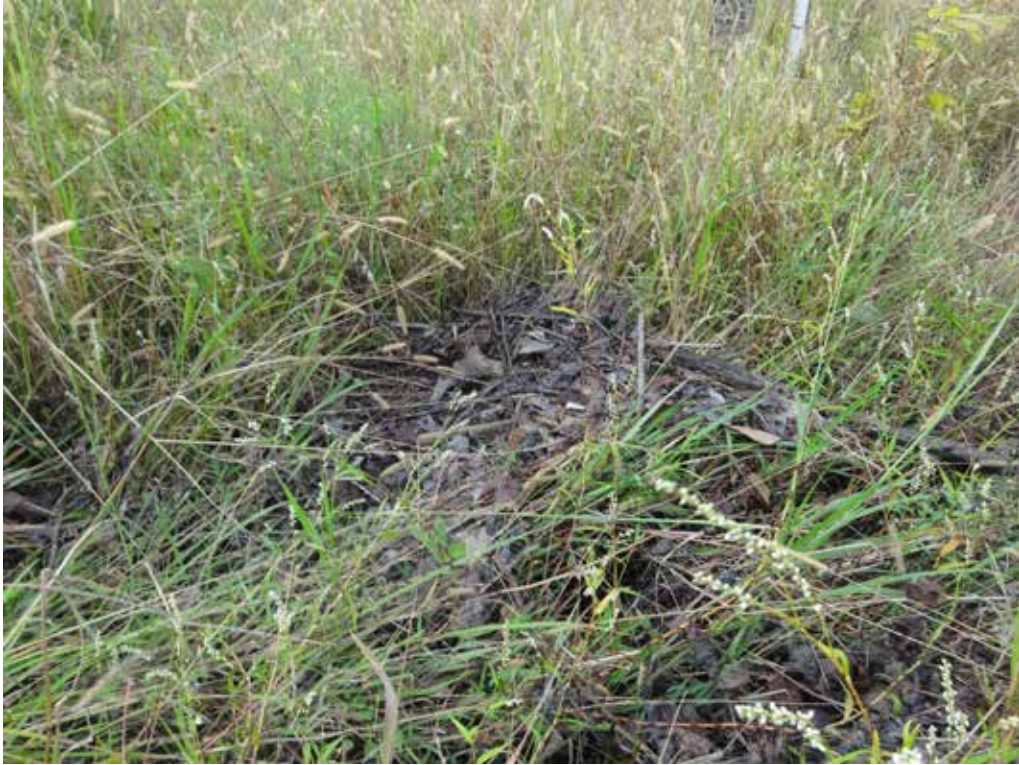
Photo 5: Wrack lines above bankfull – Reach 1

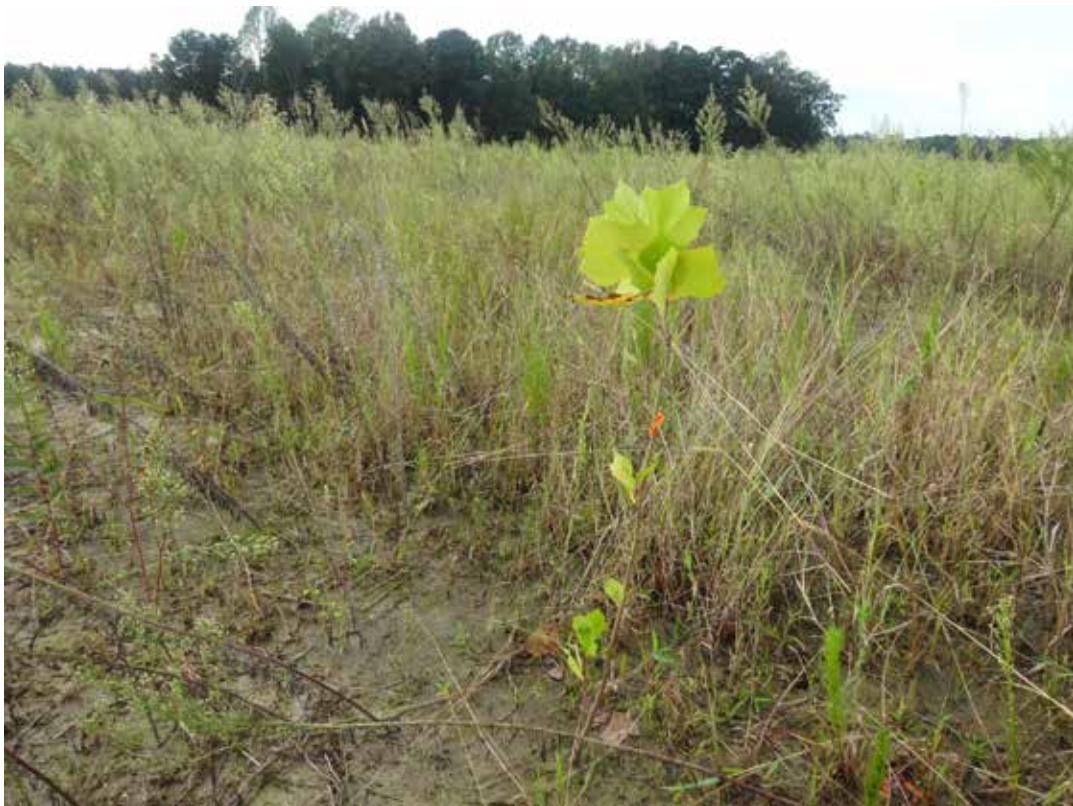
Photos 6: Veg Plot 6 and floodprone area – Reach 2

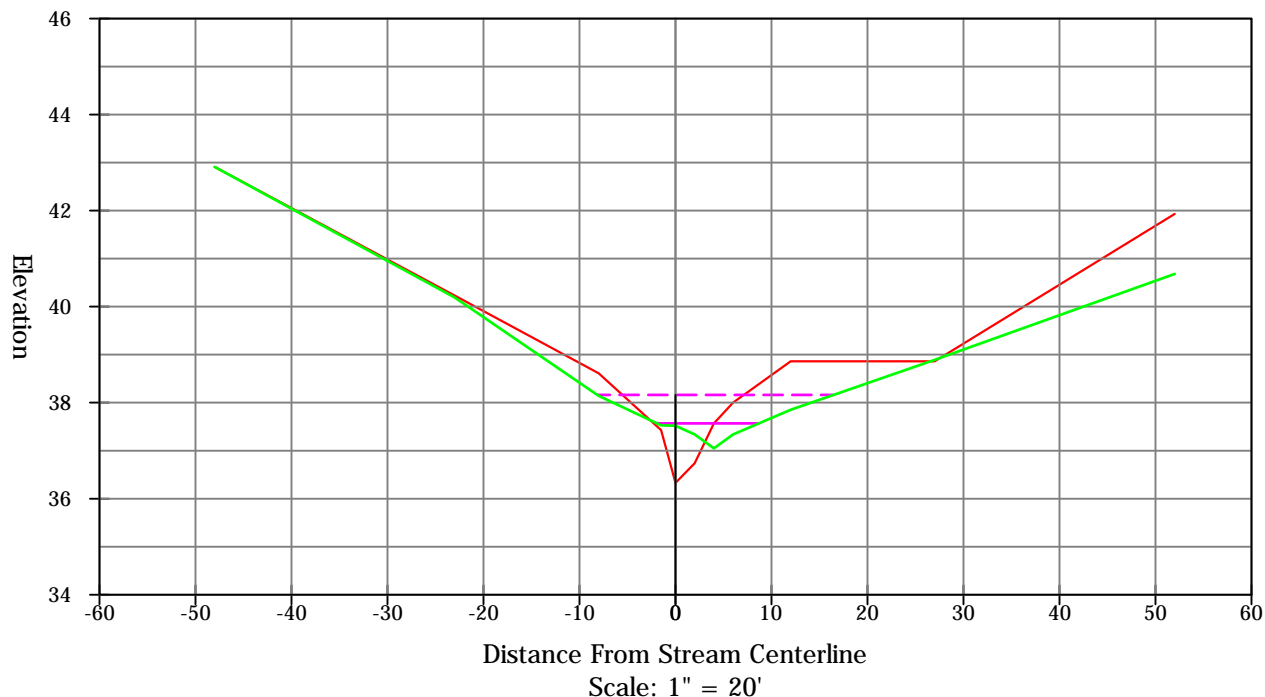
Monitoring XS 1 (Pool) - REACH 3 STA 0+09

SUMMARY DATA (FT)	
BANKFULL ELEVATION:	37.57
BANKFULL CROSS SECTIONAL AREA:	2.17
BANKFULL WIDTH:	10.63
FLOOD PRONE AREA ELEVATION:	38.16
FLOOD PRONE WIDTH:	24.55
MAX DEPTH AT BANKFULL:	0.52
MEAN DEPTH AT BANKFULL:	0.20
W/D RATIO:	NA
ENTRENCHMENT RATIO:	NA
BANK HEIGHT RATIO:	1

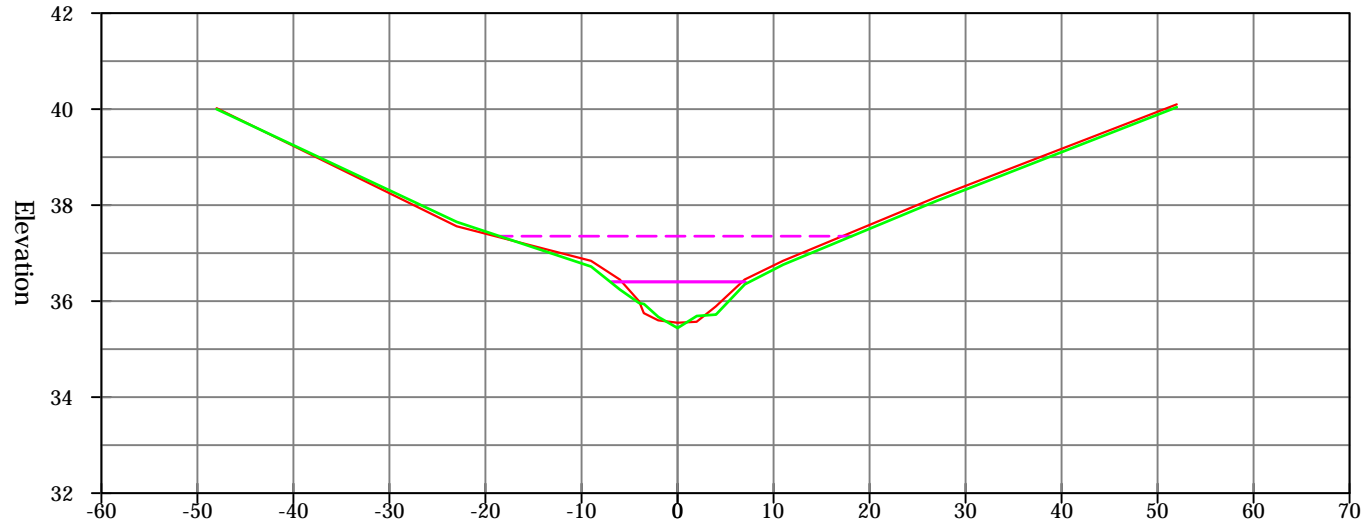
Monitoring XS 2 (Riffle) - REACH 3 STA 2+41

SUMMARY DATA (FT)	
BANKFULL ELEVATION:	36.40
BANKFULL CROSS SECTIONAL AREA:	16.24
BANKFULL WIDTH:	14.44
FLOOD PRONE AREA ELEVATION:	37.35
FLOOD PRONE WIDTH:	36.68
MAX DEPTH AT BANKFULL:	0.96
MEAN DEPTH AT BANKFULL:	0.48
W/D RATIO:	69.34
ENTRENCHMENT RATIO:	2.53
BANK HEIGHT RATIO:	1

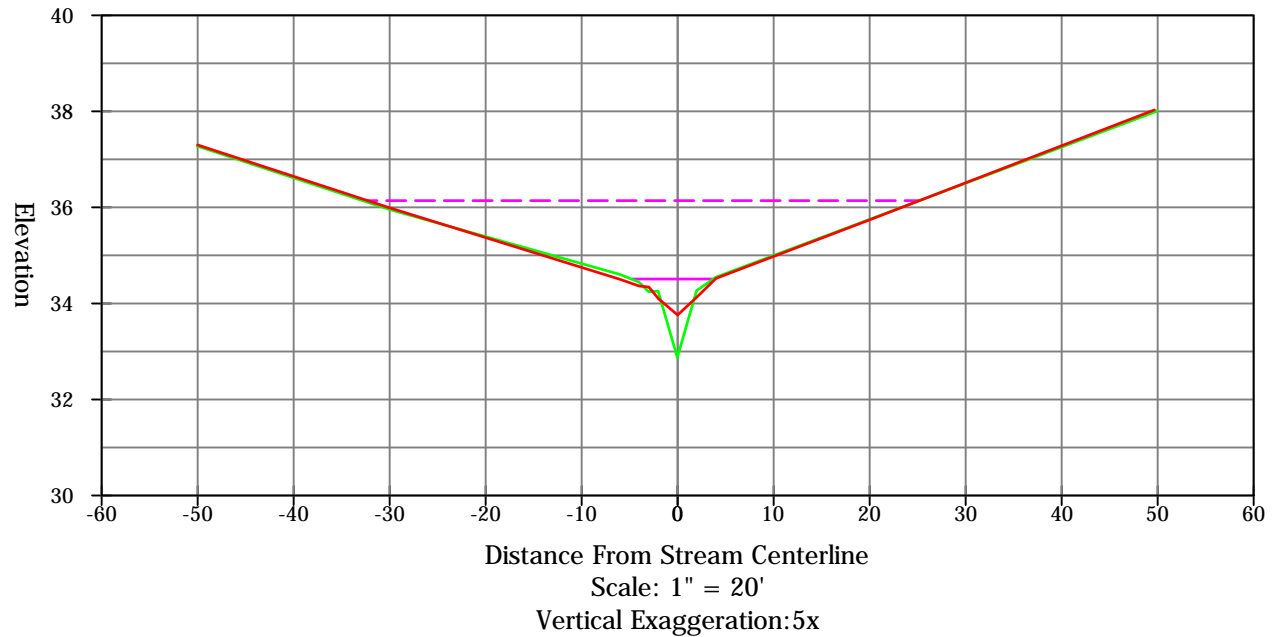
Monitoring XS 3 (Riffle) - REACH 4 STA 0+24

SUMMARY DATA (FT)	
BANKFULL ELEVATION:	34.50
BANKFULL CROSS SECTIONAL AREA:	4.31
BANKFULL WIDTH:	8.27
FLOOD PRONE AREA ELEVATION:	36.14
FLOOD PRONE WIDTH:	57.96
MAX DEPTH AT BANKFULL:	1.62
MEAN DEPTH AT BANKFULL:	0.52
W/D RATIO:	15.86
ENTRENCHMENT RATIO:	7.01
BANK HEIGHT RATIO:	1

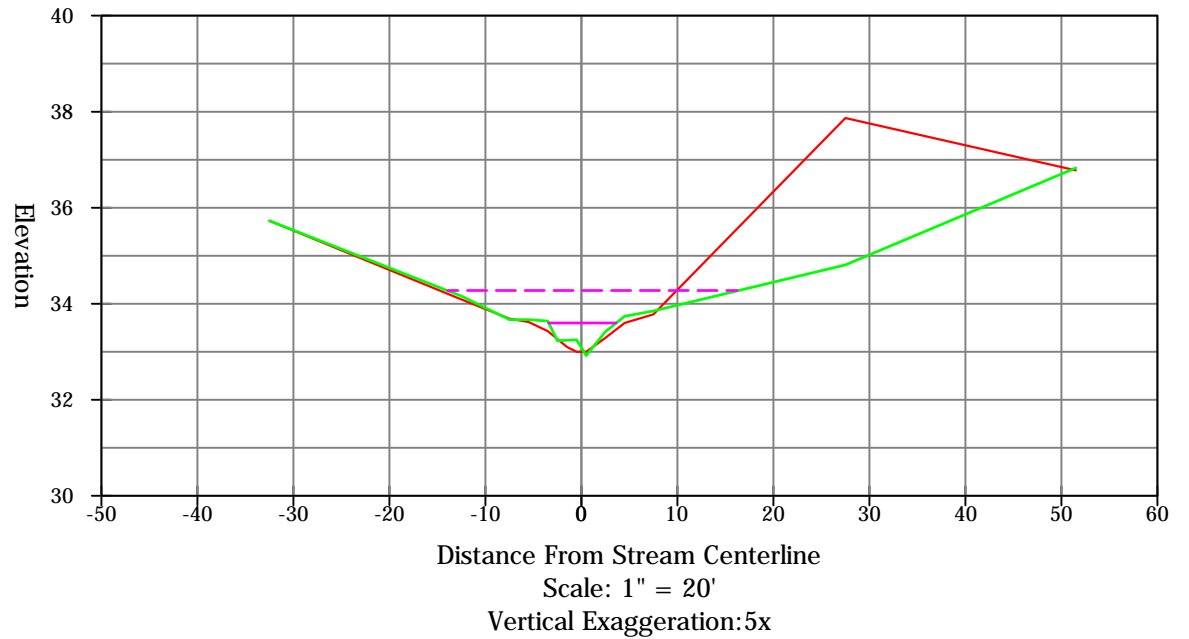
Monitoring XS 4 (Pool) - REACH 4 STA 2+69

SUMMARY DATA (FT)	
BANKFULL ELEVATION:	33.60
BANKFULL CROSS SECTIONAL AREA:	2.36
BANKFULL WIDTH:	7.03
FLOOD PRONE AREA ELEVATION:	34.28
FLOOD PRONE WIDTH:	30.15
MAX DEPTH AT BANKFULL:	0.68
MEAN DEPTH AT BANKFULL:	0.34
W/D RATIO:	NA
ENTRENCHMENT RATIO:	NA
BANK HEIGHT RATIO:	1

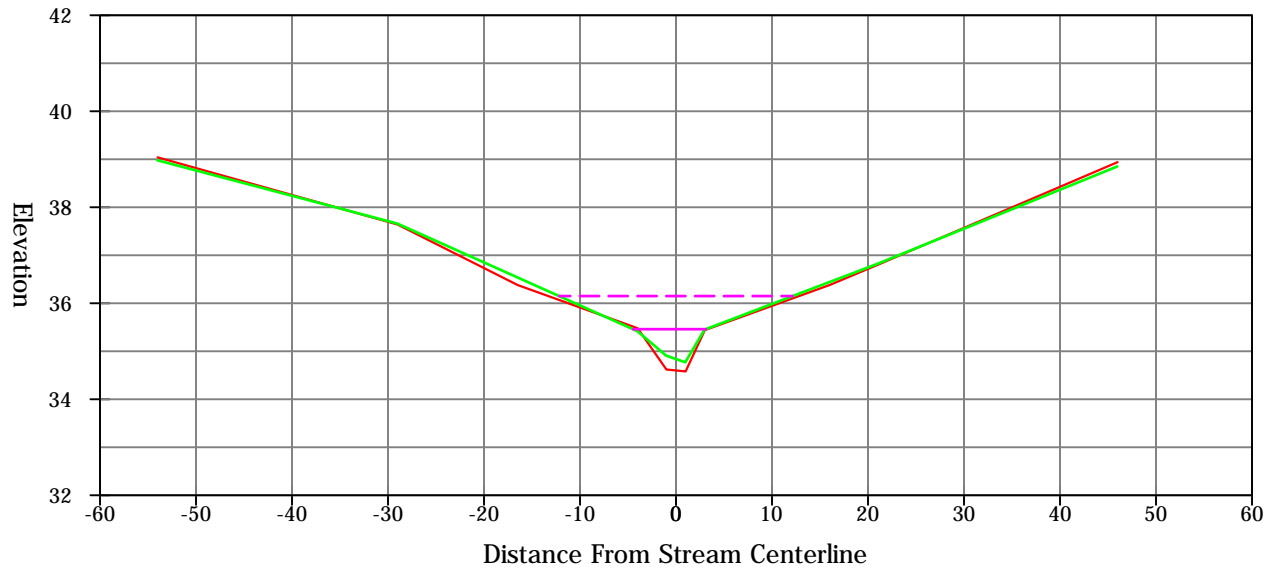
Monitoring XS 5 (Pool) - REACH 2 STA 3+95

SUMMARY DATA (FT)	
BANKFULL ELEVATION:	35.46
BANKFULL CROSS SECTIONAL AREA:	2.83
BANKFULL WIDTH:	7.58
FLOOD PRONE AREA ELEVATION:	36.15
FLOOD PRONE WIDTH:	24.33
MAX DEPTH AT BANKFULL:	0.69
MEAN DEPTH AT BANKFULL:	0.37
W/D RATIO:	NA
ENTRENCHMENT RATIO:	NA
BANK HEIGHT RATIO:	1

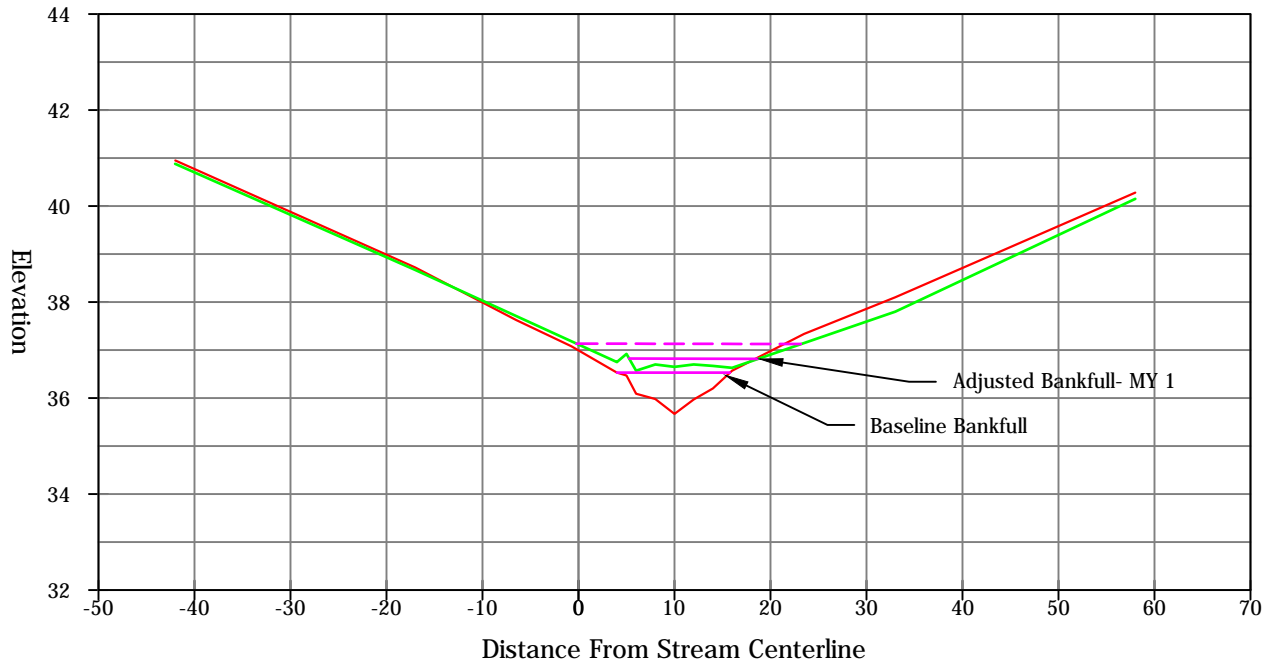
Monitoring XS 6 (Riffle) - REACH 2 STA 0+68

SUMMARY DATA (FT)	
BANKFULL ELEVATION:	36.78
BANKFULL CROSS SECTIONAL AREA:	1.39
BANKFULL WIDTH:	12.51
FLOOD PRONE AREA ELEVATION:	37.13
FLOOD PRONE WIDTH:	25.00
MAX DEPTH AT BANKFULL:	0.21
MEAN DEPTH AT BANKFULL:	0.11
W/D RATIO:	112.26
ENTRENCHMENT RATIO:	2.00
BANK HEIGHT RATIO:	1

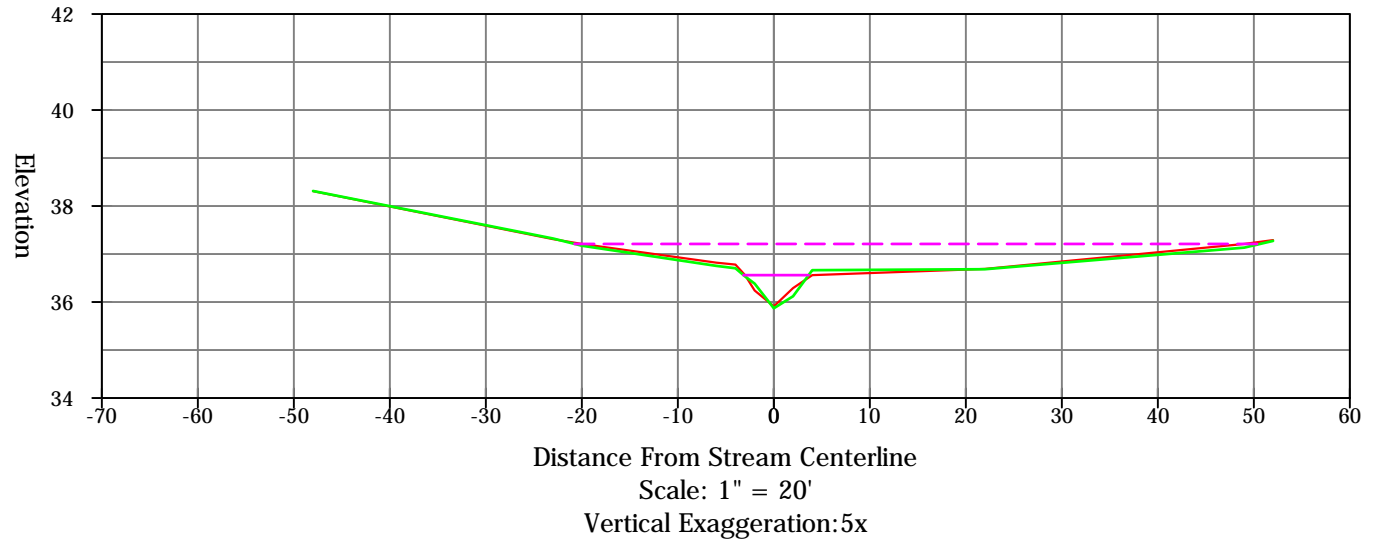
Monitoring XS 7 (Pool) - REACH 1 STA 6+47

SUMMARY DATA (FT)	
BANKFULL ELEVATION:	36.56
BANKFULL CROSS SECTIONAL AREA:	2.47
BANKFULL WIDTH:	6.81
FLOOD PRONE AREA ELEVATION:	37.21
FLOOD PRONE WIDTH:	71.00
MAX DEPTH AT BANKFULL:	0.69
MEAN DEPTH AT BANKFULL:	0.36
W/D RATIO:	NA
ENTRENCHMENT RATIO:	NA
BANK HEIGHT RATIO:	1

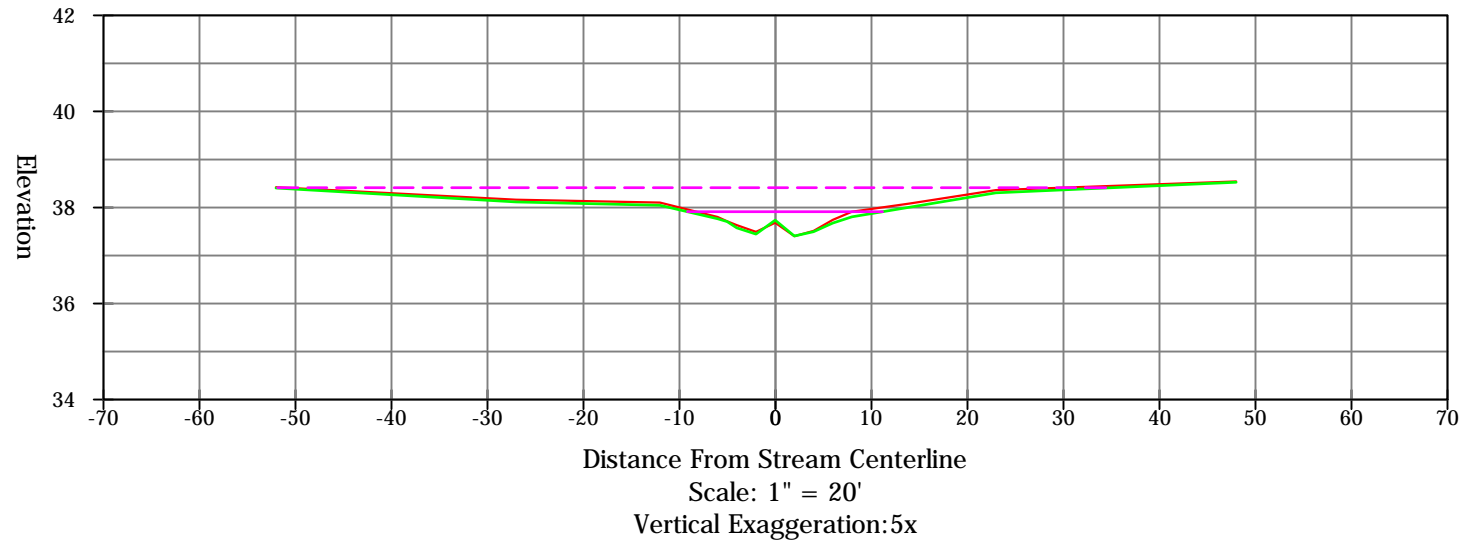
Monitoring XS 8 (Riffle) - REACH 1 STA 4+43

SUMMARY DATA (FT)	
BANKFULL ELEVATION:	37.91
BANKFULL CROSS SECTIONAL AREA:	4.77
BANKFULL WIDTH:	20.00
FLOOD PRONE AREA ELEVATION:	38.41
FLOOD PRONE WIDTH:	86.26
MAX DEPTH AT BANKFULL:	0.50
MEAN DEPTH AT BANKFULL:	0.24
W/D RATIO:	83.95
ENTRENCHMENT RATIO:	4.31
BANK HEIGHT RATIO:	1

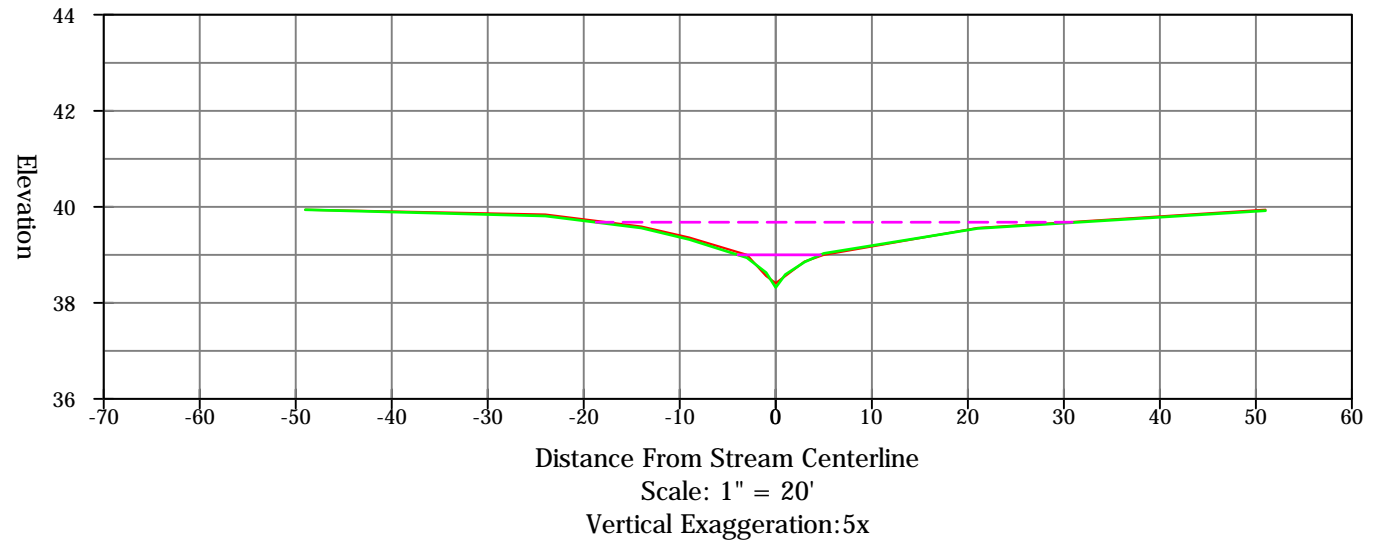
Monitoring XS 9 (Pool) - REACH 1 STA 2+73

SUMMARY DATA (FT)	
BANKFULL ELEVATION:	39.00
BANKFULL CROSS SECTIONAL AREA:	2.21
BANKFULL WIDTH:	8.61
FLOOD PRONE AREA ELEVATION:	39.68
FLOOD PRONE WIDTH:	49.57
MAX DEPTH AT BANKFULL:	0.68
MEAN DEPTH AT BANKFULL:	0.26
W/D RATIO:	NA
ENTRENCHMENT RATIO:	NA
BANK HEIGHT RATIO:	1

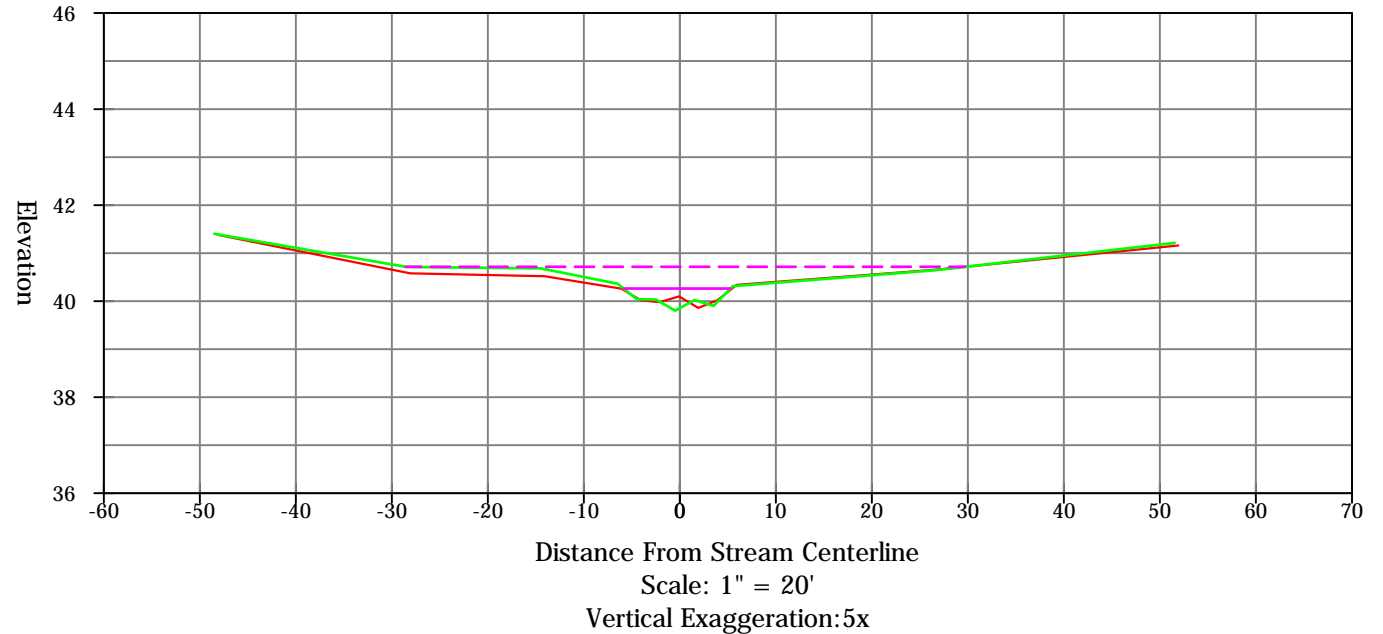
Monitoring XS 10 (Riffle) - REACH 1 STA 0+64

SUMMARY DATA (FT)	
BANKFULL ELEVATION:	40.26
BANKFULL CROSS SECTIONAL AREA:	3.25
BANKFULL WIDTH:	11.46
FLOOD PRONE AREA ELEVATION:	40.72
FLOOD PRONE WIDTH:	58.28
MAX DEPTH AT BANKFULL:	0.49
MEAN DEPTH AT BANKFULL:	0.28
W/D RATIO:	40.49
ENTRENCHMENT RATIO:	5.08
BANK HEIGHT RATIO:	1

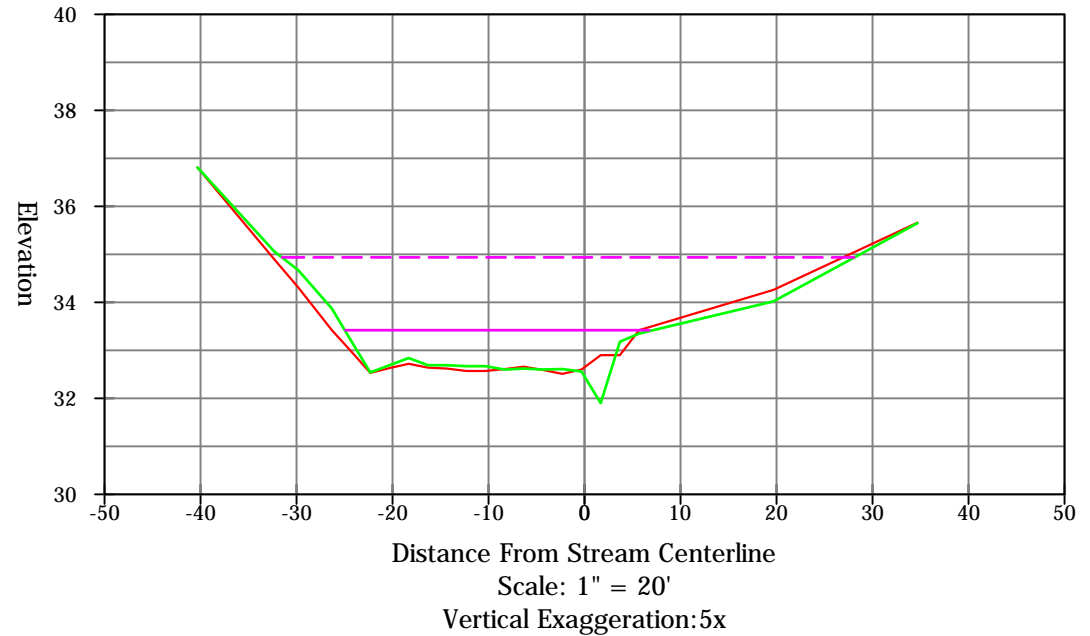
Monitoring XS 11 REACH 1 STA 8+14 & Reach 4 (Station 4+28)

SUMMARY DATA (FT)	
BANKFULL ELEVATION:	33.42
BANKFULL CROSS SECTIONAL AREA:	22.13
BANKFULL WIDTH:	31.88
FLOOD PRONE AREA ELEVATION:	34.94
FLOOD PRONE WIDTH:	59.59
MAX DEPTH AT BANKFULL:	1.51
MEAN DEPTH AT BANKFULL:	0.69
W/D RATIO:	NA
ENTRENCHMENT RATIO:	NA
BANK HEIGHT RATIO:	1
