Year 2 Monitoring Report Final

Hudson Property

DMS Project ID #: 95361

Beaufort County, North Carolina

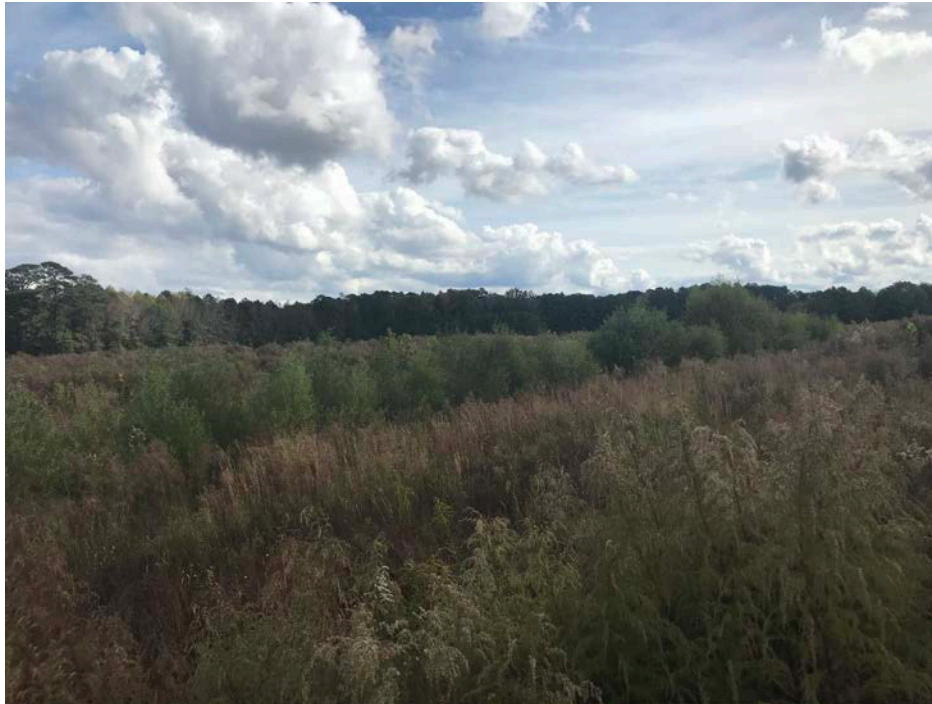
Photo 1: Highly vegetated restoration area along Reach 2 - View North

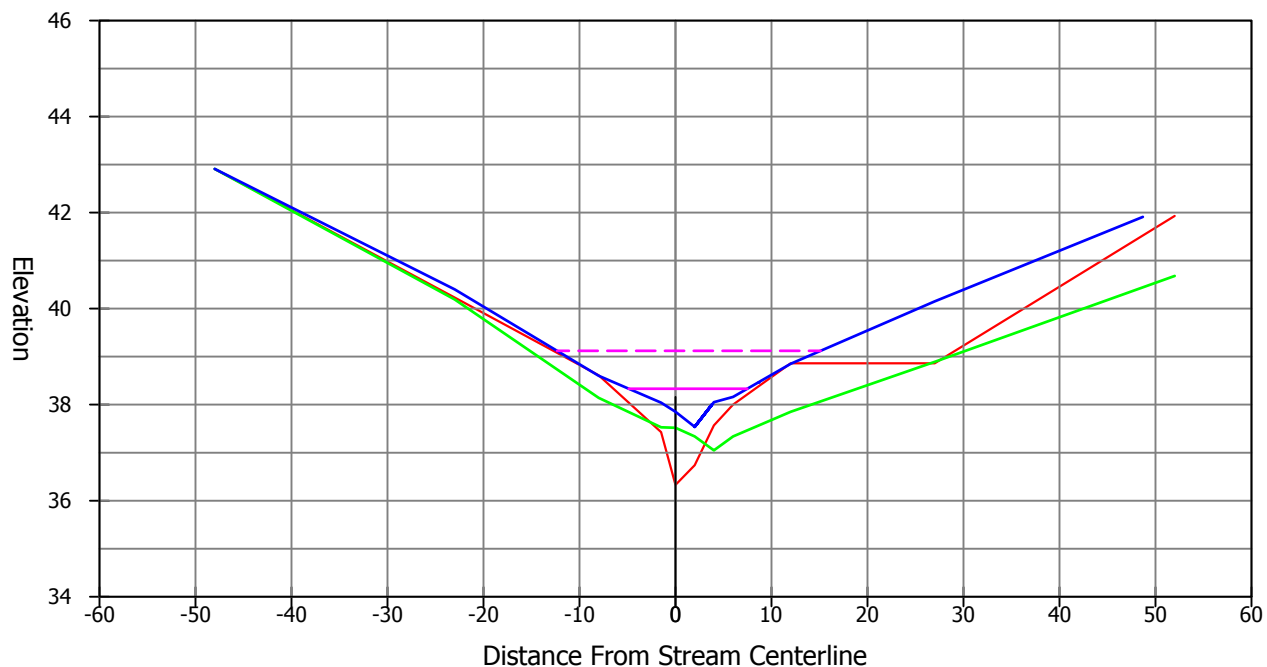
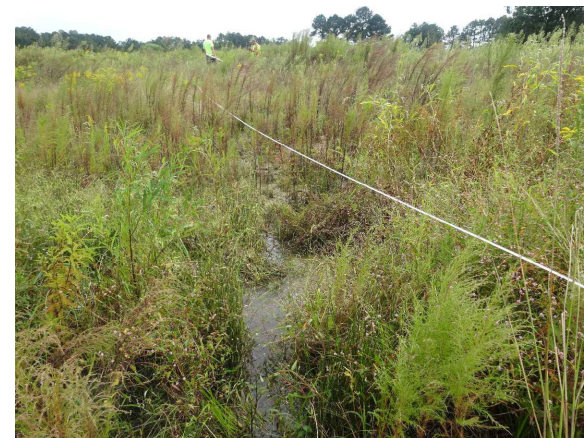
Monitoring XS 1 (Pool) - REACH 3 STA 0+09

Note:
Channel has aggraded as anticipated and remains stable.

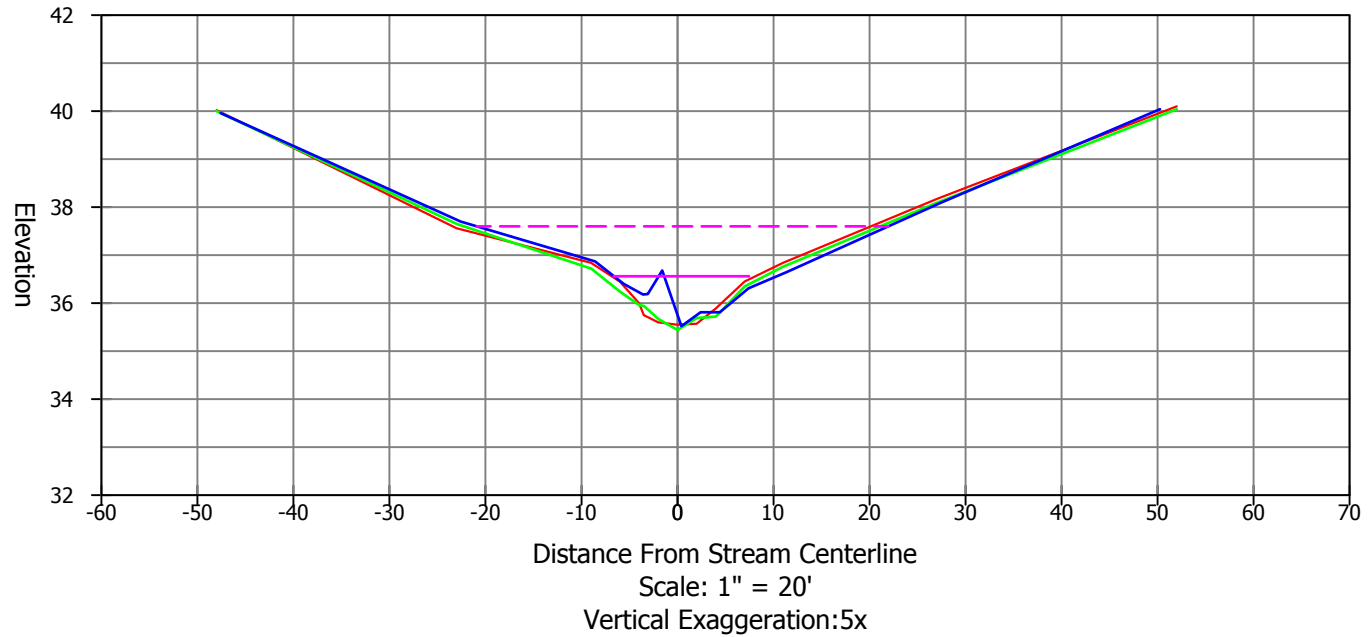
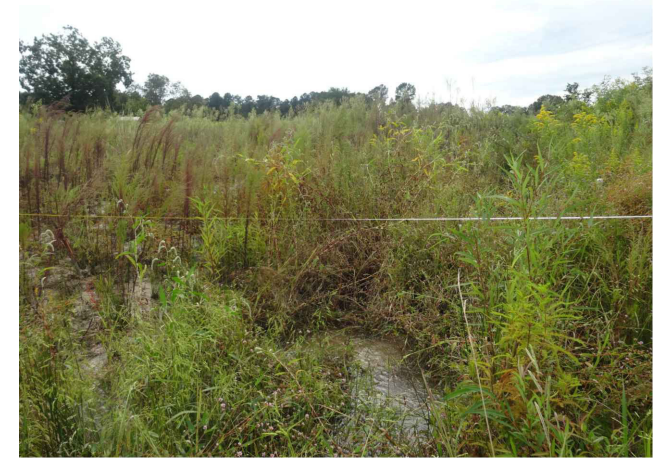
Monitoring XS 2 (Riffle) - REACH 3 STA 2+41

Note:
Cross section displays survey error.
Channel remains stable and functioning.

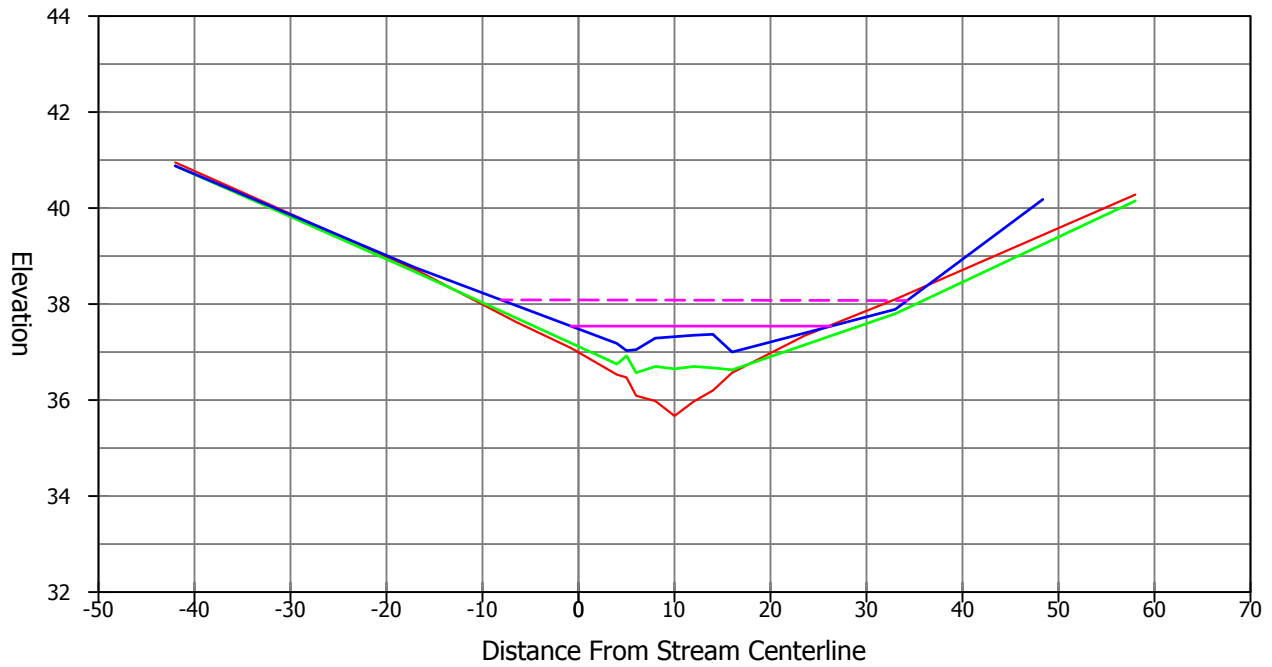
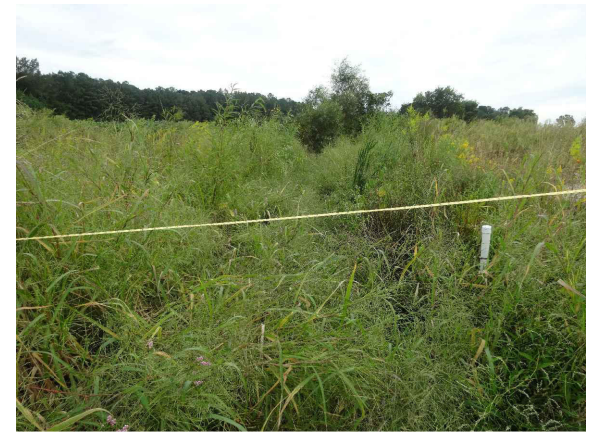
Monitoring XS 6 (Riffle) - REACH 2 STA 0+68

The cross section shows aggradation across the entire valley. Since aggradation was not noted during field investigation, we believe this cross section may need to be resurveyed.

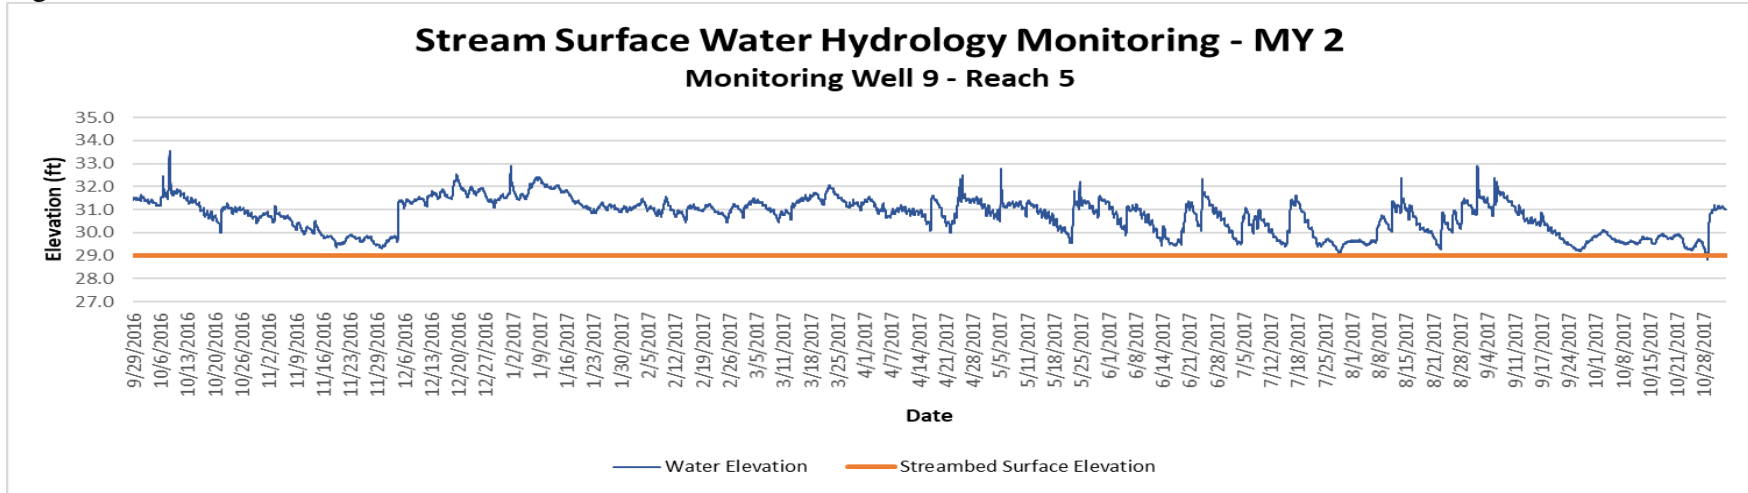
Figure 11¹

¹ Grading occurred in November 2017 that changed streambed surface elevation on Reach 5.
