Year 3 Monitoring Report FINAL

Hudson Property

DMS Project ID #: 95361

Beaufort County, North Carolina

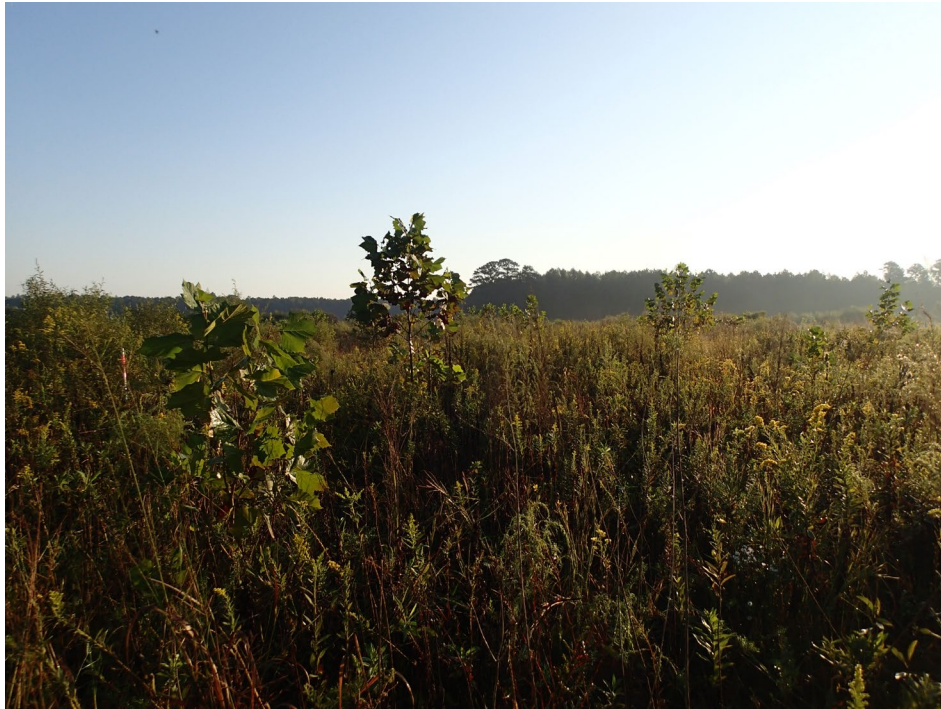
Photo 1: Highly vegetated restoration area along Reach 2 - View North

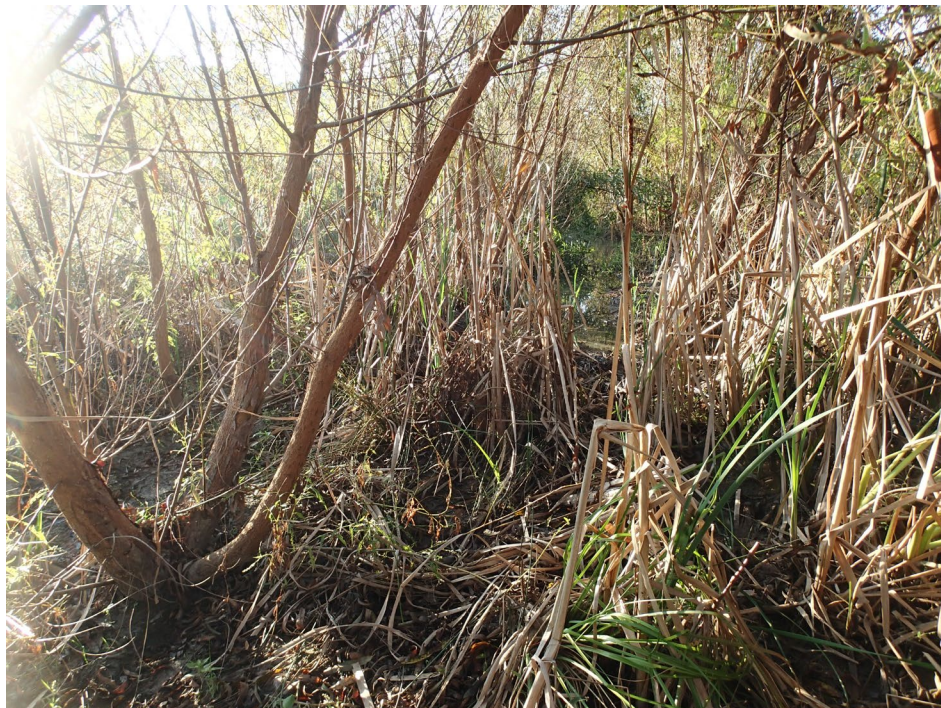
Photo 2: View Upstream on Reach 1, Cross Section 9 – standing water and wetland vegetation in channel

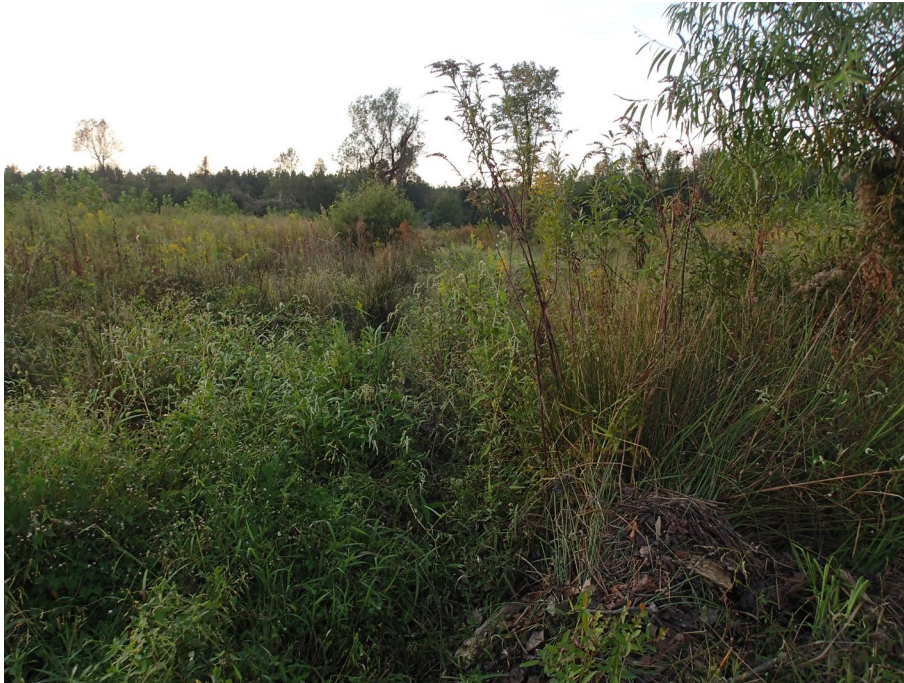
Photo 3: View of Reach 5 downstream – area of previous corrective measures

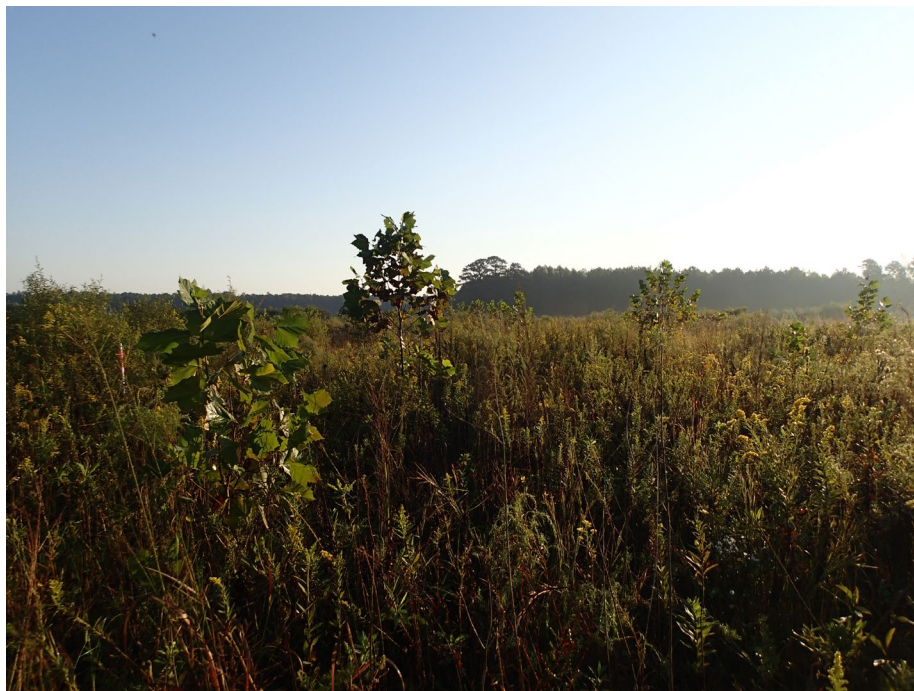
Photo 4: View of vegetation plot
