Year 4 Monitoring Report FINAL

Hudson Property

DMS Project ID #: 95361

Beaufort County, North Carolina

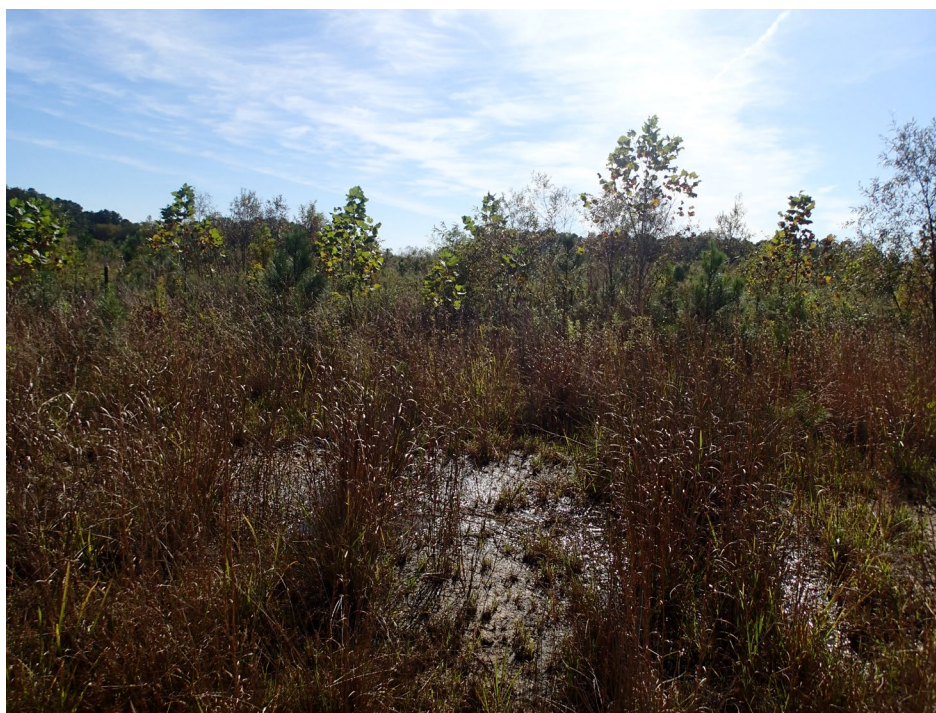
Photo 1: Highly vegetated restoration area with wetland along Reach 1 - View South.

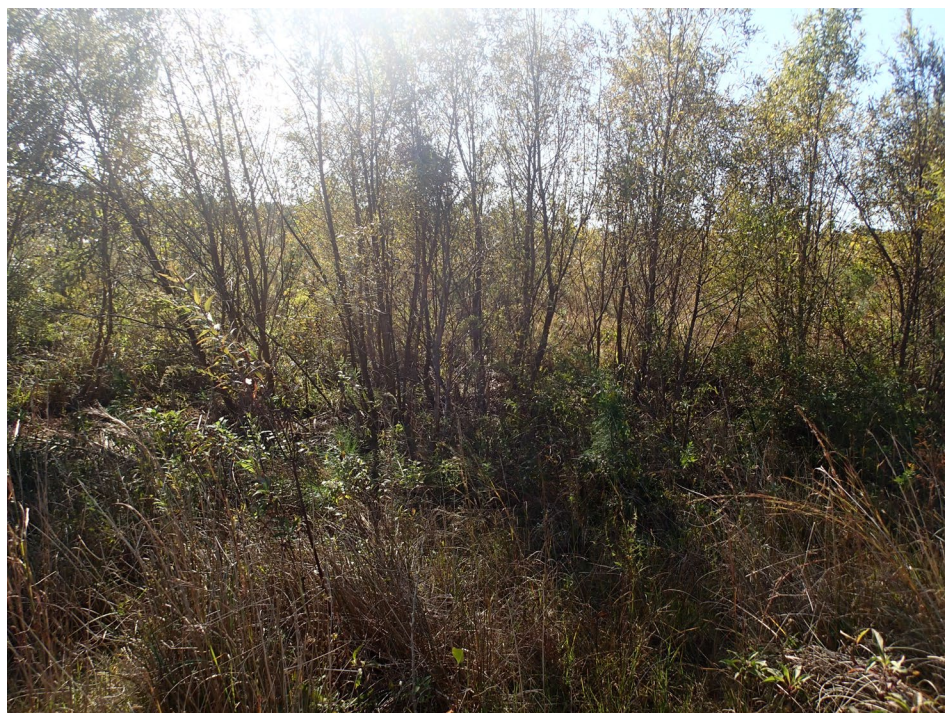
Photo 2: View of Cross Section 5 on Reach 2 – View Northeast.

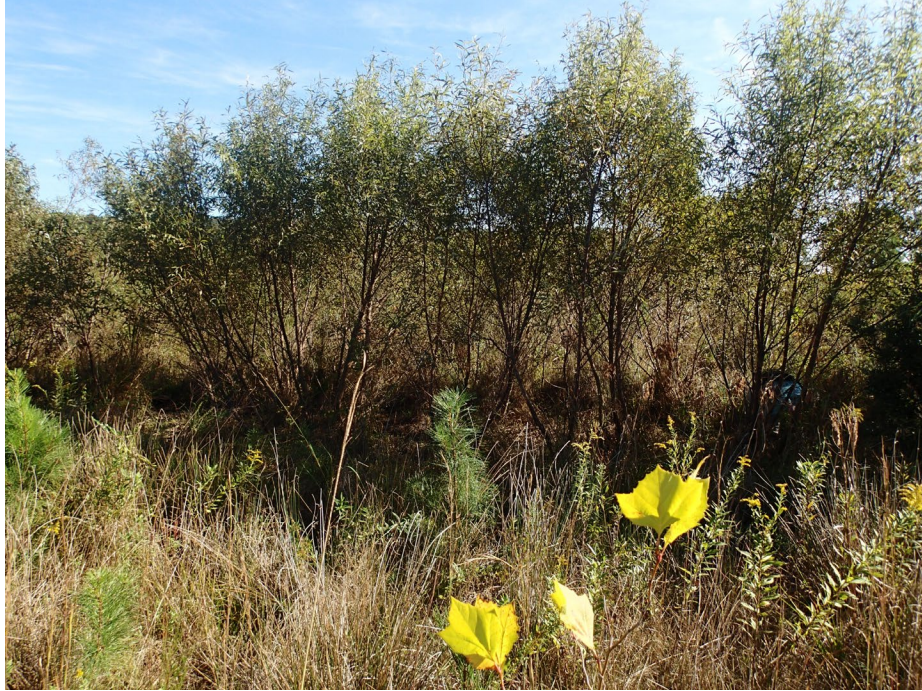
Photo 3: View of Cross Section 1 on Reach 3 – View Southeast.

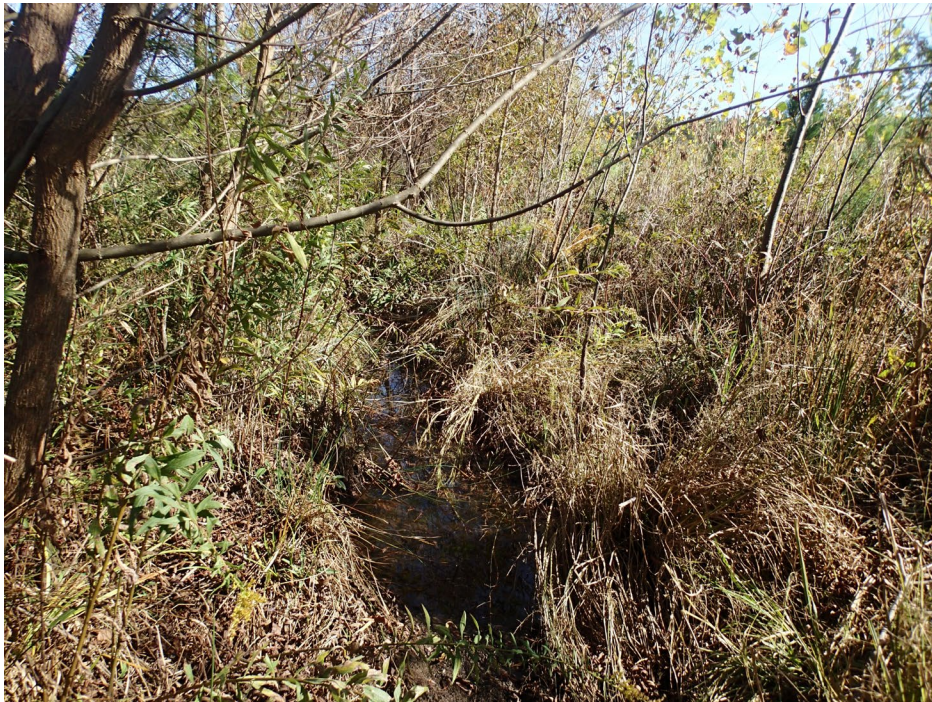
Photo 4: View of Cross Section 3 on Reach 4 – water in stream – View Northeast.

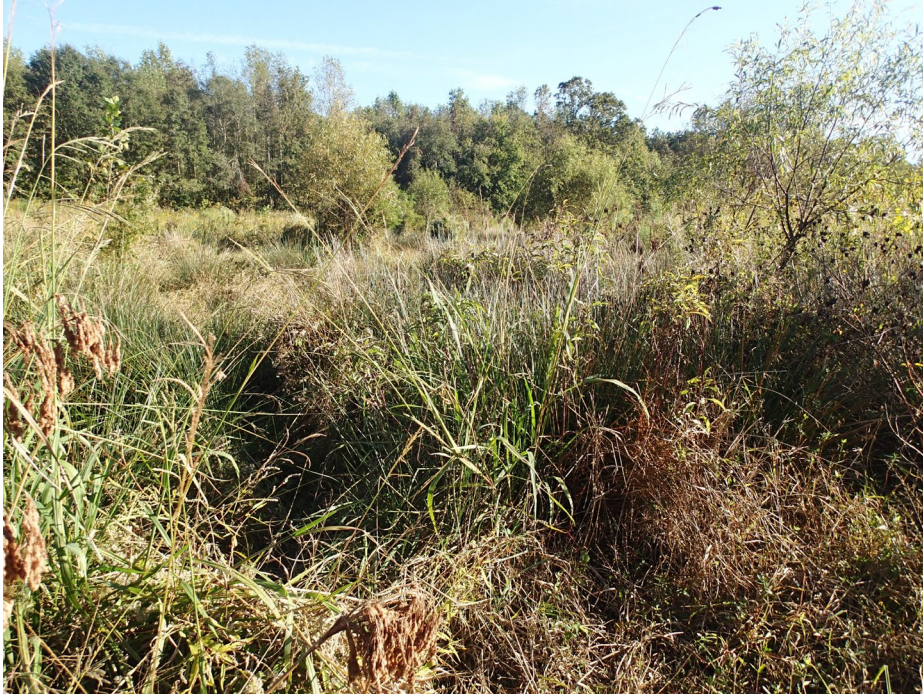
Photo 5: View downstream of Reach 5 Swamp Run.

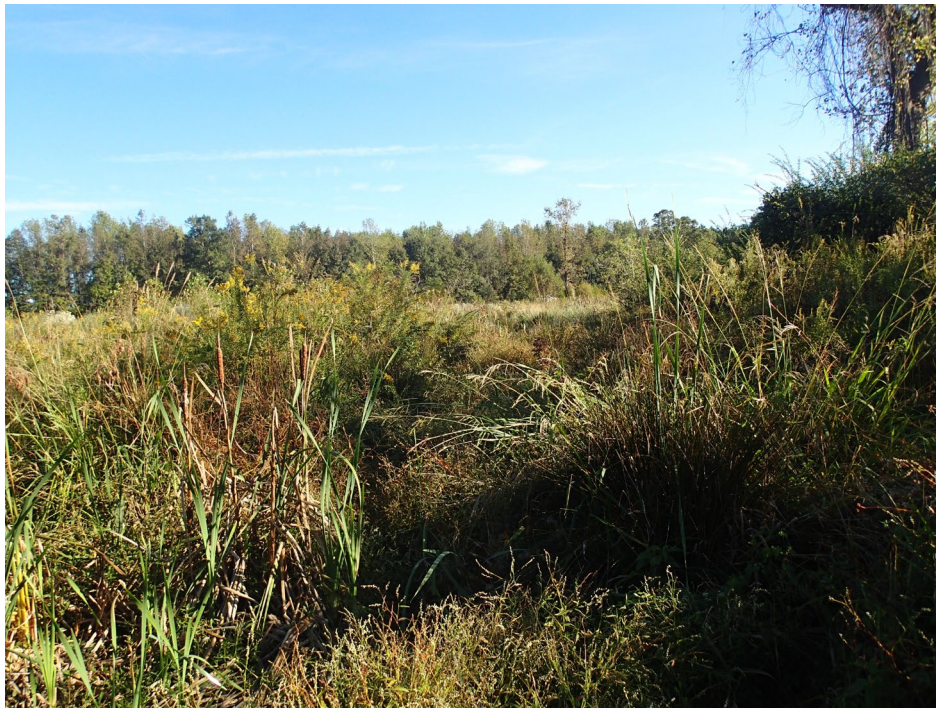
Photo 6: View upstream on Reach 5 Swamp Run.
