Year 5 Monitoring Report FINAL

Hudson Property

DMS Project ID #: 95361

Beaufort County, North Carolina

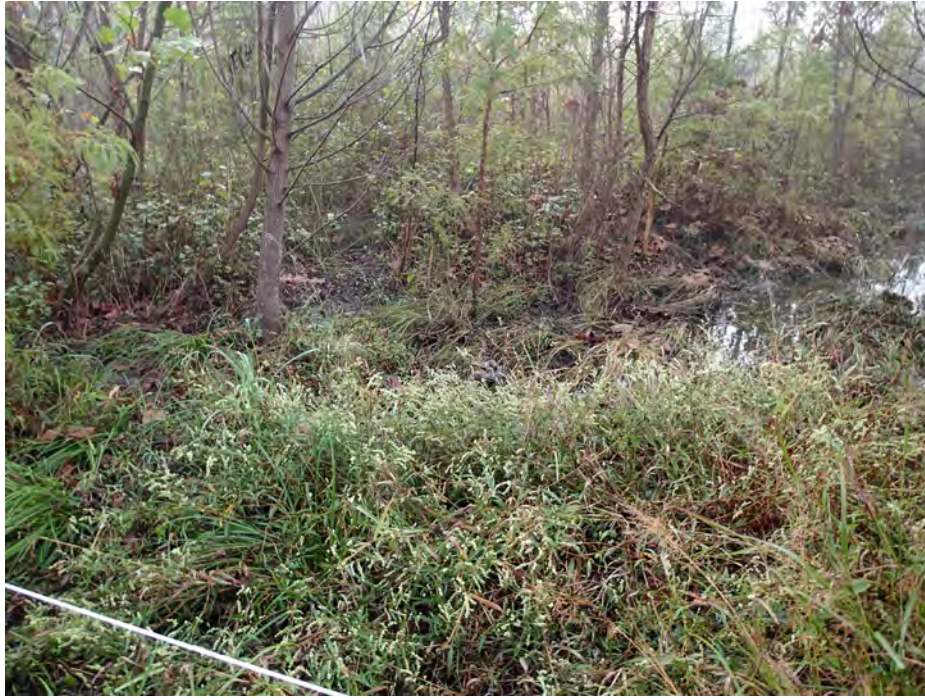
Photo 1: Highly vegetated stream area with wetland along Reach 1 - View South.

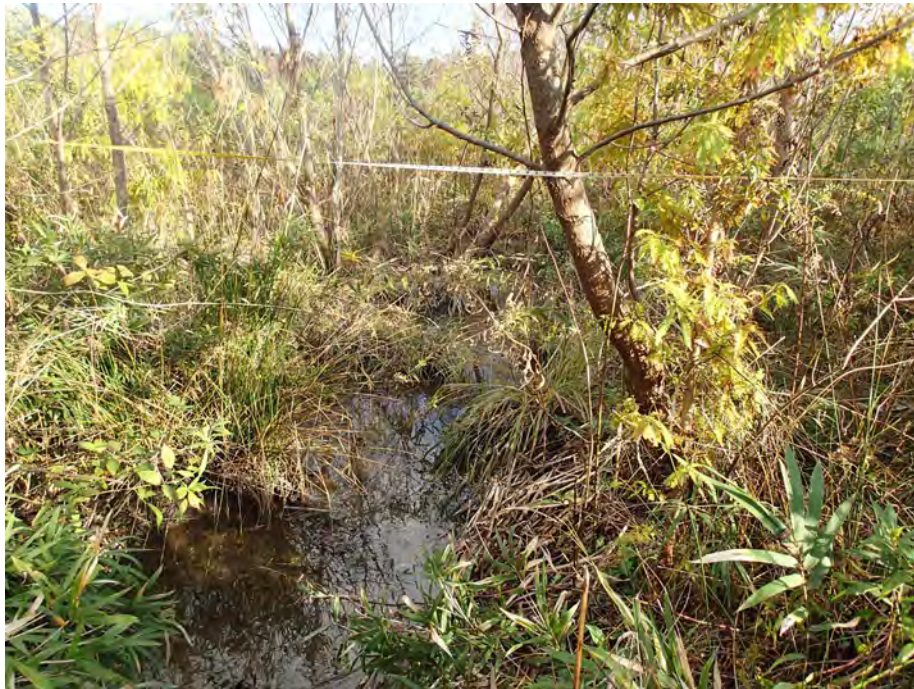
Photo 2: View of Cross Section 5 on Reach 2 – View Northwest.

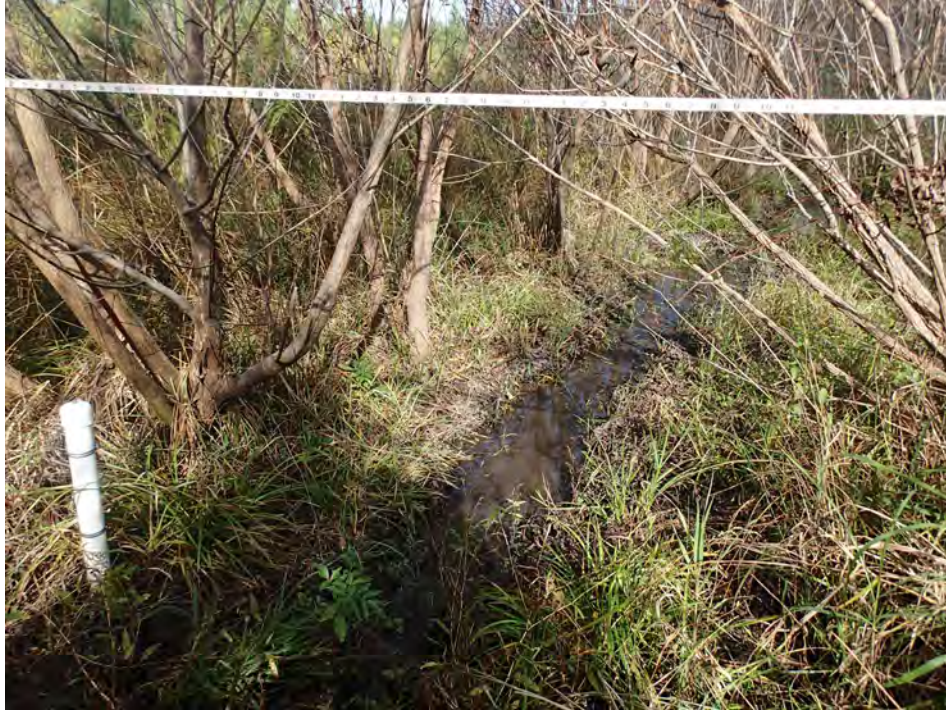
Photo 3: View of Cross Section 1 on Reach 3 – View North.

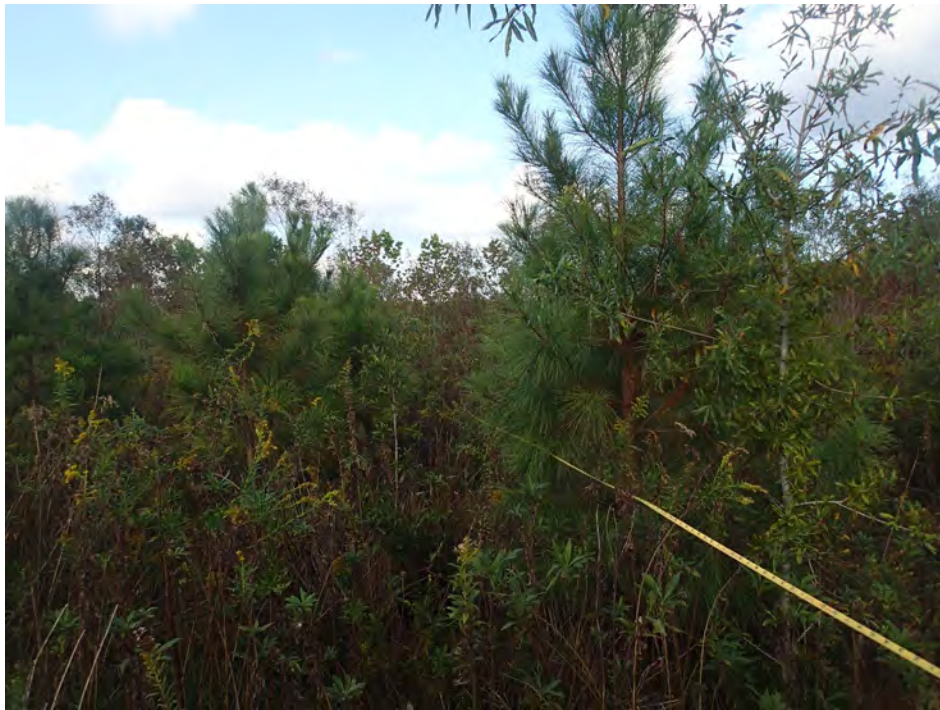
Photo 4: View of Cross Section 3 on Reach 4 –View Northeast.

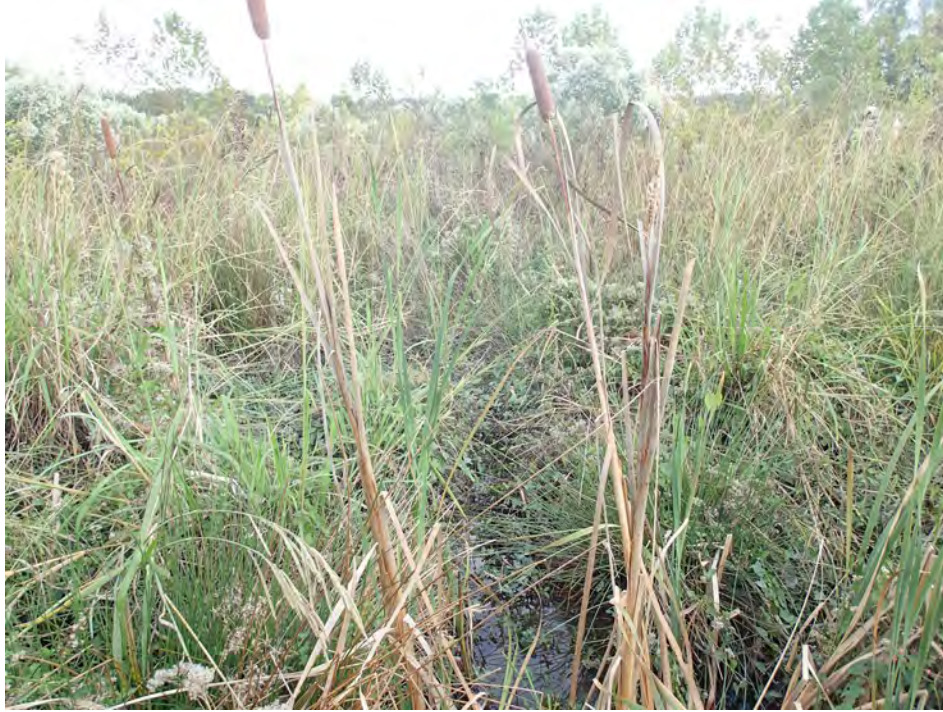
Photo 5: View downstream of Reach 5 Swamp Run.

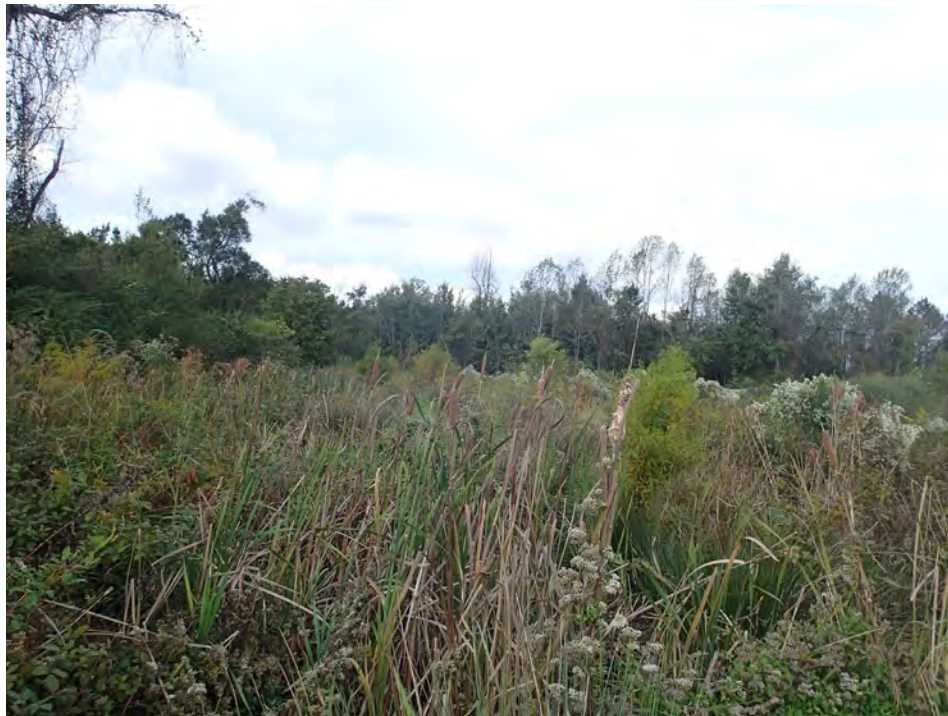
Photo 6: View upstream on Reach 5 Swamp Run.

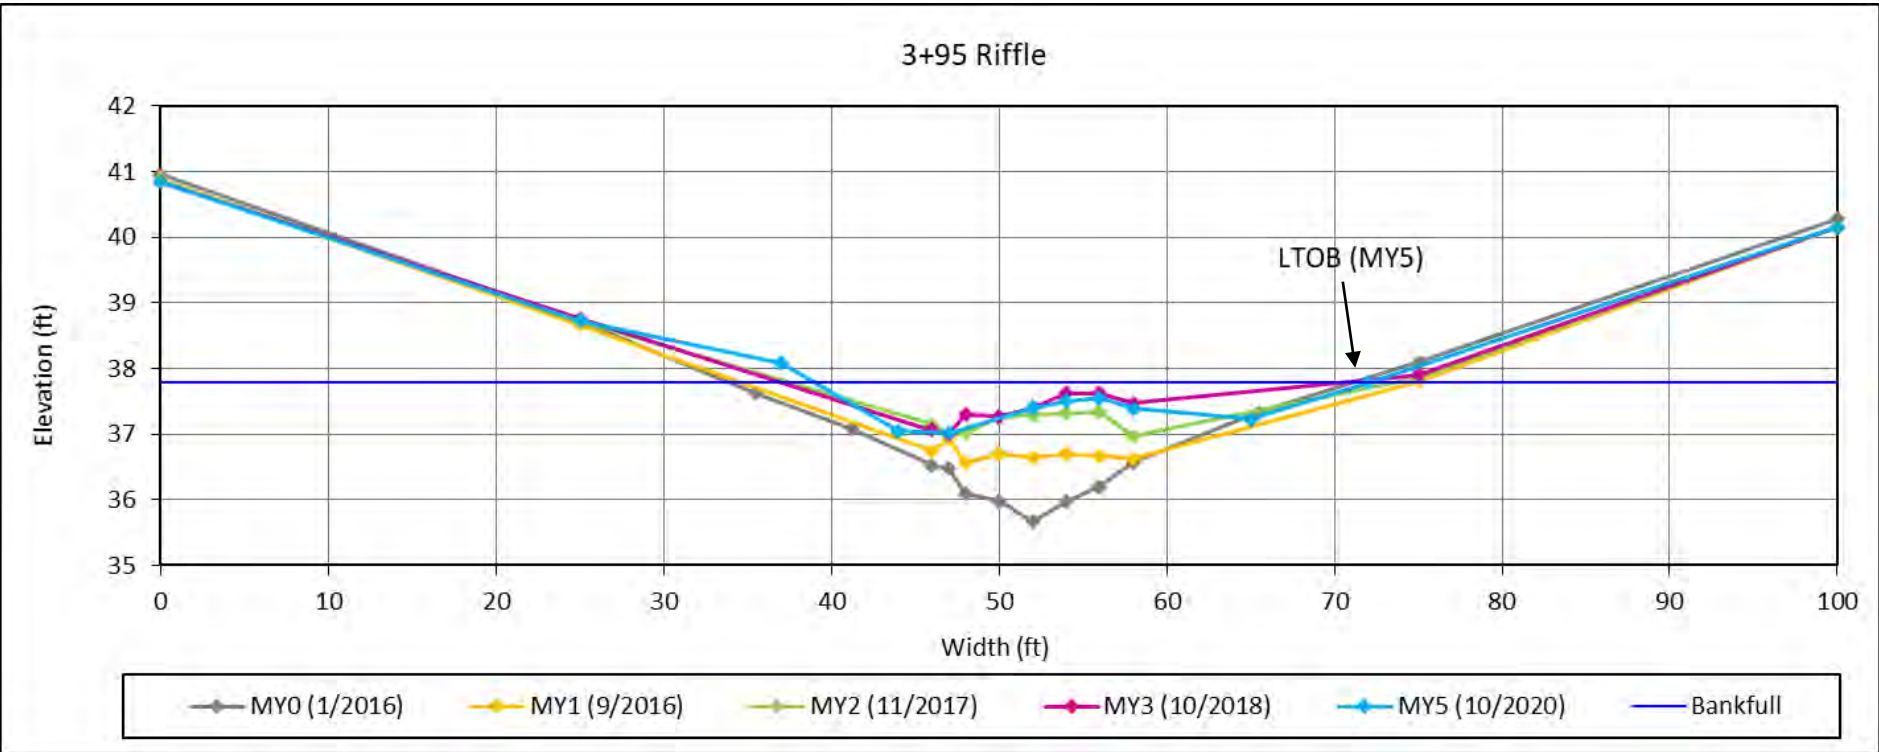
Cross Section 6 – Reach 2

a. Please verify geomorphic data for cross section 6. LTOB Cross Sectional Area changed from 2.66 ft² in MY3 to 13.89 ft² in MY5. Also BHR went from 0.74 in MY3 to 1.60 in MY5. We recommend consideration be given to adding a line or point identifying the current monitoring year LTOB on the Cross Sections with Annual Overlays charts. This is useful for us when reviewing cross section data. *ECOTONE RESPONSE: A revision was needed in the "omit bankful" checkbox of the survey overlay file. This slightly decreased BHR and LTOB Cross Sectional Area, though they are still higher than previous years. This is likely because after a few years of aggradation, the channel has degraded slightly. An arrow indicating the Year 5 LTOB has been added to the cross section 6 chart.*
