Year 7 Monitoring Report

Hudson Property

DMS Project ID #: 95361
DMS Contract #: 004638
DWR Project #: 20140422
USACE Action ID# SAW-2012-01394

Submitted: December 2022

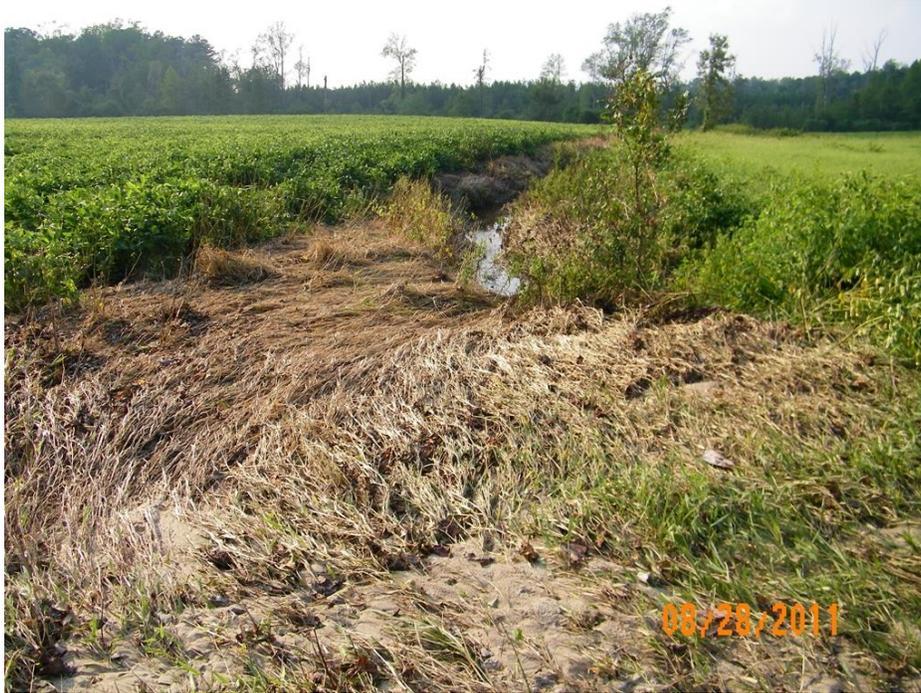
Photo 1: High flow drift lines after storm on proposed Reach 3.

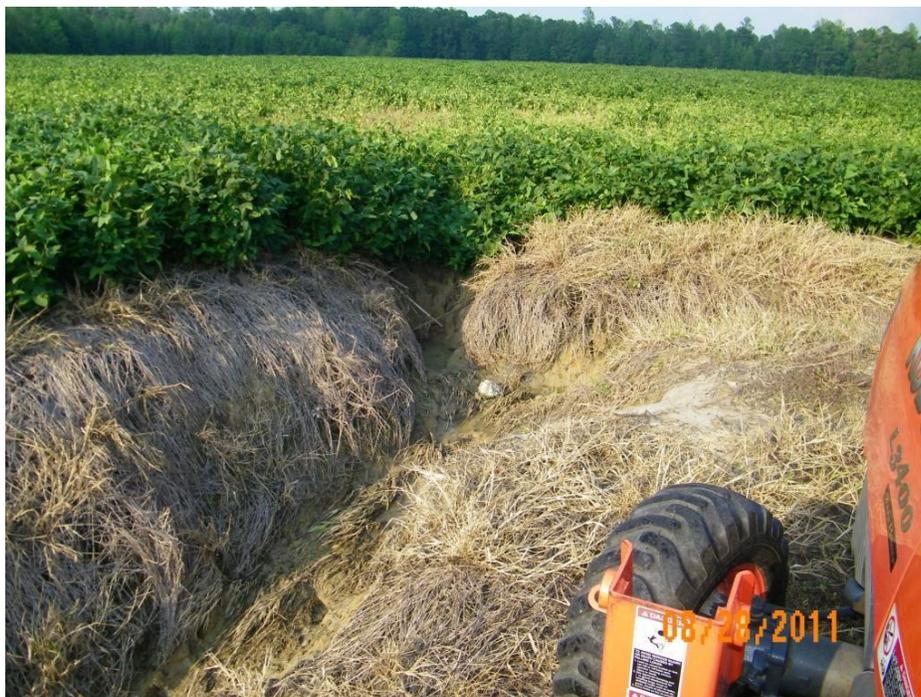
Photo 2: Facing upstream confined flow path causing erosion from existing crop field.

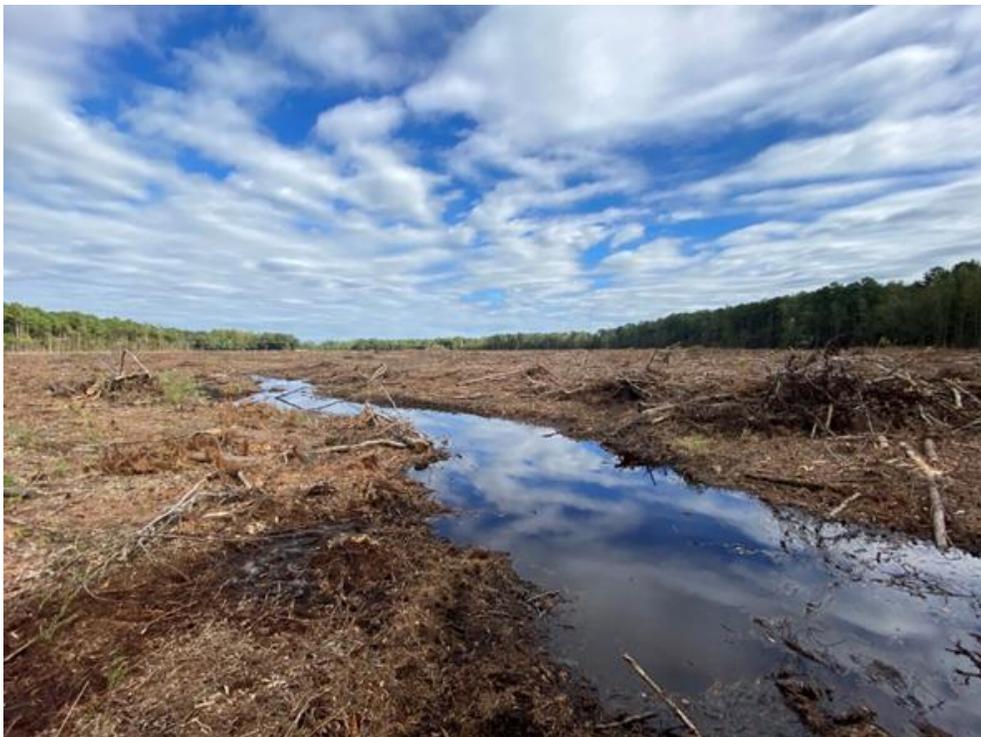
Photo 2: Clear Cutting at the top of reach 1, outside of project boundary.

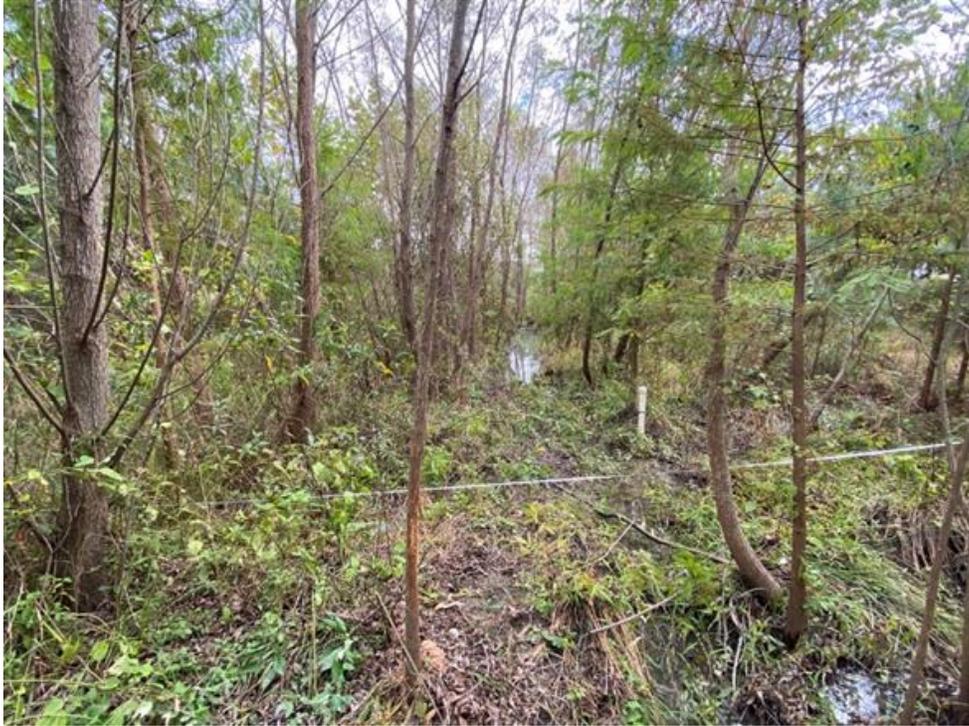
Photo 19: Cross section #6.

- In Table 11a, please verify the morphology data, specifically for XS6. The XS graph shows aggradation, and the max depth has decreased from 0.86 at AB to 0.60 in MY7, yet the LTOB cross sectional area is shown to have increased since MY0. Please verify or correct.*

- Ecotone Response: A revision was needed in the “omit bankful” checkbox of the survey overlay file. This slightly decreased LTOB Cross Sectional Area, though they are still higher than previous years. This is likely because aggradation has increased channel width. An arrow indicating the Year 7 LTOB has been added to the cross section 6 chart.

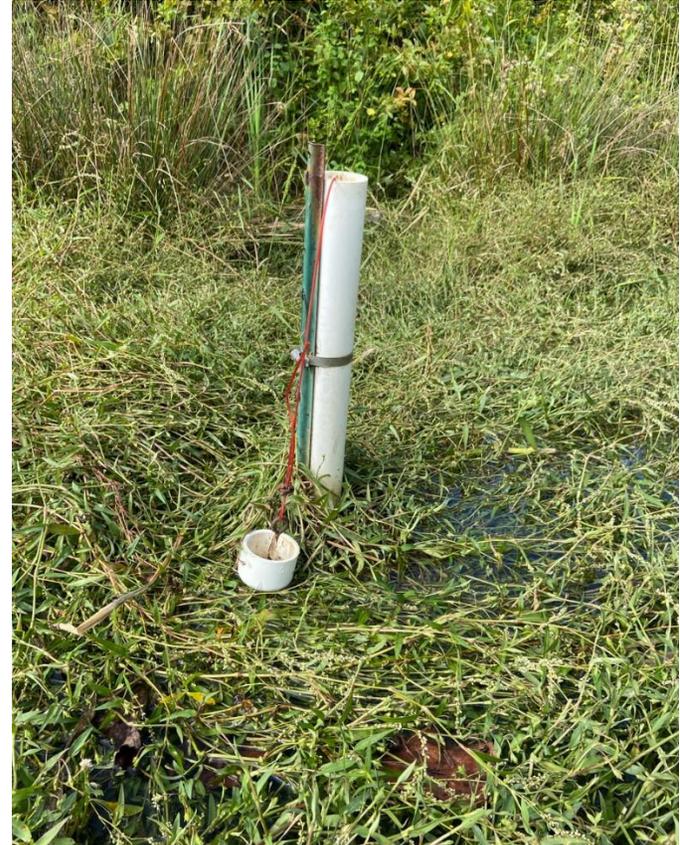
- HOBO Logger could not read out data. When the logger was retrieved, the cap of the well was dislodged, and the logger string was not fully extended. Logger cap could have been dislodged by animal activity, or from high water flow. The well was situated in standing water and would have met hydrology requirements. See photo to the right.

Photo 1: Logger dislodged at monitoring well 10, on the multi-thread channel Reach 5.

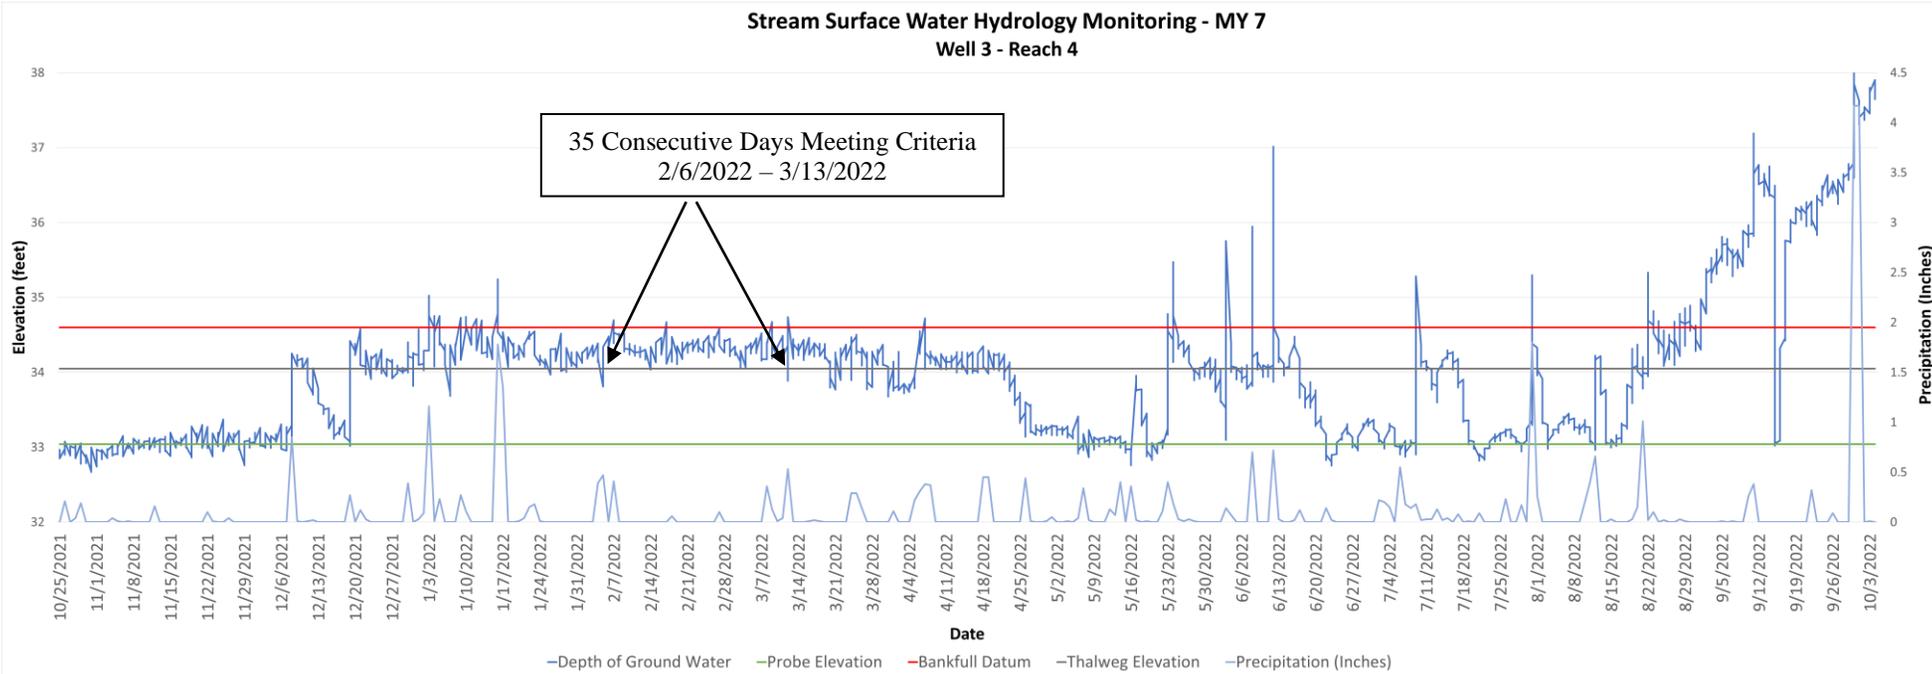
Figure 5: Monitoring Well 3 – Reach 4

7. *Some flow gauges show hydrology that dipped below the thalweg and yet was counted toward consecutive days of flow (Figure 5 for example). Recommend recalculating consecutive days of flow for MY7, and all prior years if possible, and updating Table 13 accordingly. Please remove footnotes that say “Ground water line may drop below thalweg...”*
Ecotone Response: Consecutive days meeting flow was recounted for monitoring year 7 and adjusted on the graphs, as well as in Table 13.

Comment Revisited 1/6/2023: Consecutive days meeting flow was also recalculated for all 10 wells from monitoring years 1-6. All the changes listed above can be seen in the updated Table 13.
