# **MONITORING YEAR 1 ANNUAL REPORT FINAL**

## **HUNTSMAN MITIGATION SITE**

Wilkes County, NC  
Yadkin River Basin  
HUC 03040102

DMS Project No. 100123

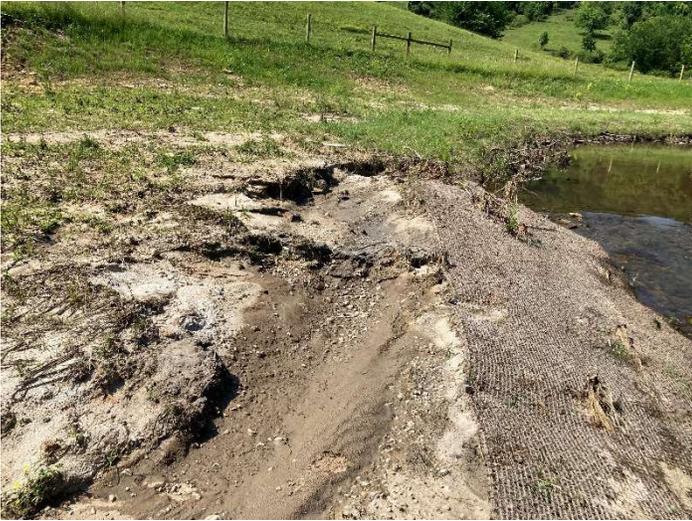
**NL Hunting Reach 1, station 102+50 – Bank scour before repairs**  
*(6/1/2022)*

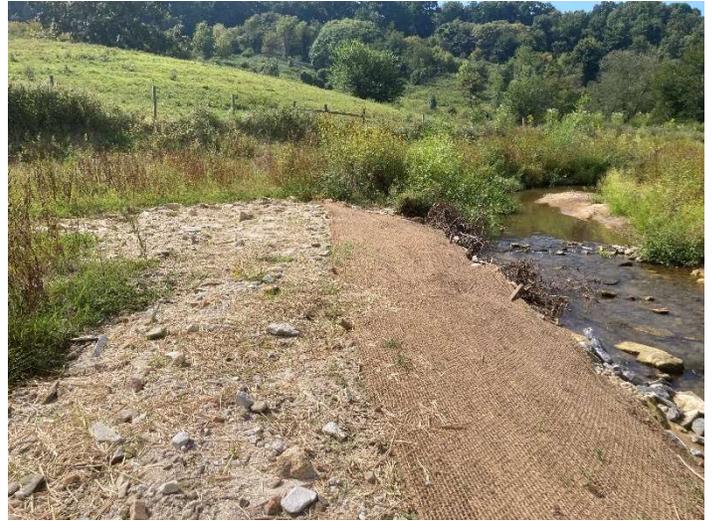
**NL Hunting Reach 1, station 102+50 – Restabilized bank after repairs**  
*(9/26/2022)*

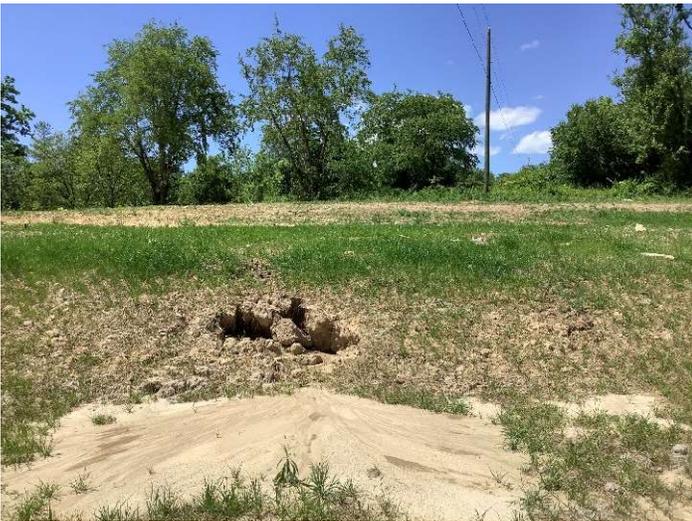
**NL Hunting Reach 1, station 102+50 – Floodplain scour before repairs**  
*(5/24/2022)*

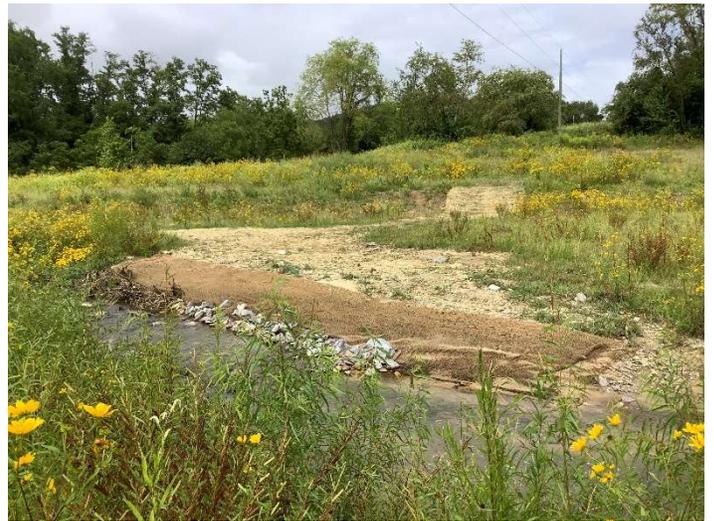
**NL Hunting Reach 1, station 102+50 – Restabilized floodplain and bank after repairs**  
*(9/26/2022)*

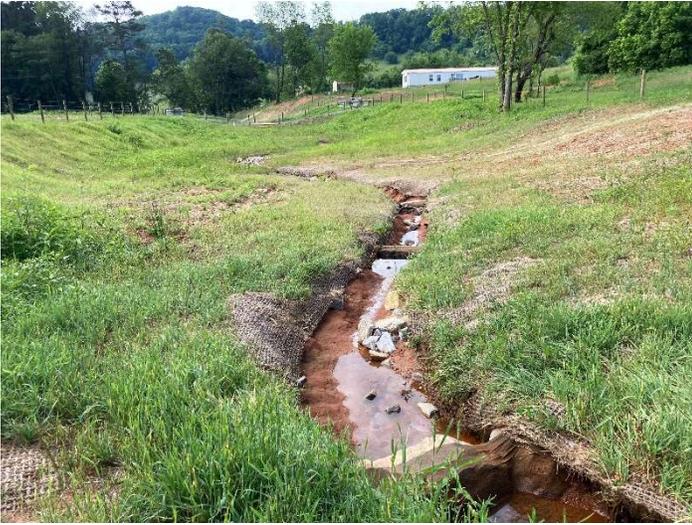
While the Site was largely resilient against several large storm events in 2022, MY1 visual assessments revealed several areas of concern including instances of scour and structure issues. On UT1 Reach 1, riffle material was washed out of one of the repaired riffles resulting in some minor bed scour.

**UT1 Reach 1, station 210+50 to 212+00** – Riffle scour before repairs (6/1/2022)

Wildlands plans to reposition and embed the riffle stone in the degraded riffle, add a log sill at 211+40, and install livestock stakes to the entire length of UT1. Other areas of concern on Site include the piping rock sill on UT1 Reach 3, downstream of the culvert under Ingle Hollow Road. The sill was designed and installed six inches higher than the culvert invert but resulted in a perched culvert. Repairs will include replacing the rock sill so that water backs up into the culvert. Additionally, on UT2 Reach 3, wetland hydrology is abutting the stream which has caused approximately 40 feet of stream bank to slump and scour. Wildlands will repair and stabilize the areas by re-grading both banks and reinforcing them with clay soil and brushstone. Repairs will be completed on these areas in winter 2023.

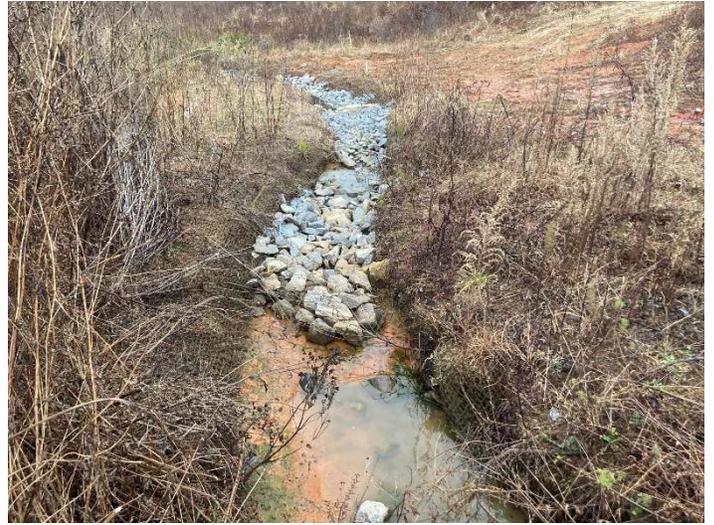
**UT1 Reach 1, station 210+50 to 212+00** – Restabilized riffle after repairs (12/8/2022)

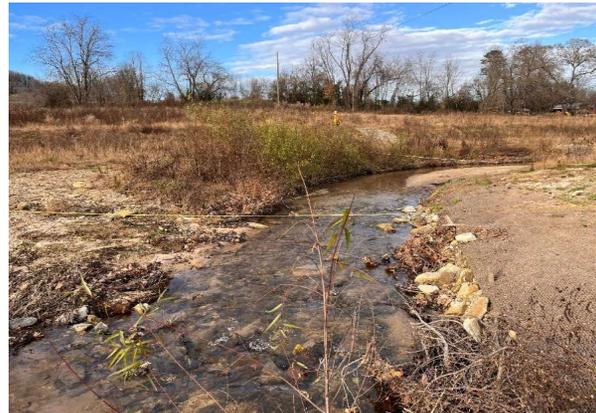
XS 1 is located in an area that was repaired in MY1.

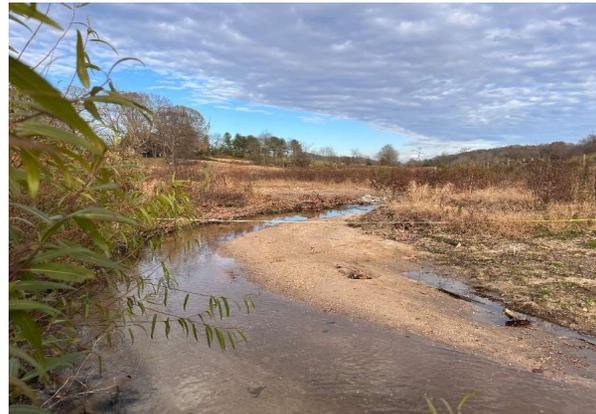
XS 2 is located in an area that was repaired in MY1.

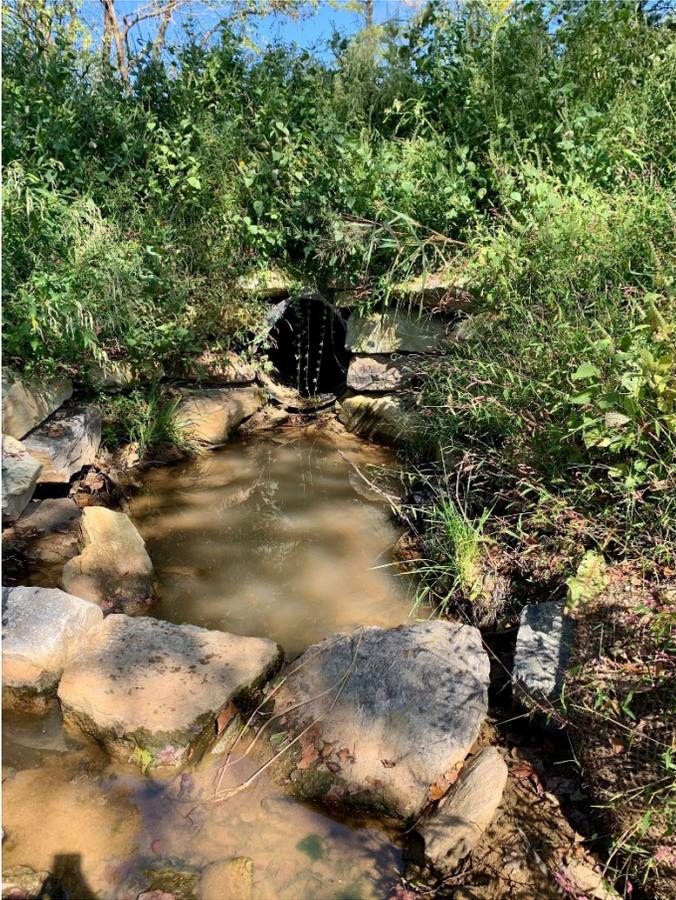
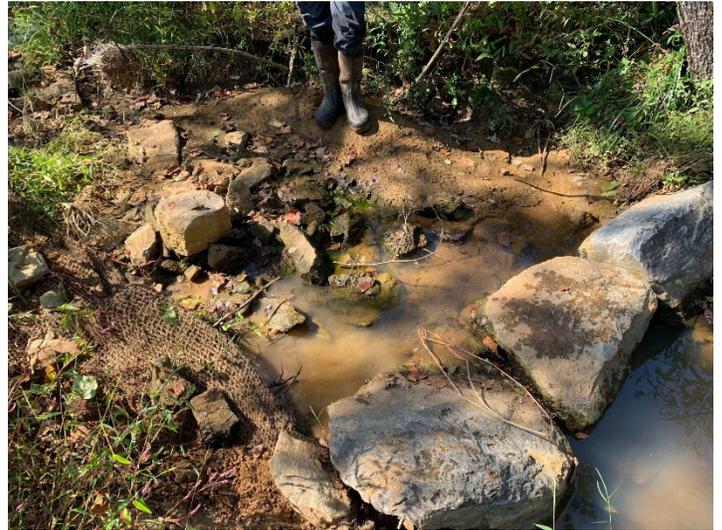
**NCDWR Comment 1 (Erin Davis) – Ingle Hollow Road Culvert –** Stream flow is piping around the sill and lowering the water surface elevation at the culvert's outlet (09/27/2022).

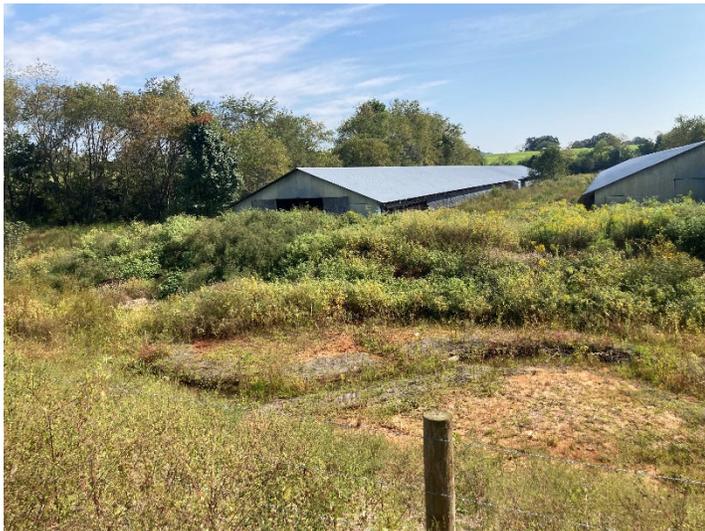
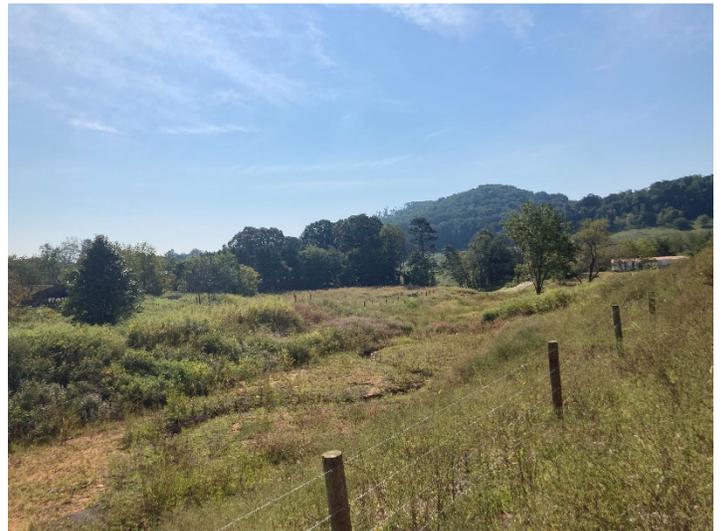
**NCDWR Comment 2 (Erin Davis) – UT1 Reach 1 PP8 & PP9 –** Herbaceous cover has become well established on the hillsides of UT1 (09/27/2022).
