MONITORING YEAR 2 ANNUAL REPORT FINAL

HUNTSMAN MITIGATION SITE

Wilkes County, NC
Yadkin River Basin
HUC 03040102

DMS Project No. 100123
DMS Contract No. 7891
DMS RFP No. 16-007728; Date of Issue: 11/13/2018
USACE Action ID No. SAW-2019-00836
DWR Project No. 20190866
Data Collection Dates: February - November 2023
Submission Date: January 2024

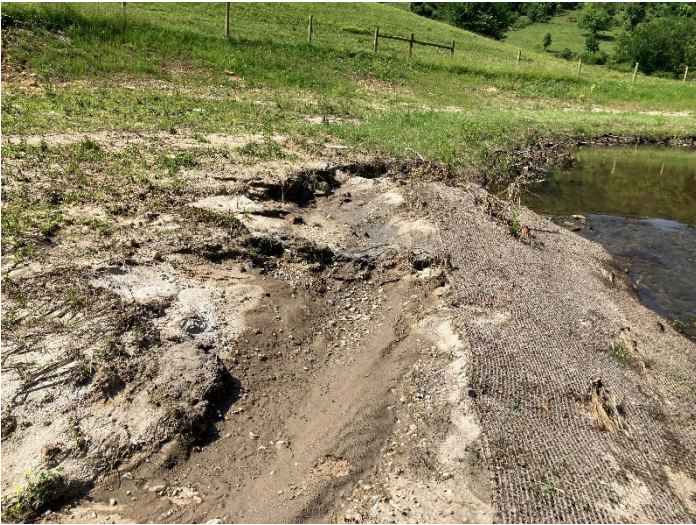
MY0-1 – NL Hunting Reach 1, 102+25 - 102+75
– Right bank scour before repairs (06/01/2022)

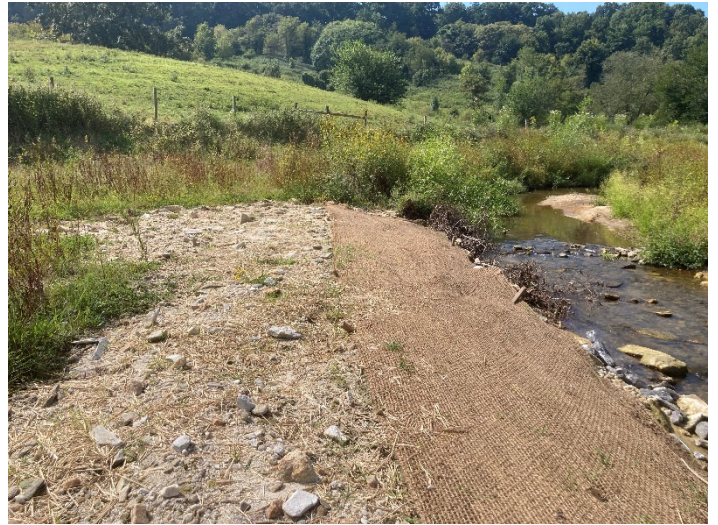
MY0-1 – NL Hunting Reach 1, 102+25 - 102+75 – Re-stabilized
right bank after repairs (09/26/2022)

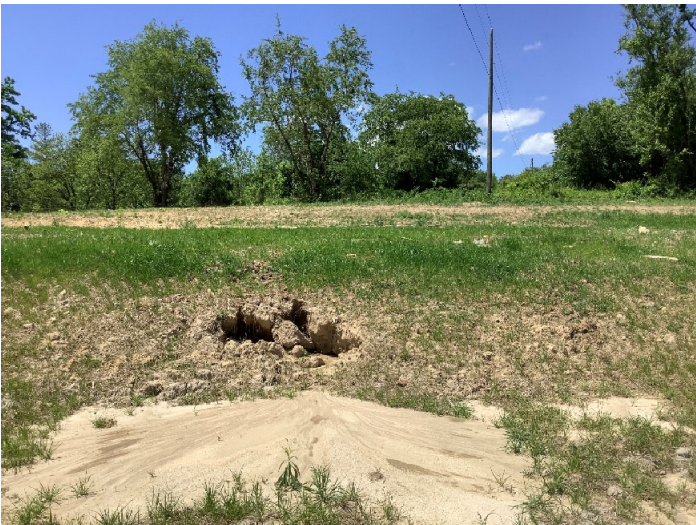
MY0-1 – NL Hunting Reach 1, 102+85 - 103+00 – Floodplain scour
before repairs on left bank (05/24/2022)

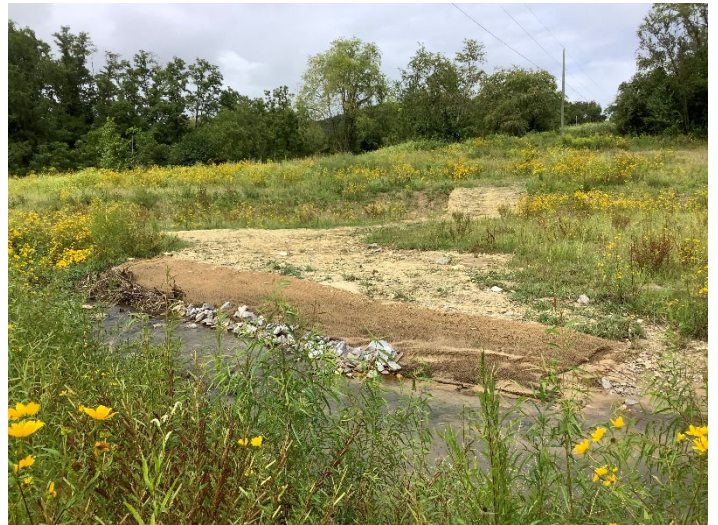
MY0-1 – NL Hunting Reach 1, 102+85 - 103+00 – Re-stabilized
floodplain and left bank after repairs (09/26/2022)

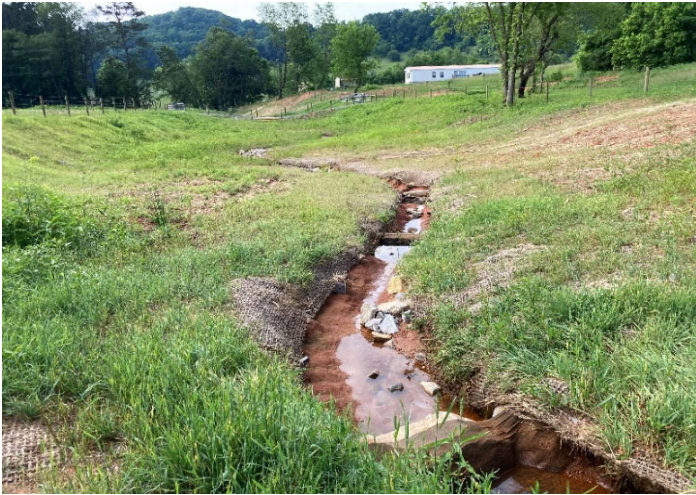
MY0-2 – UT1 Reach 1, station 210+50 to 212+00 – Riffle scour before repairs (06/01/2022)

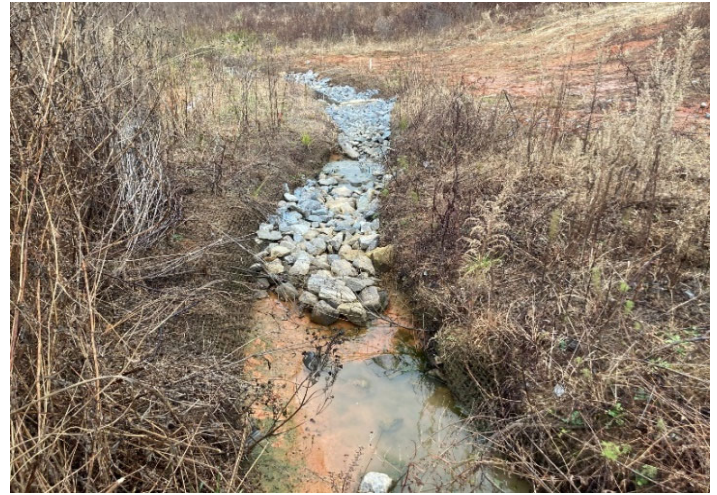
MY0-2 – UT1 Reach 1, station 210+50 to 212+00 – Re-stabilized riffle after repairs (01/08/2023)

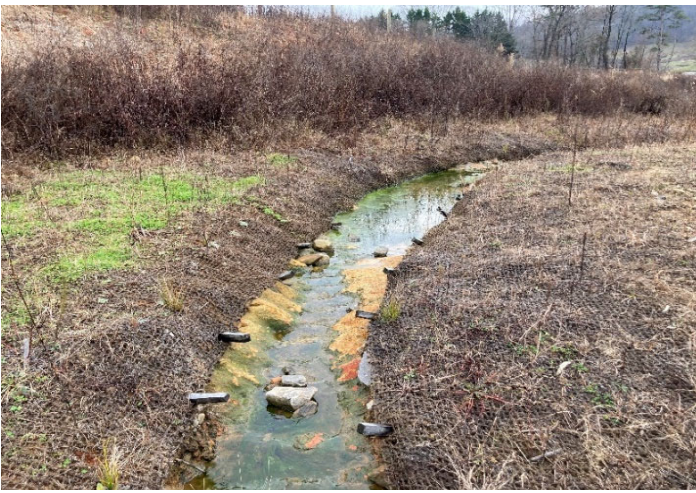
MY1-1 – UT1 Reach 1, station 210+50 to 210+70 – Riffle scour before repairs (12/08/2022)

- **UT1 Reach 1: STA 210+50 to 210+70** – Riffle material was washed out of one of the previously repaired riffles resulting in some minor bed scour. Wildlands repositioned and embedded the riffle material in the degraded riffle, added a log sill at Sta 210+55, and installed livestakes on both banks along the entire length of UT1.

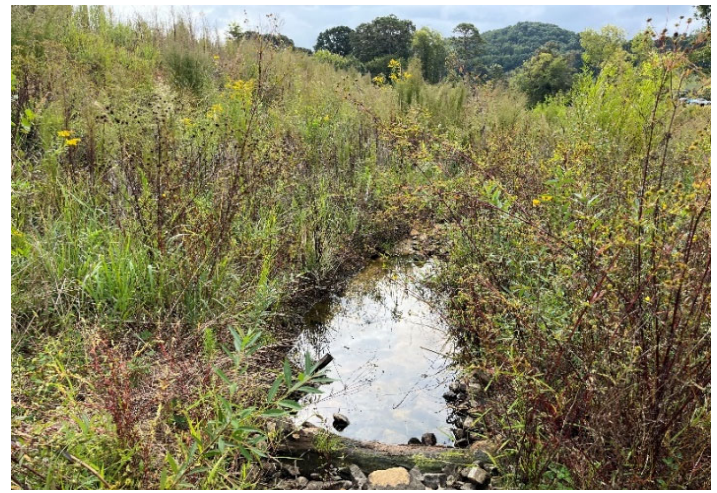
MY1-1 – UT1 Reach 1, station 210+50 to 210+70 – Re-stabilized riffle after repairs (09/26/2023)

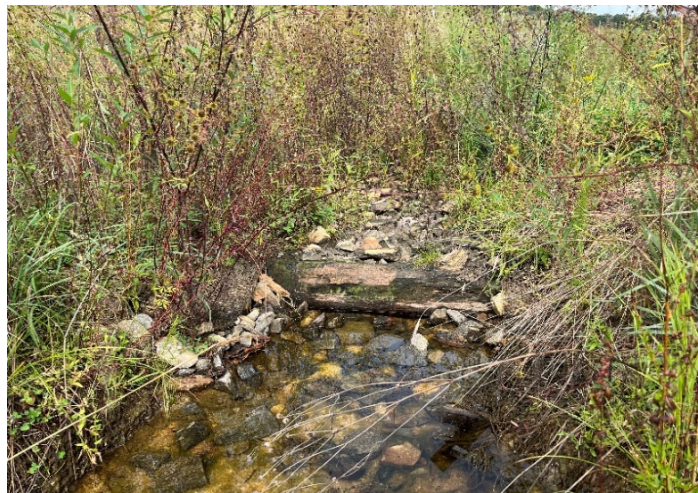
UT1 Reach 1, station 210+45 – Additional installed log sill after repairs (09/26/23)

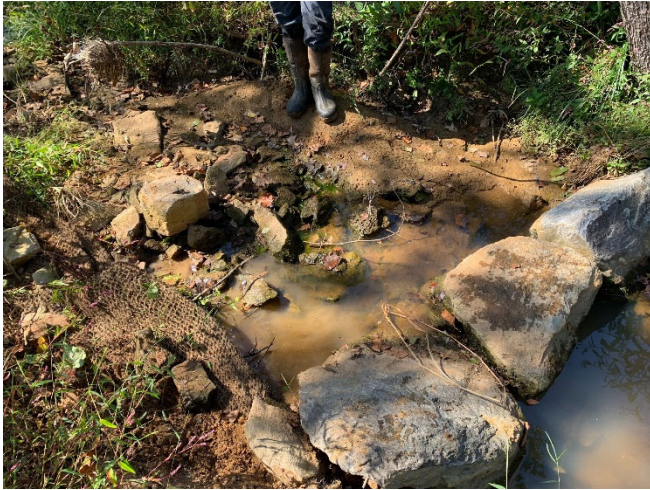
MY1-2 – UT1 Reach 3, station 218+23 – Rock sill piping before repairs (09/27/2022)

- **UT1 Reach 3: STA 218+23** – A rock sill was piping resulting in a perched culvert. Wildlands added geotextile fabric and rip-rap to the back of the rock sill to backup water into the culvert for aquatic passage. Since the repair was first completed, the rip-rap has washed downstream and the culvert is once again perched.
- **UT2 Reach 3: STA 308+00 to 308+30** – Hydrological seepage from a wetland area that abuts the reach resulted in stream bank slump and scour. Wildlands re-graded both banks, installed brushtoe, and re-seeded and matted the banks and floodplain.

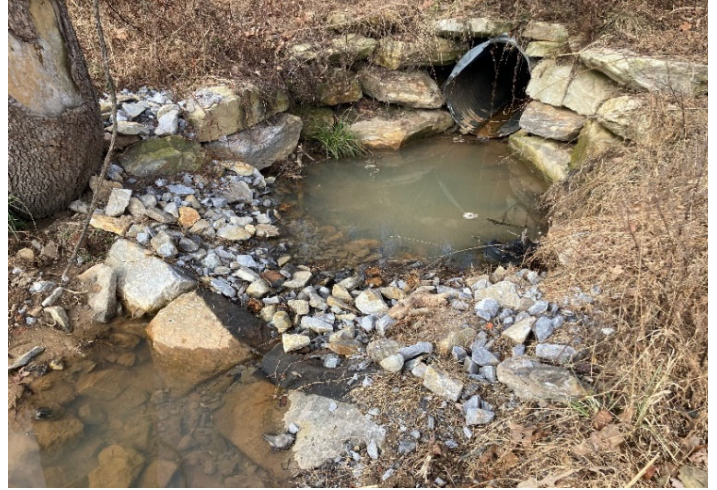
MY1-2 – UT1 Reach 3, station 218+23 – Rock sill after repairs (01/08/2023)

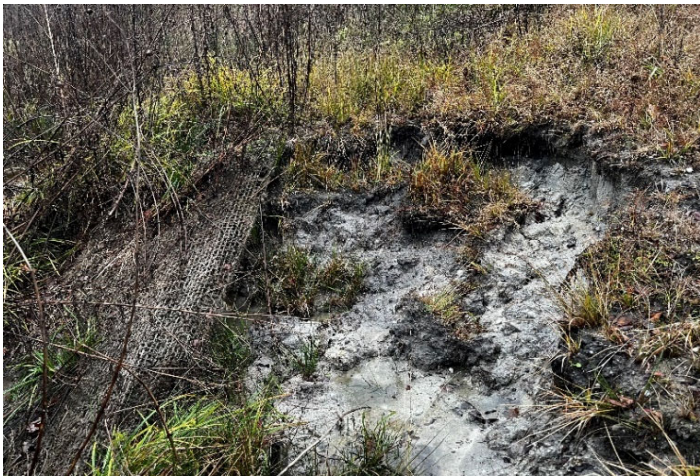
MY1-3 – UT2 Reach 3, station 308+00 to 308+36 – Bank scour before repairs (12/08/2022)

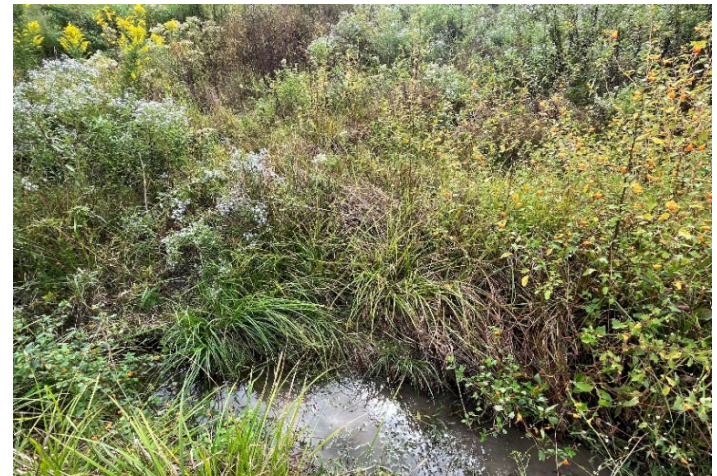
MY1-3 – UT2 Reach 3, station 308+00 to 308+36 – Re-stabilized bank after repairs (09/26/2023)

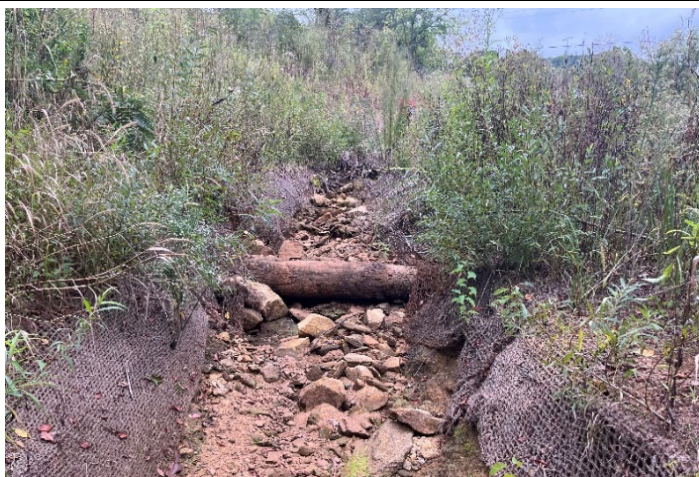
- **UT1 Reach 2: STA 216+00 to 216+75** – A lack of baseflow in this segment of stream was observed in late August. Wildlands installed a game camera in November 2023 to monitor baseflow and reassess the area in MY3.
- **UT1 Reach 3: STA 218+23** – A rock sill is piping resulting in a perched culvert. A repair was completed on this area in January 2023; however, the repair was unsuccessful, and the rock sill is piping again. To address this issue, Wildlands will repair the rock sill to backup water into the culvert in late 2023/early 2024.
- **UT1 Reach 3: STA 219+80 to 219+86** – There is localized scour on riffle XS10 resulting in undercut banks and bed scour. Wildlands will continue to monitor this area and will repair the area if needed.

MY2-1 – UT1 Reach 2, station 216+00 to 216+75 – Lack of base flow (09/29/2023)

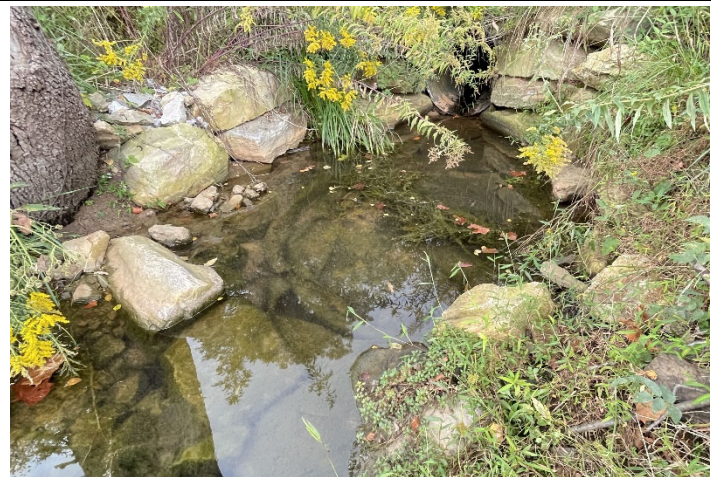
MY2-2 – UT1 Reach 3, station 218+23 – Rock sill piping, perched culvert before repairs (09/26/2023)

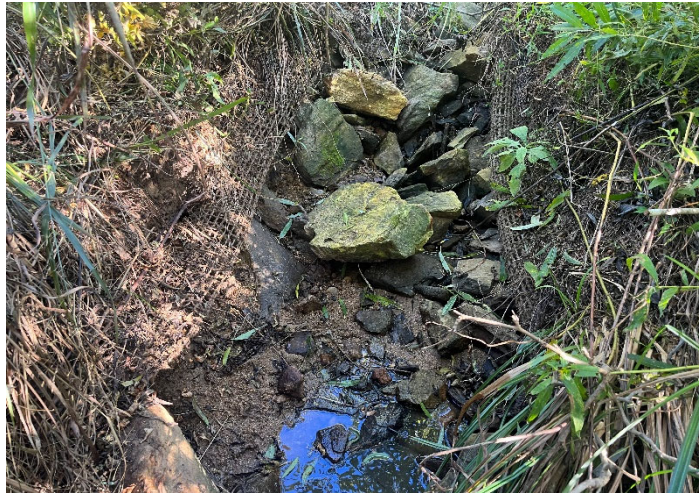
DMS' Comment: Section 2.3 contains a short discussion regarding the isolated bed scour at XS10 and the resulting BHR of 1.3. It should also be noted that when the BHR is calculated using the AB bankfull area, the BHR is 1.0 as shown on Table 10.

MY2-3	UT1 Reach 3	219+80 - 219+86	Localized incision on cross-section 10.	N/A	No repair needed at this time. Wildlands will continue to monitor the area of localized incision and will report on conditions in 2024.	6 LF

MY2-3 – UT1 Reach 3, station 219+80 to 219+86 – Isolated riffle scour (10/17/2023)
