# **Jacksonville Country Club Stream Restoration and Enhancement Project**

**SCO No. 070715501  
DENR Contract No. D08049S  
EEP Project No. 194  
Onslow County, North Carolina**

**Year 1 of 5 Monitoring Report  
Data Collection: January through December 2014  
Submission Date: March 31, 2015**

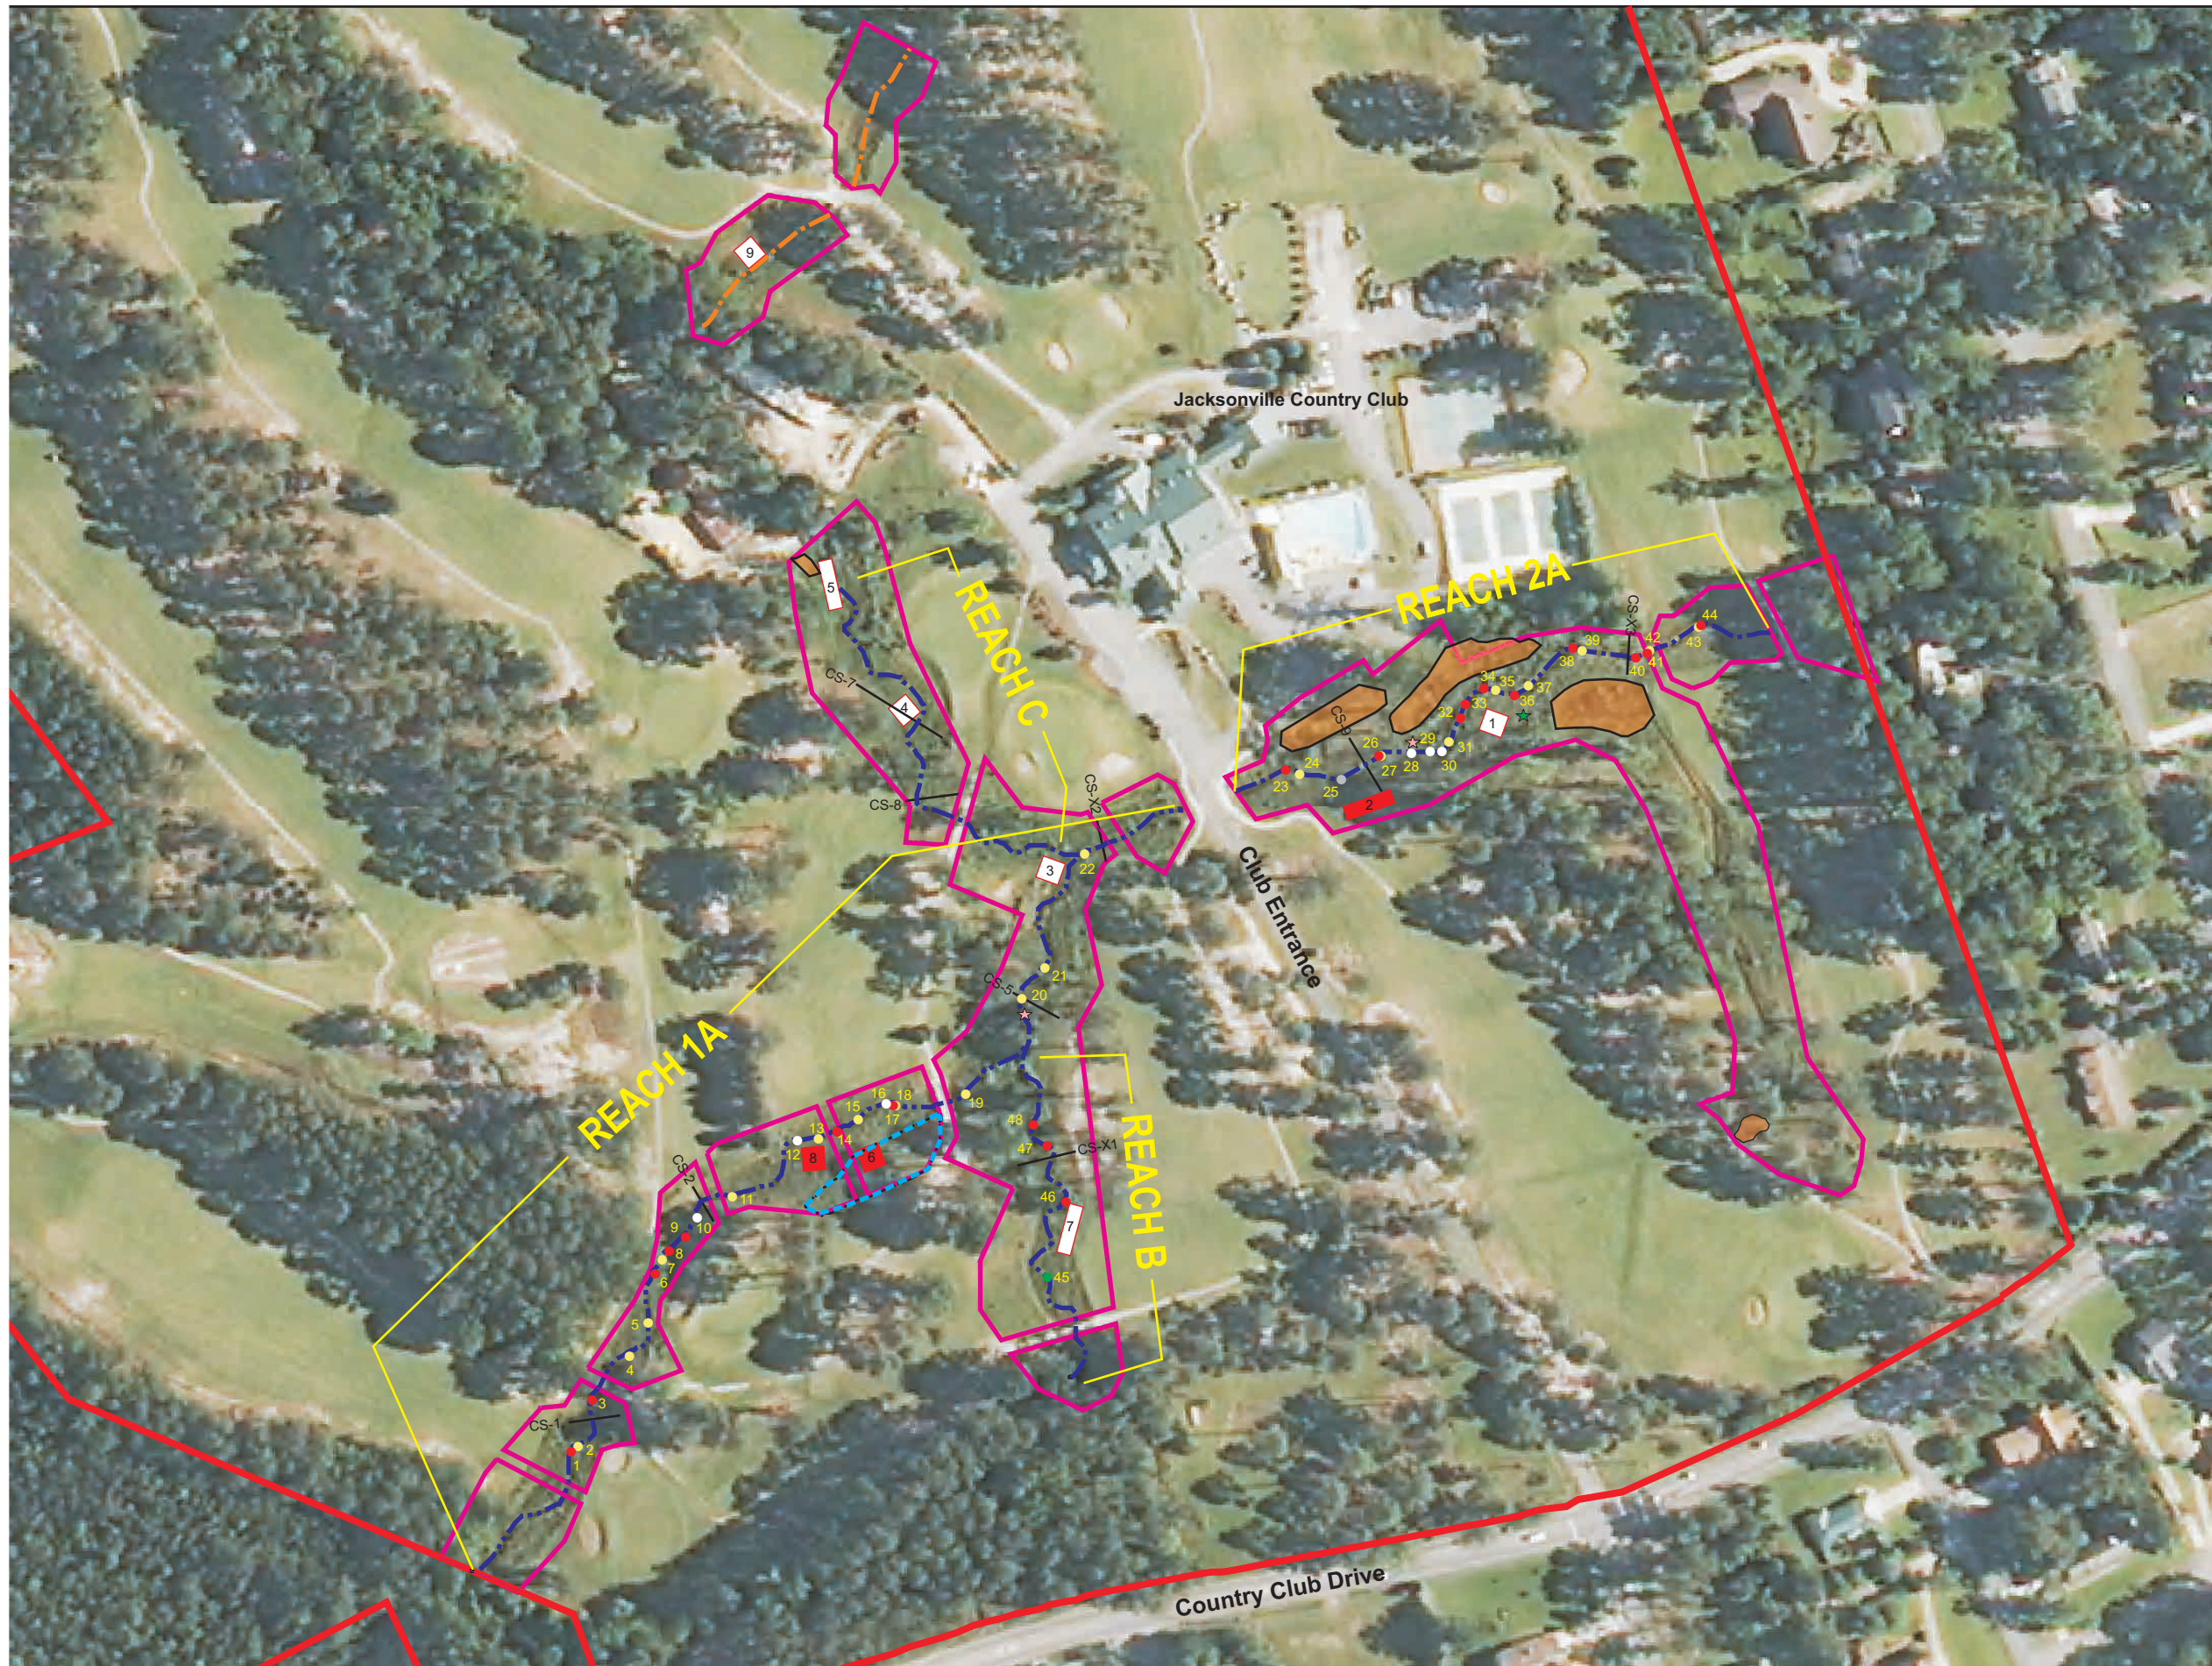
Current Conditions Plan View

Many problem areas were identified along the four restored stream reaches (1A, 2A, B & C) during the visual inspection. Appendix B contains photographs of most of the problem areas and Figure 2 depicts the GPS location of specific points noted below.

A total of 22 problem areas were noted within Reach 1A. These included 7 undercuts, 12 areas of degradation, and 3 scour holes.

Twenty two problem areas were noted within this reach during the visual inspection. These included 10 bank undercuts, 8 areas of degradation, 3 scour holes, and one area of mass wasting.

As observed during the baseline monitoring, it appeared that some water was bypassing the constructed channel and forming another, more direct route to the main channel (Pt 45). This was classified as aggradation. Additionally, three bank undercuts were noted within this reach. Three of the seven grade controls features were not observed and it was assumed that they have been buried by sediment. However, the stream appeared to be functioning properly in these areas.

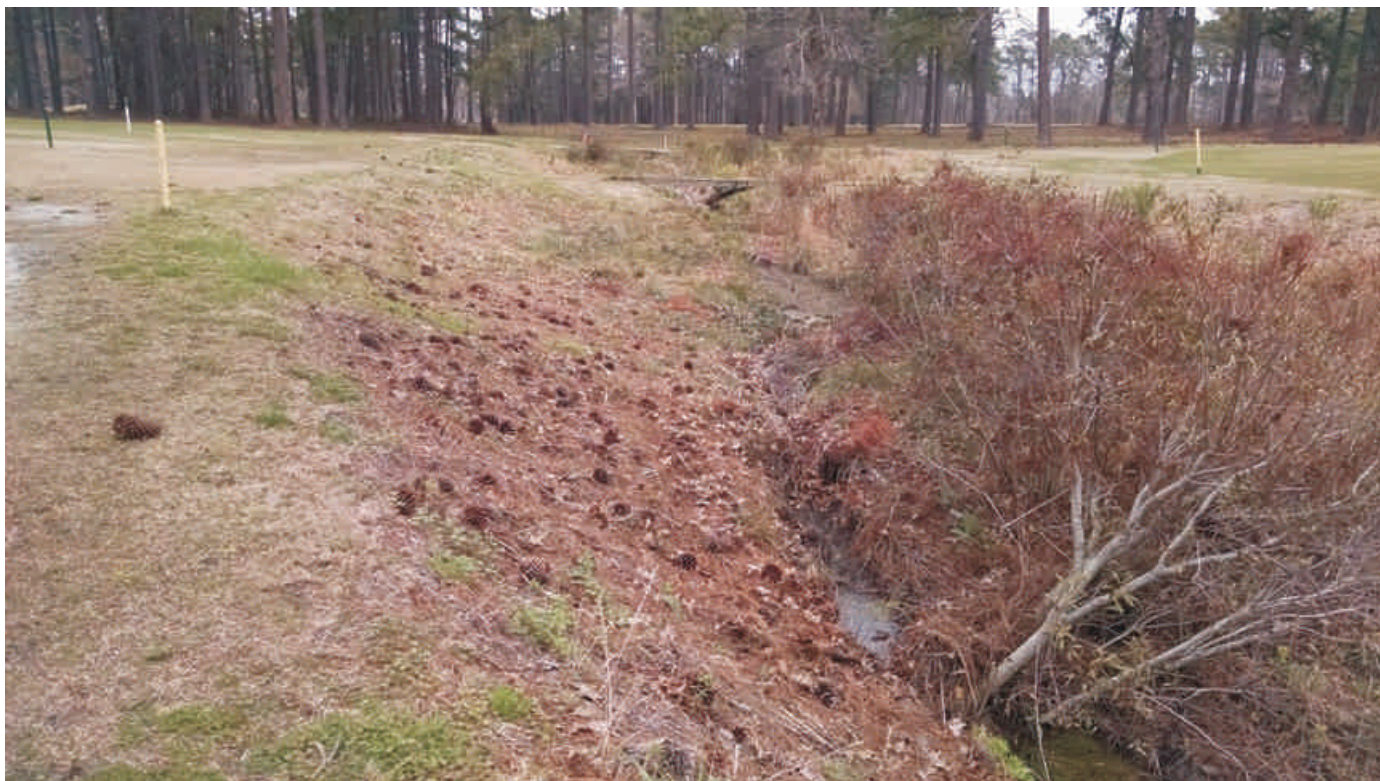
**Stream Enhancement Reach - Looking North Along Channel**

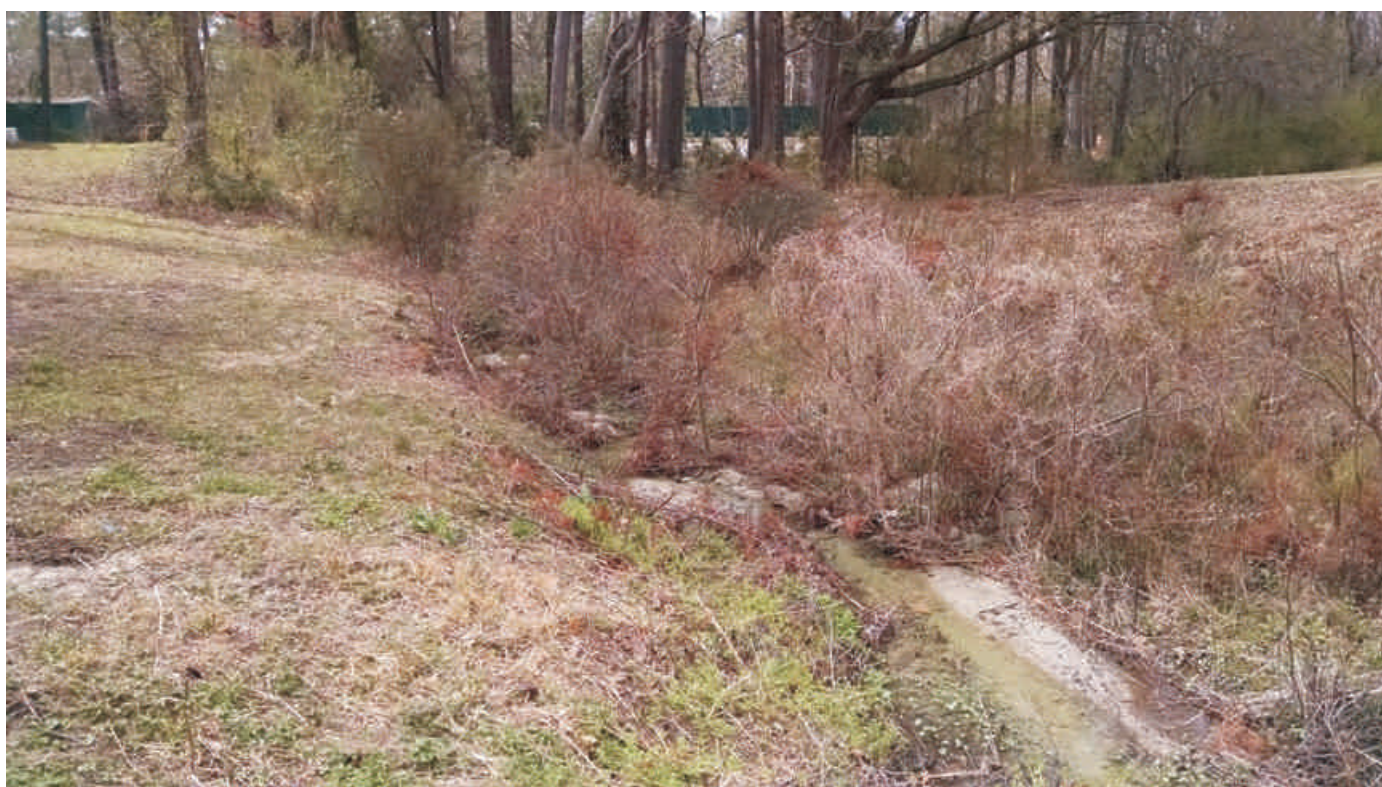
**Stream Enhancement Reach - Looking South At End of Reach**
