Jacksonville Country Club Stream Restoration and Enhancement Project

**SCO No. 070715501
DEQ Contract No. D08049S
DMS Project No. 194
Action ID# 2006-40325-067
Onslow County, North Carolina**

**Year 2 of 5 Monitoring Report
Data Collection: January through December 2015
Submission Date: April 13, 2016**

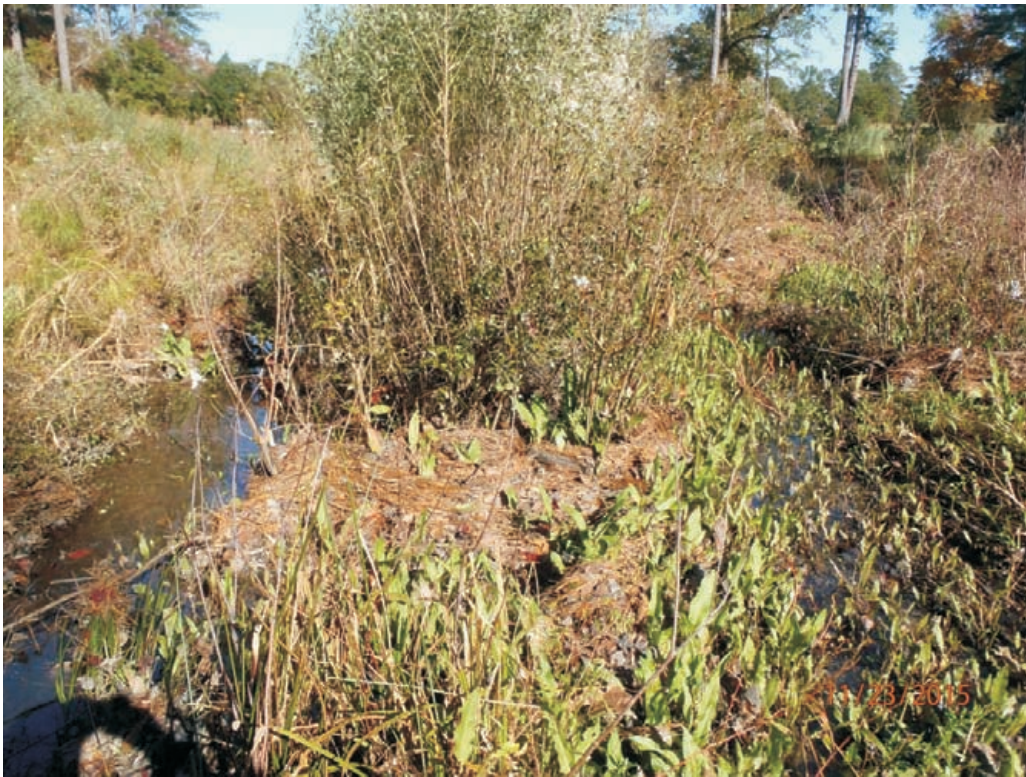
A total of 24 problem areas were noted within Reach 1A (compared to 22 areas in MY1). These included 6 undercuts, 13 areas of degradation, 3 scour holes, one area of mass wasting, and one area of aggradation. This area of aggradation appears to be causing a new channel to form at the very top of the reach.

Reach 1A - Stream Problem Area 1; Aggradation; New Channel Forming

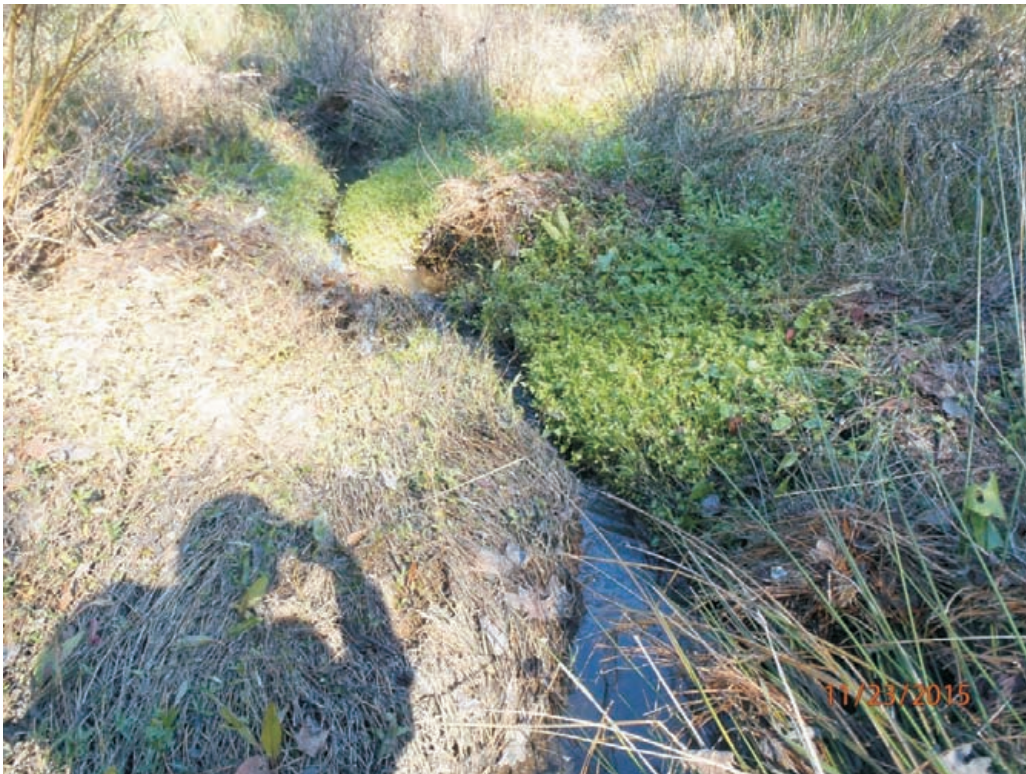
Reach 1A - Stream Problem Area 2; Degradation

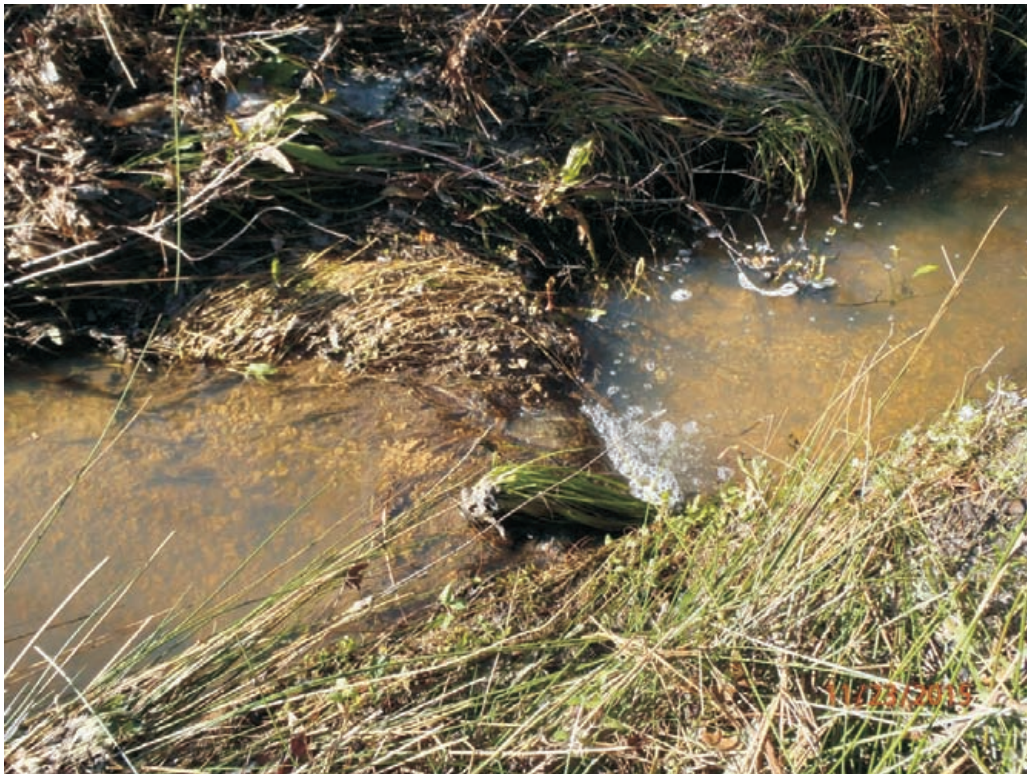
Reach 1A - Stream Problem Area #4; bank undercut

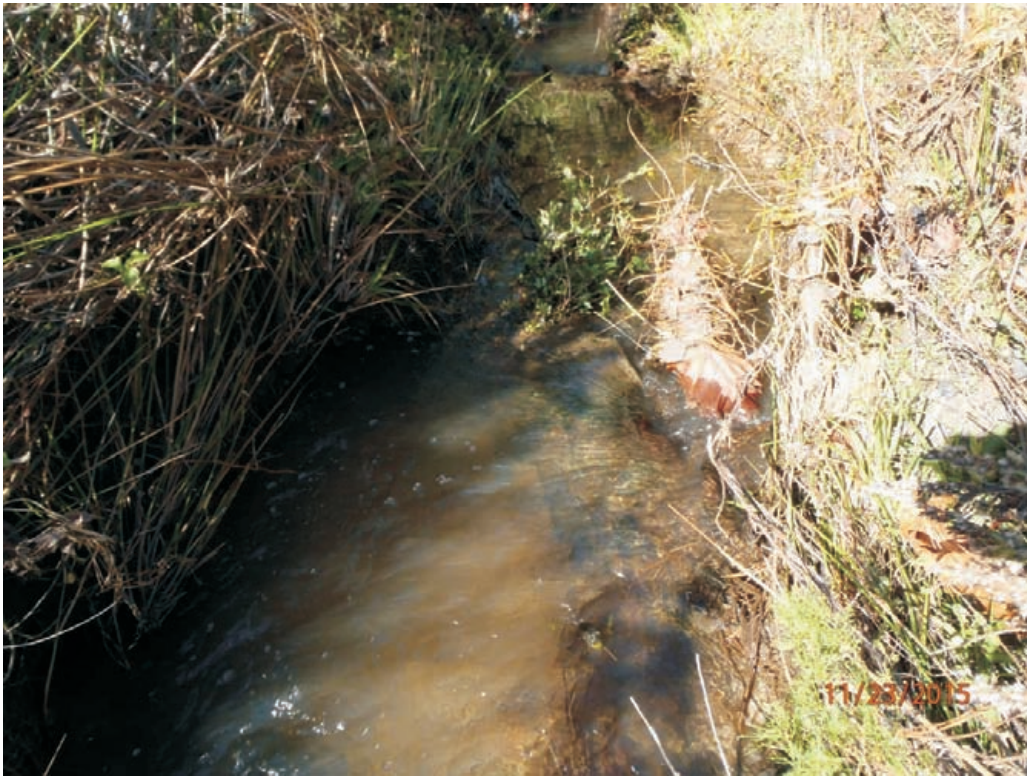
Reach 1A - Stream Problem Area #5; bank undercut

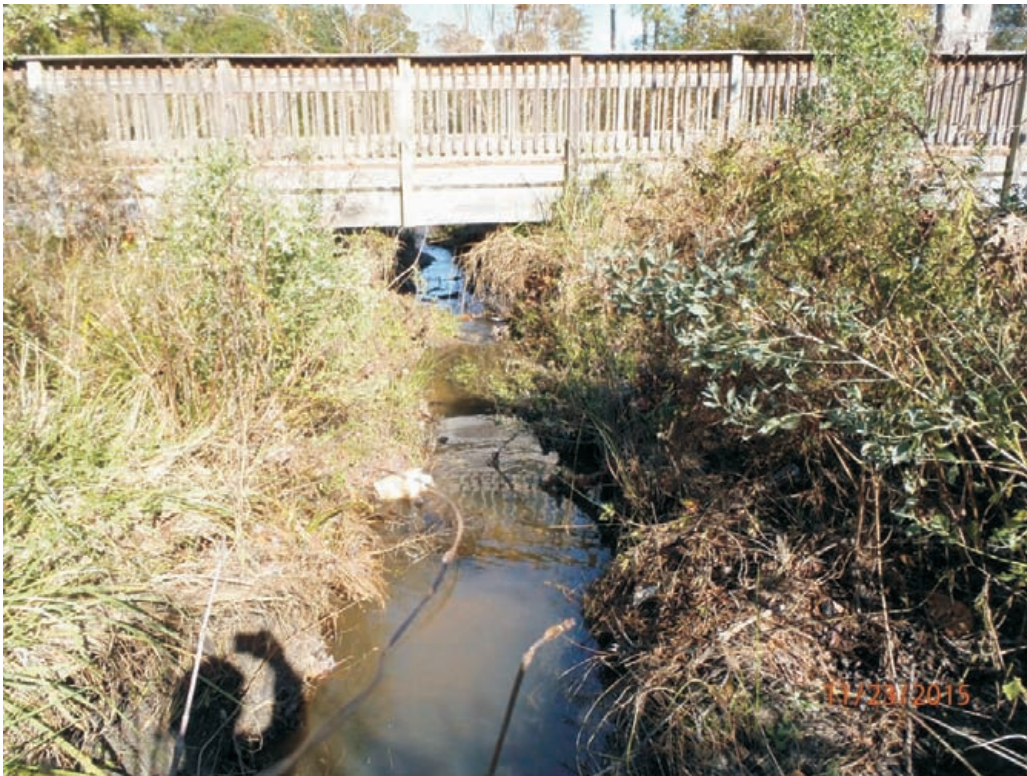
Reach 1A - Stream Problem Area #6; degradation

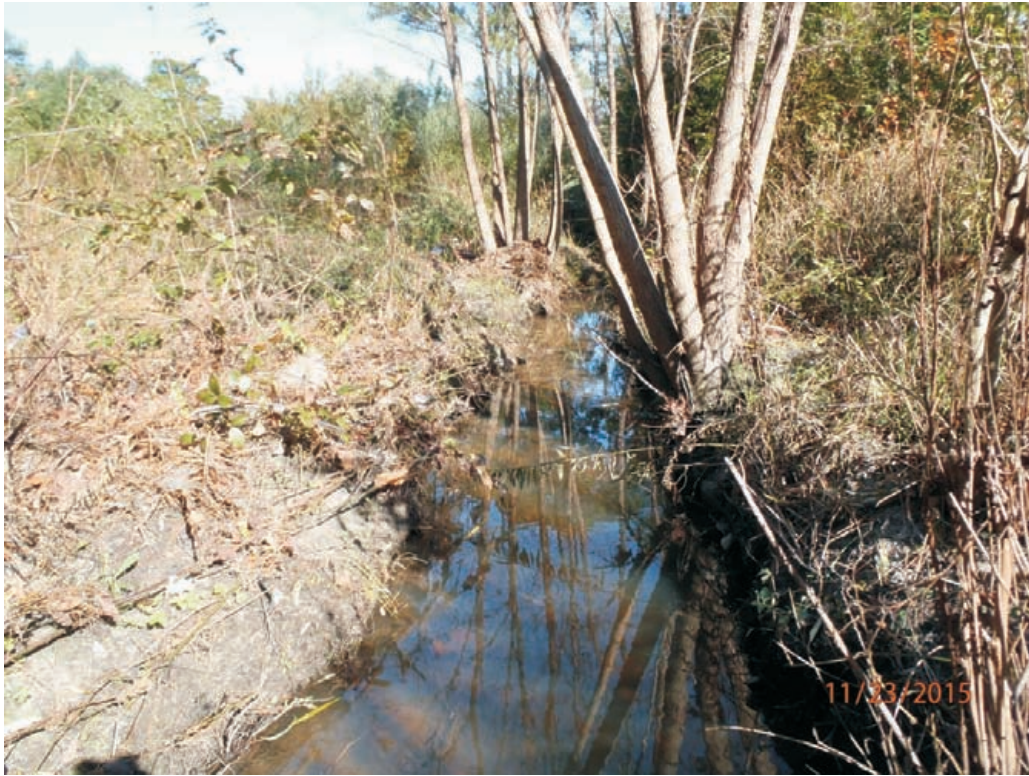
Reach 1A - Stream Problem Area #7; degradation

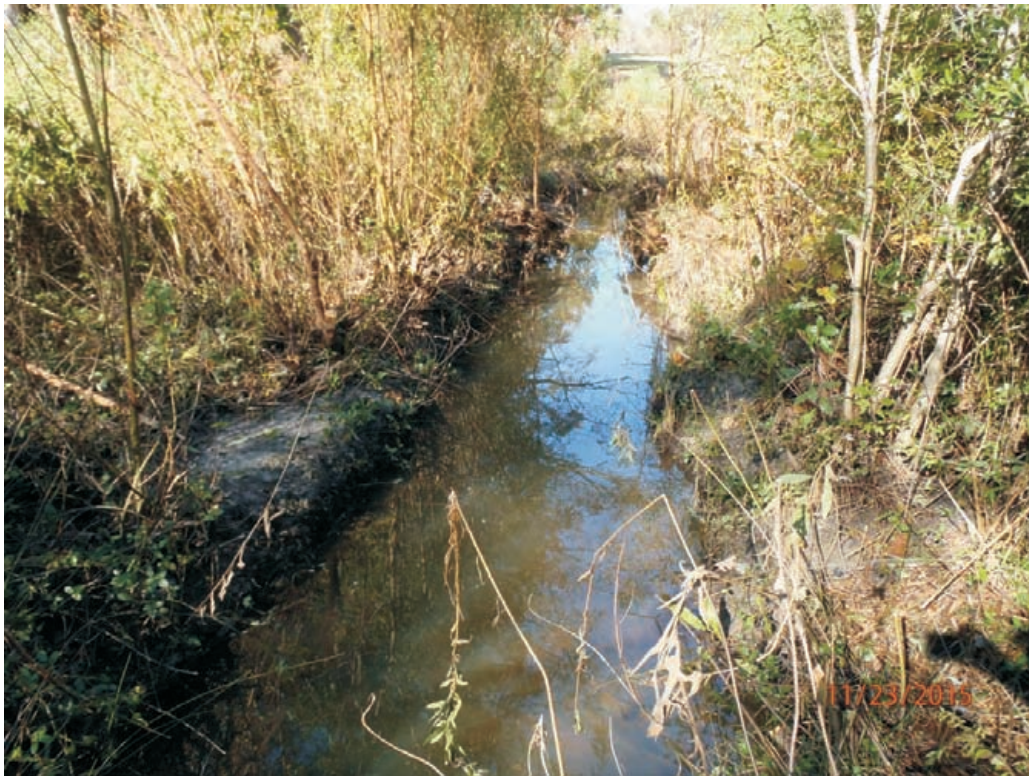
Reach 1A - Stream Problem Area #8; degradation

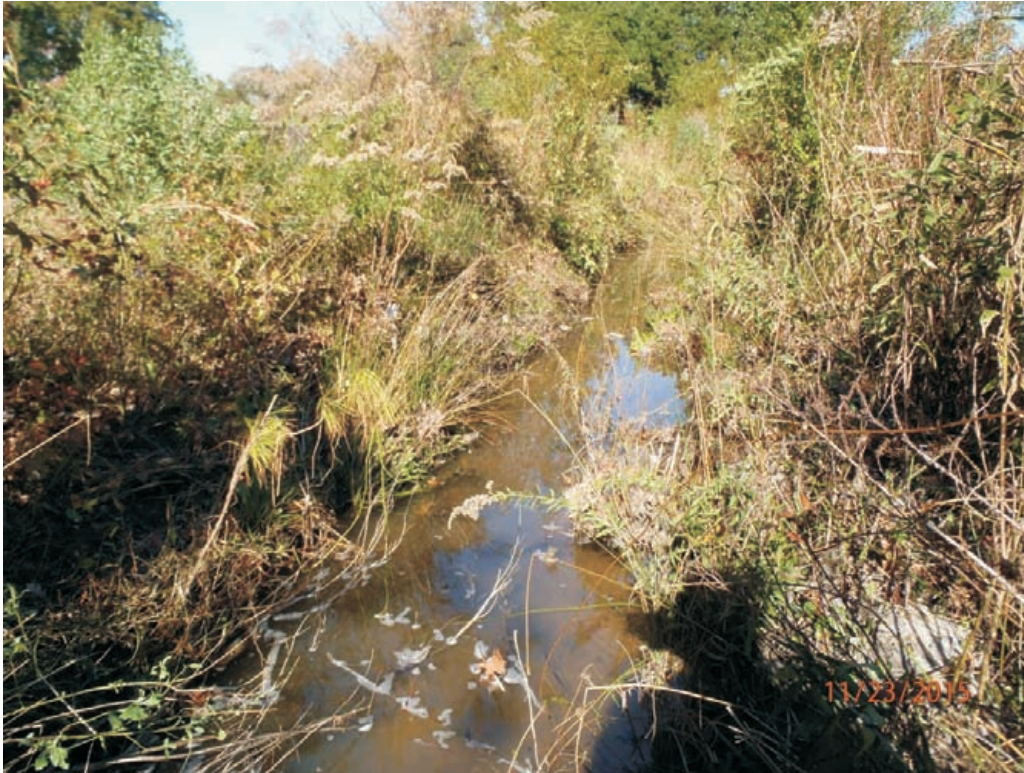
Reach 1A - Stream Problem Area #9; Degradation

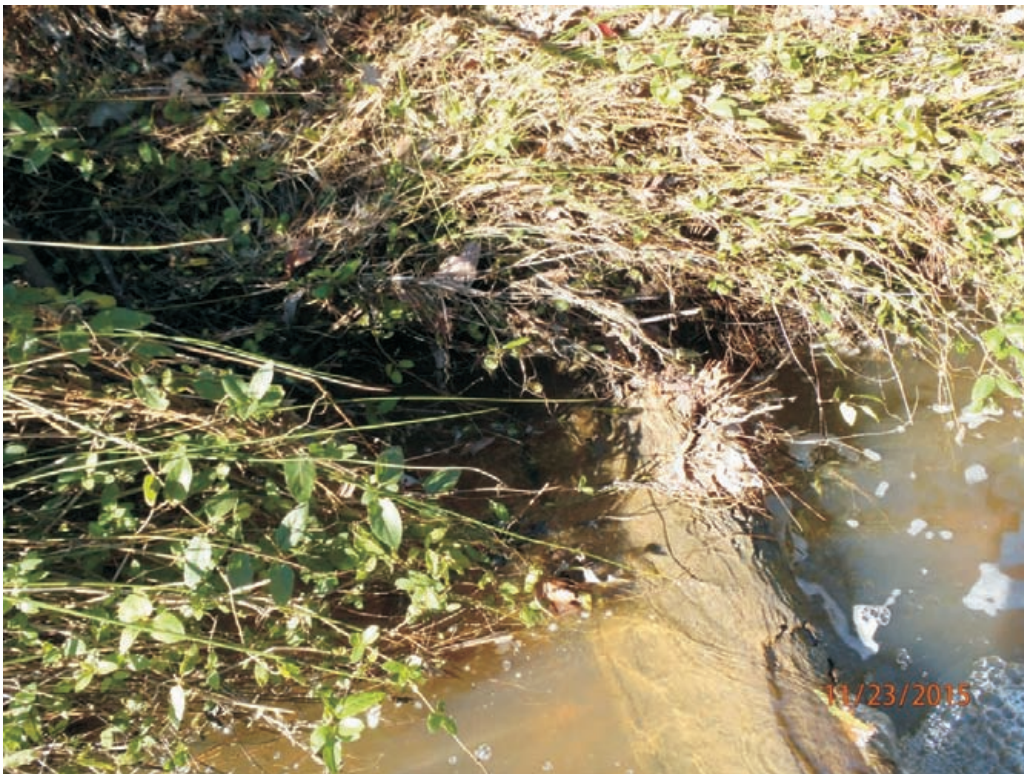
Reach 1A - Stream Problem Areas #10; Log Vane Undercut

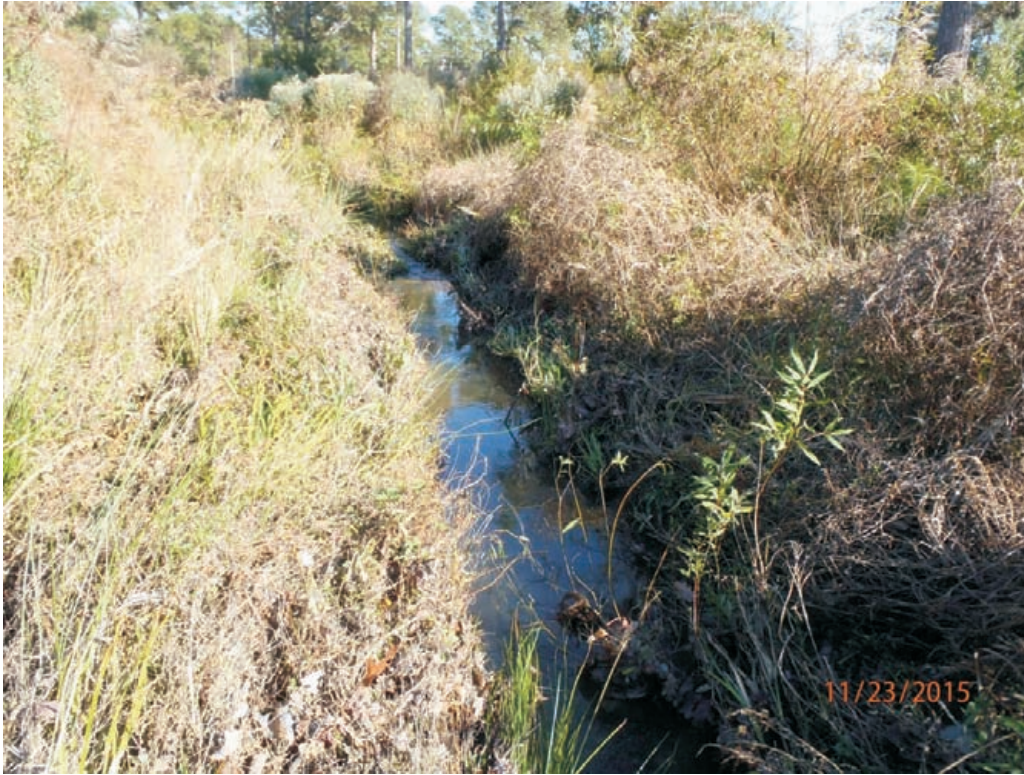
Reach 1A - Stream Problem Area #13; Degradation

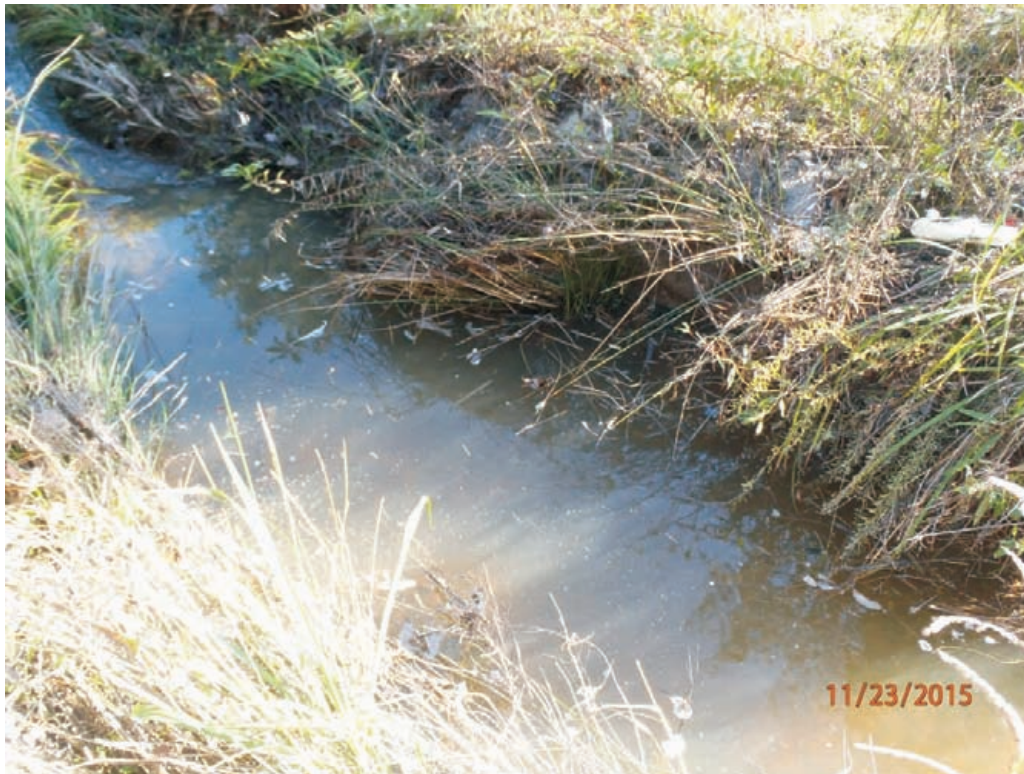
Reach 1A - Stream Problem Area #14; Scour

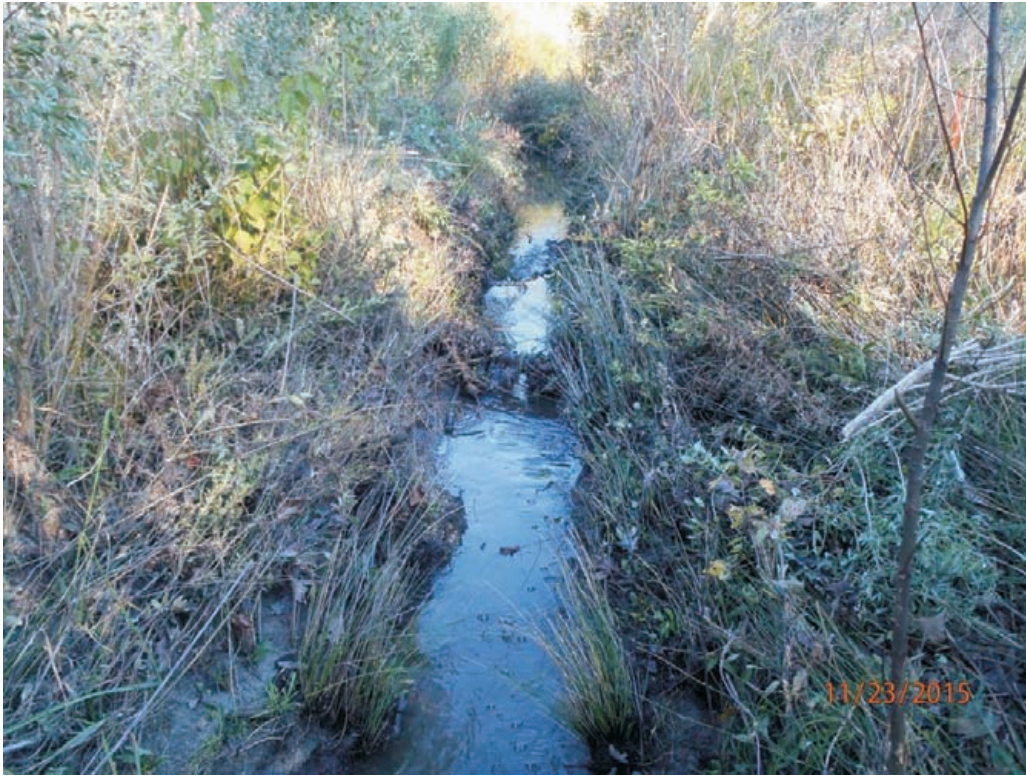
Reach 1A - Stream Problem Area #15; Degradation

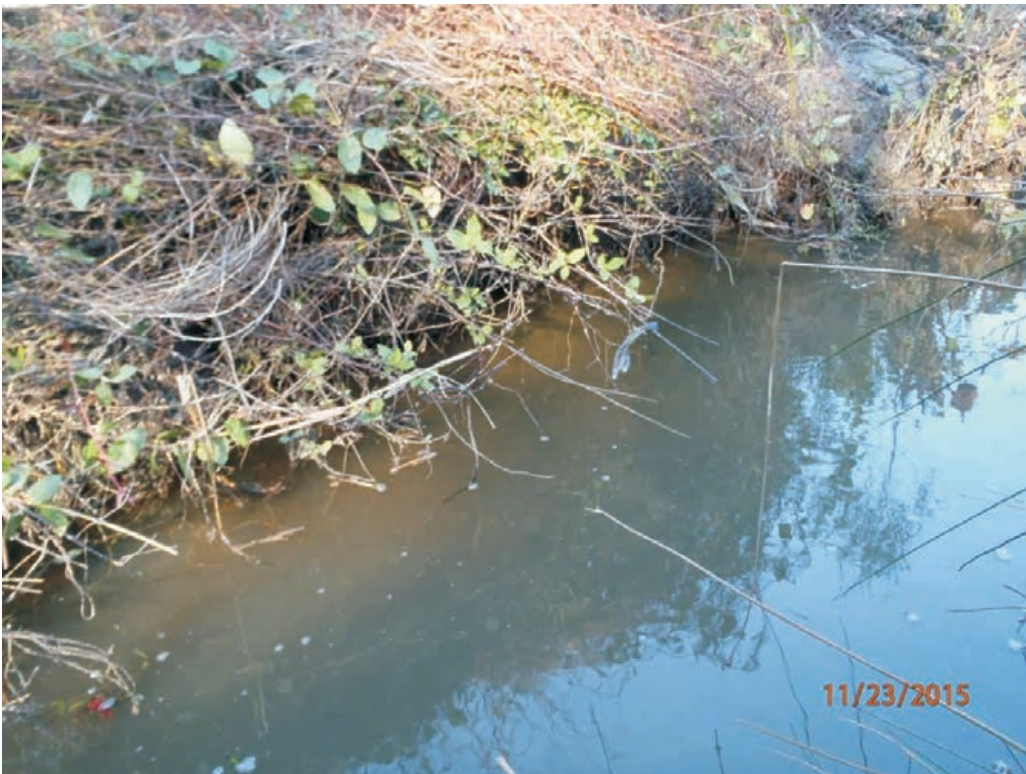
Reach 1A - Stream Problem Area #16; Bank Undercut

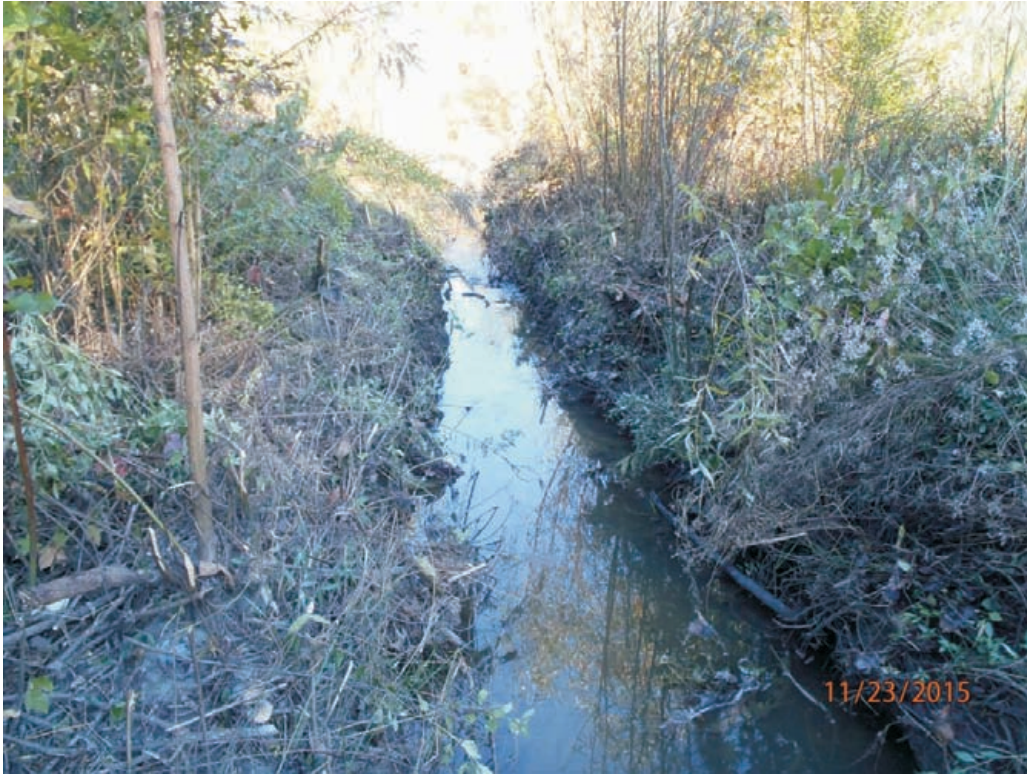
Reach 1A - Stream Problem Area #17; Degradation

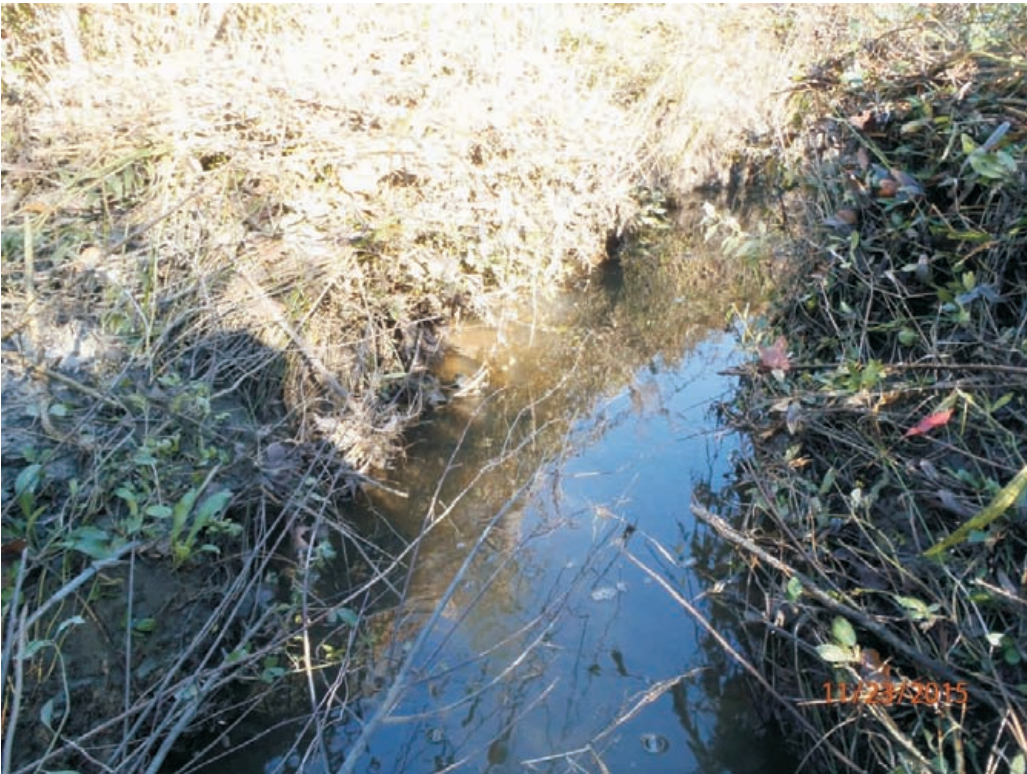
Reach 1A - Stream Problem Area #18; Scour

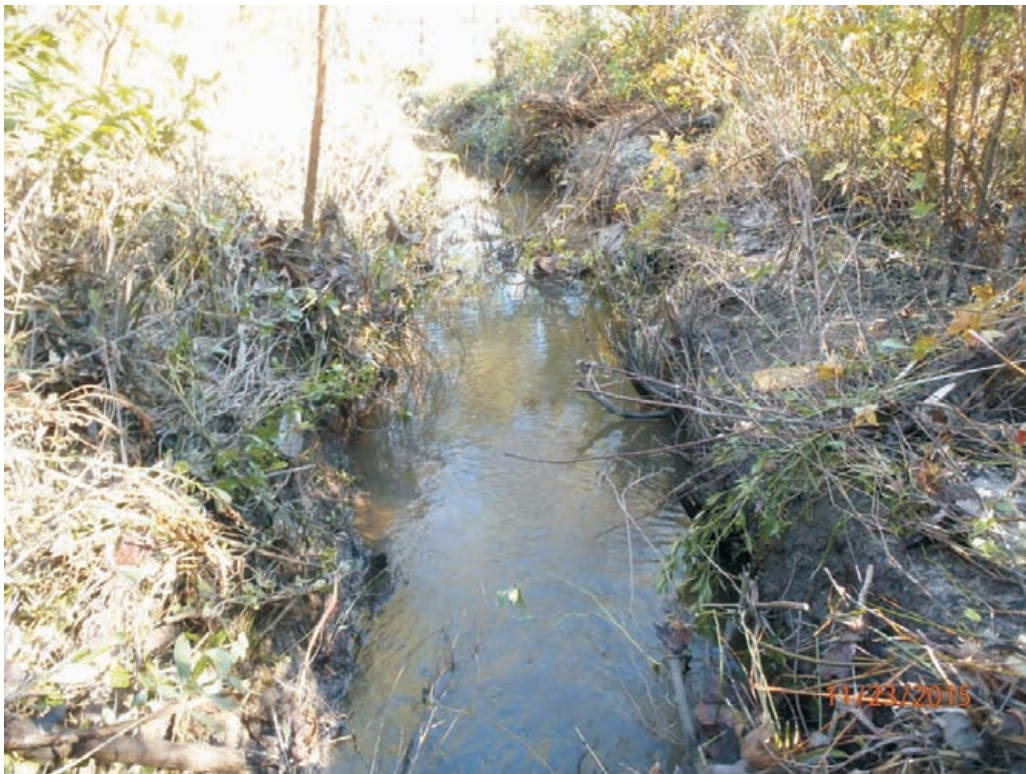
Reach 1A - Stream Problem Area #20; Degradation

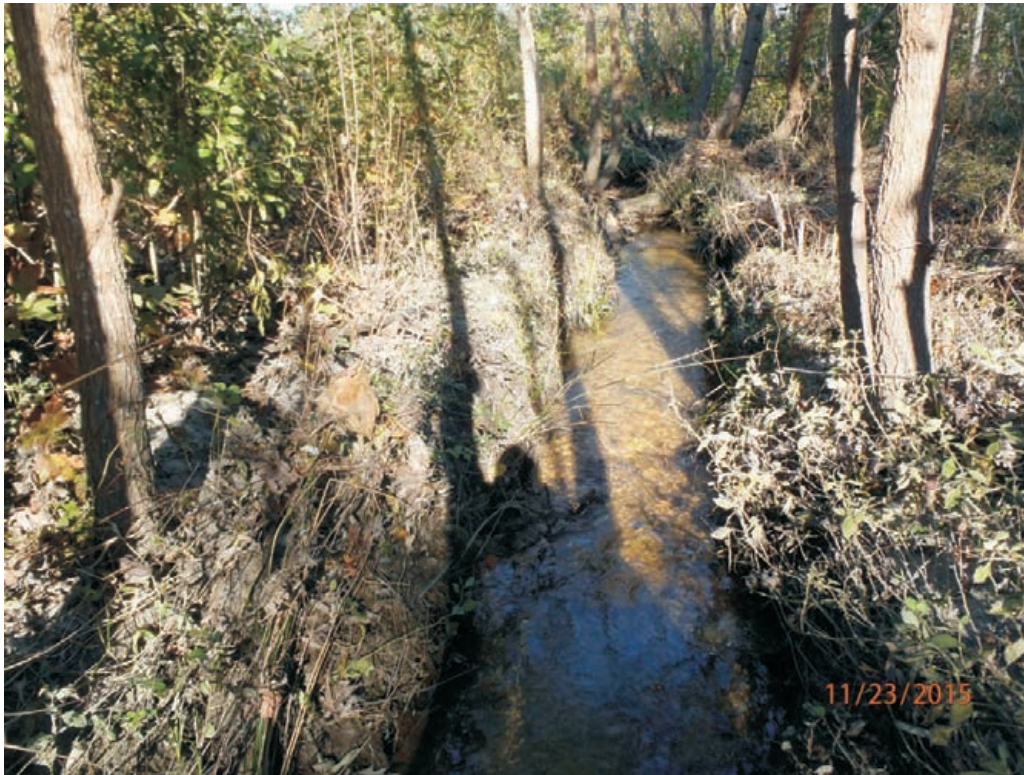
Reach 1A - Stream Problem Area #21; Degradation

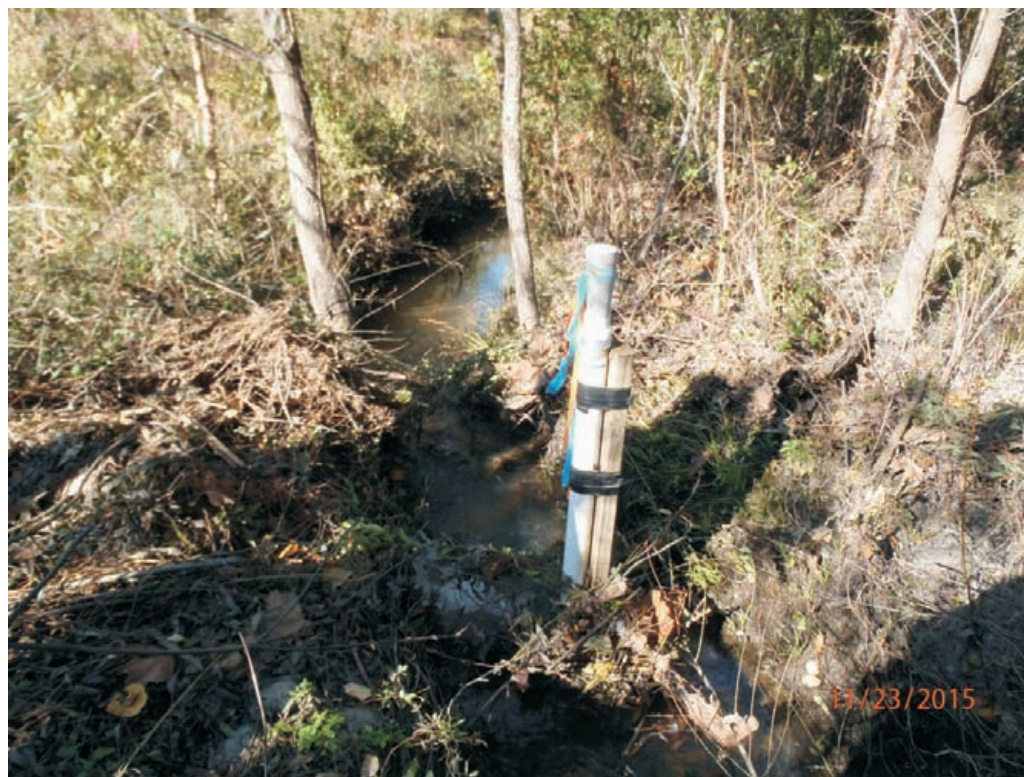
Reach 1A - Stream Problem Area #22; Degradation

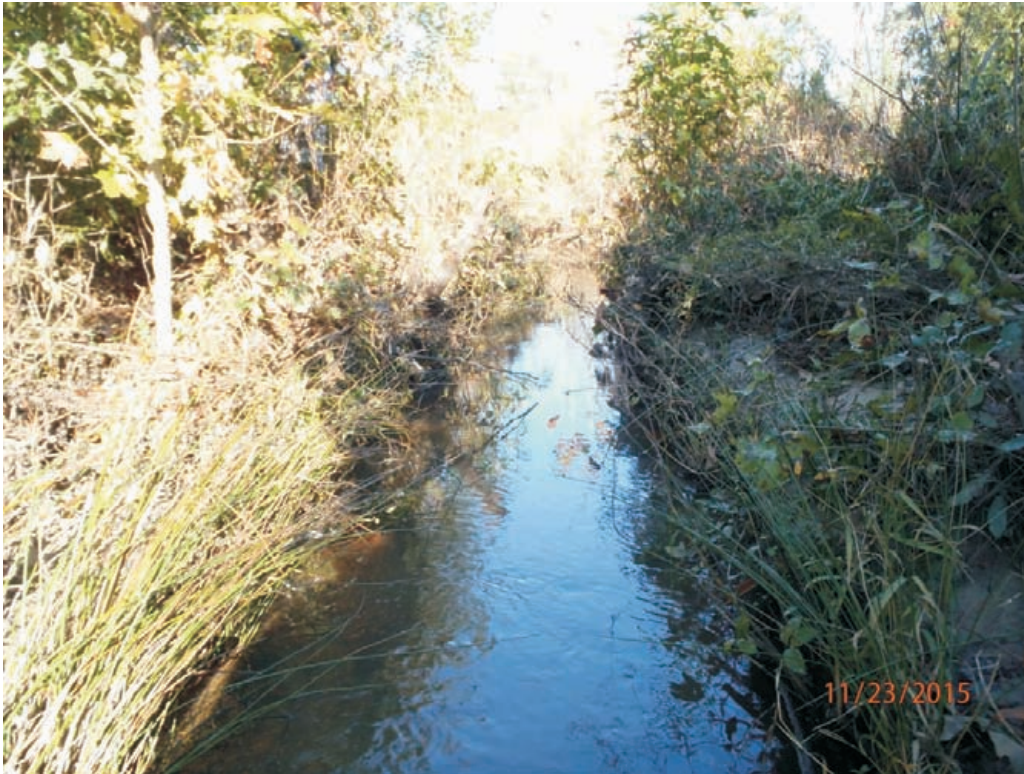
Reach 1A - Stream Problem Area #23; Degradation

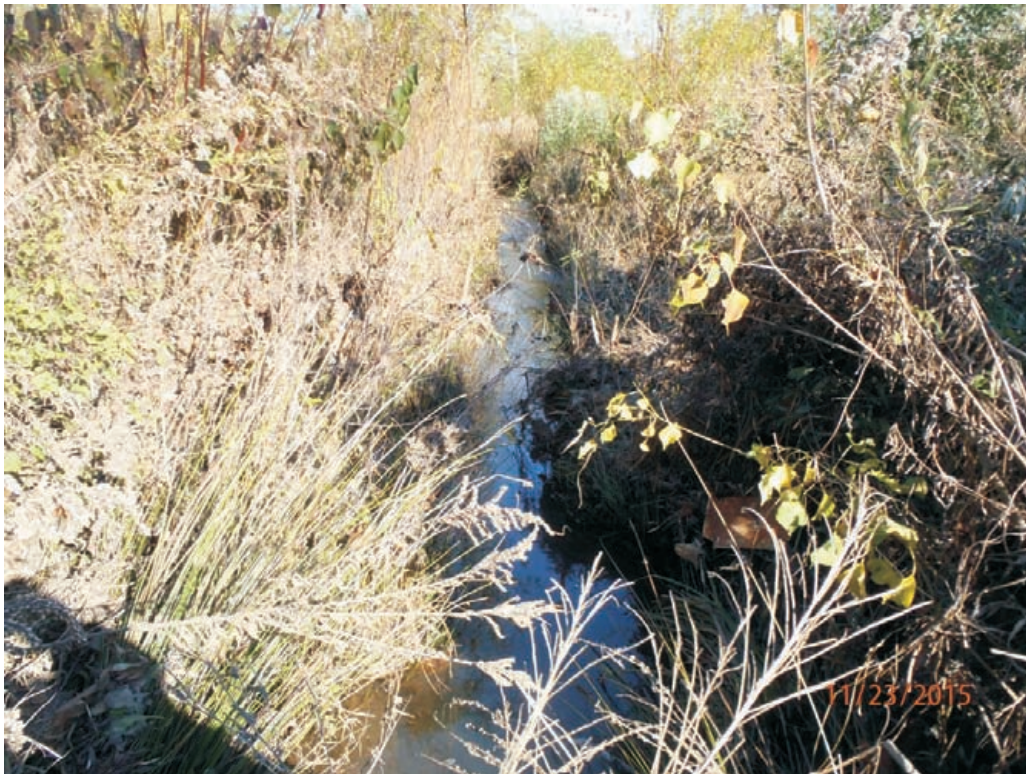
Reach 1A - Stream Problem Area #24; Degradation

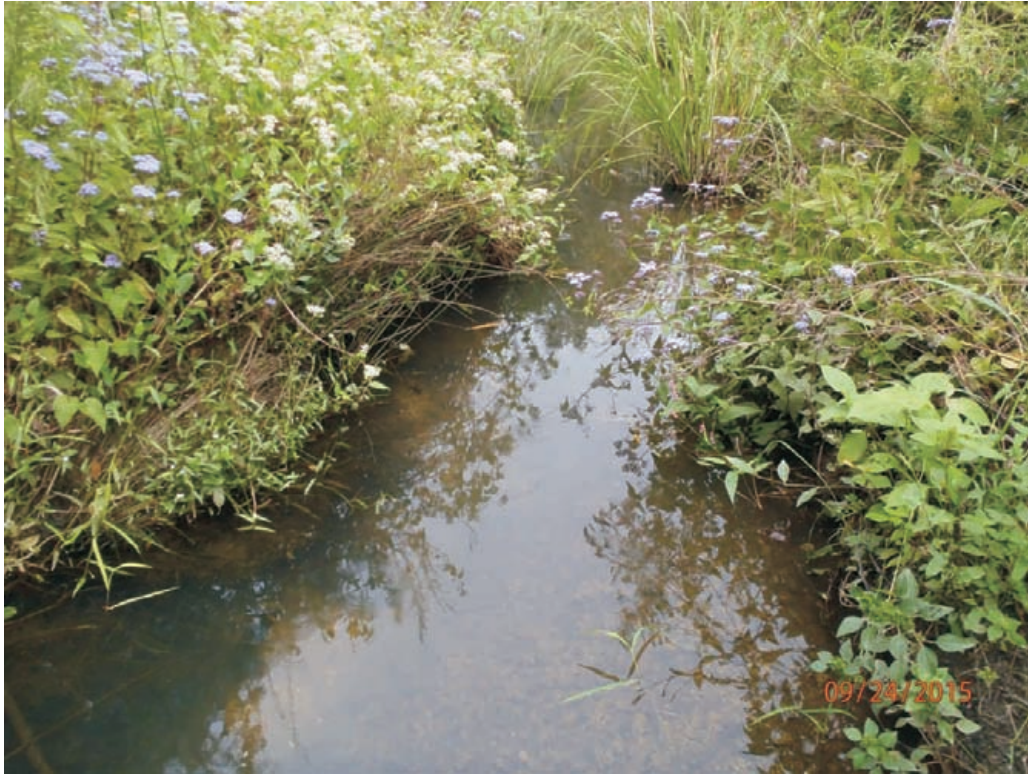
Reach 2A - Stream Problem Area #25; Degradation

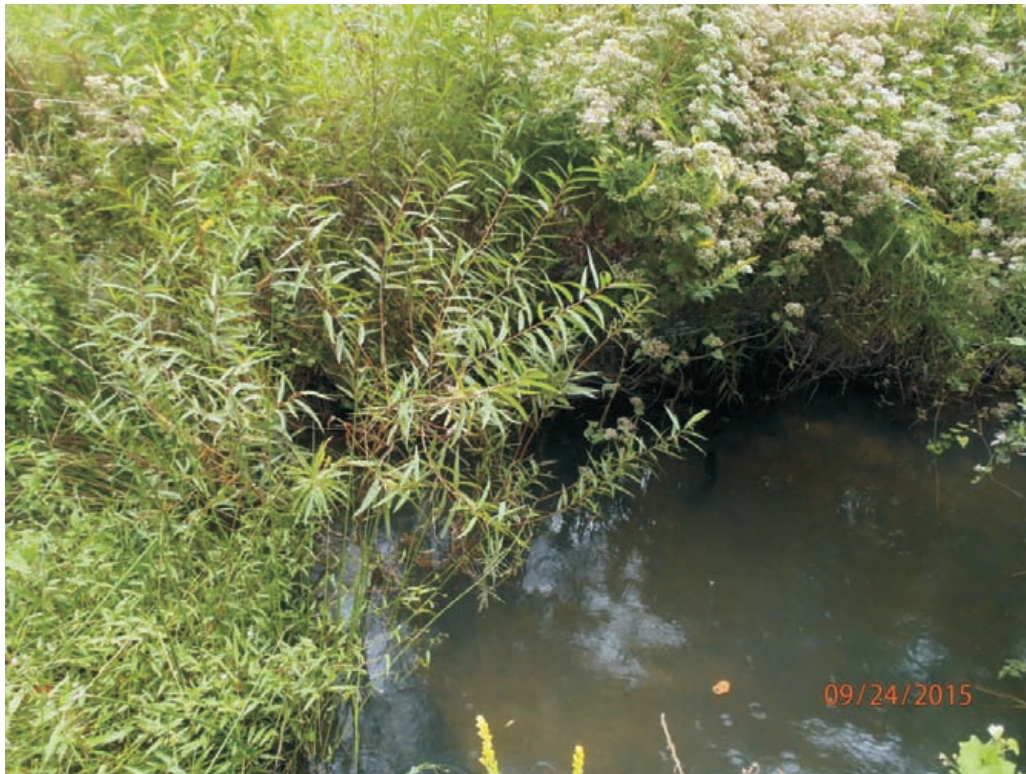
Reach 2A - Stream Problem Area #26; Scour

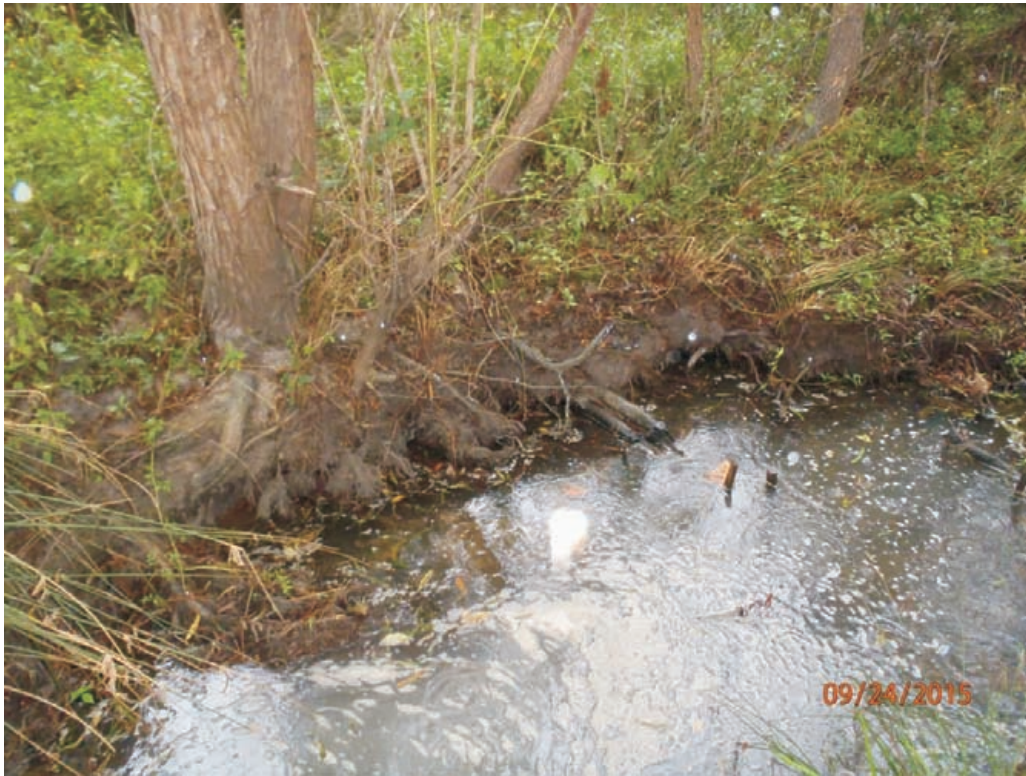
Reach 2A - Stream Problem Area #27; Undercut

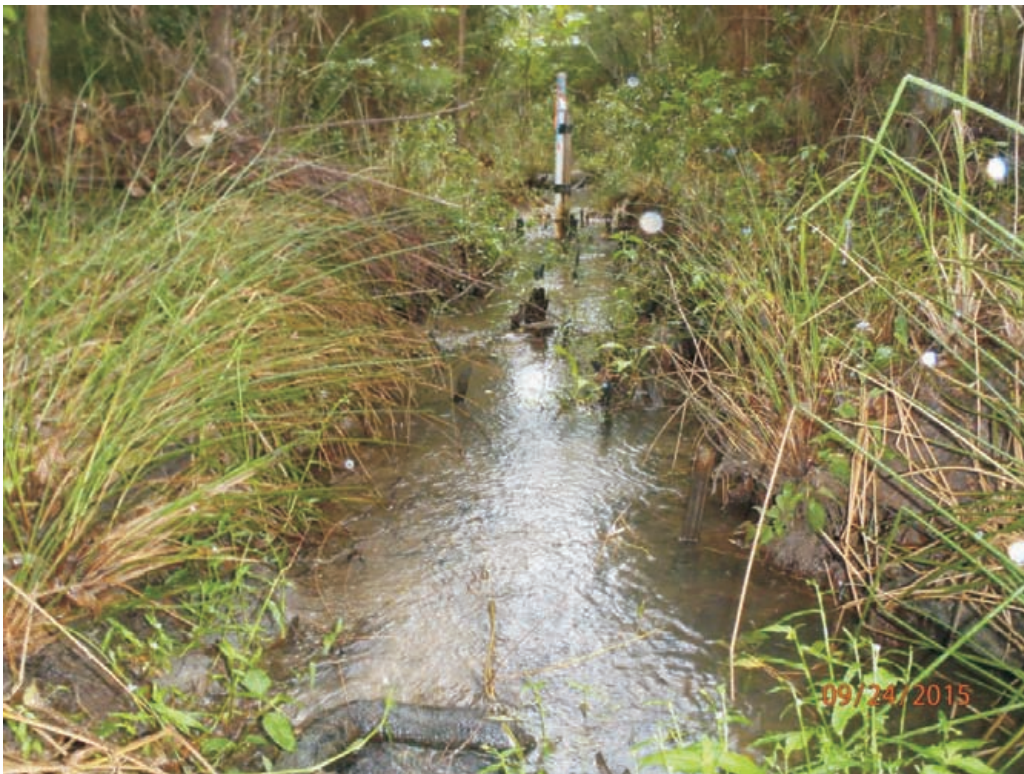
Reach 2A - Stream Problem Area #28: Degradation

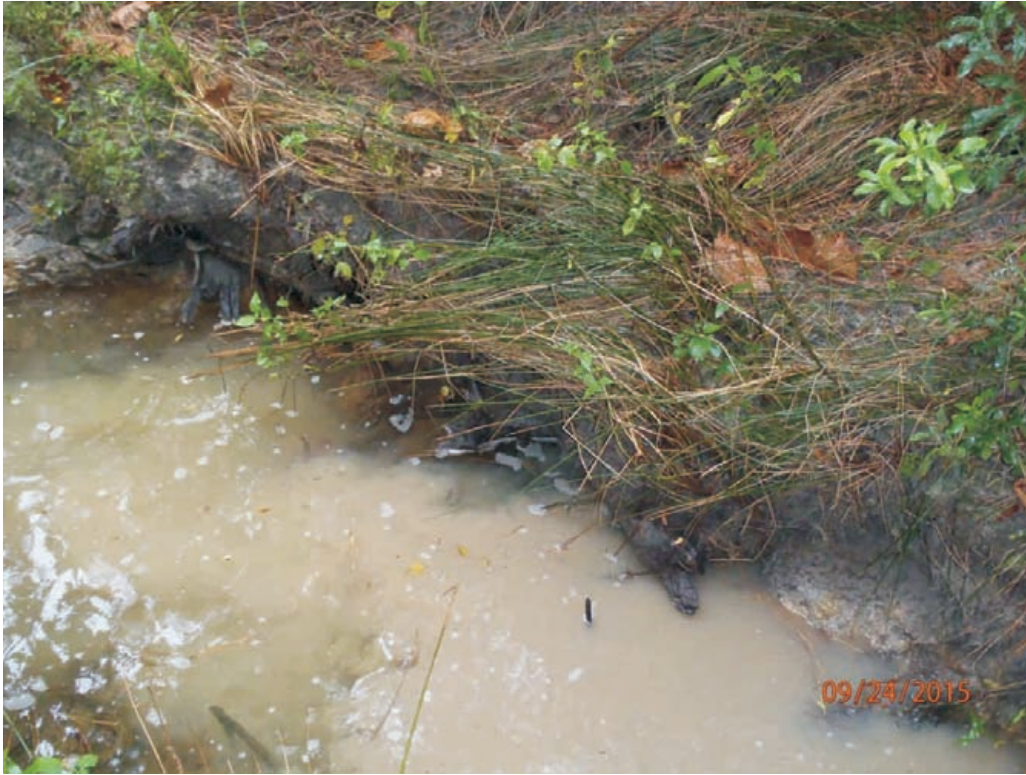
Reach 2A - Stream Problem Area #29; Scour

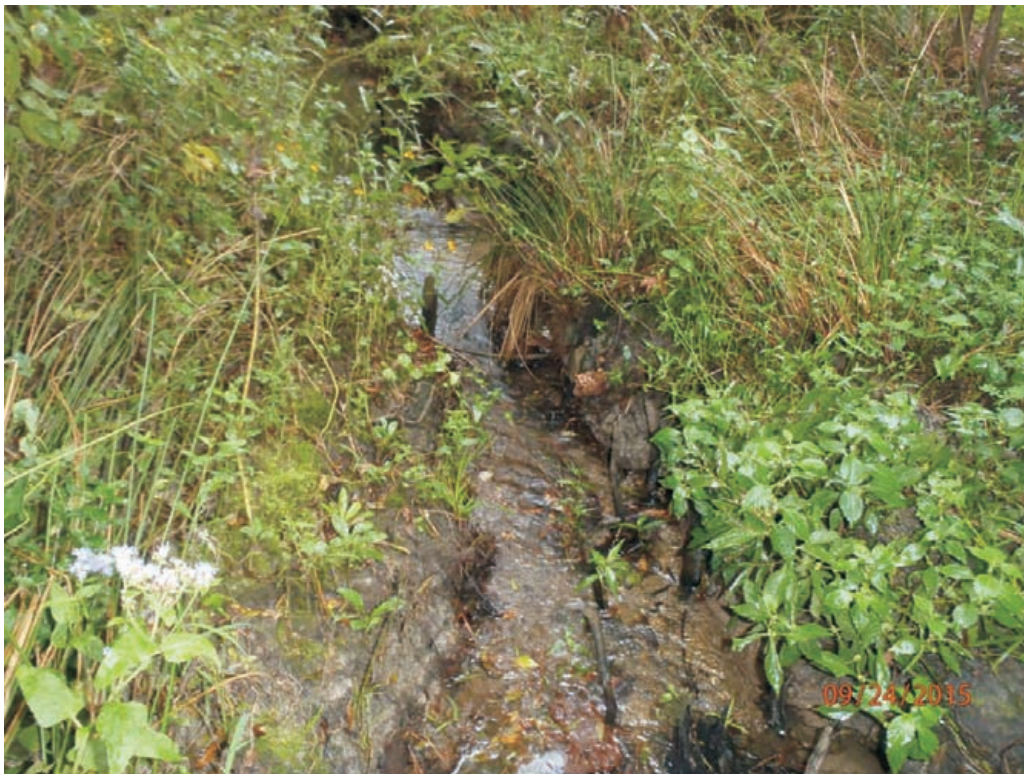
Reach 2A - Stream Problem Area #32; Degradation

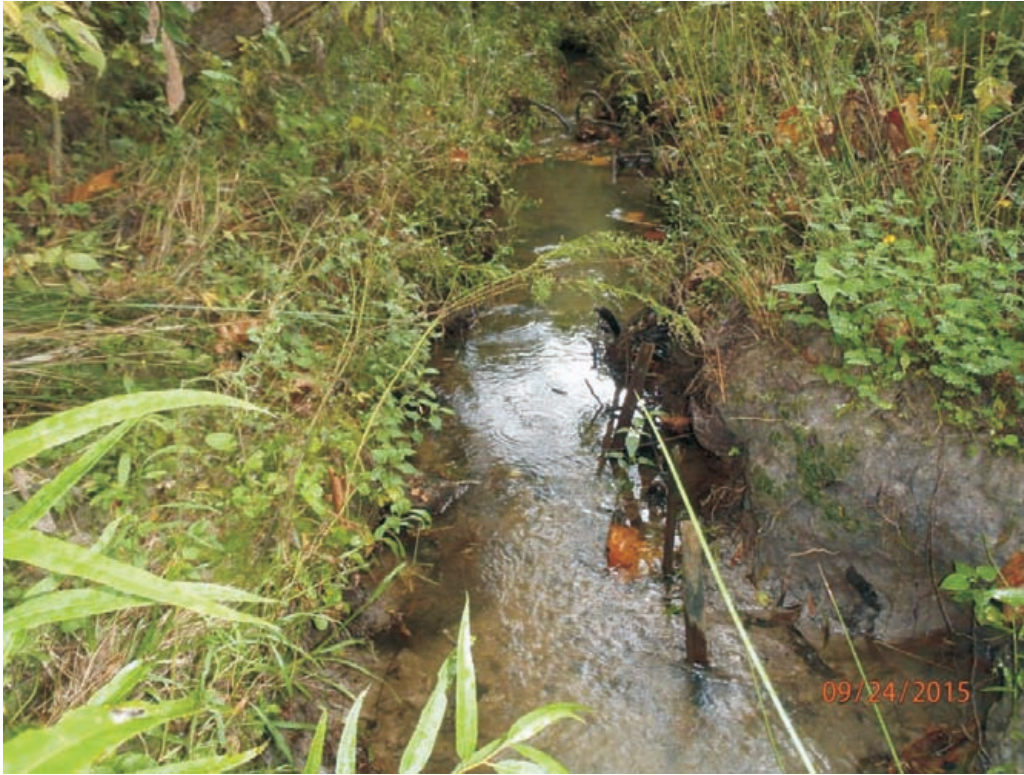
Reach 2A - Stream Problem Area #33; Scour

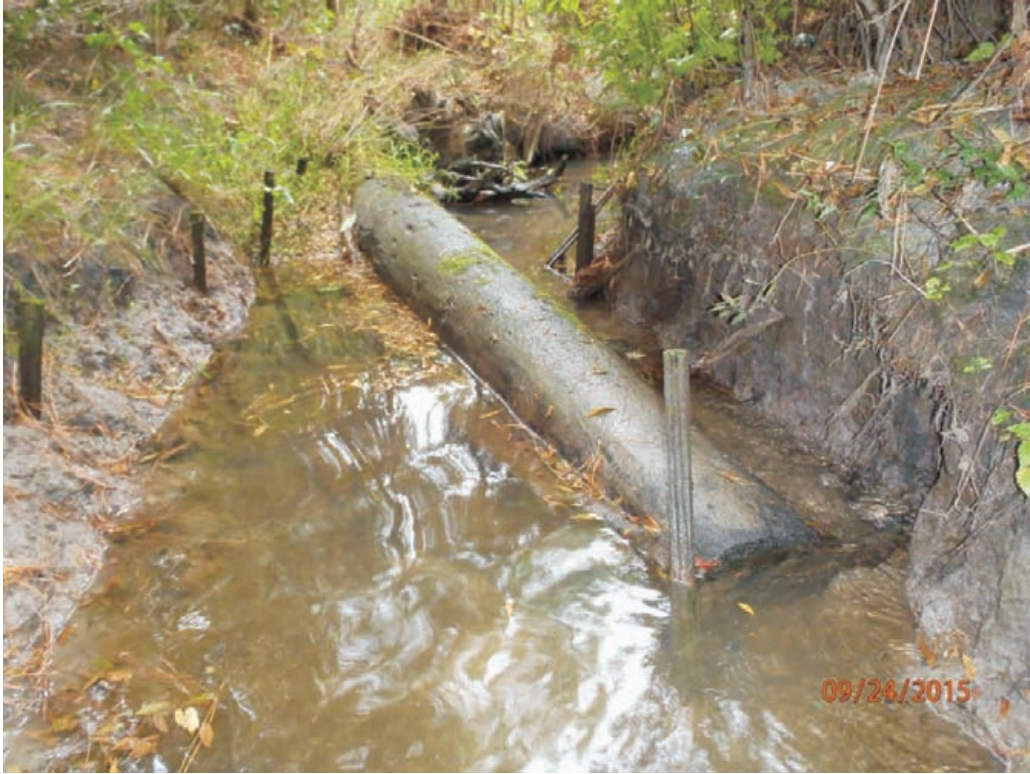
Reach 2A - Stream Problem Area #35; Log Vane Mass Wasting
