Jacksonville Country Club Stream Restoration and Enhancement Project

**SCO No. 070715501
DEQ Contract No. D08049S
DMS Project No. 194
Action ID# 2006-40325-067
Onslow County, North Carolina**

**Year 2 of 5 Monitoring Report
Data Collection: January through December 2015
Submission Date: April 13, 2016**

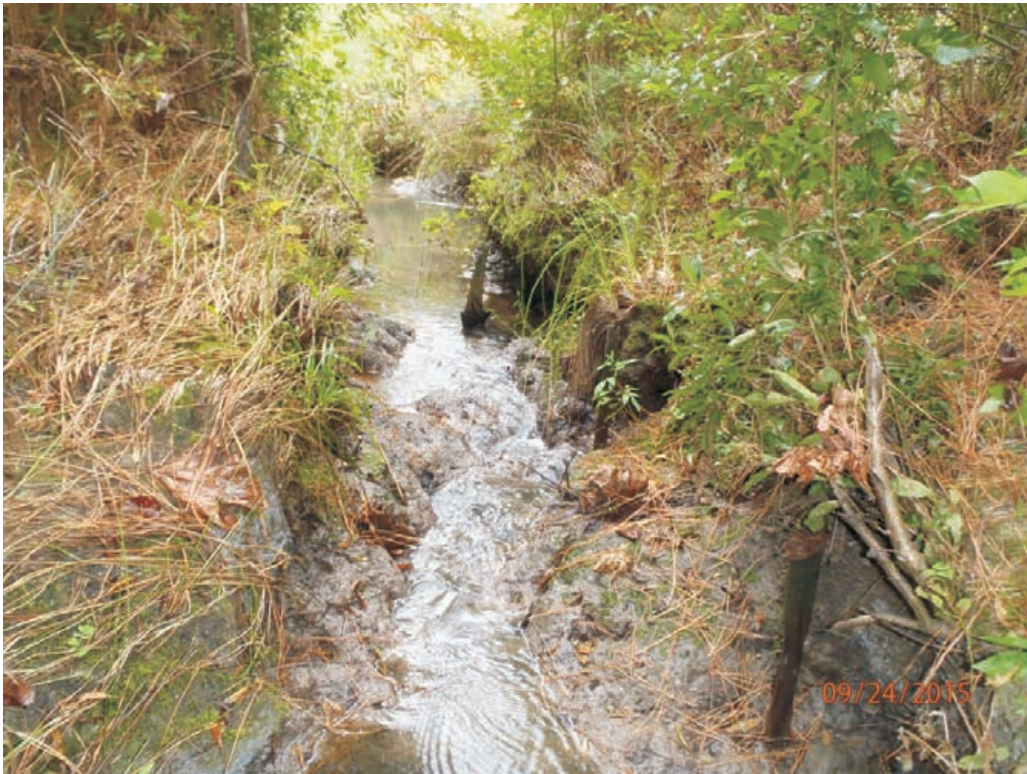
Reach 2A - Stream Problem Area #36; Degradation

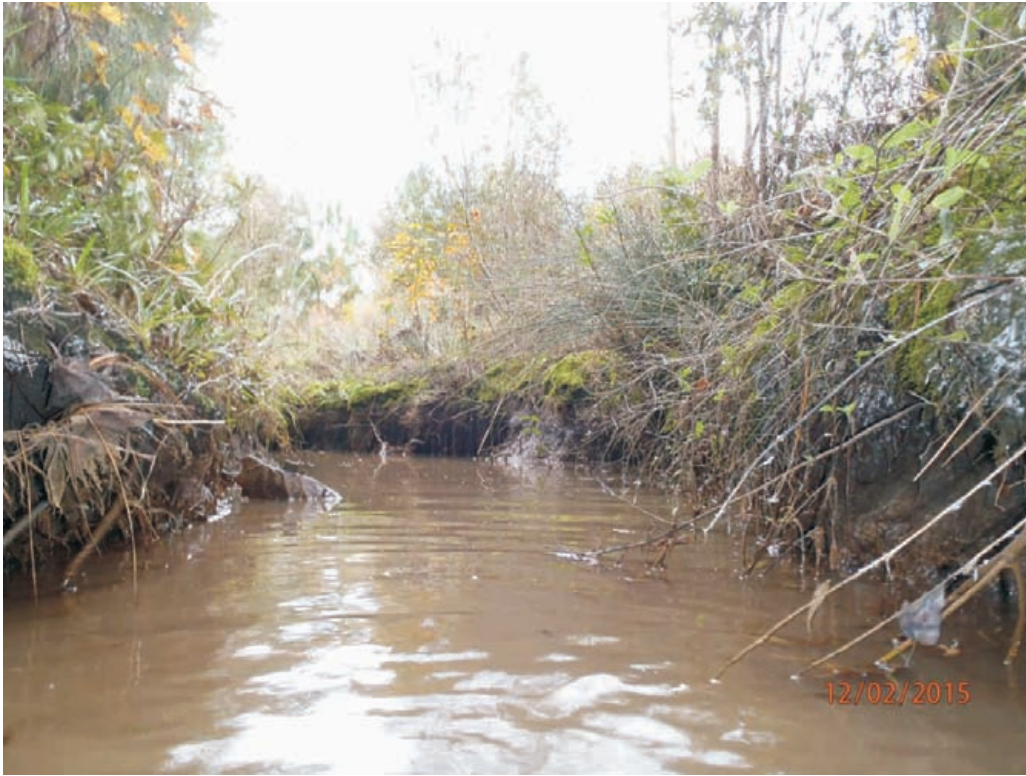
Reach 2A - Stream Problem Area #37; Undercut

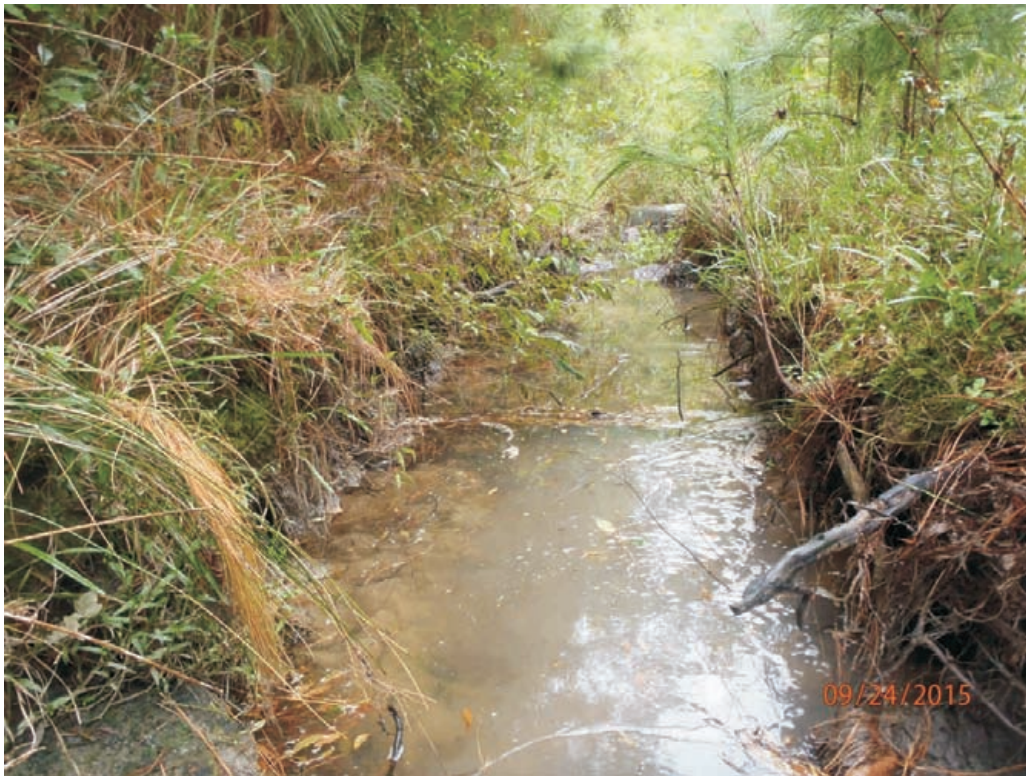
Reach 2A - Stream Problem Area #38; Degradation

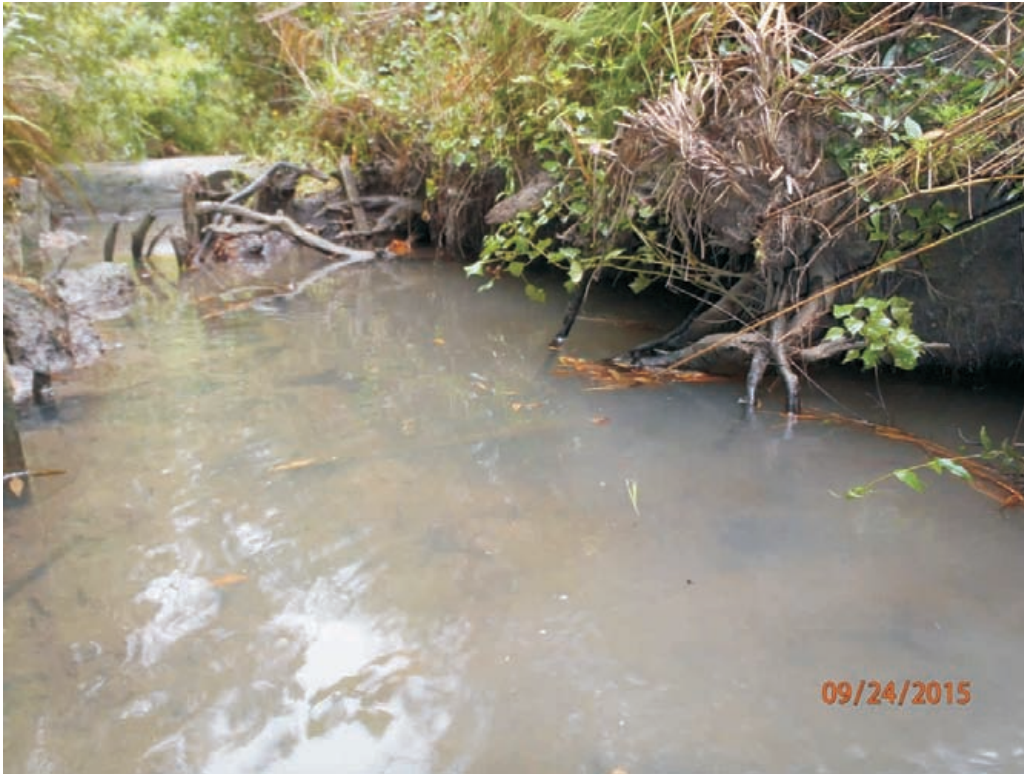
Reach 2A - Stream Problem Area #39; Undercut

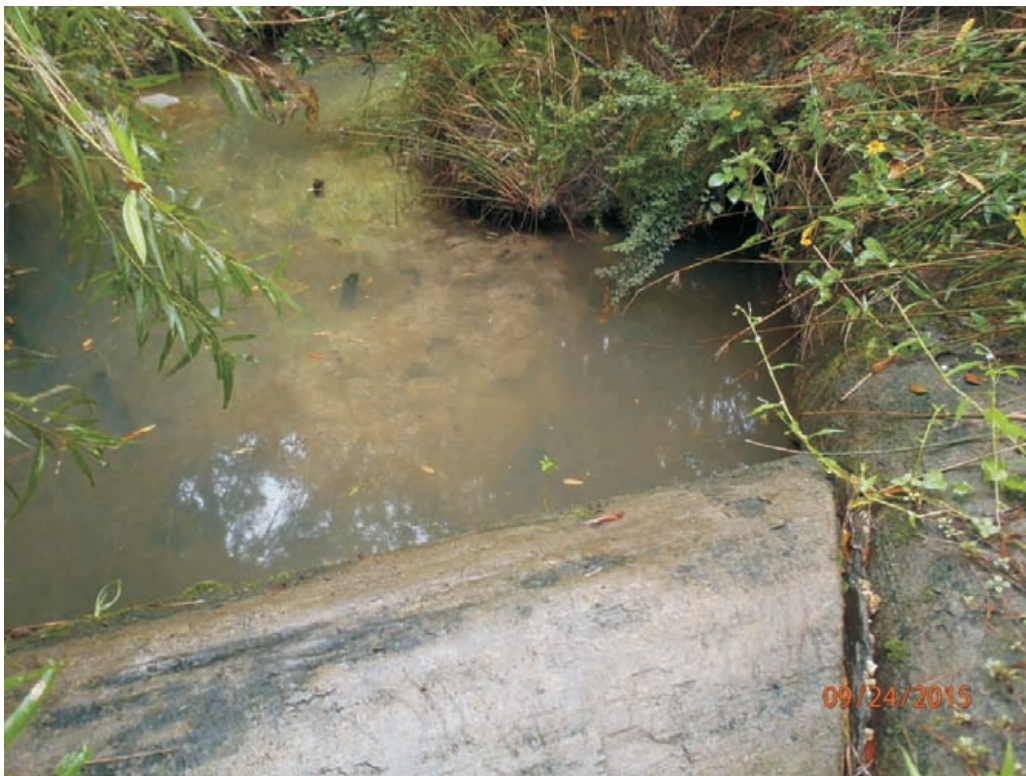
Reach 2A - Stream Problem Area #40; Log Vane Scour

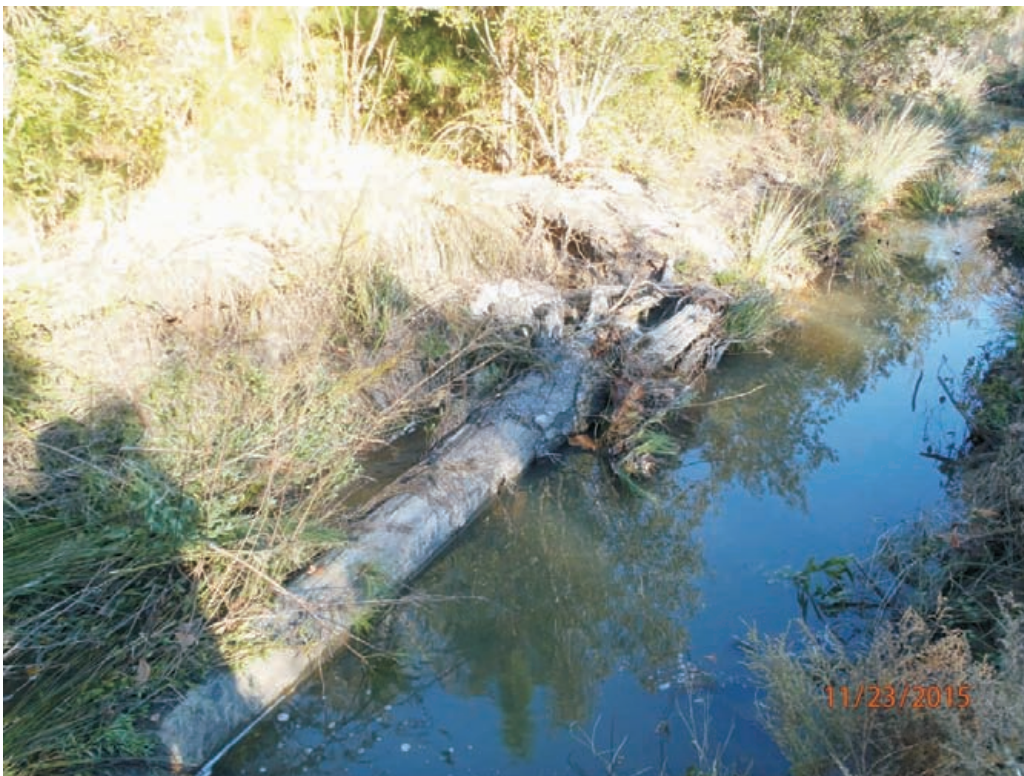
Reach 2A - Stream Problem Area #42; Mass Wasting

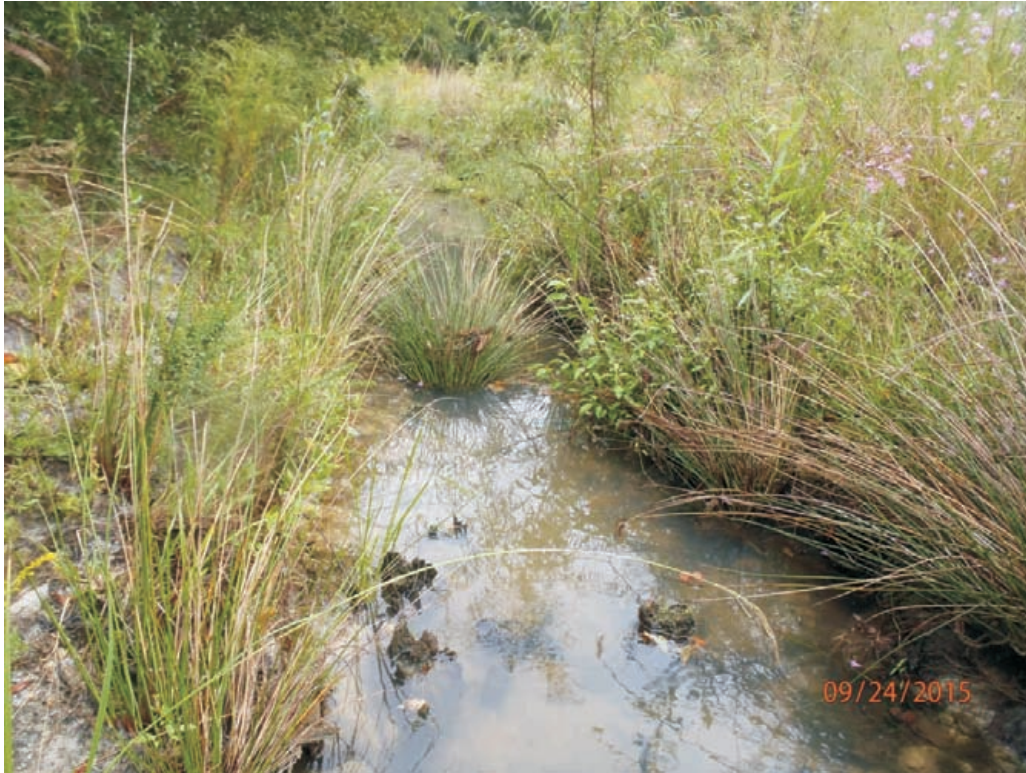
Reach 2A - Stream Problem Area #43; Degradation

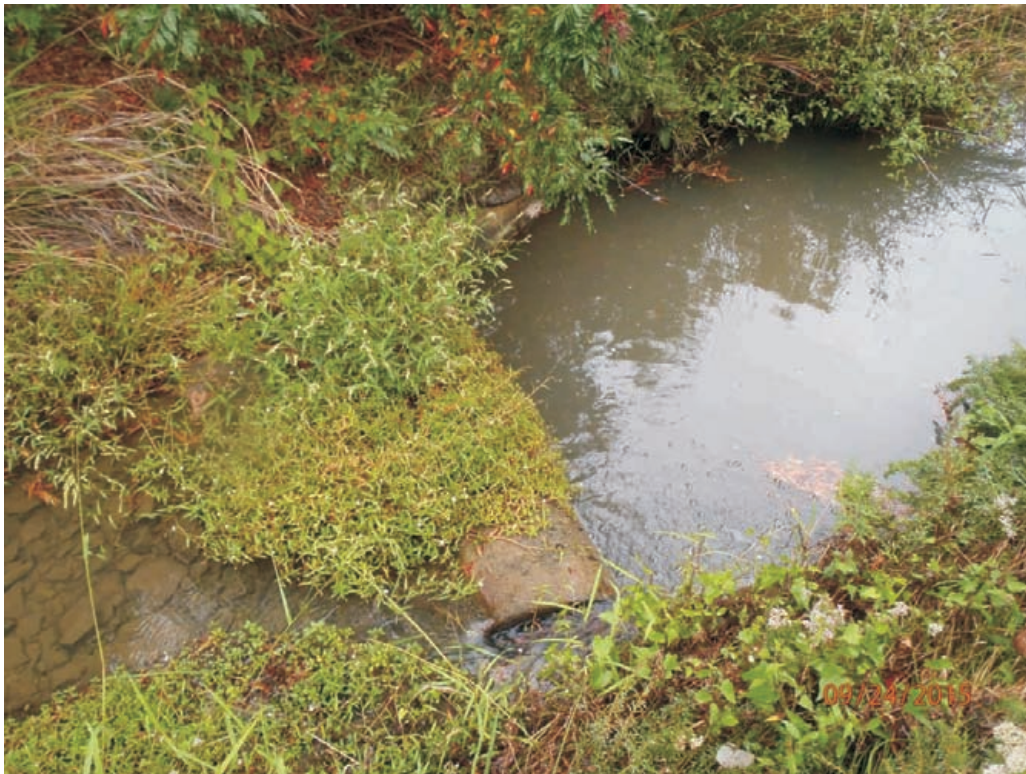
Reach 2A - Stream Problem Area #44; Log Vane Scour

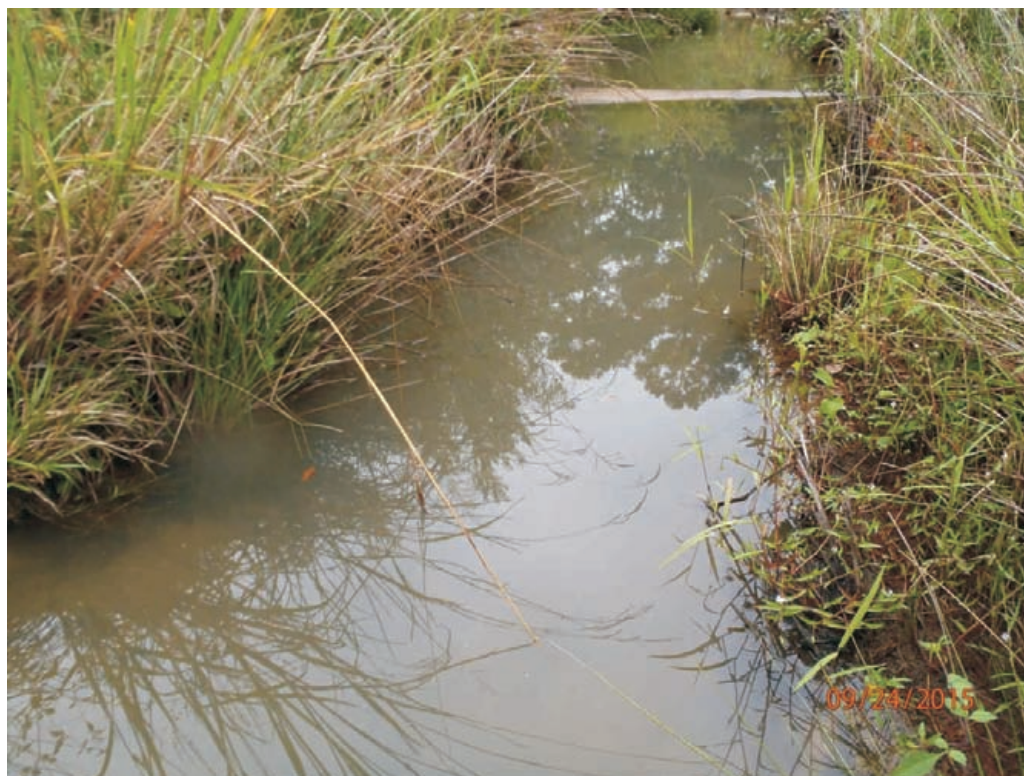
Reach 2A - Stream Problem Area #46; Degradation

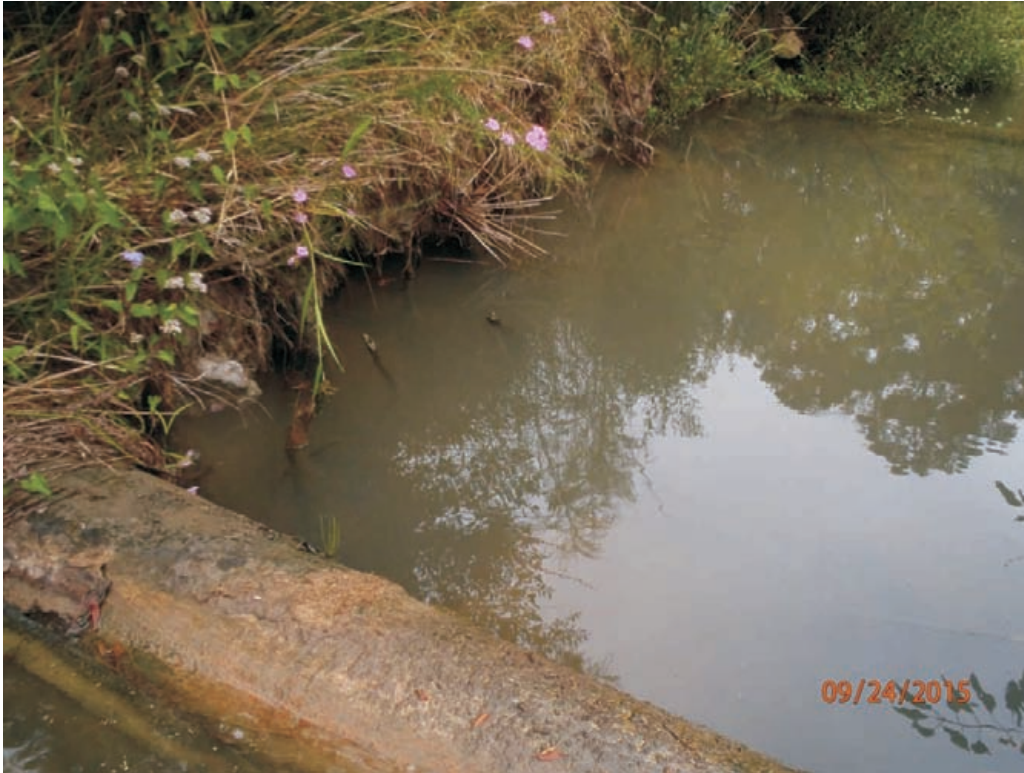
Reach 2A - Stream Problem Area #47; Log Vane Scour

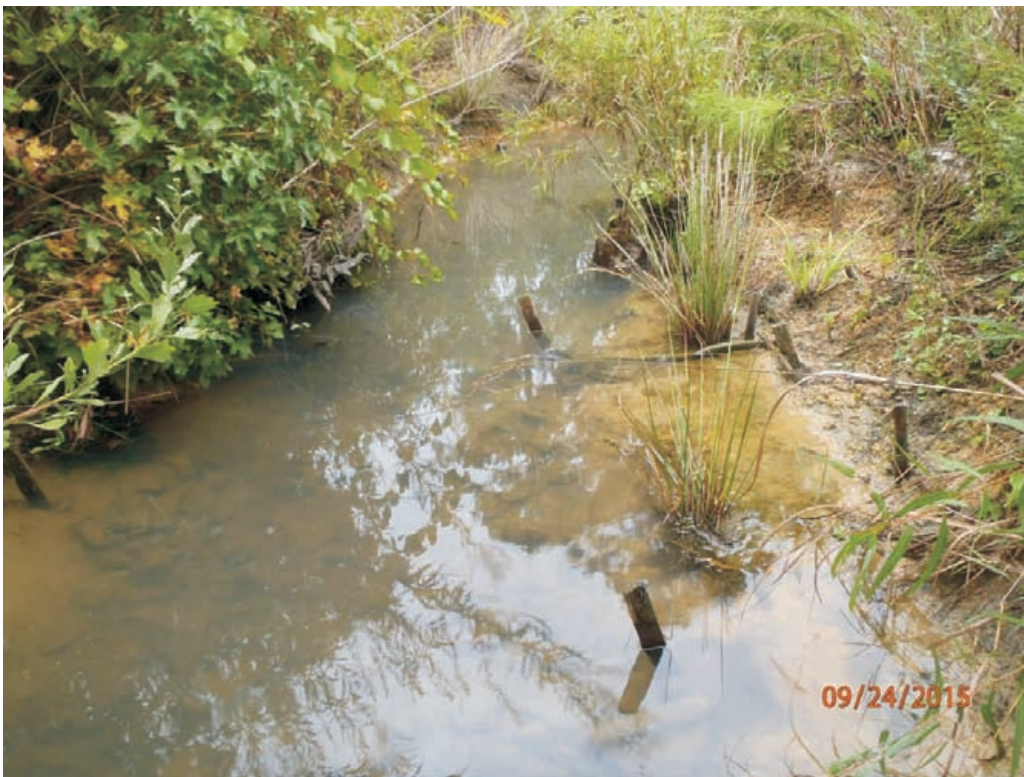
Reach 2A - Stream Problem Area #48; Scour

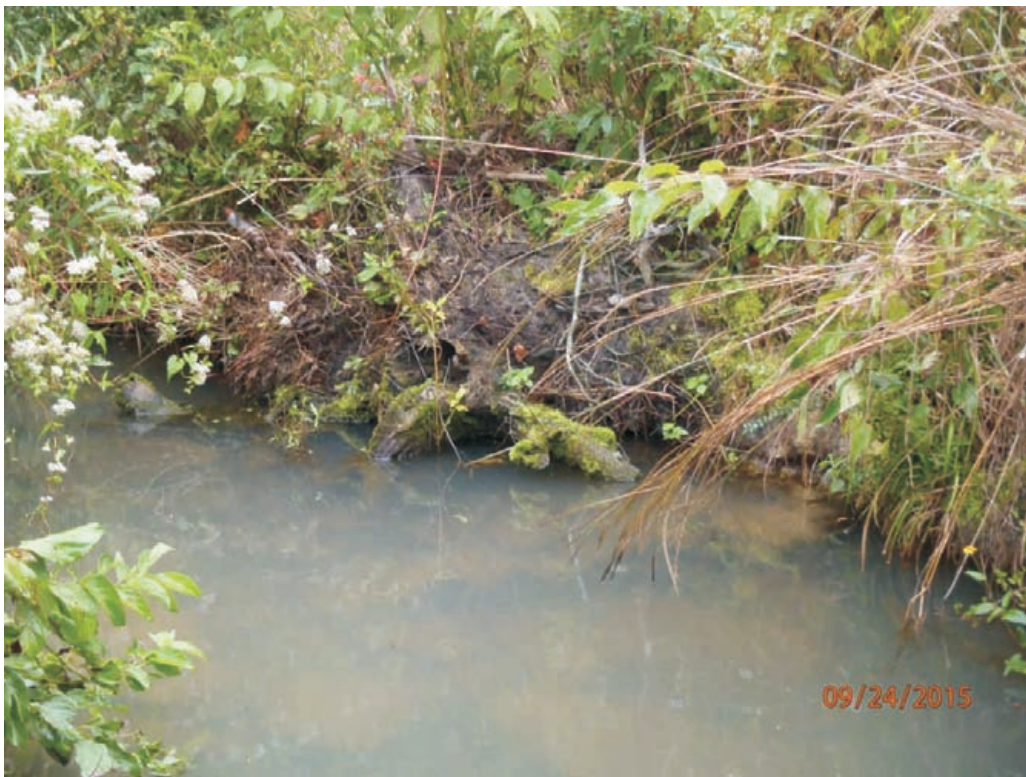
Reach 2A - Stream Problem Area #50; Undercut

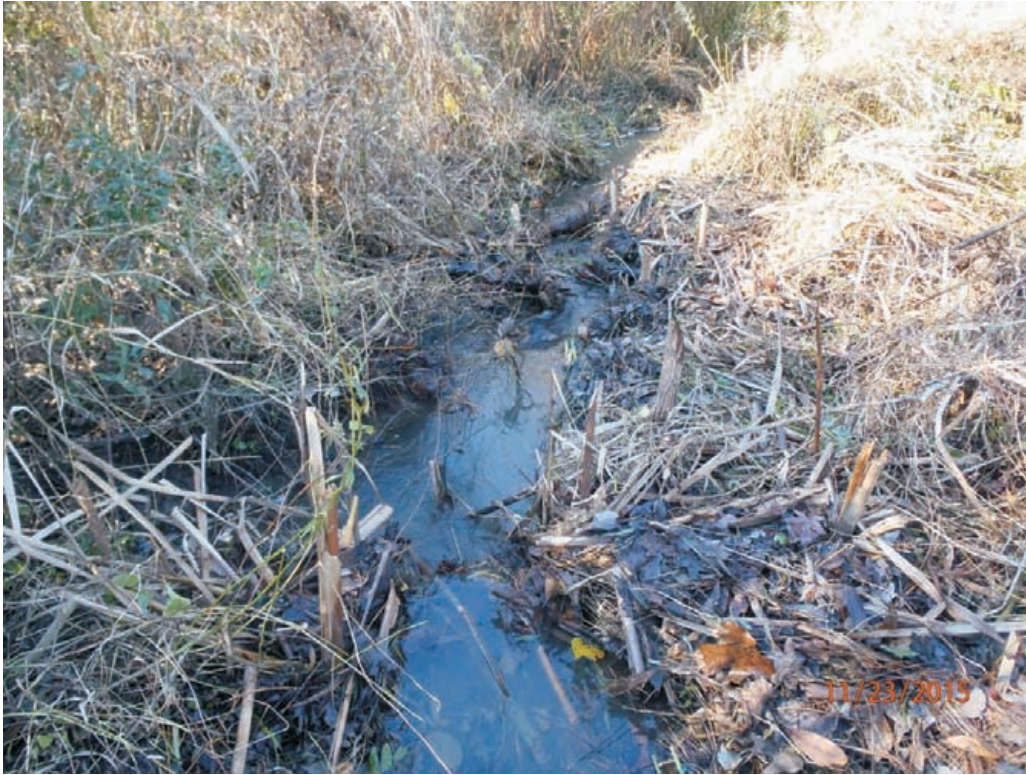
As observed during the baseline and MY1 monitoring, some water was bypassing the constructed channel and forming another, more direct route to the main channel (Pt 51). This was again classified as aggradation. Additionally, two bank undercuts, one area of degradation, and one area of mass wasting were noted within this reach. Several grade controls features were not observed and it was assumed that they have been buried by sediment. However, the stream appeared to be functioning properly in these areas.

Reach B - Stream Problem Area #51; Aggradation

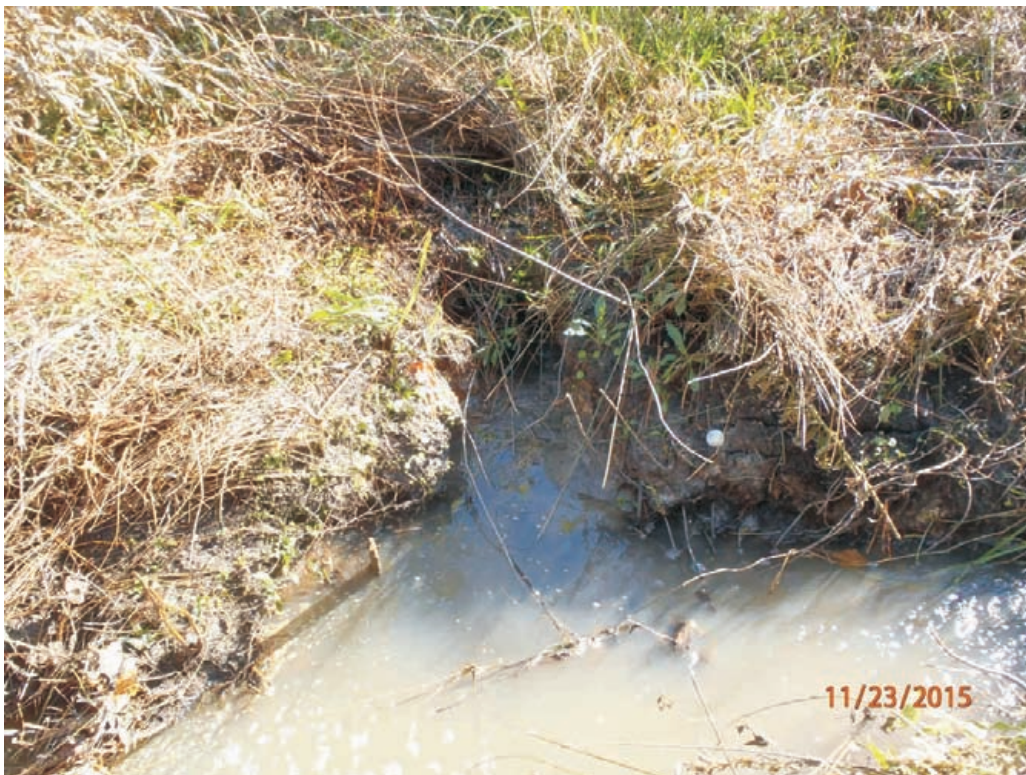
Reach B - Stream Problem Area #52; Mass Wasting

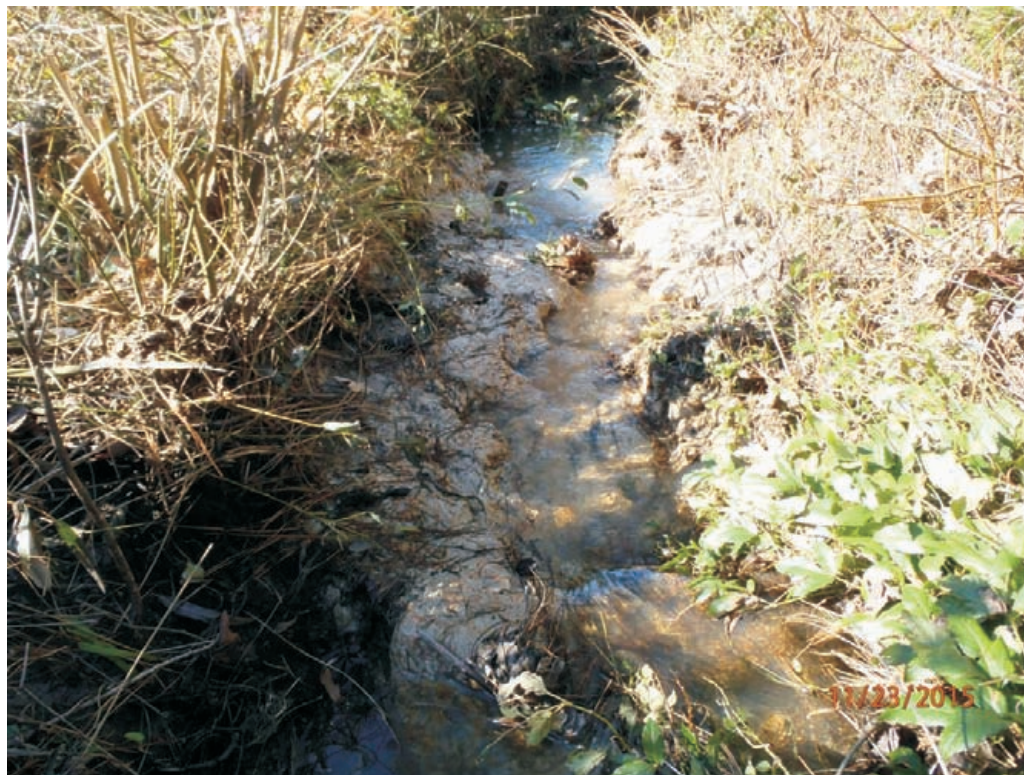
Reach B - Stream Problem Area #54; Degradation

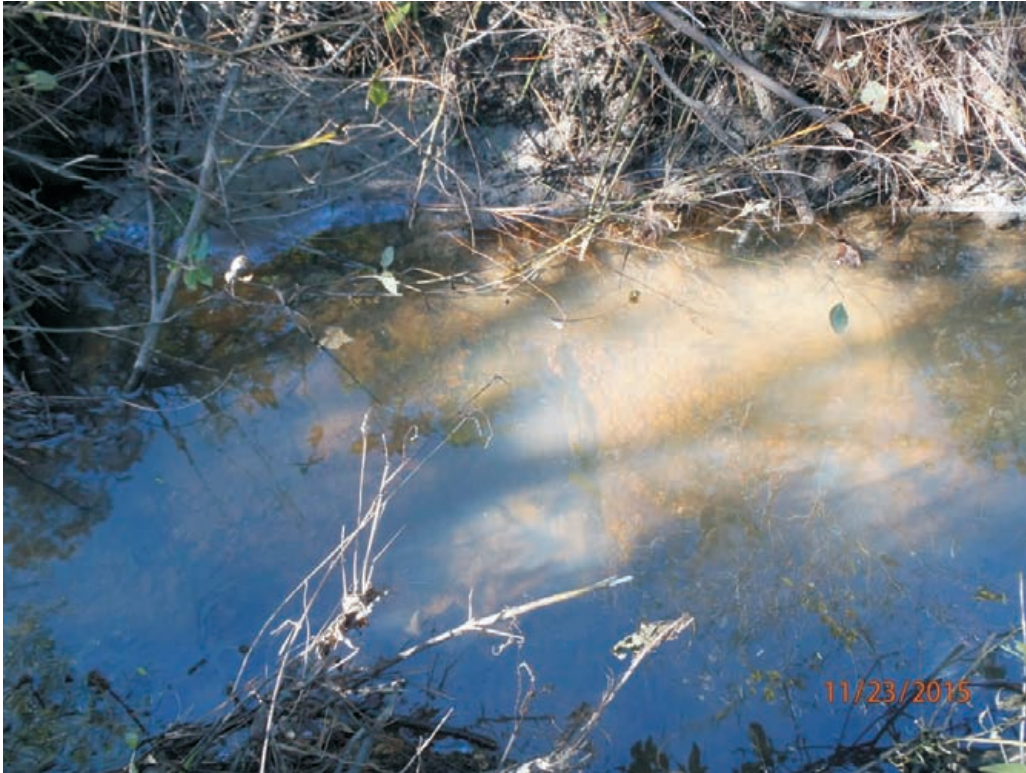
Reach B - Stream Problem Area #55; Undercut

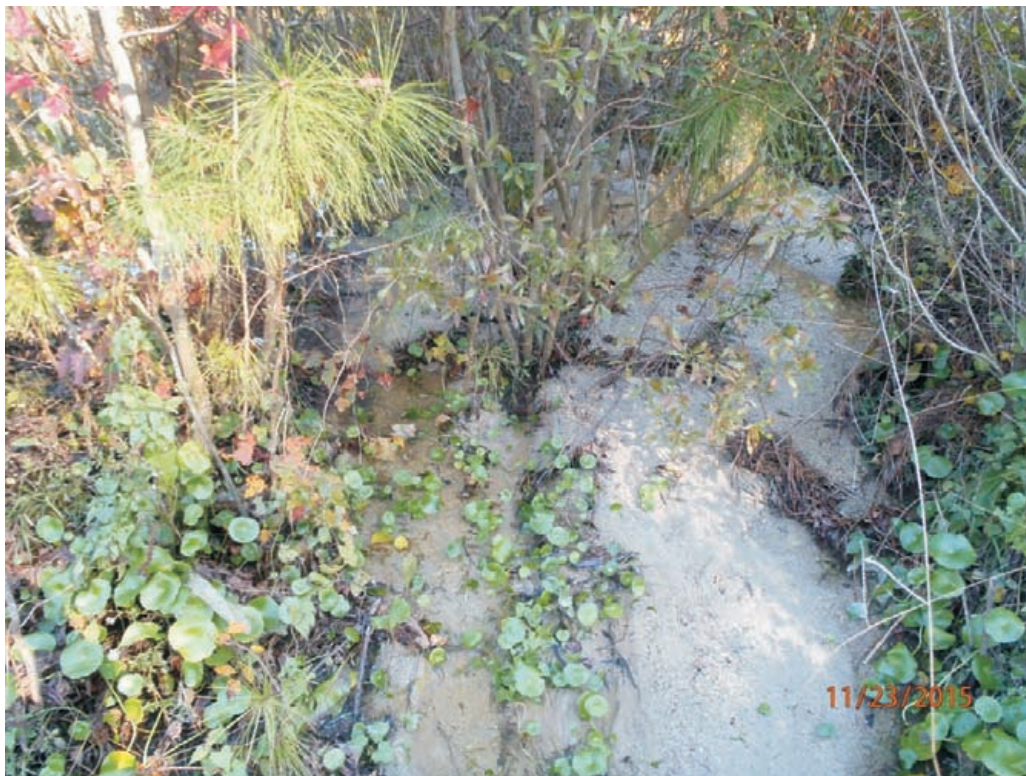
The enhancement reach is a small channel and it contains a great deal of vegetative debris. Two areas of aggradation were also noted within this channel.

Enhancement Reach - Stream Problem Area #56; Aggradation
