Jacksonville Country Club Stream Restoration and Enhancement Project

**SCO No. 070715501
DEQ Contract No. D08049S
DMS Project No. 194
Action ID# 2006-40325-067
Onslow County, North Carolina**

**Year 3 of 5 Monitoring Report
Data Collection: January through December 2016
Submission Date: February 9, 2017**

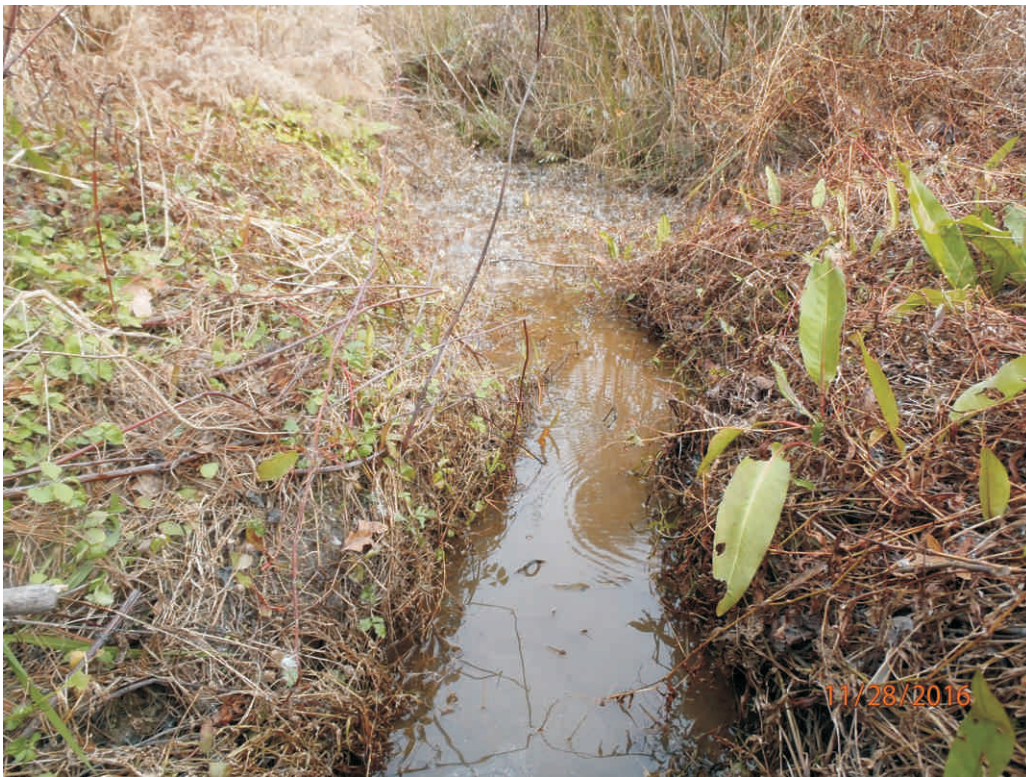
Reach 1A - Stream Problem Area 1; Aggradation; New Channel Continues to Form

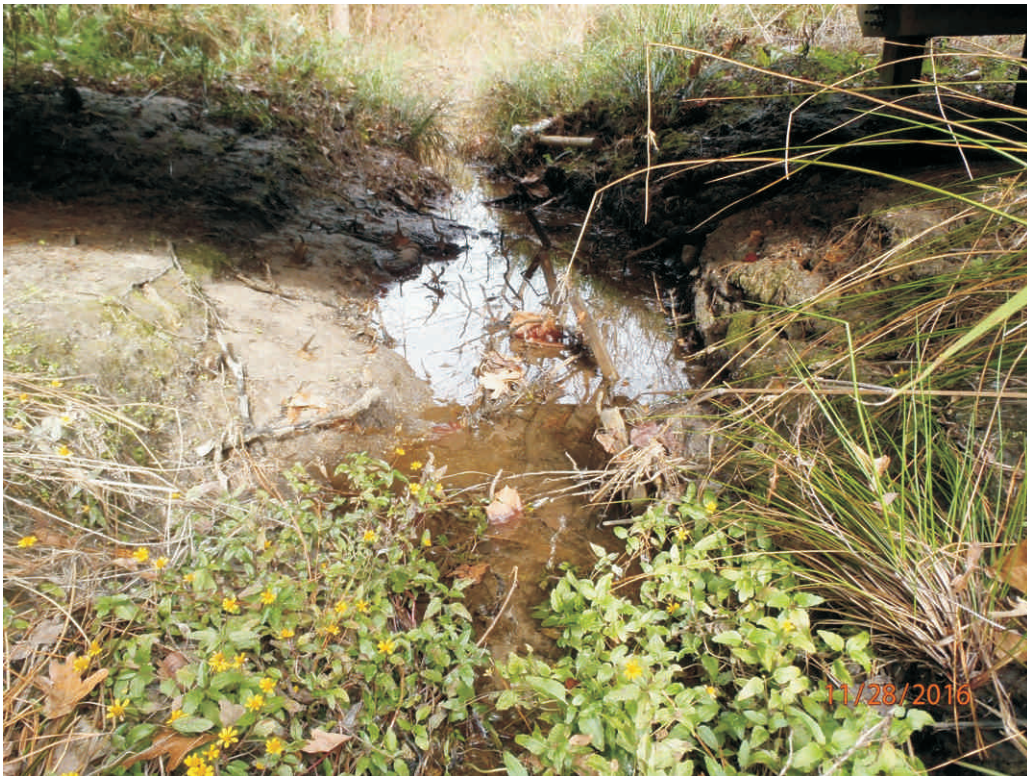
Reach 1A - Stream Problem Area #5; bank undercut becoming scour

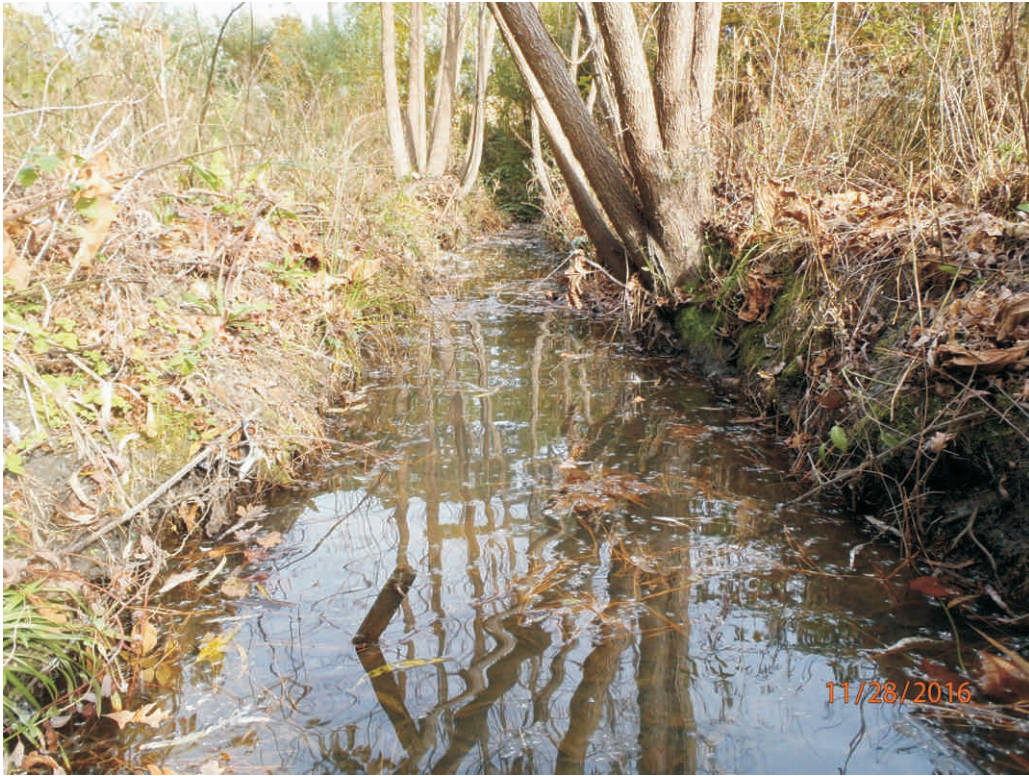
Reach 1A - Stream Problem Area #7; degradation

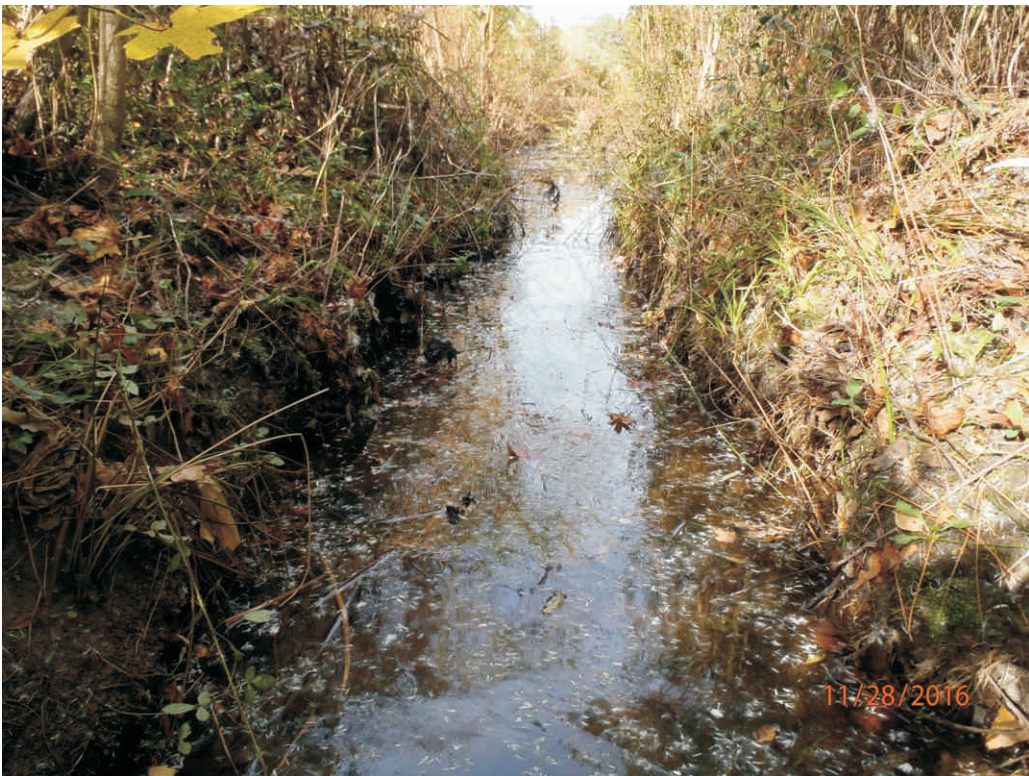
Reach 1A - Stream Problem Area #8; degradation

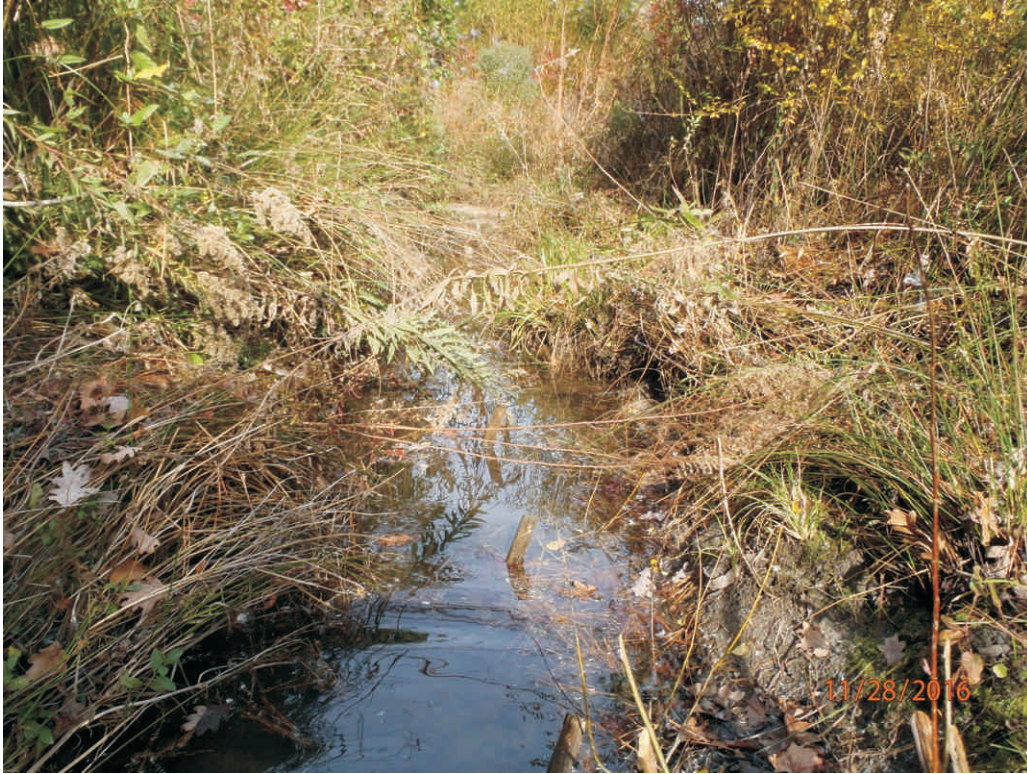
Reach 1A - Stream Problem Area #9; Degradation

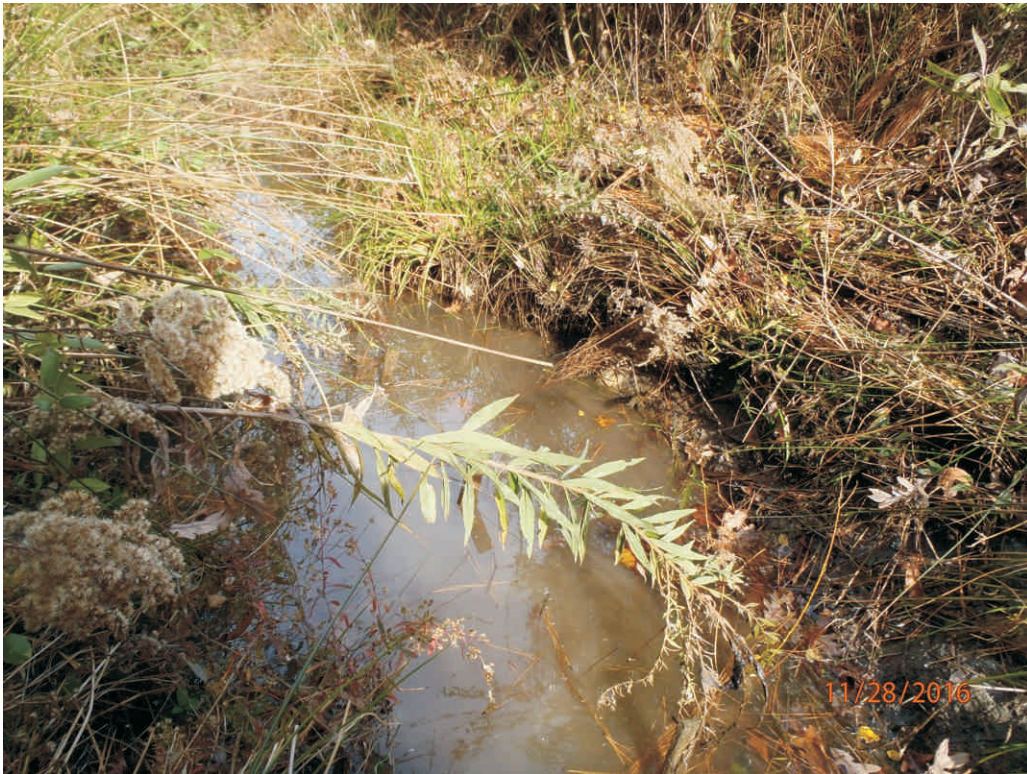
Reach 1A - Stream Problem Area #10; Log Vane Undercut becoming scour

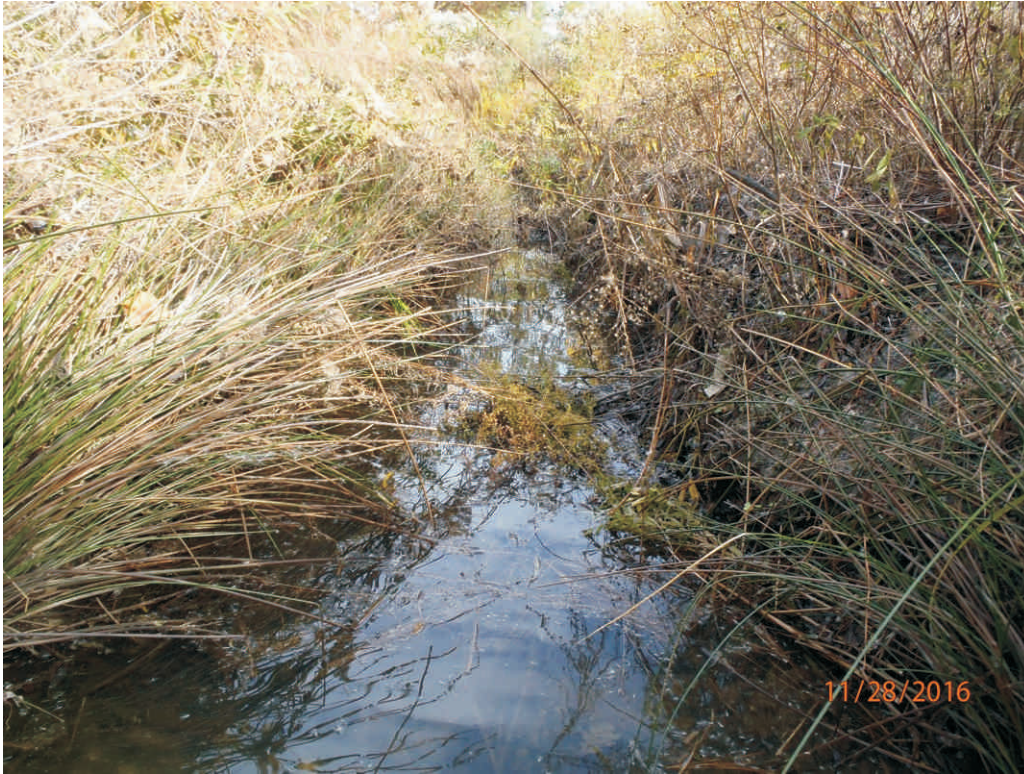
Reach 1A - Stream Problem Area #13; Degradation

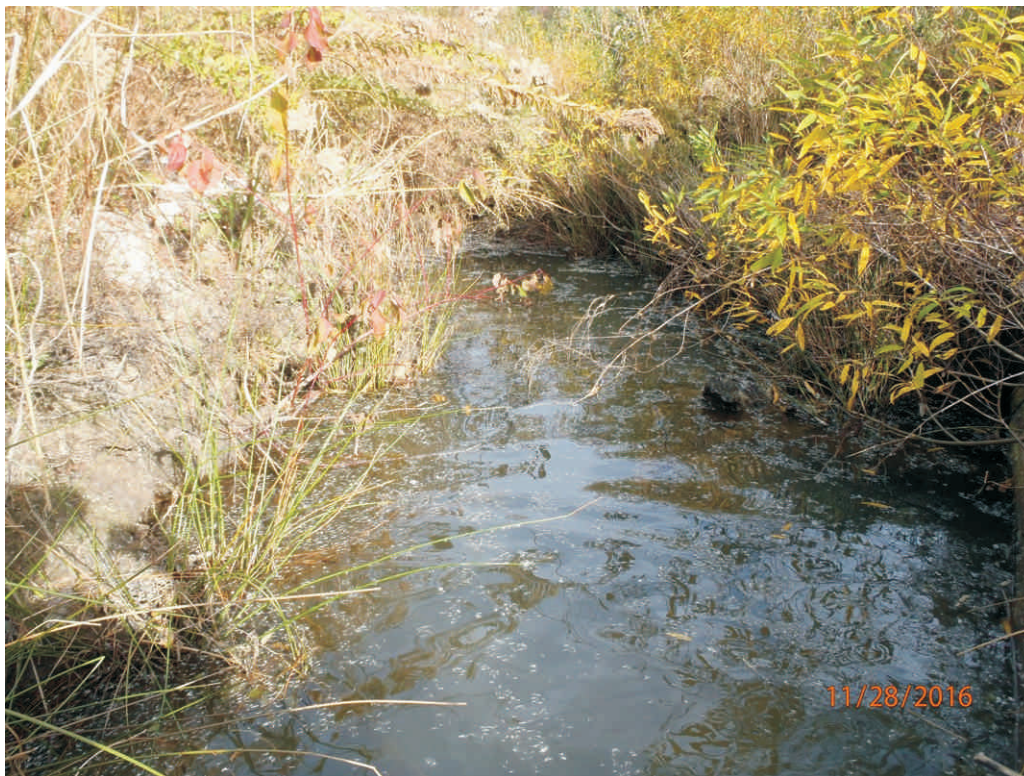
Reach 1A - Stream Problem Area #13a; Scour

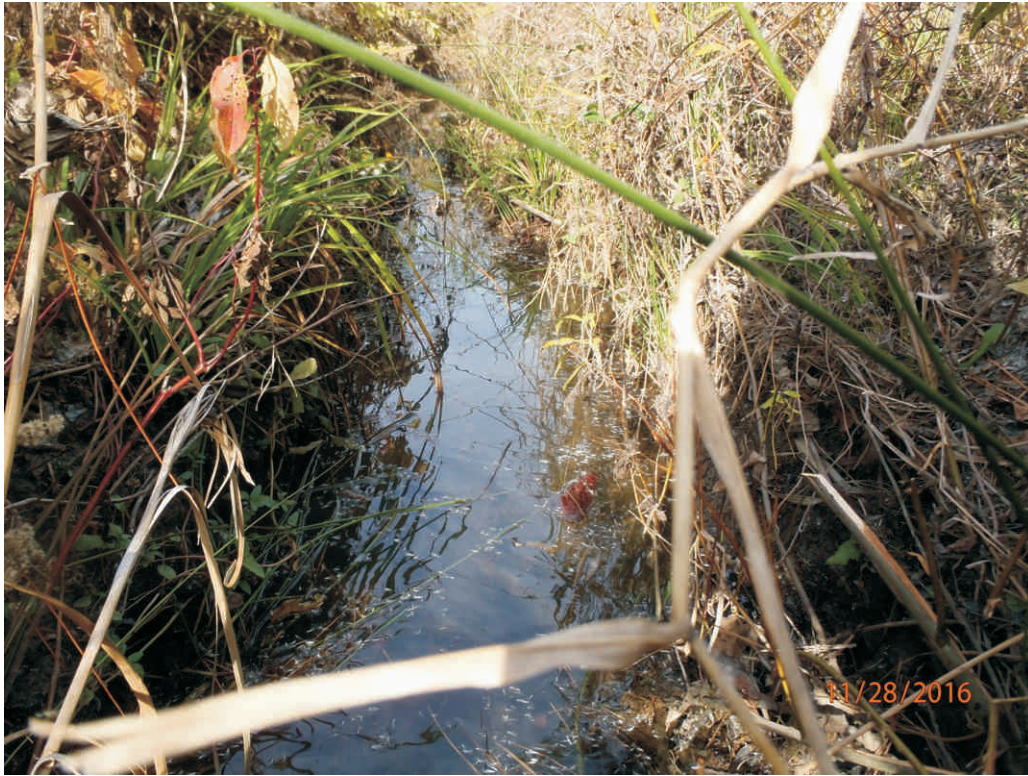
Reach 1A - Stream Problem Area #13b; Degradation

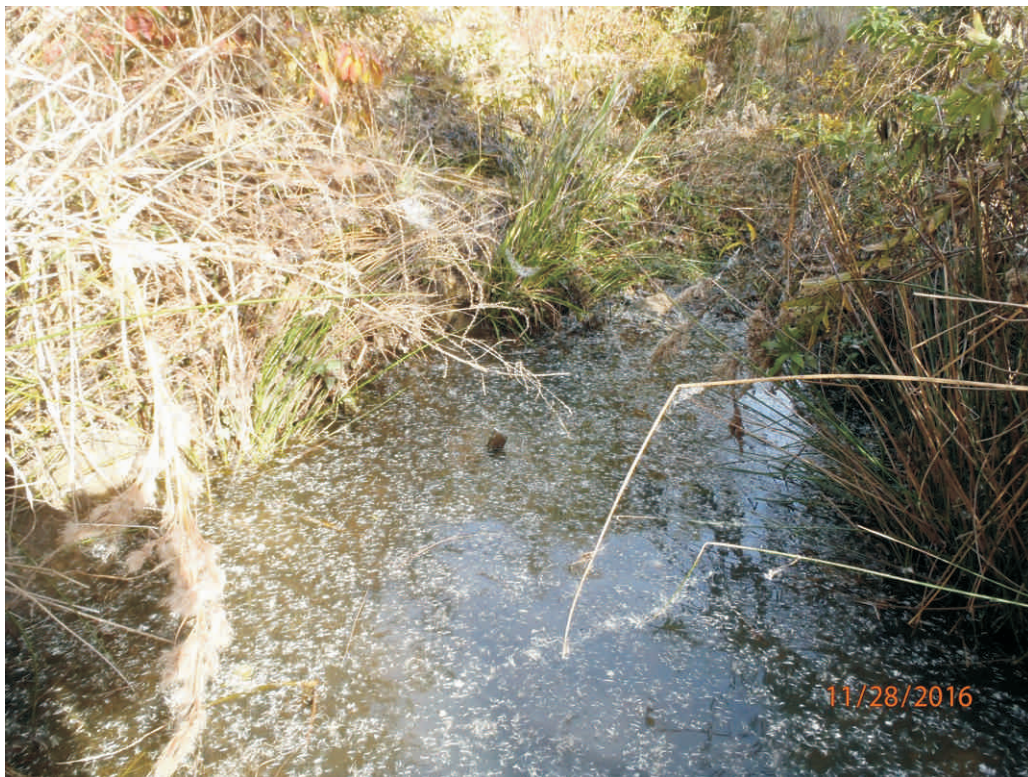
Reach 1A - Stream Problem Area #14; Scour

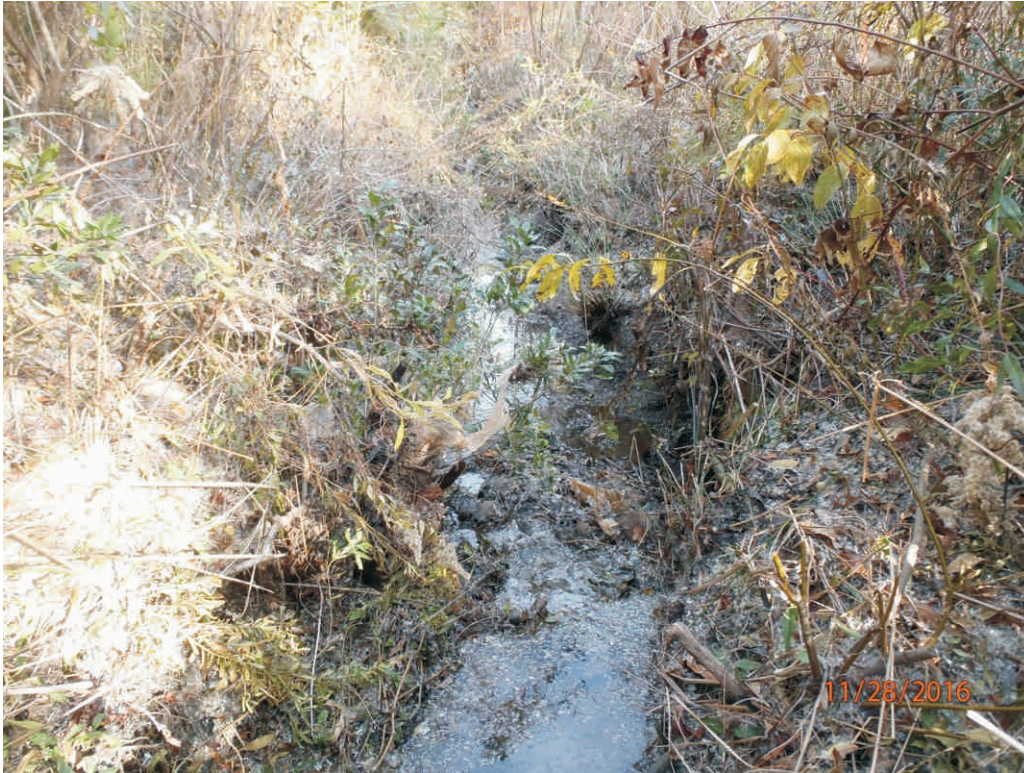
Reach 1A - Stream Problem Area #15; Degradation

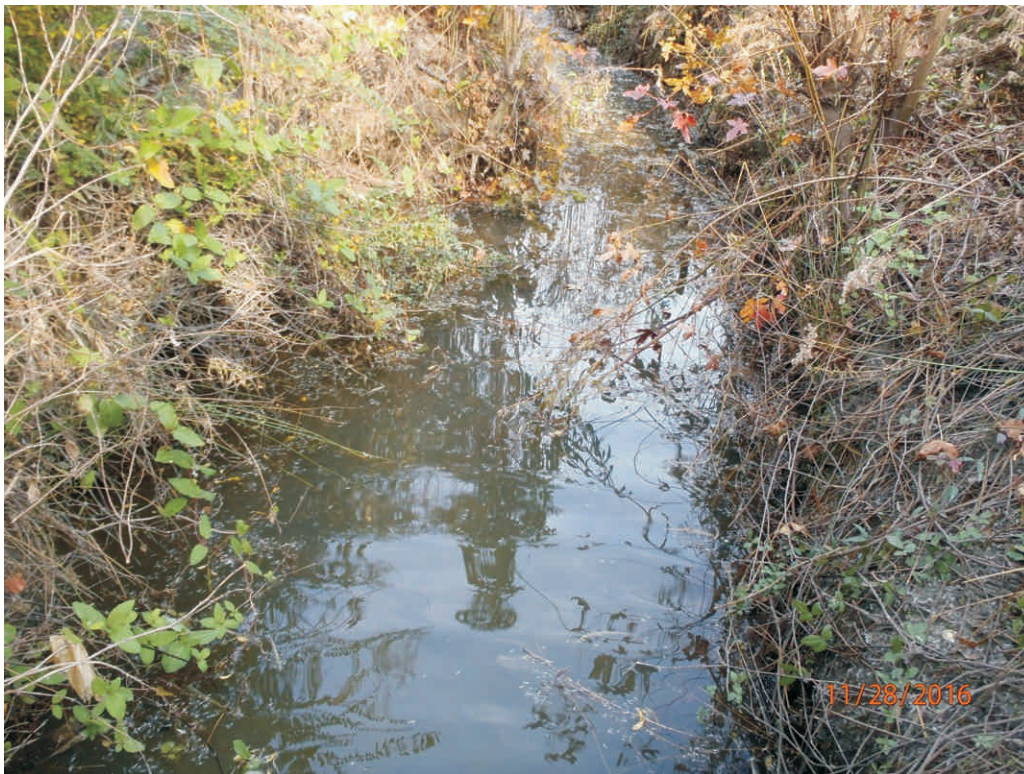
Reach 1A - Stream Problem Area #16; Bank Undercut becoming Scour

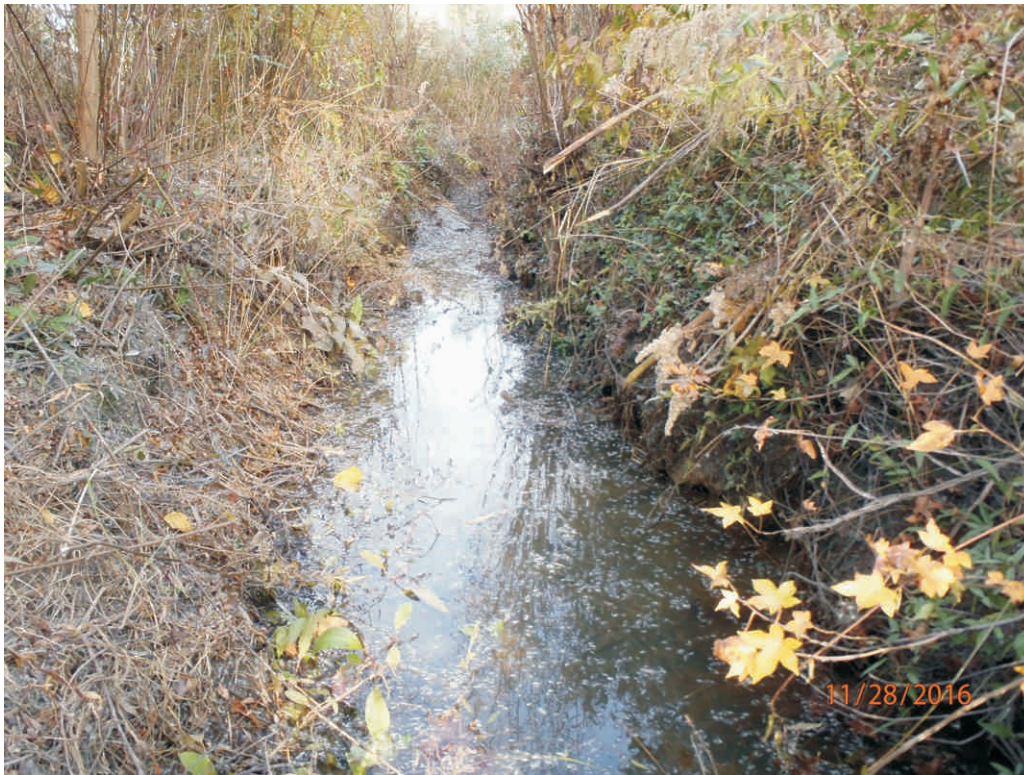
Reach 1A - Stream Problem Area #17; Degradation

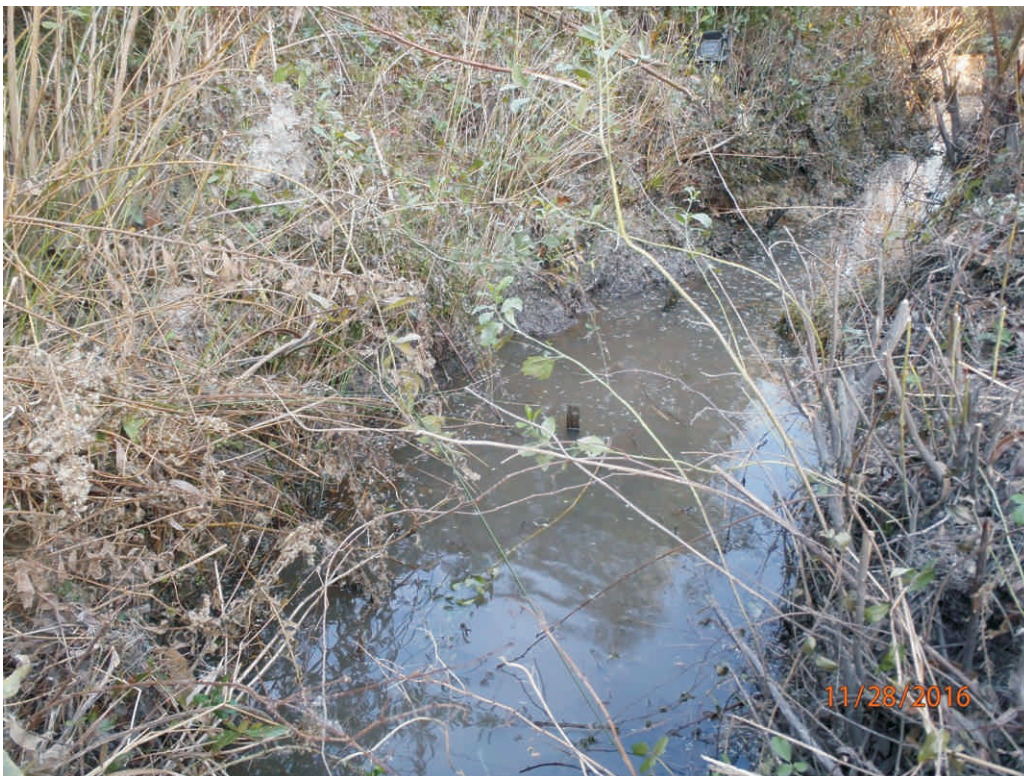
Reach 1A - Stream Problem Areas #18 & 19; Scour & Mass Wasting

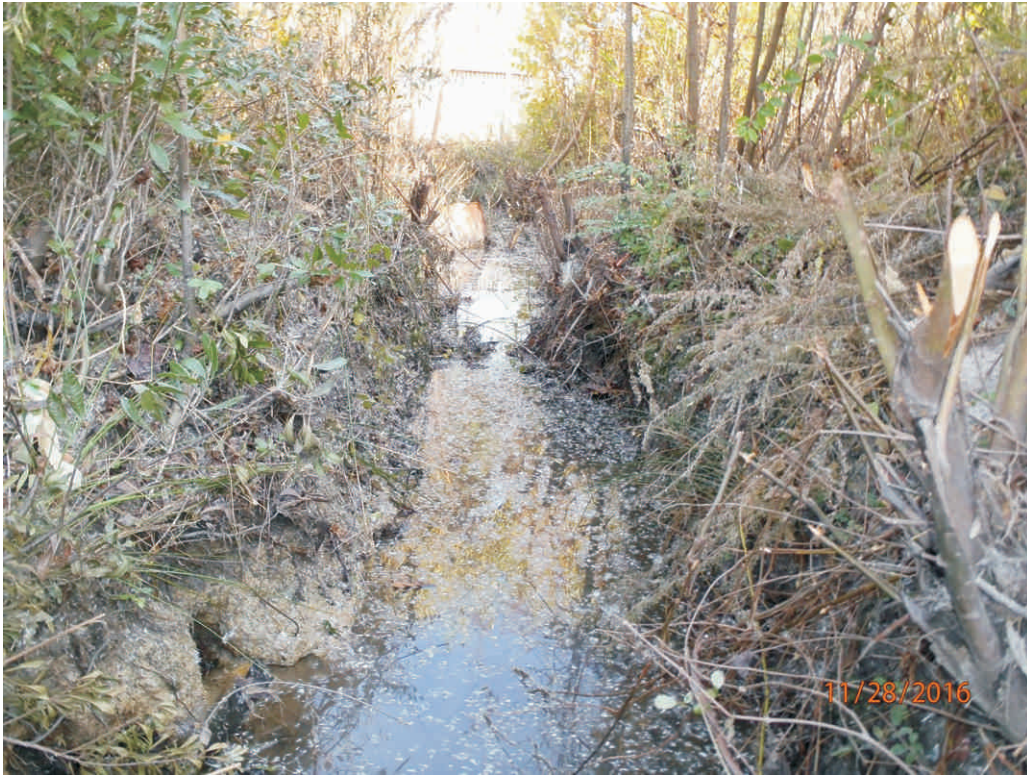
Reach 1A - Stream Problem Area #20; Degradation

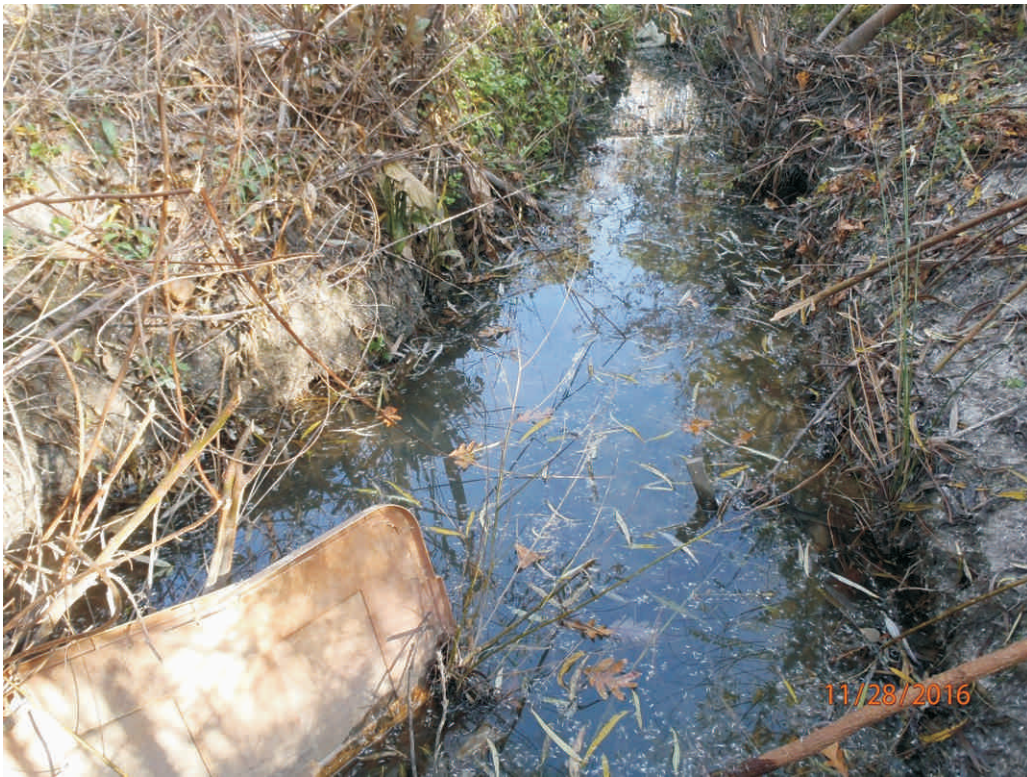
Reach 1A - Stream Problem Area #20a; Scour

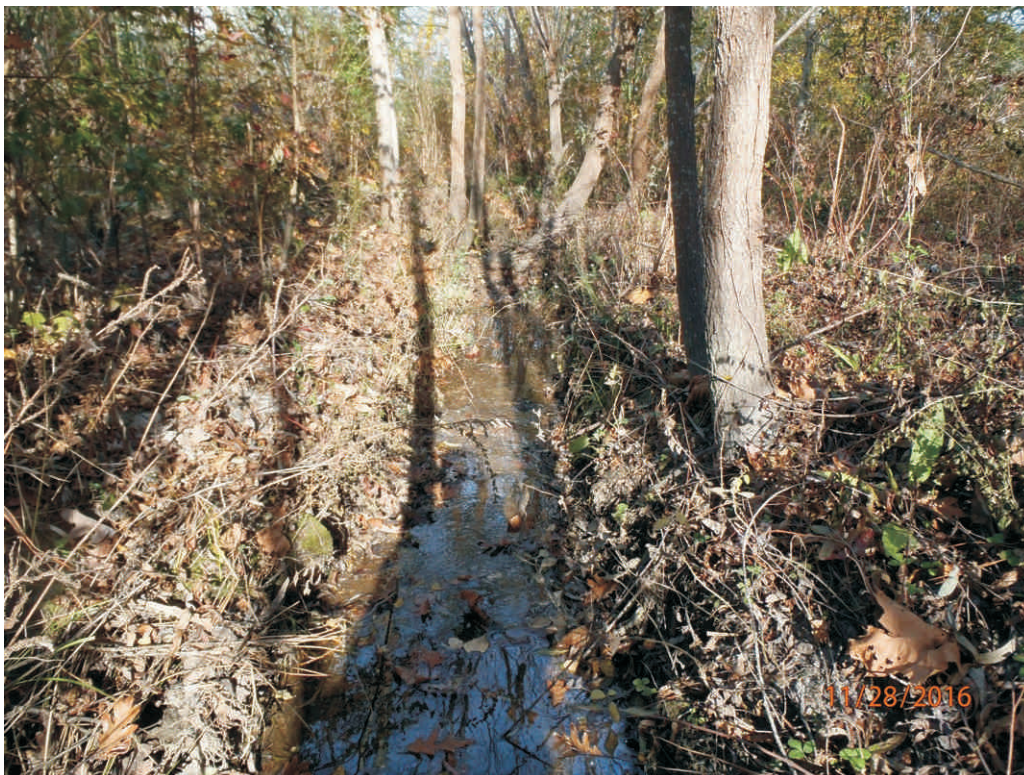
Reach 1A - Stream Problem Area #21; Degradation

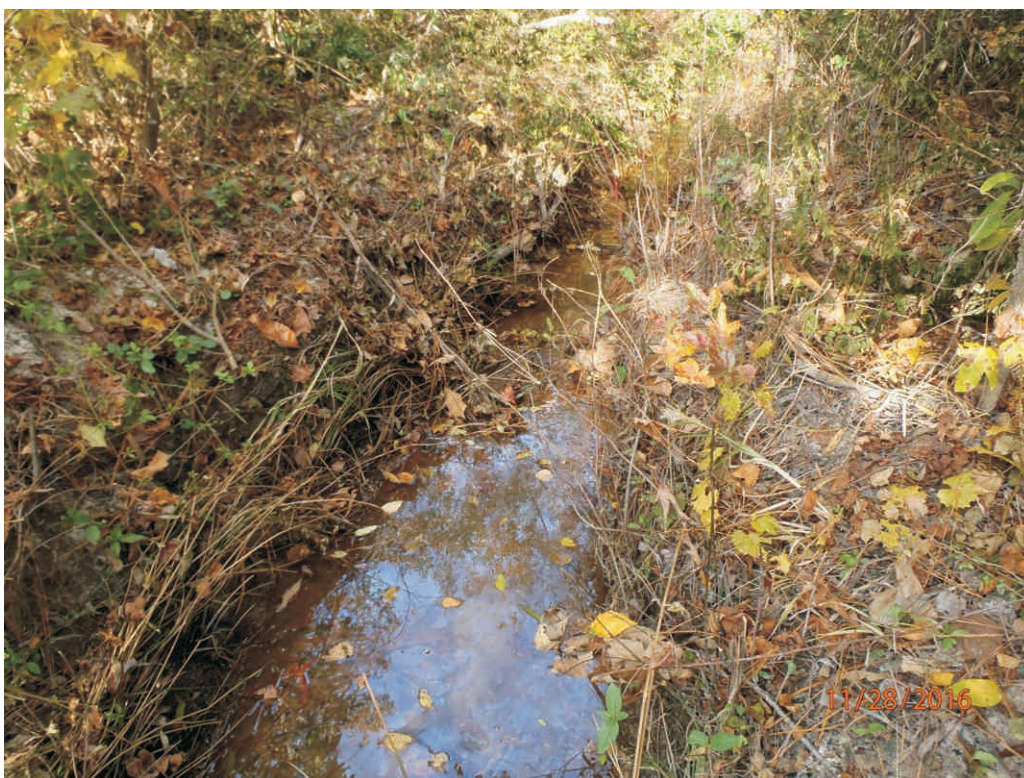
Reach 1A - Stream Problem Area #22; Degradation

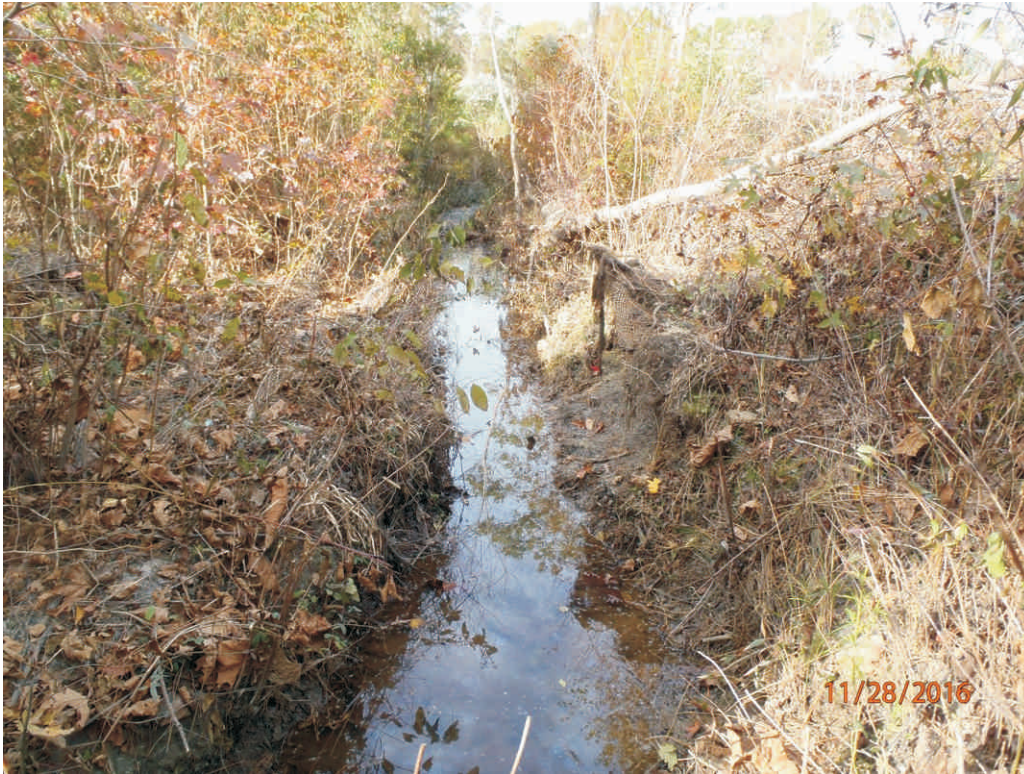
Reach 1A - Stream Problem Area #23; Degradation

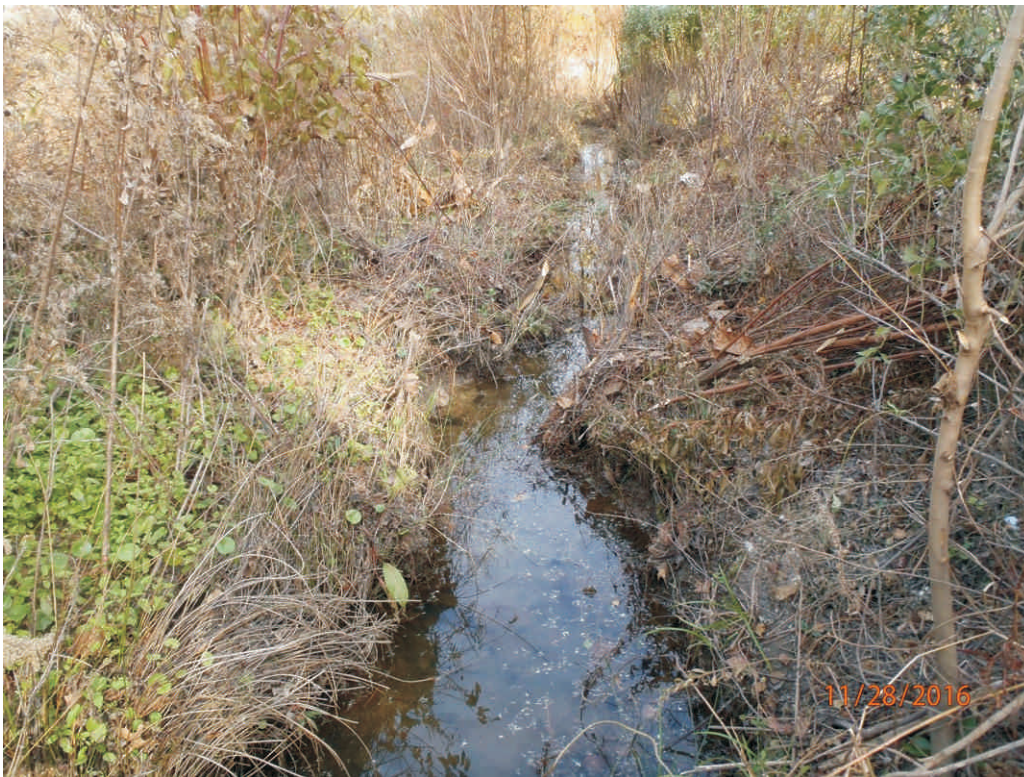
Reach 1A - Stream Problem Area #24; Degradation

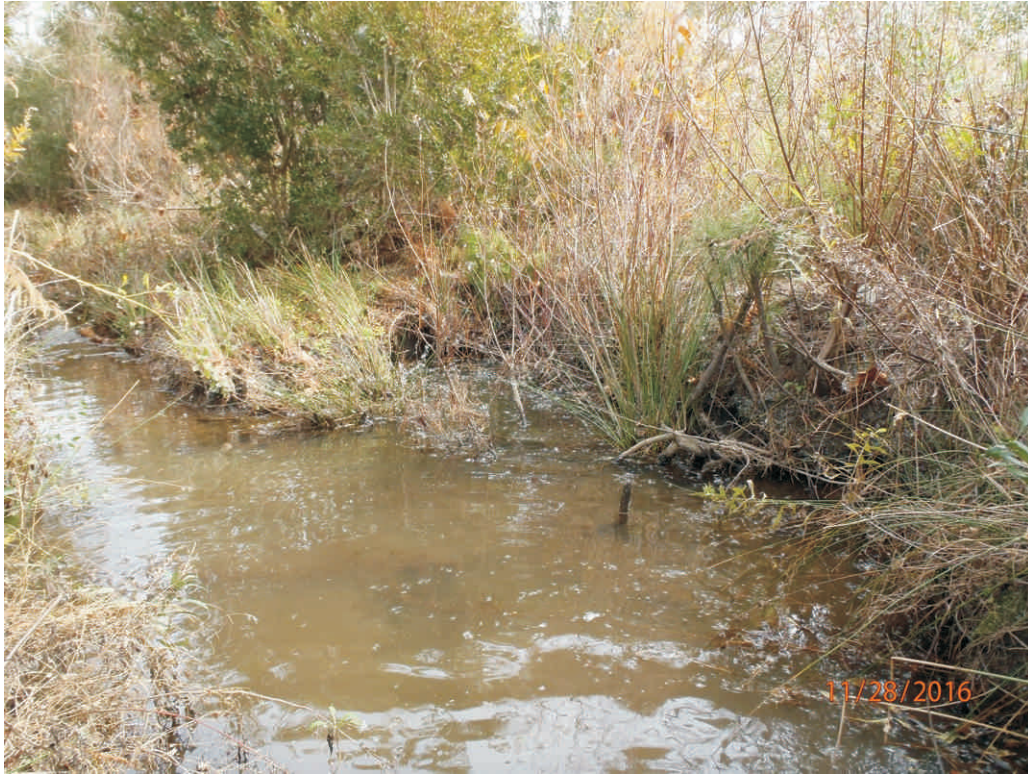
Reach 2A - Stream Problem Area #26; Mass Wasting

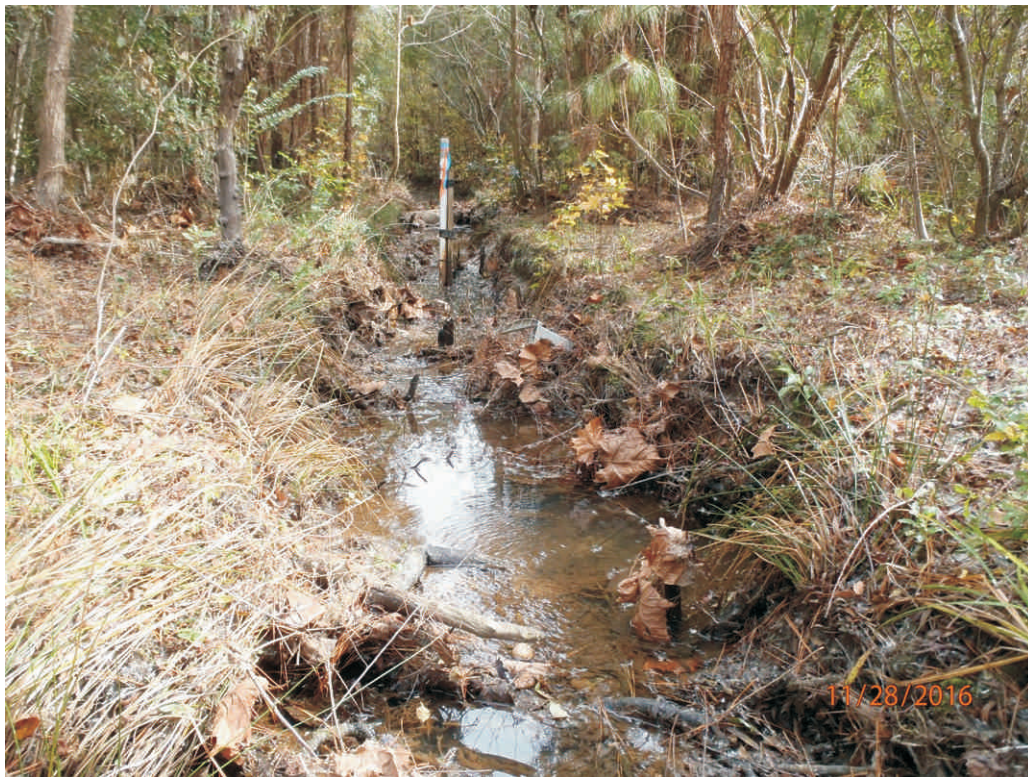
Reach 2A - Stream Problem Area #28; Degradation

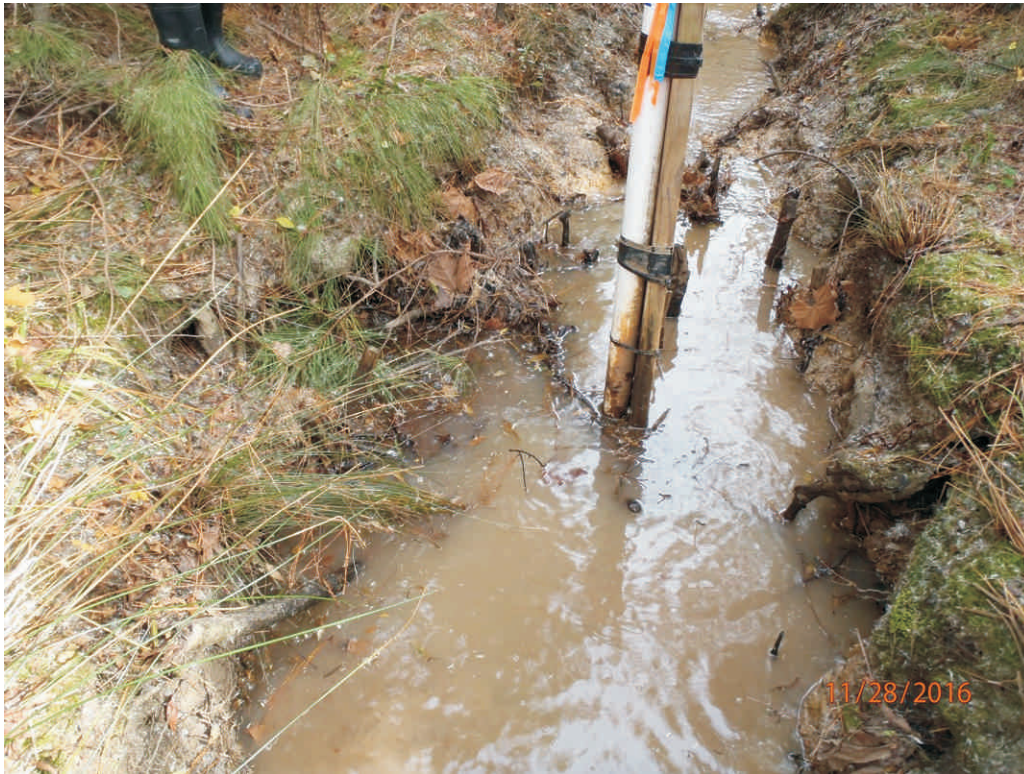
Reach 2A - Stream Problem Area #29; Scour

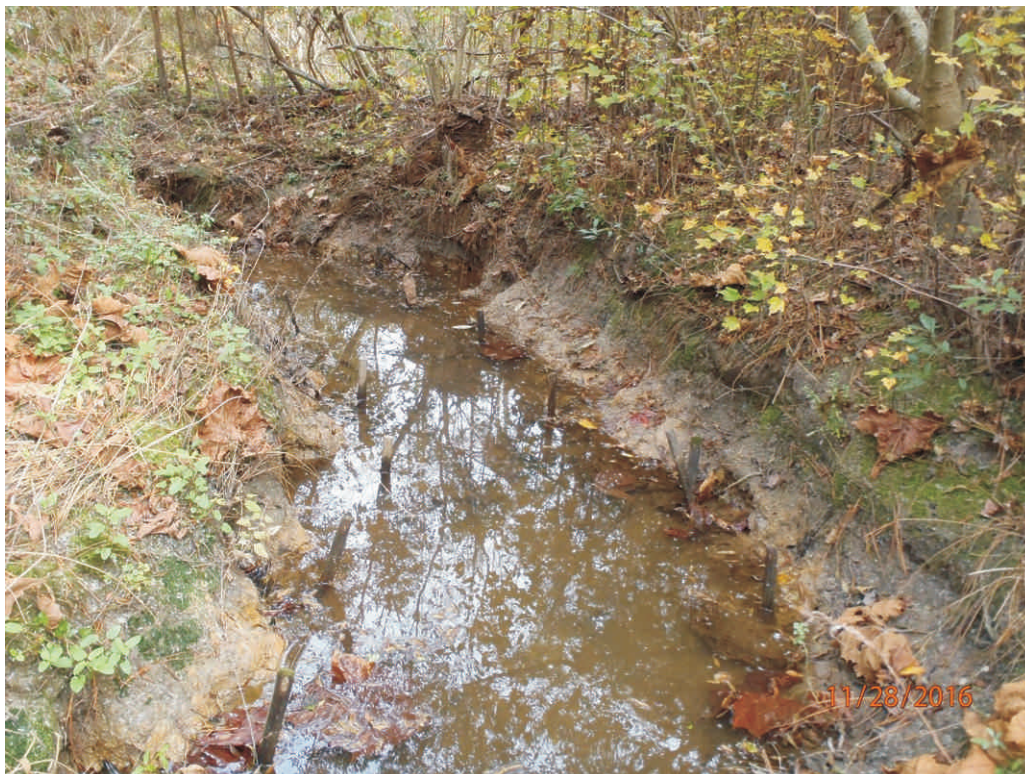
Reach 2A - Stream Problem Area #32; Degradation

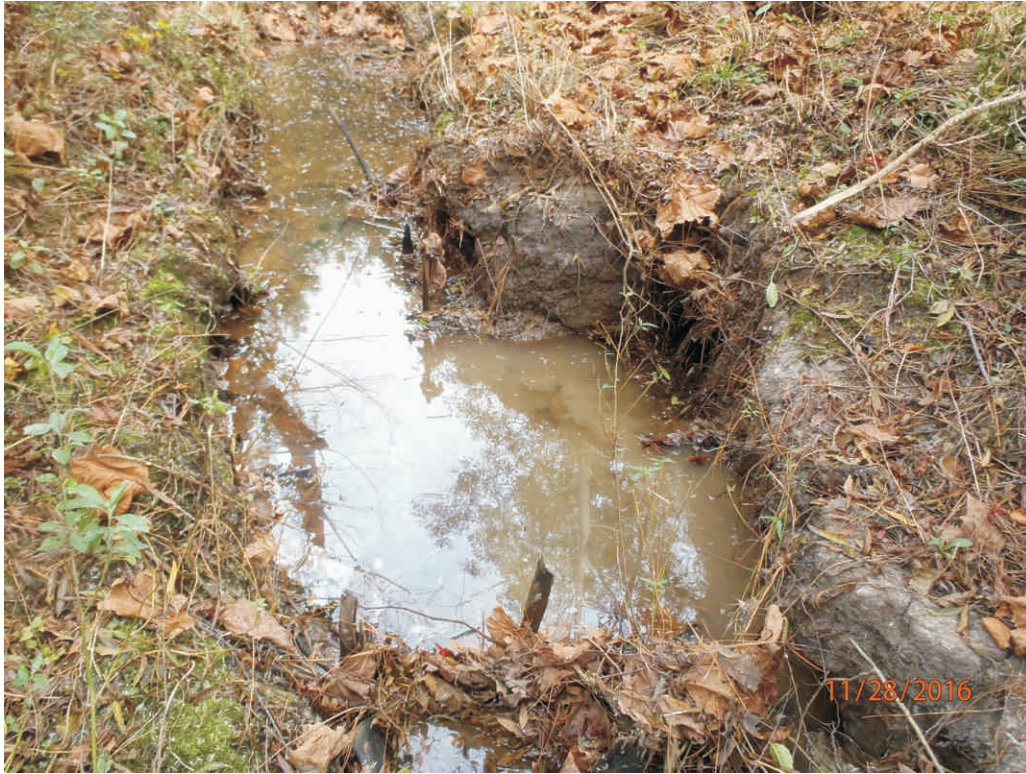
Reach 2A - Stream Problem Area #33; Scour

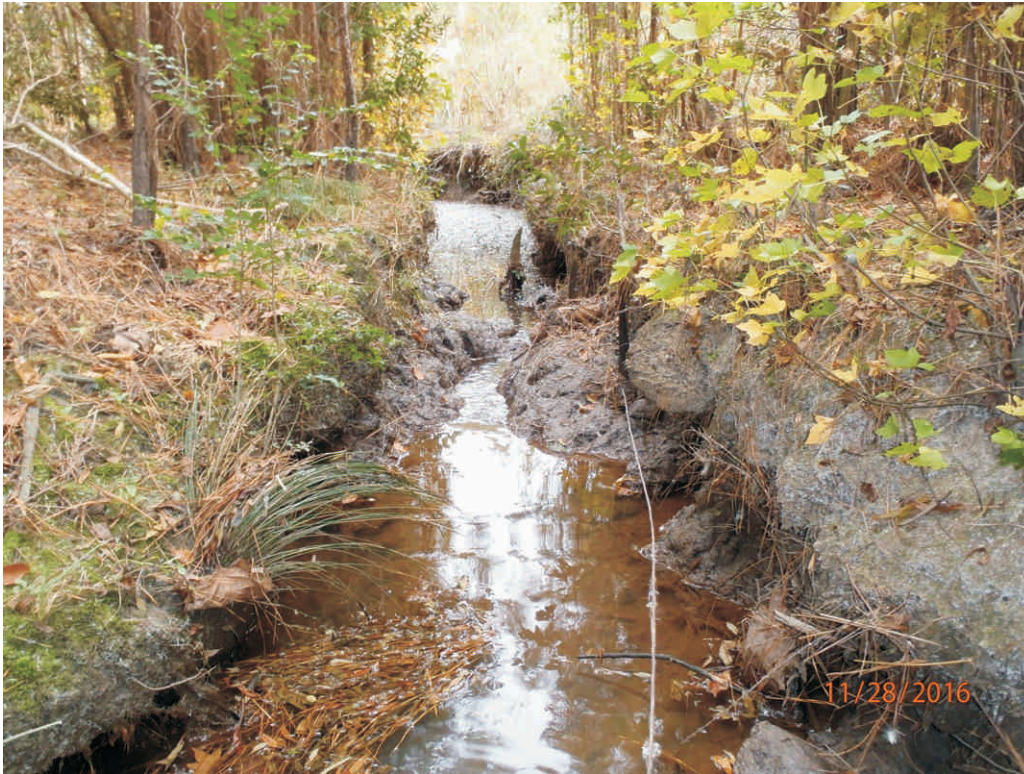
Reach 2A - Stream Problem Area #36; Degradation

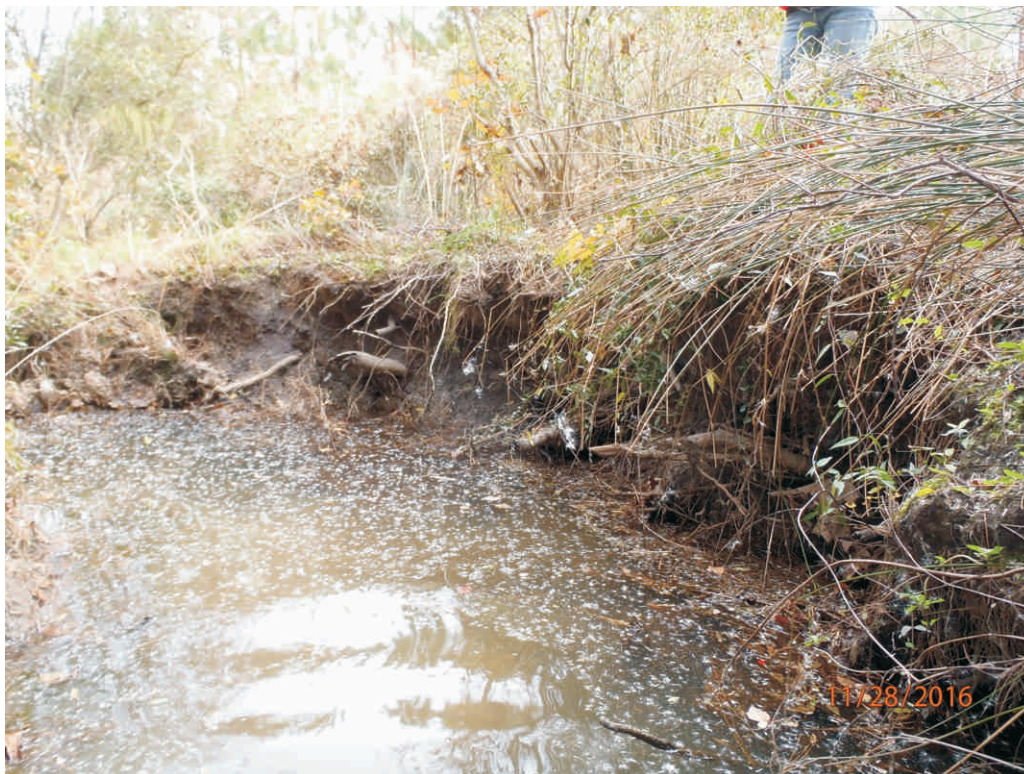
Reach 2A - Stream Problem Area #37; Undercut turning into Mass Wasting

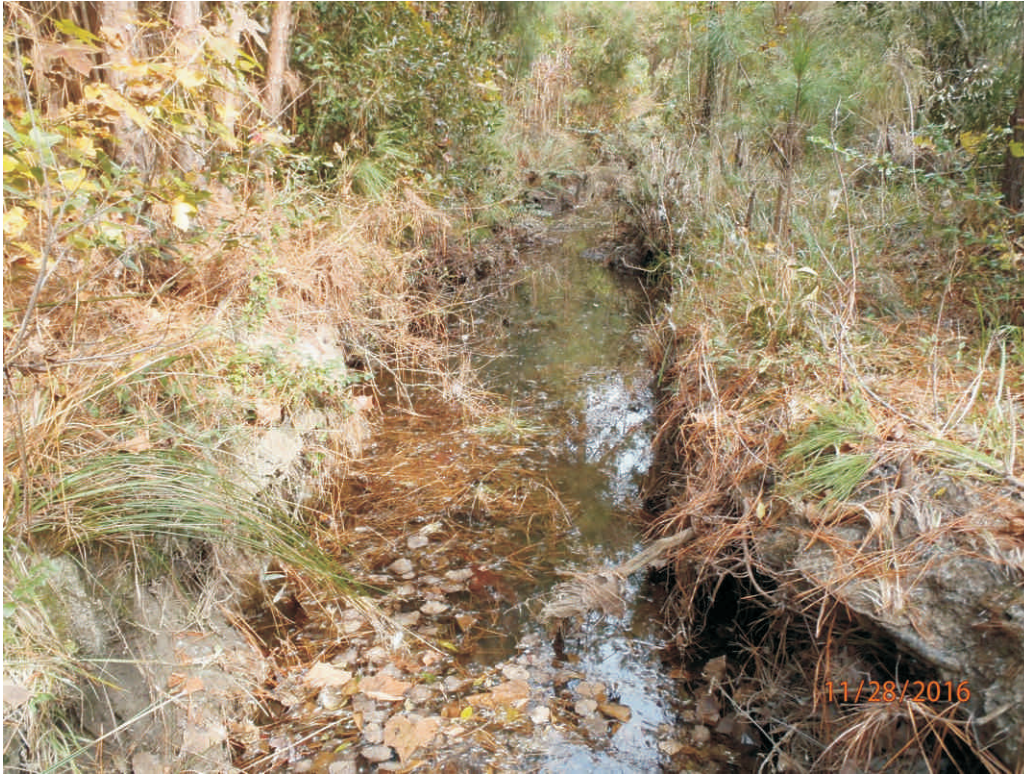
Reach 2A - Stream Problem Areas #38 & 39; Long Degradation and Undercut
