Jacksonville Country Club Stream Restoration and Enhancement Project

**SCO No. 070715501
DEQ Contract No. D08049S
DMS Project No. 194
Action ID# 2006-40325-067
Onslow County, North Carolina**

**Year 3 of 5 Monitoring Report
Data Collection: January through December 2016
Submission Date: February 9, 2017**

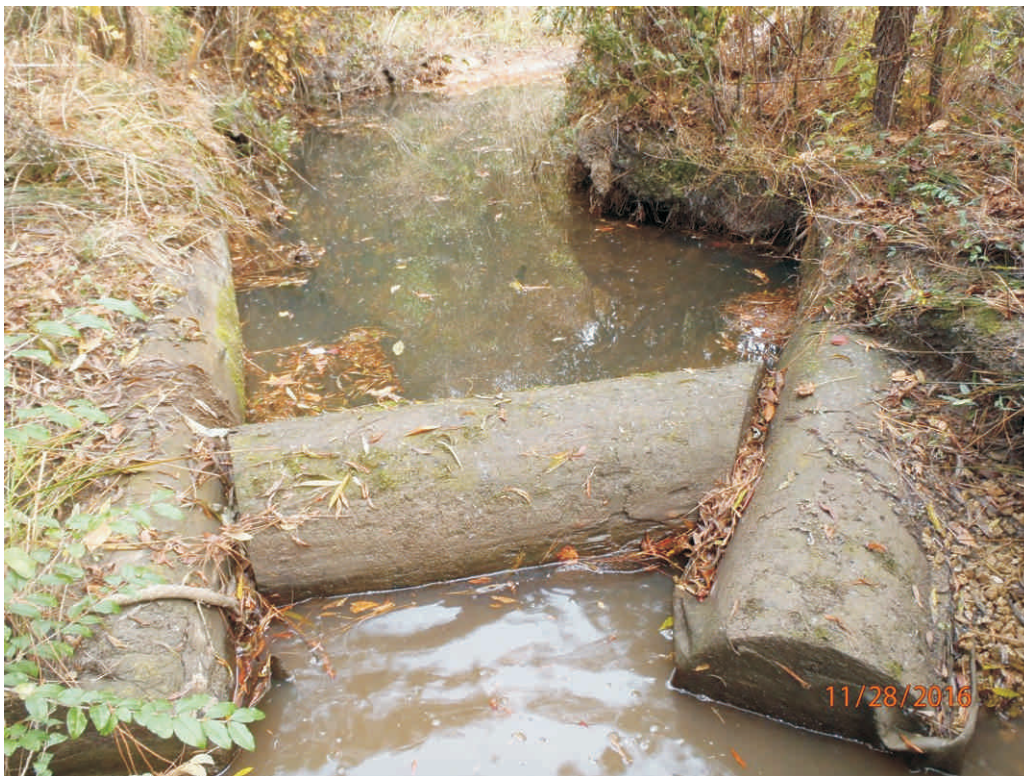
Reach 2A - Stream Problem Area #40; Log Vane Scour

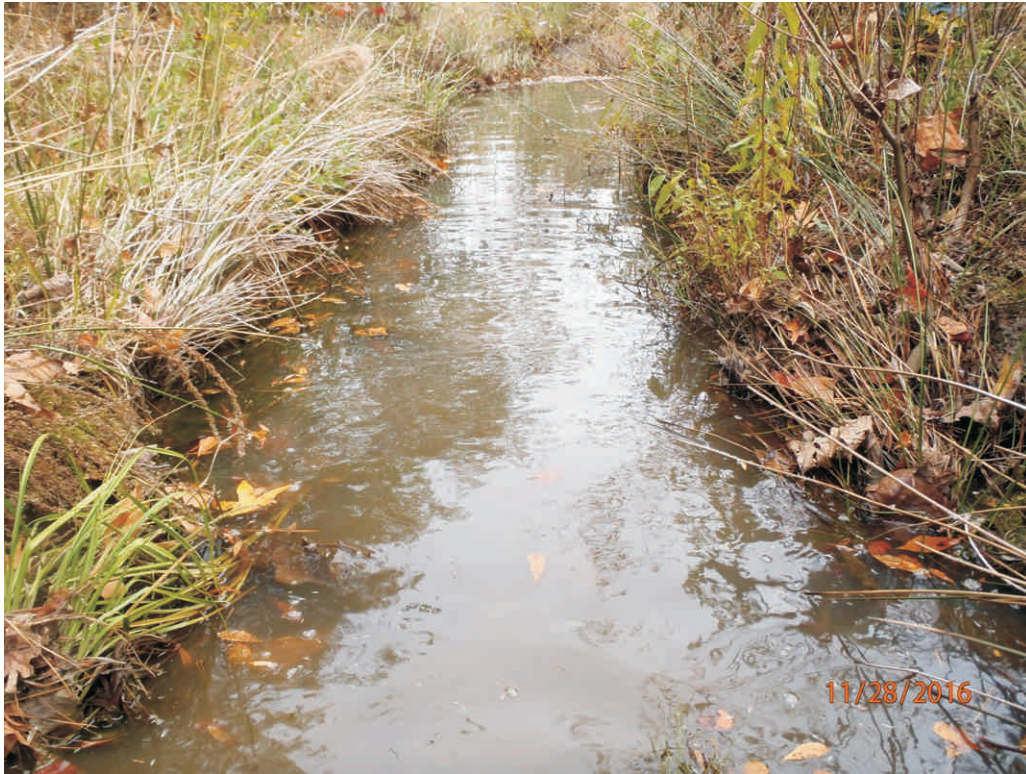
Reach 2A - Stream Problem Area #43; Degradation

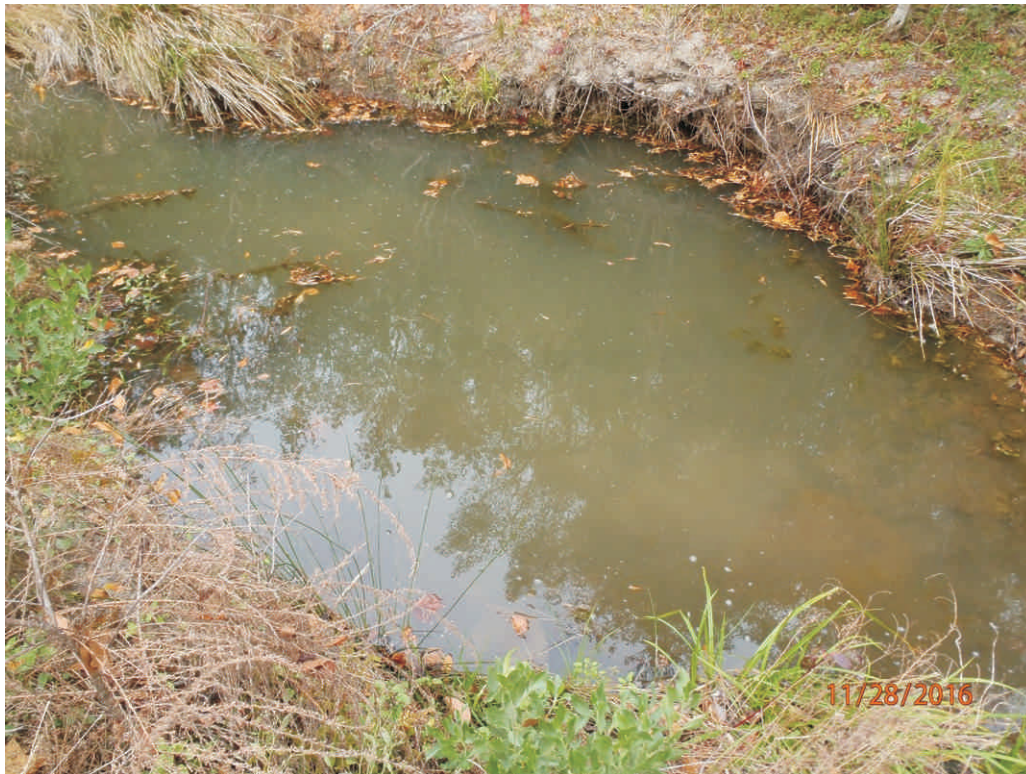
Reach 2A - Stream Problem Area #43a; Scour

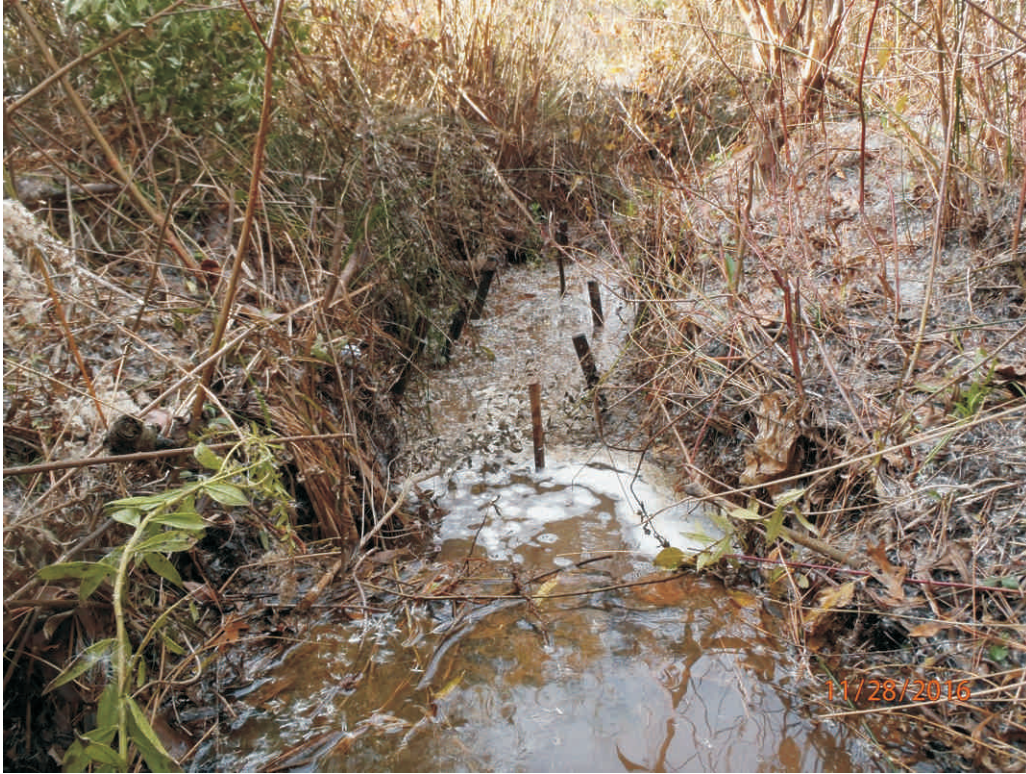
Reach B - Stream Problem Area #52a; Degradation

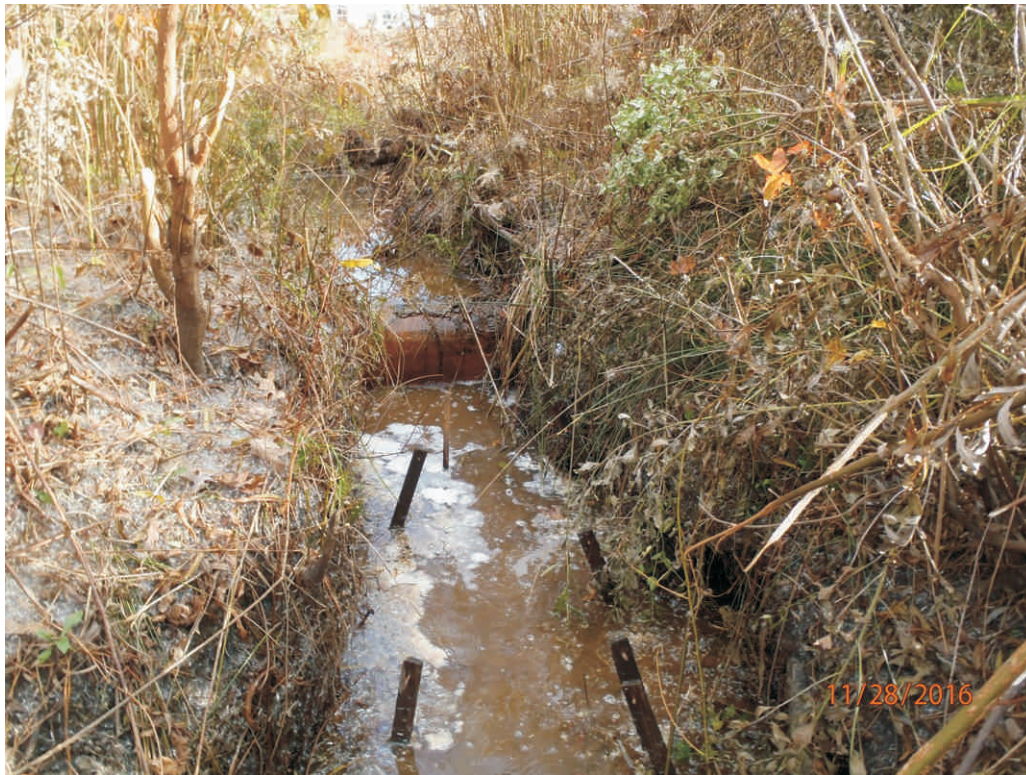
Reach B - Stream Problem Area #52b; Mass Wasting

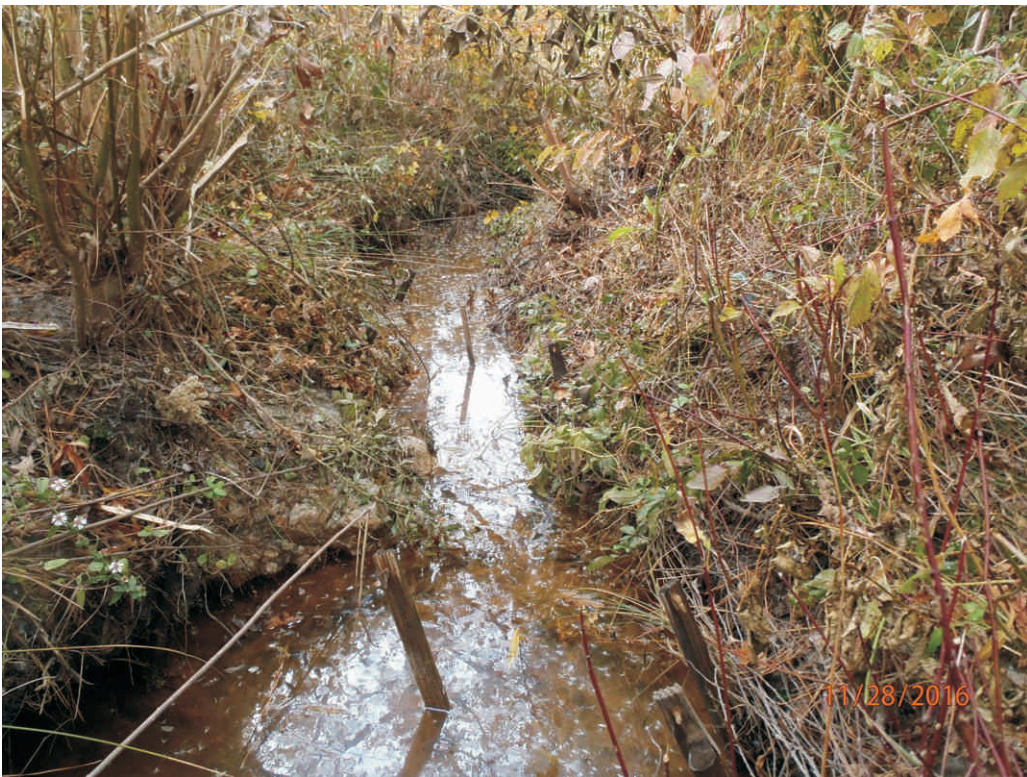
Reach B - Stream Problem Area #54; Degradation

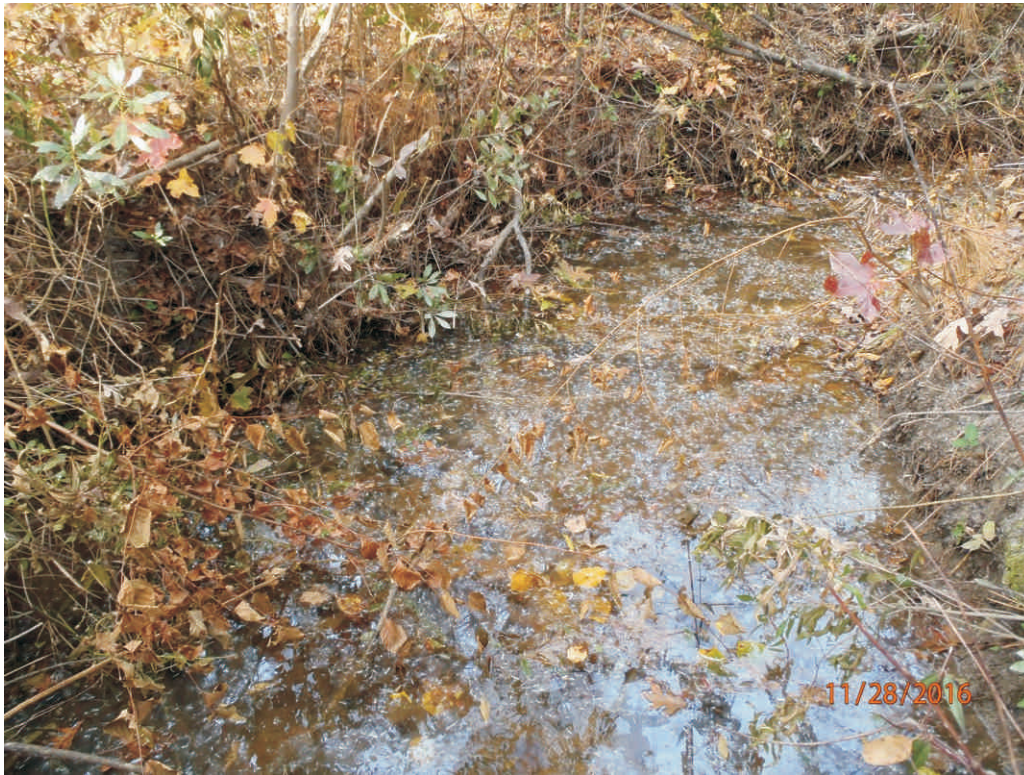
Reach B - Stream Problem Area #55; Undercut becoming Scour
