Jacksonville Country Club Stream Restoration and Enhancement Project

**SCO No. 070715501
DEQ Contract No. D08049S
DMS Project No. 194
Action ID# 2006-40325-067
Onslow County, North Carolina**

**Year 4 of 5 Monitoring Report
Data Collection: January through December 2017
Submission Date: March 9, 2018**

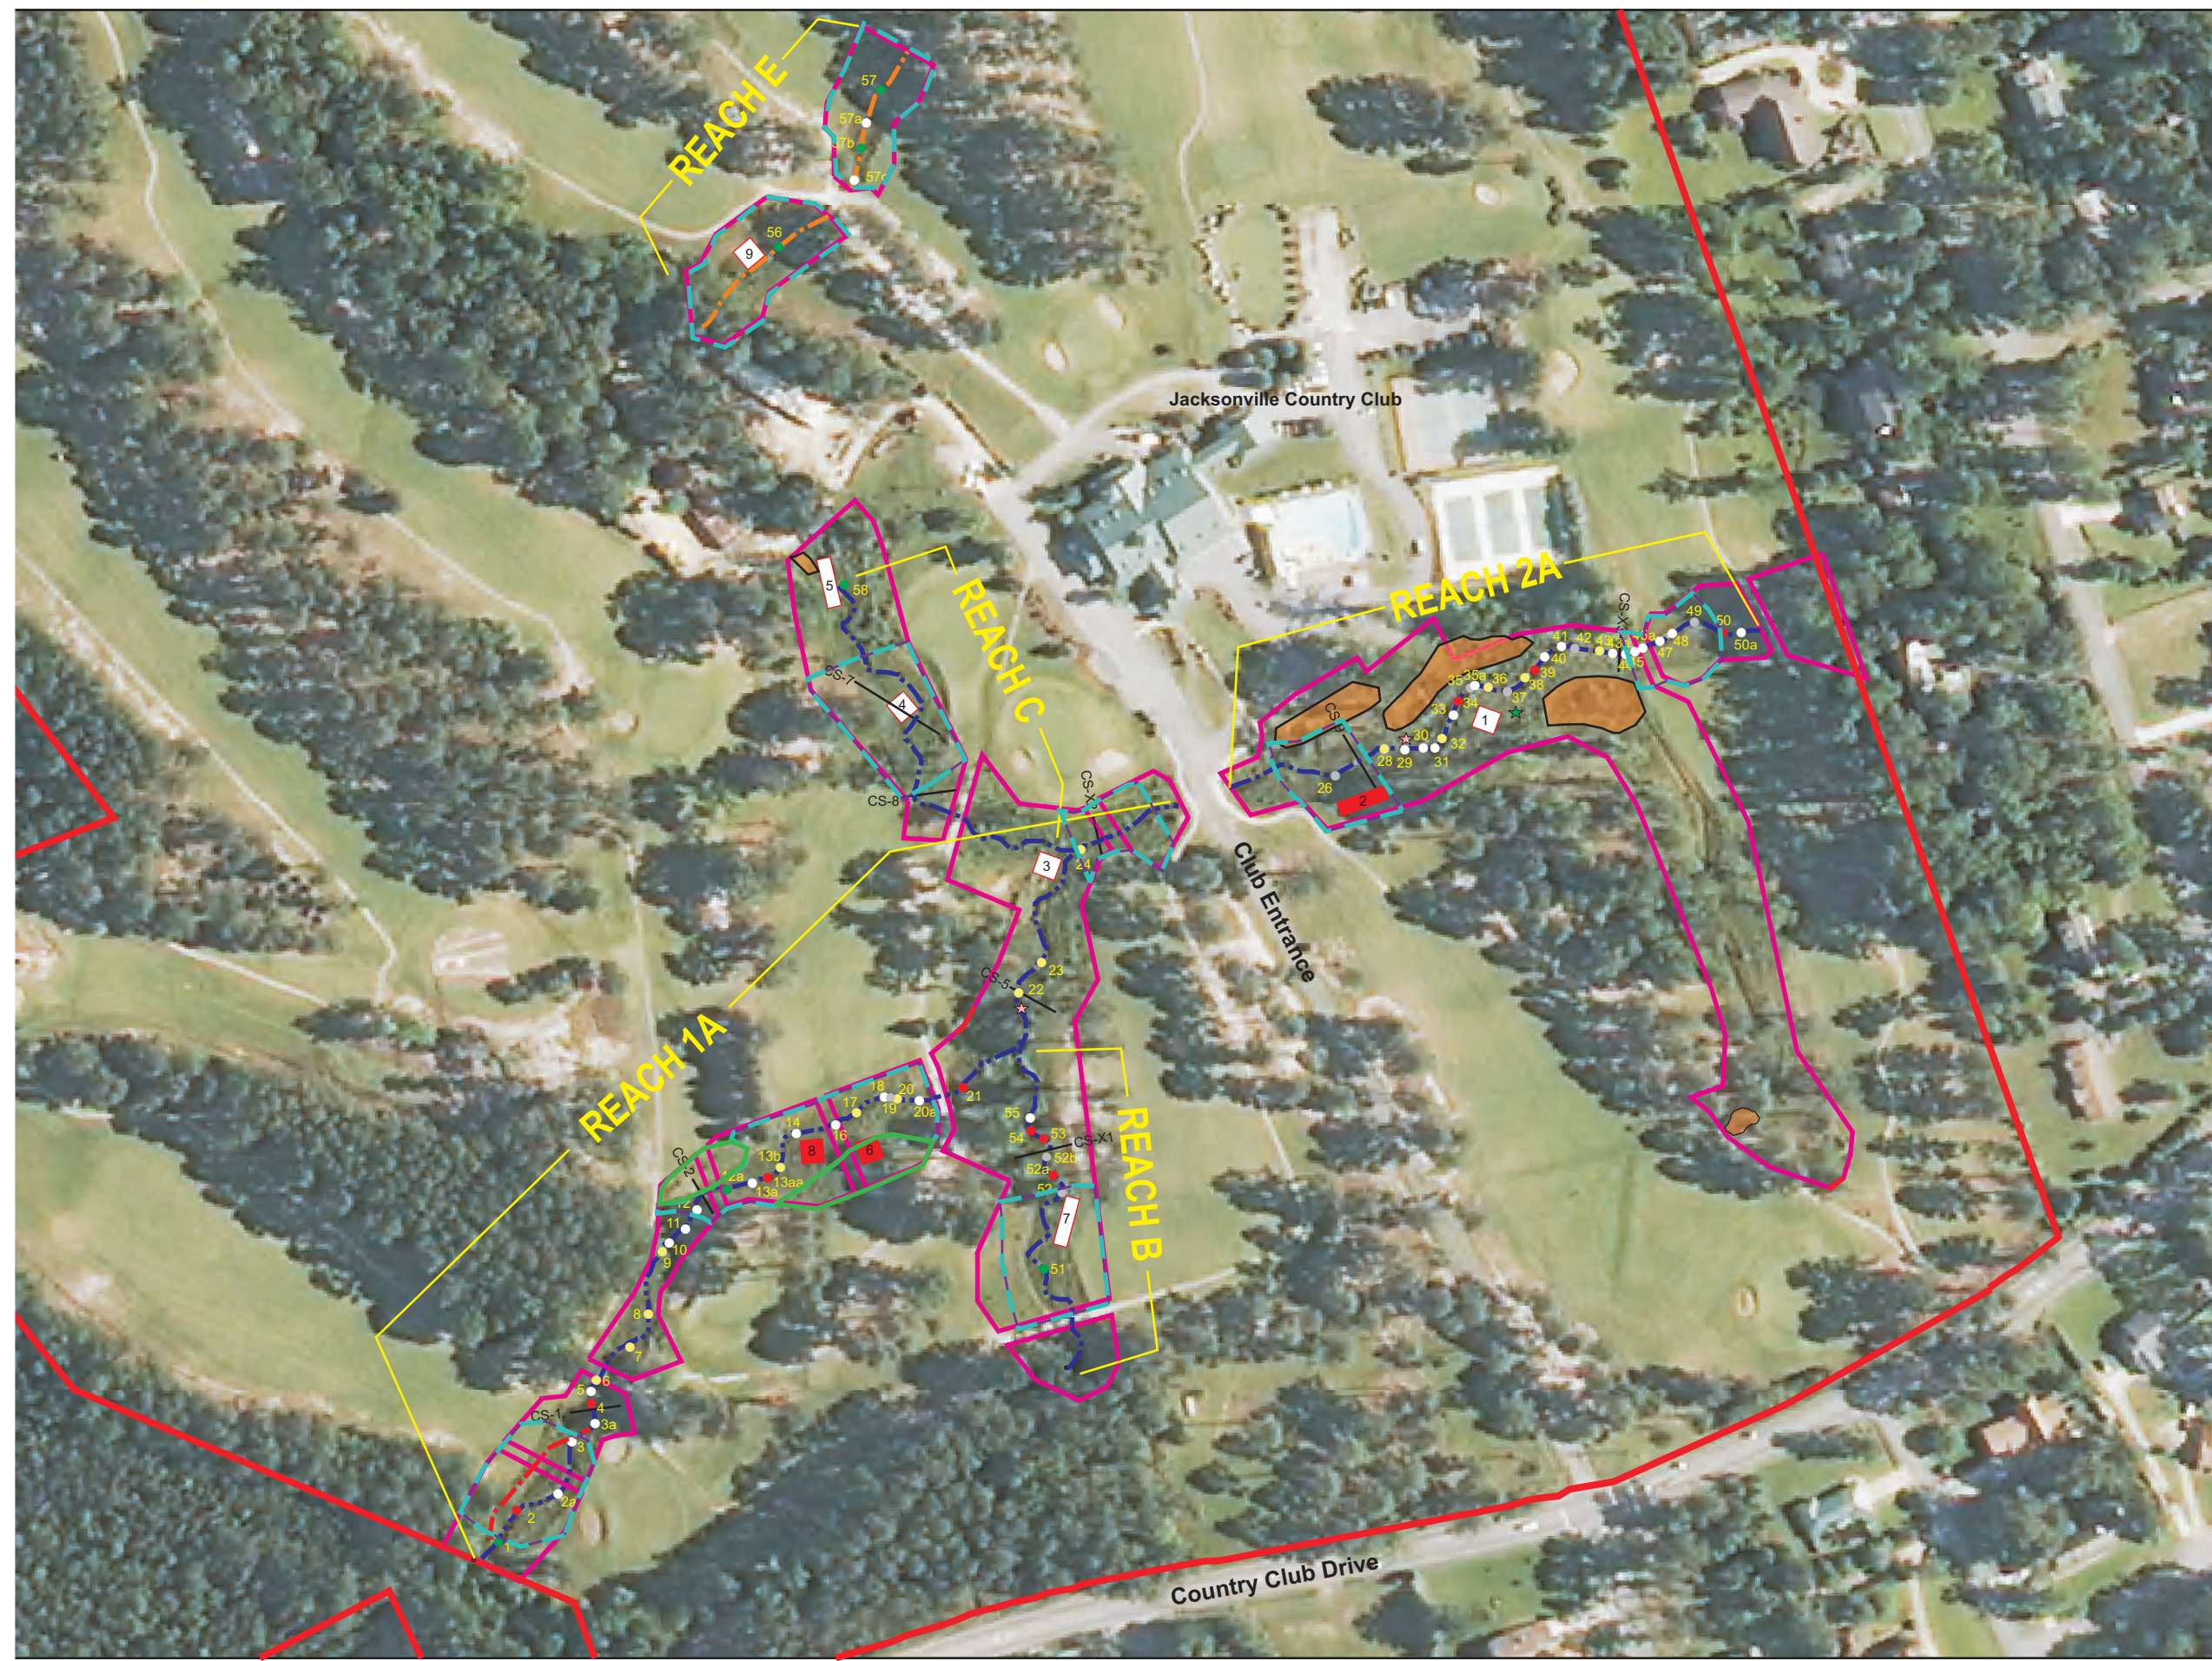
Current Conditions Plan View

LMG staff observed vegetation maintenance in several locations within the project area. Most of the maintenance occurred around the playover areas and consisted of cutting the tops of the trees so that greens are visible to the golfers (total of approximately 3.2 acres). Trees were generally cut to approximately 5' in height, although it varied based on the topography of the area. Some mowing, where vegetation was cleared to the ground, also occurred in two areas near Vegetation Plots #6 & #8 (total of approximately 0.26 acre) (see Figure 2). The mowed areas are considered an encroachment.

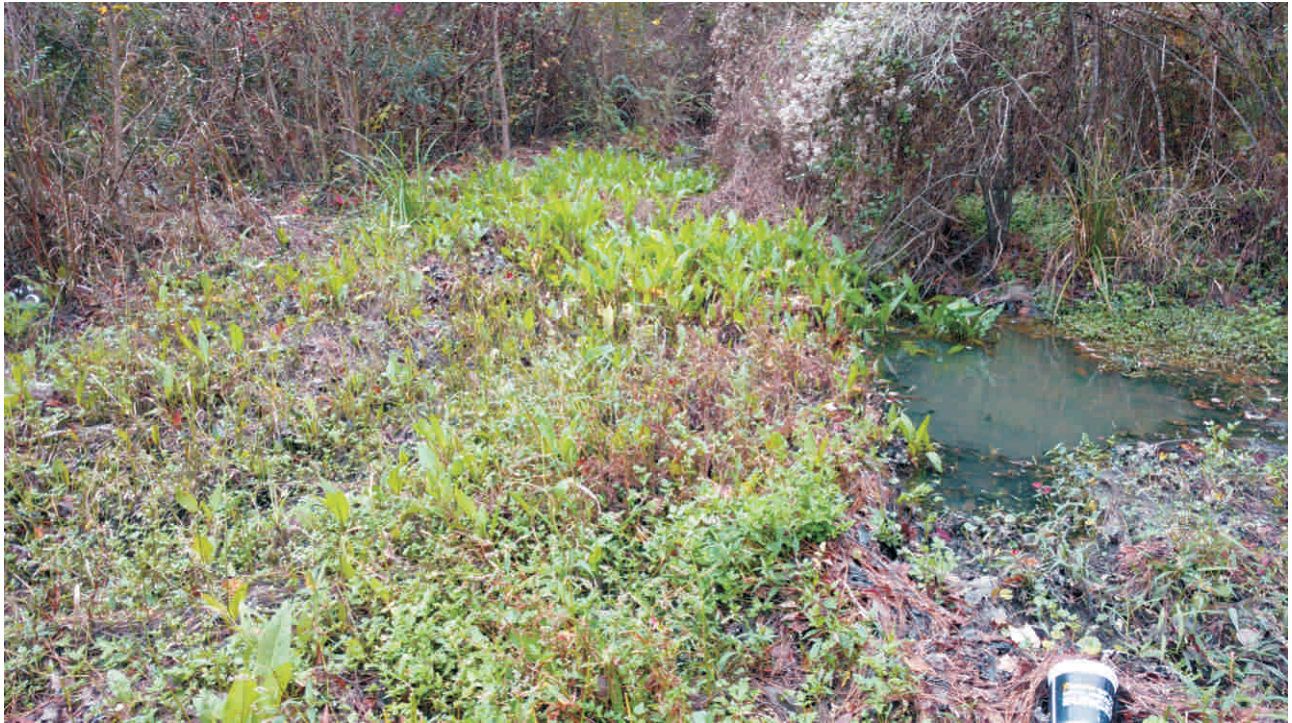
Reach 1A - Stream Problem Area 1; Aggradation; New Channel Continues to Form

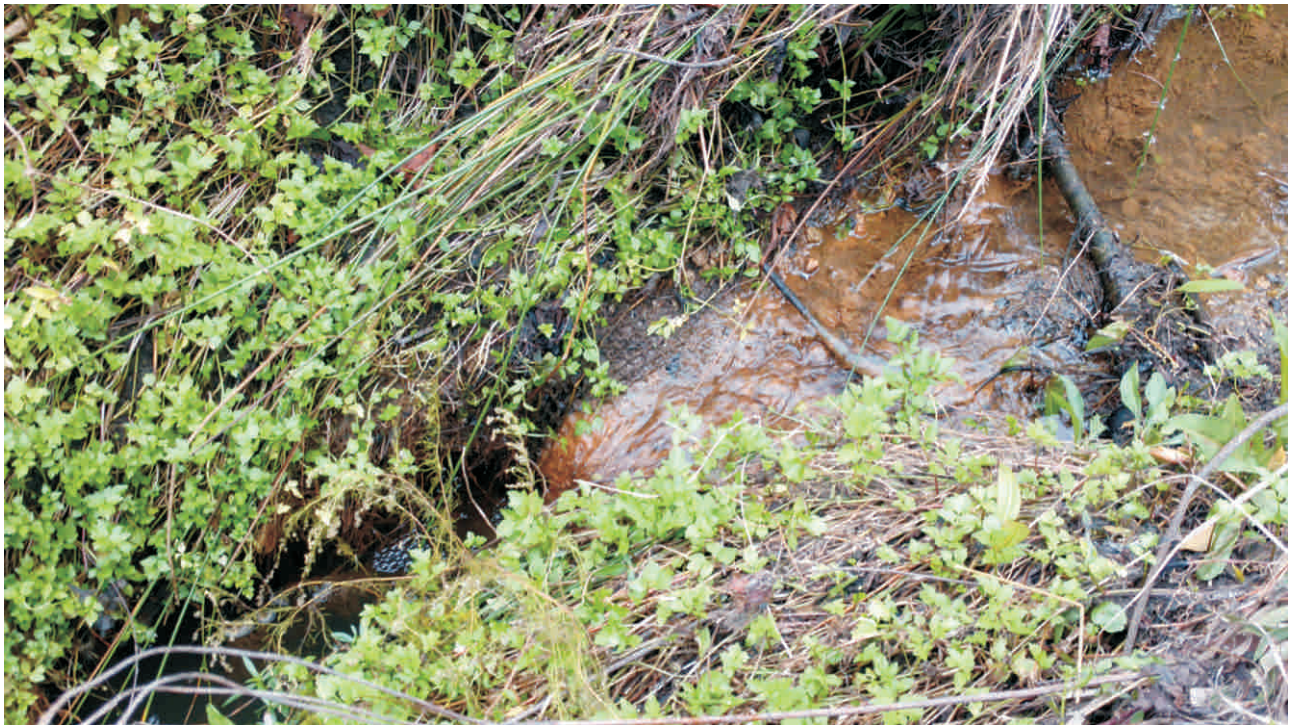
Reach 1A - Stream Problem Area 2; Undercut near Log Vane Structure

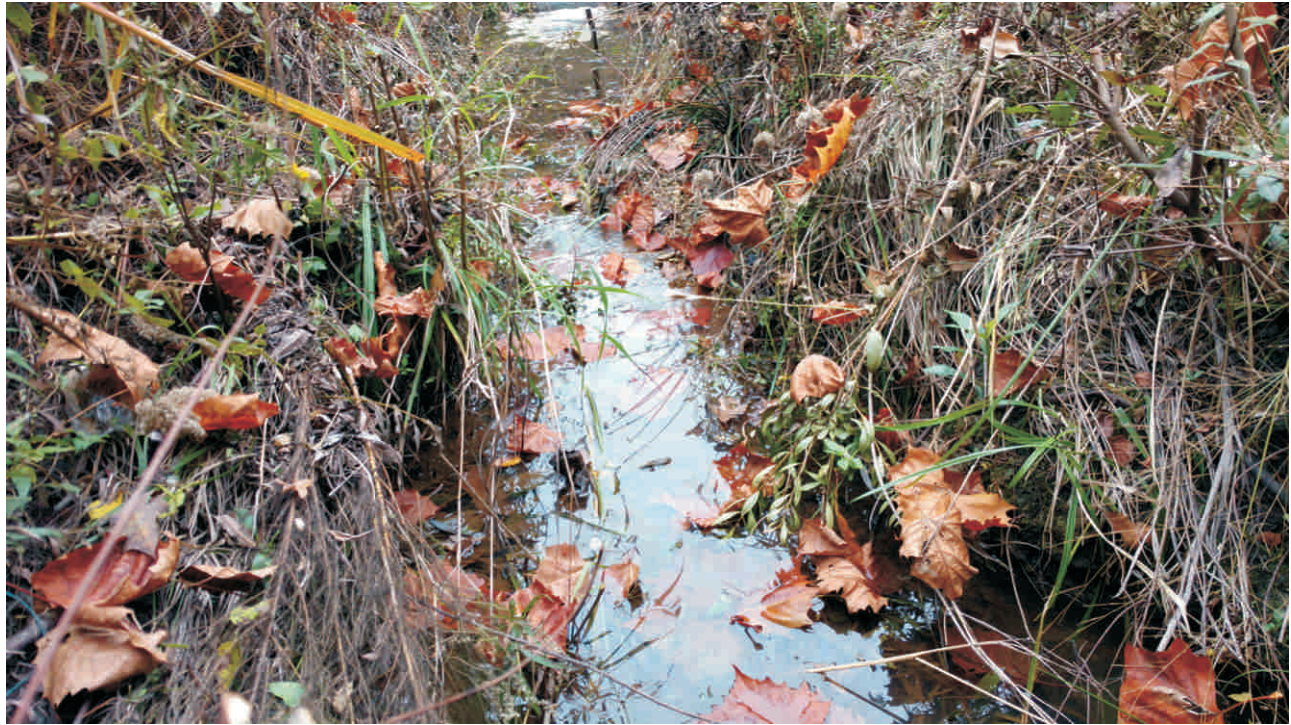
Reach 1A - Stream Problem Area #4; bank undercut

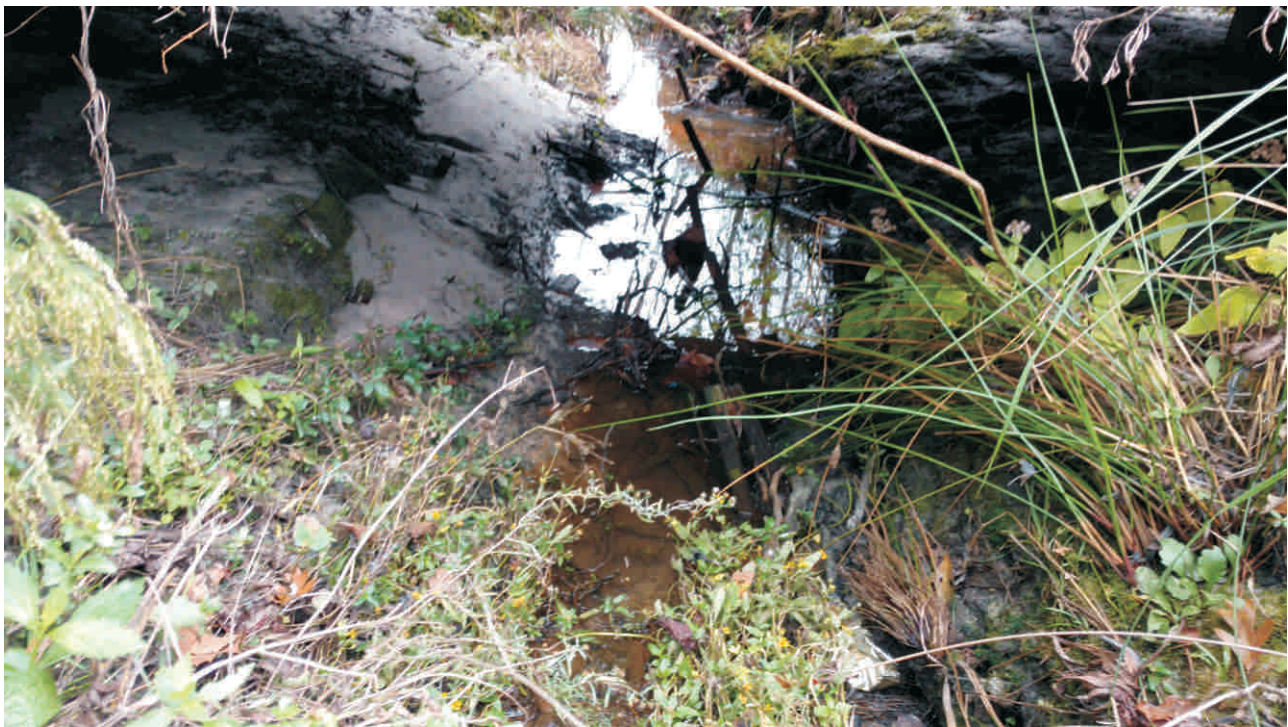
Reach 1A - Stream Problem Area #6; degradation

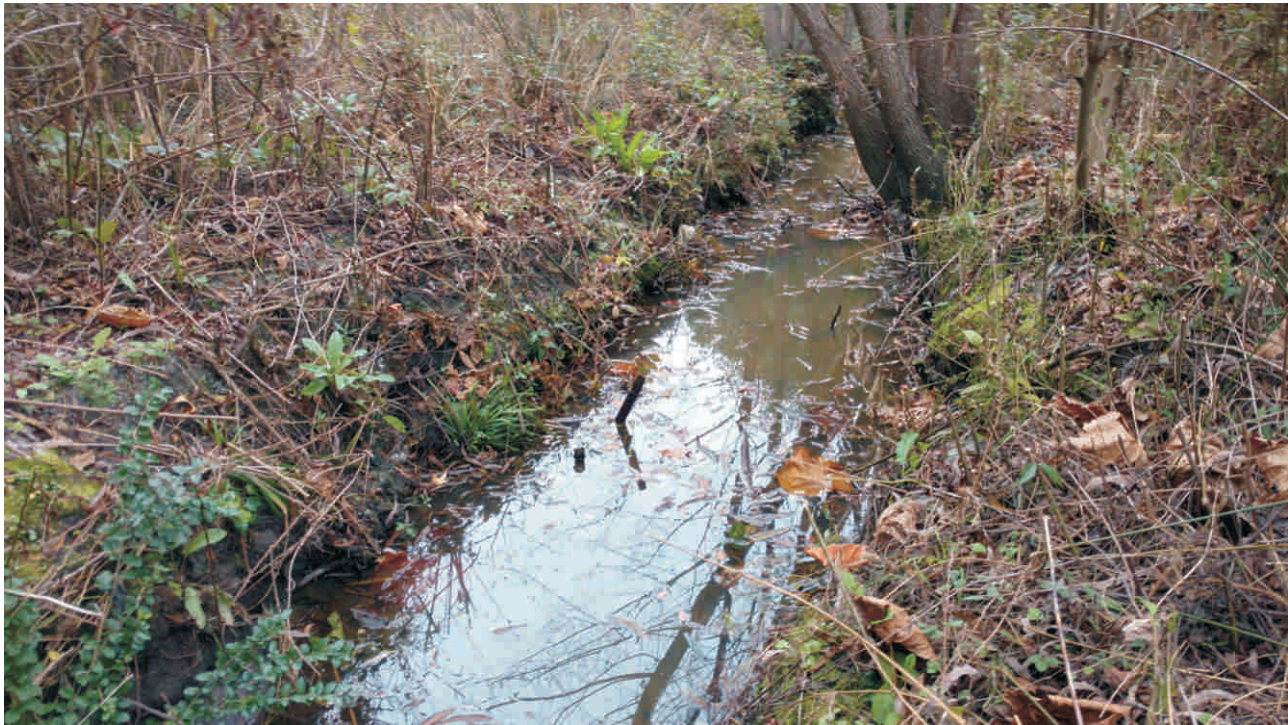
Reach 1A - Stream Problem Area #7; degradation

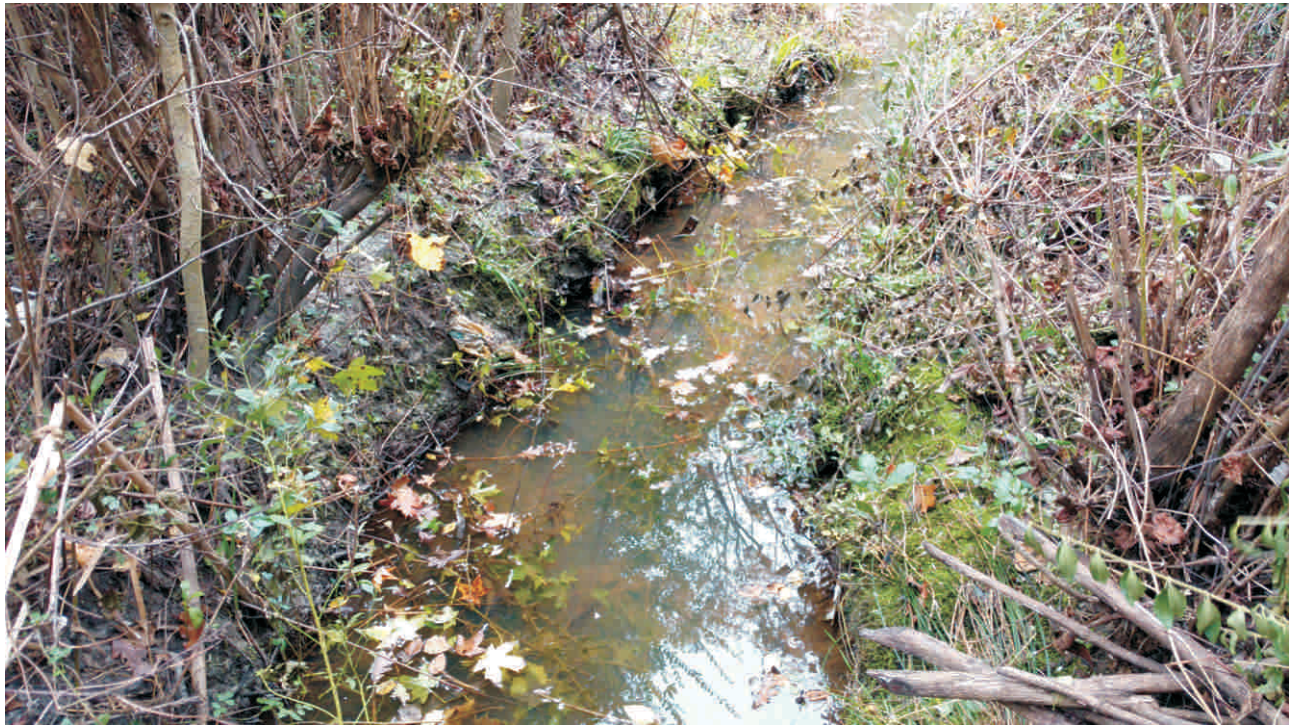
Reach 1A - Stream Problem Area #8; degradation

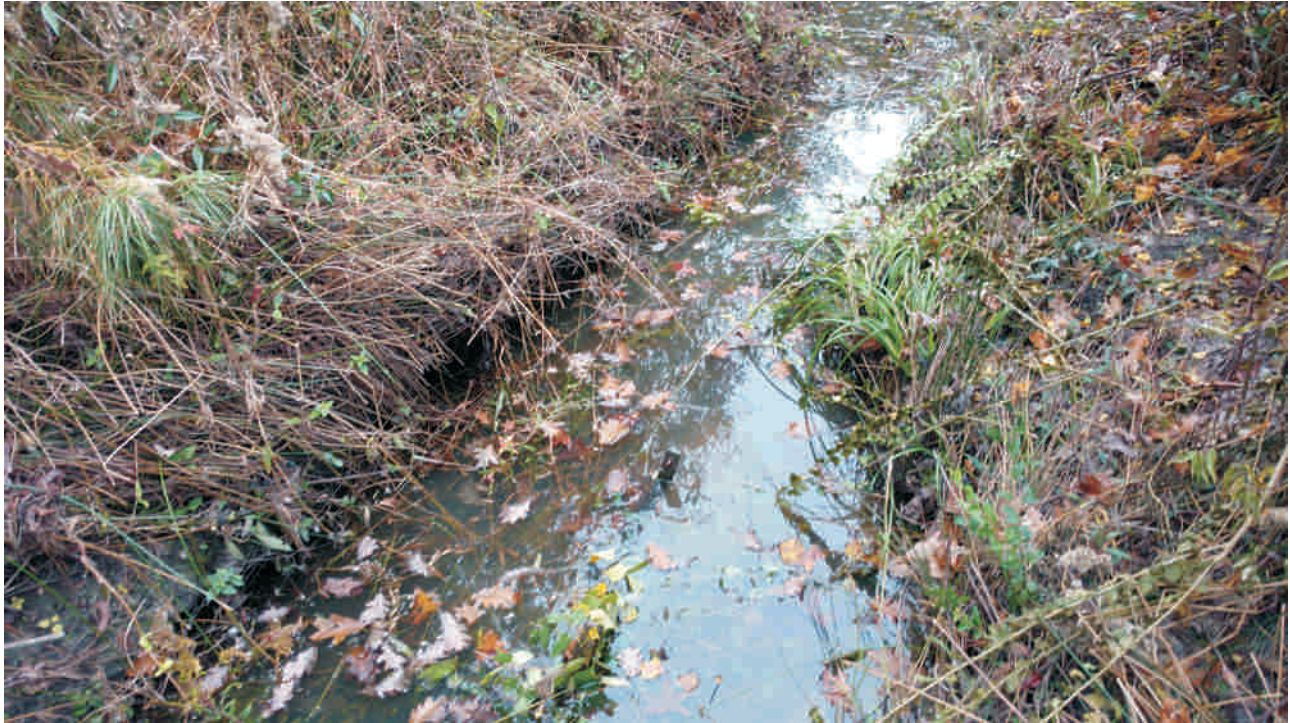
Reach 1A - Stream Problem Area #9; Degradation

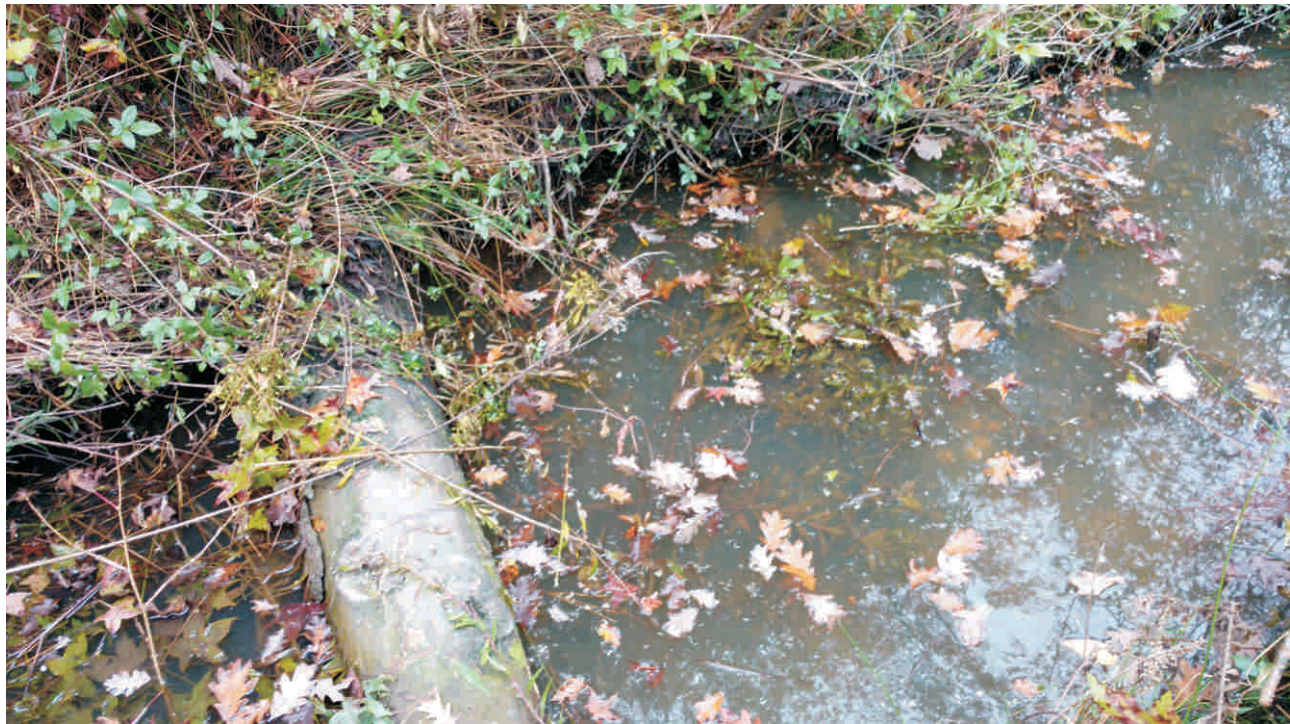
Reach 1A - Stream Problem Area #10; Log Vane Undercut becoming scour

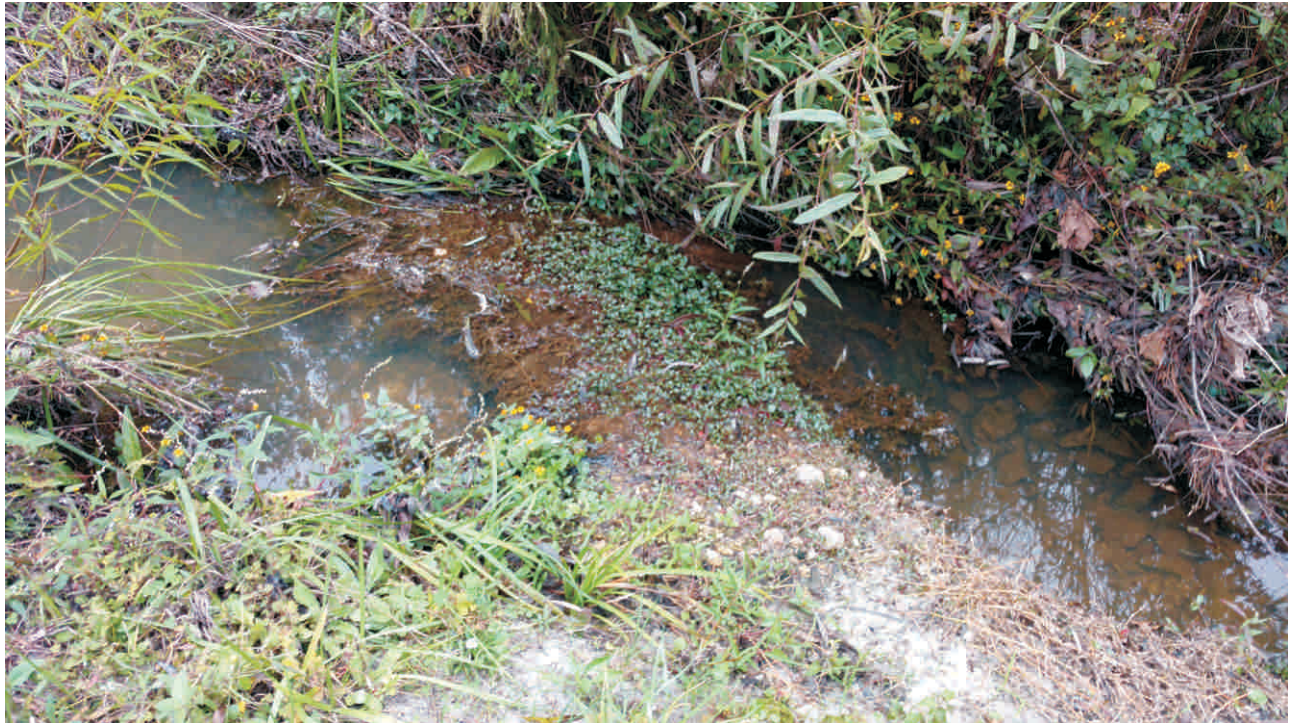
Reach 1A - Stream Problem Area #12a; Aggradation

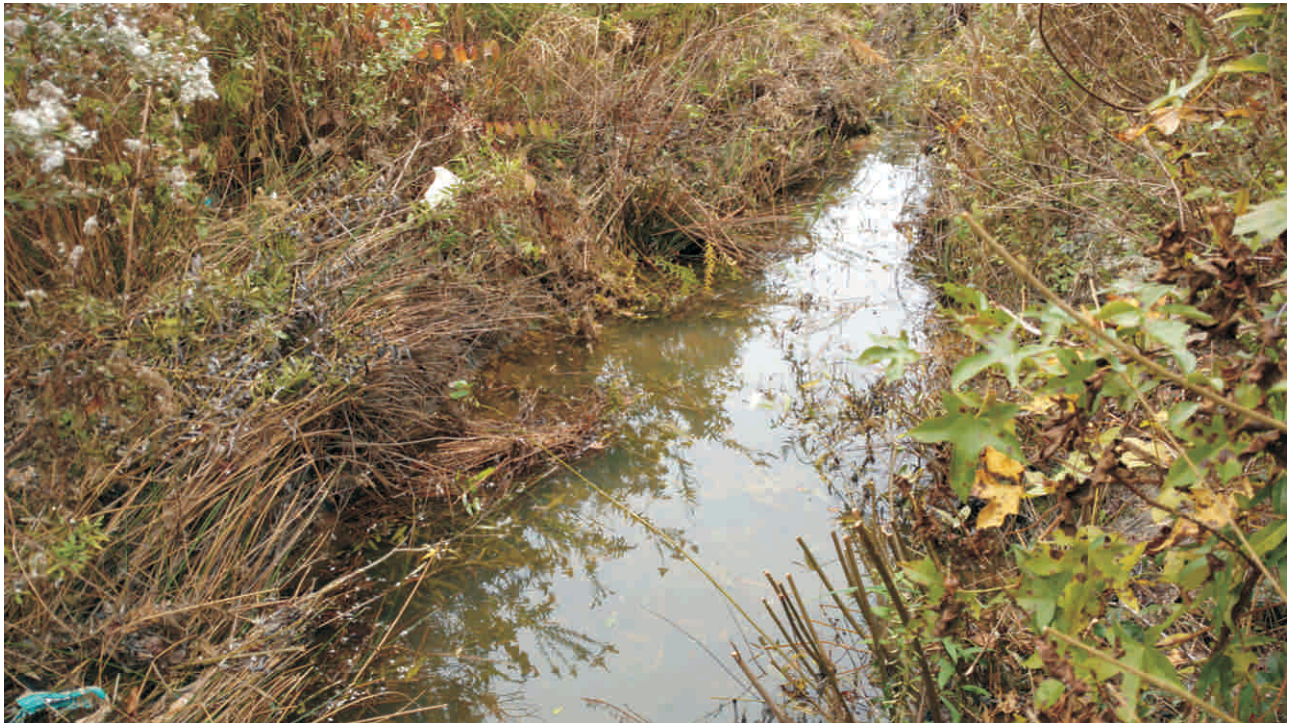
Reach 1A - Stream Problem Area #13a; Scour

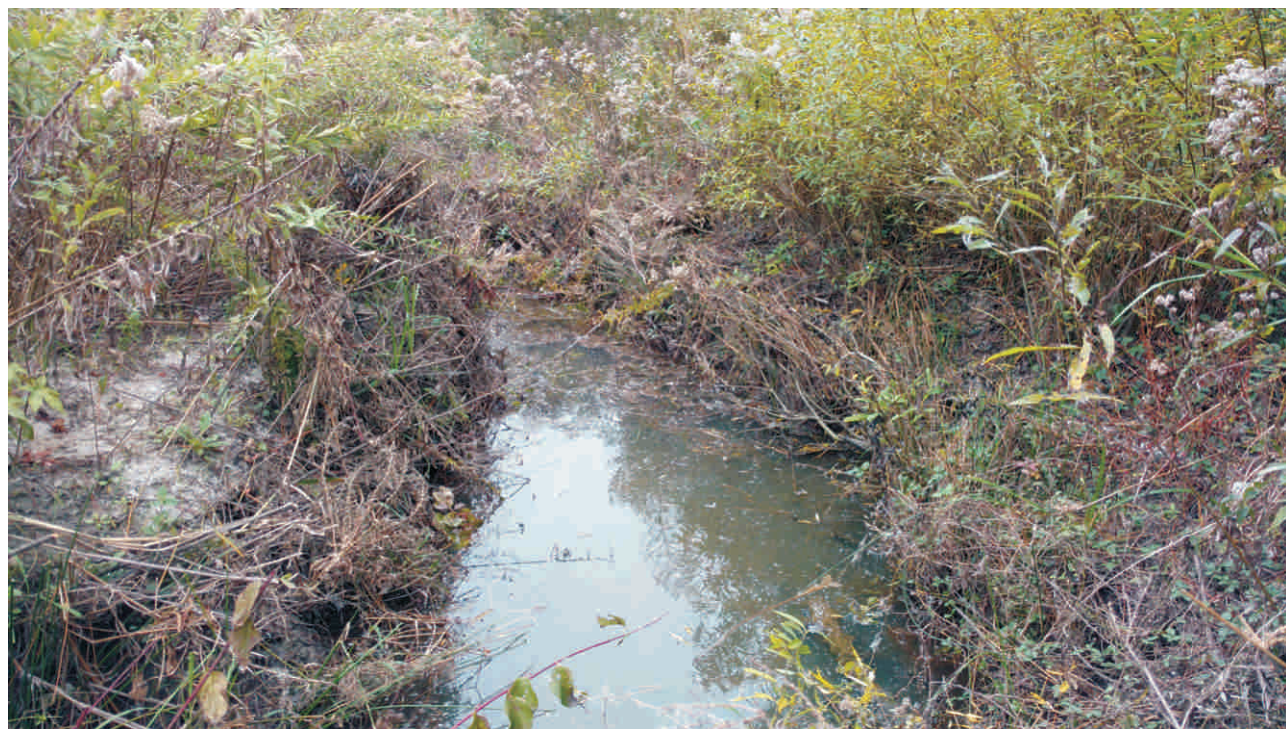
Reach 1A - Stream Problem Area #13b; Degradation

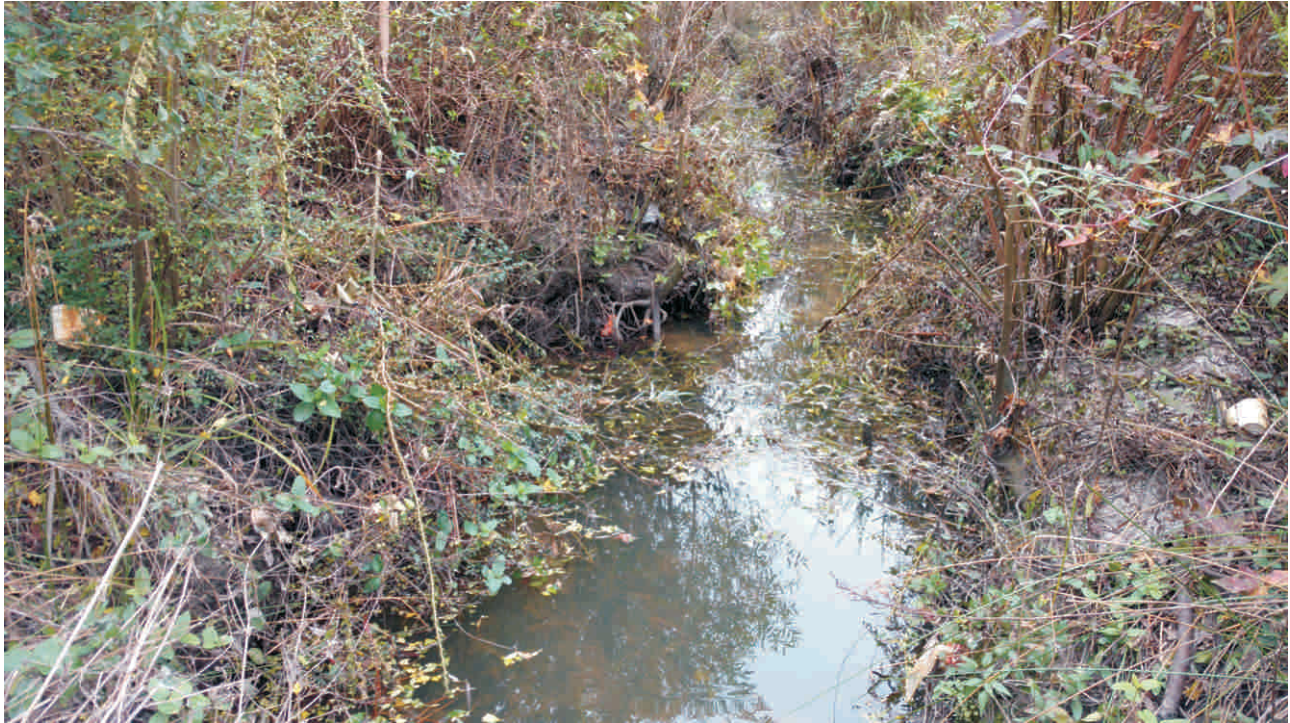
Reach 1A - Stream Problem Area #14; Scour

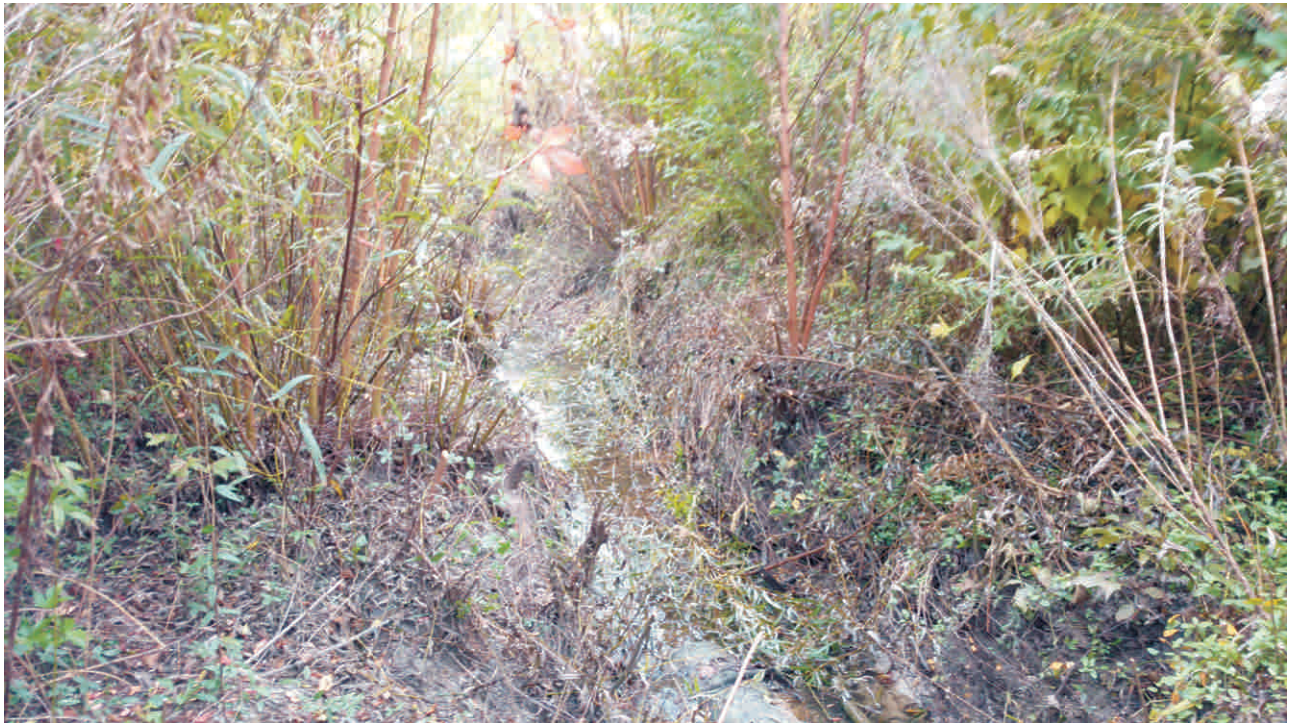
Reach 1A - Stream Problem Area #17; Degradation

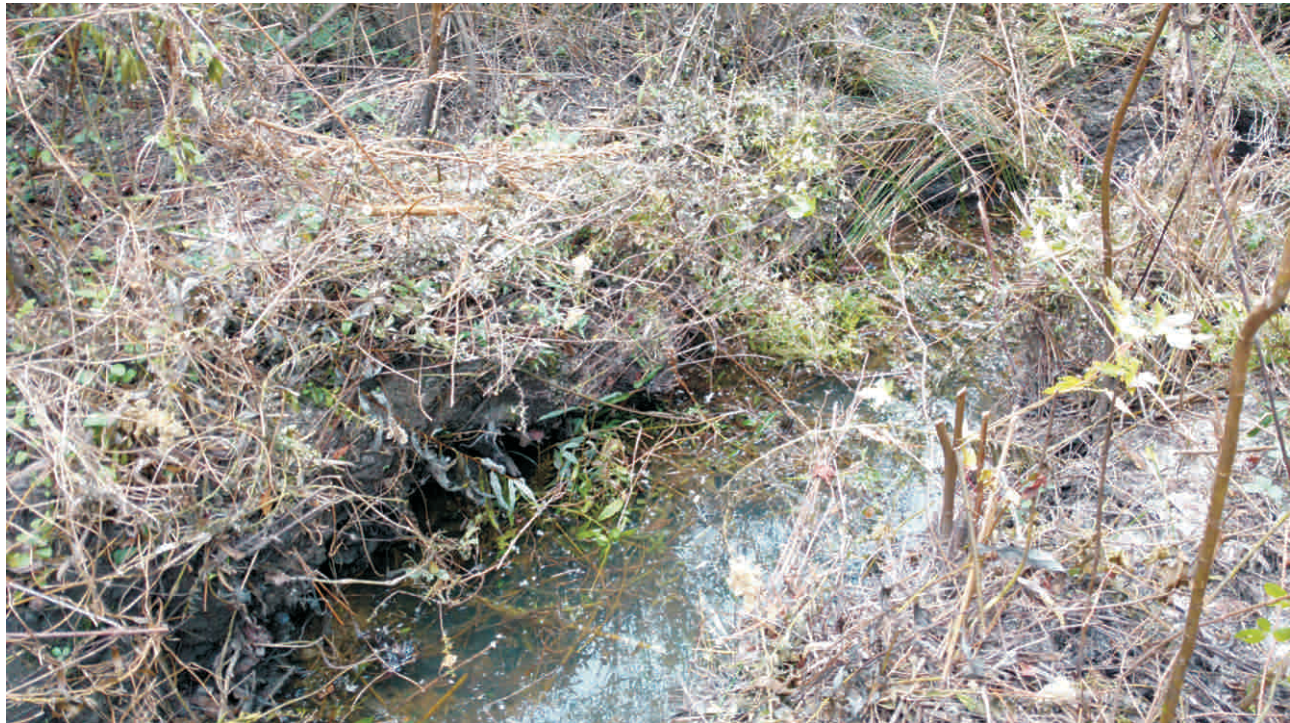
Reach 1A - Stream Problem Areas #18 & 19; Scour & Mass Wasting

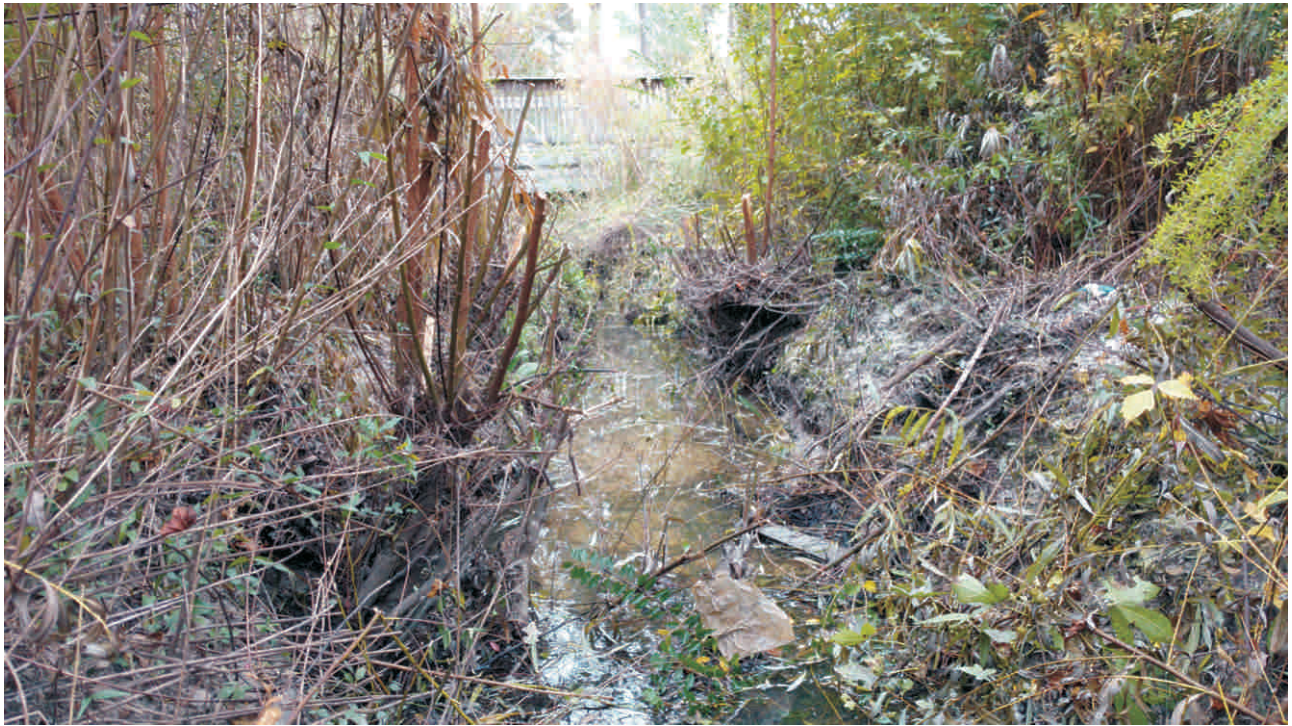
Reach 1A - Stream Problem Area #20; Degradation

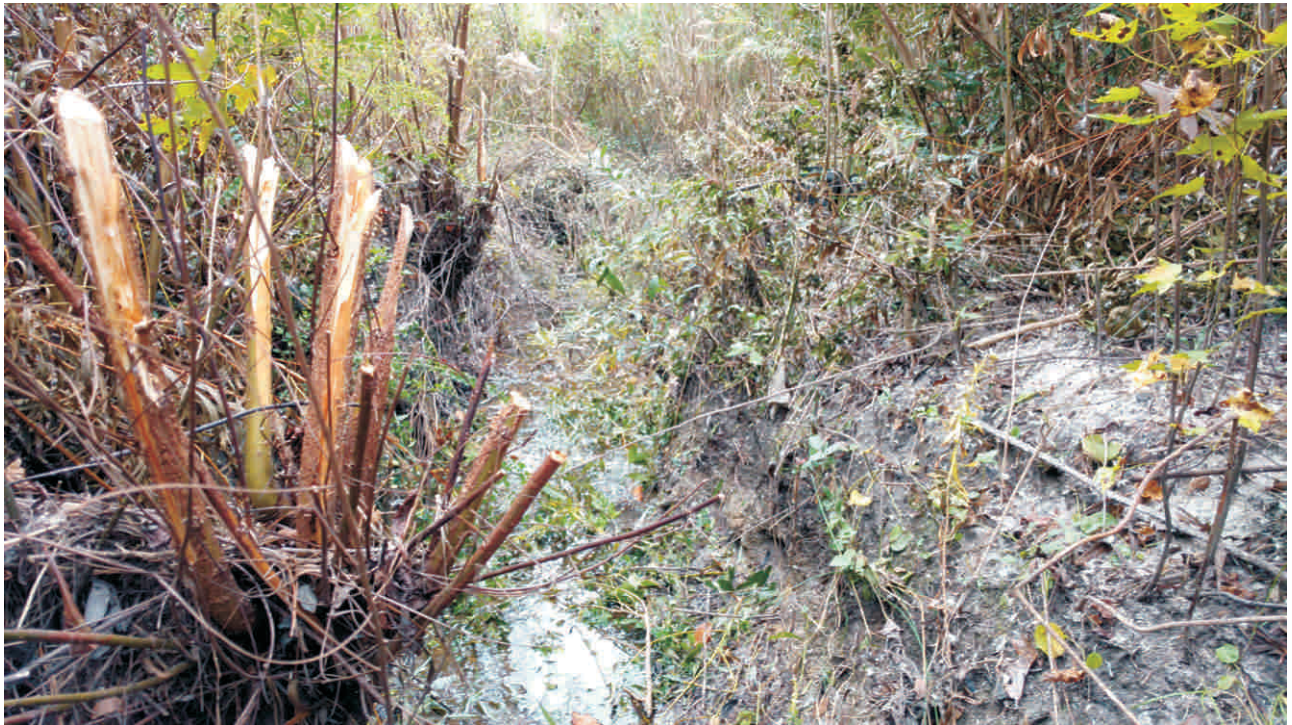
Reach 1A - Stream Problem Area #20a; Scour

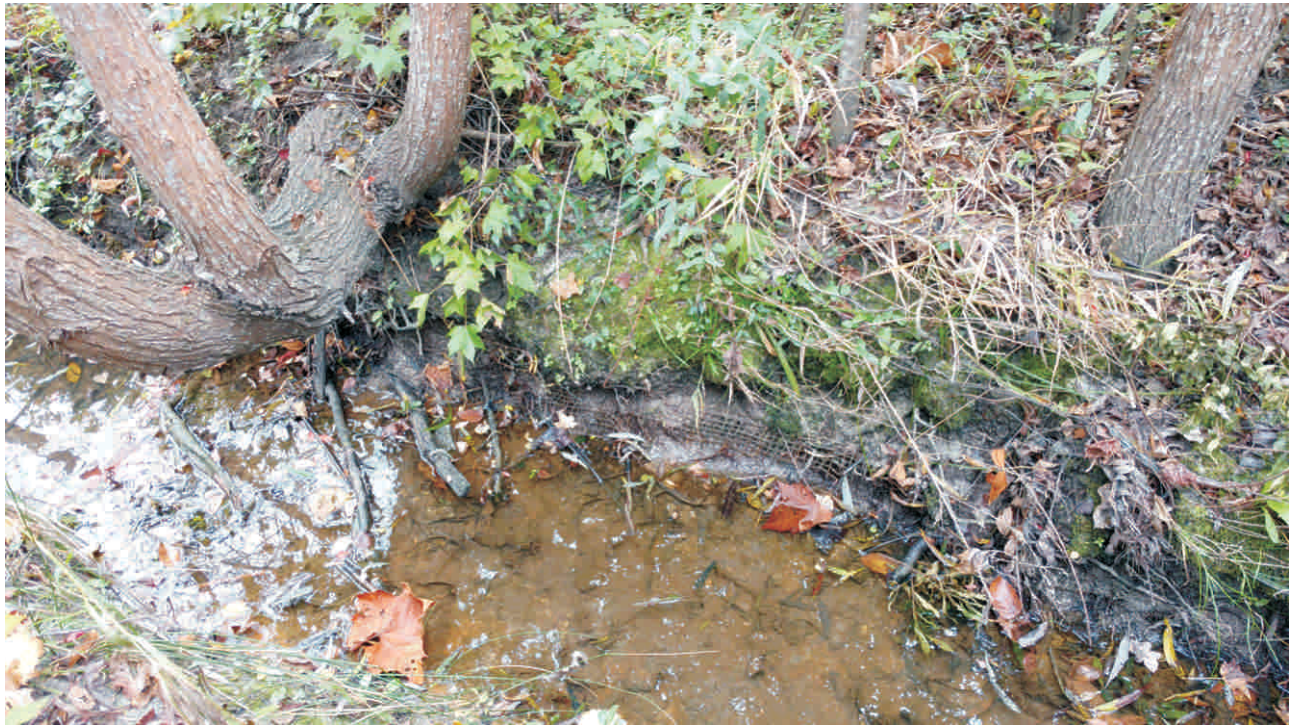
Reach 1A - Stream Problem Area #21; Bank Undercut

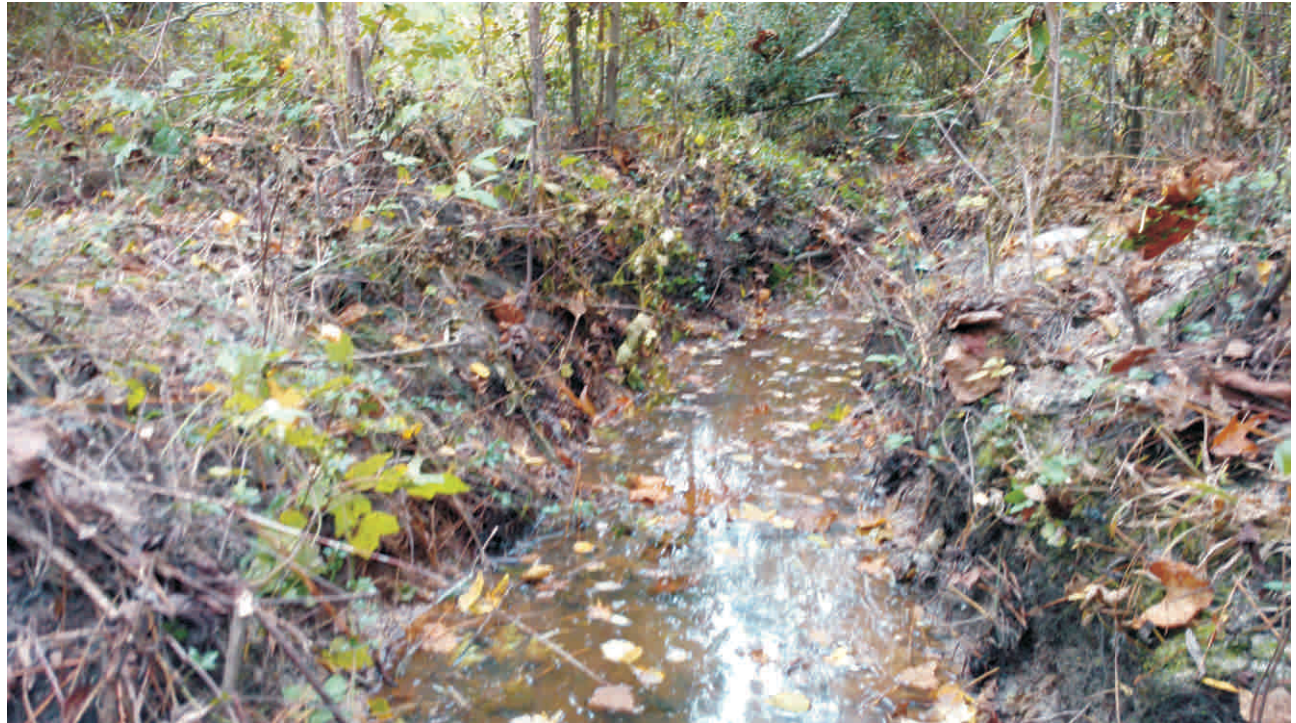
Reach 1A - Stream Problem Area #22; Degradation

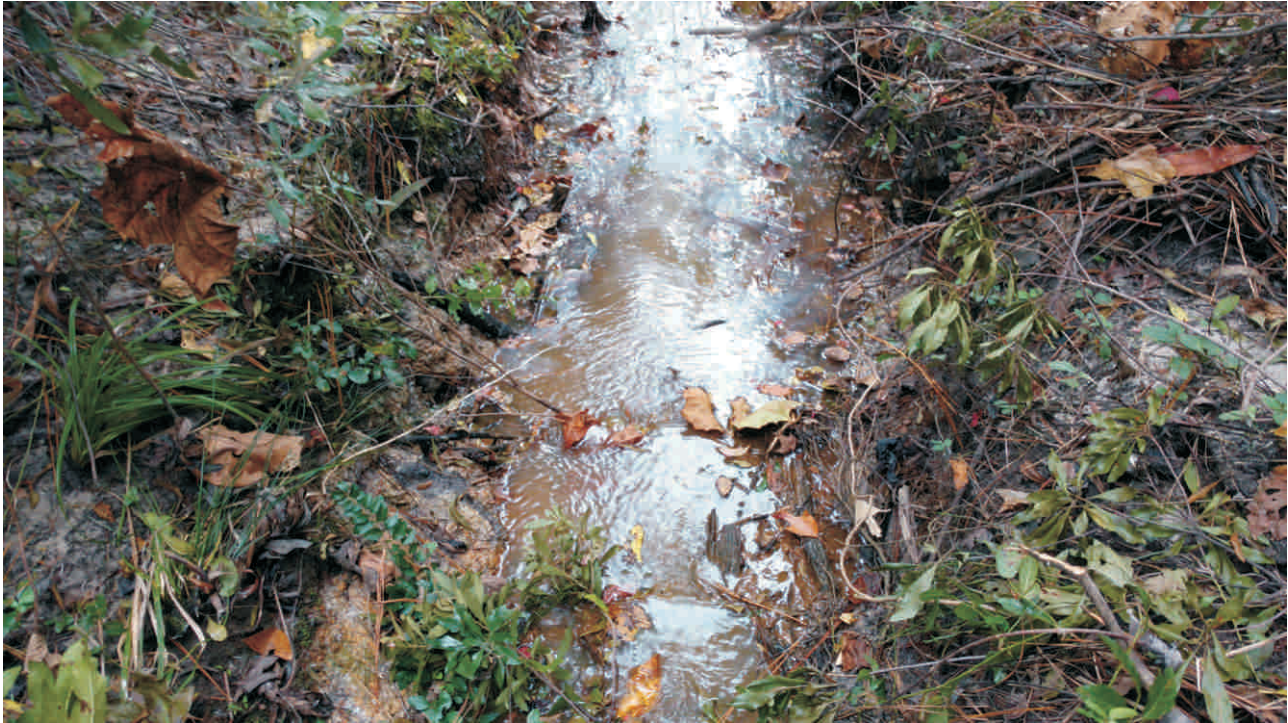
Reach 1A - Stream Problem Area #23; Degradation

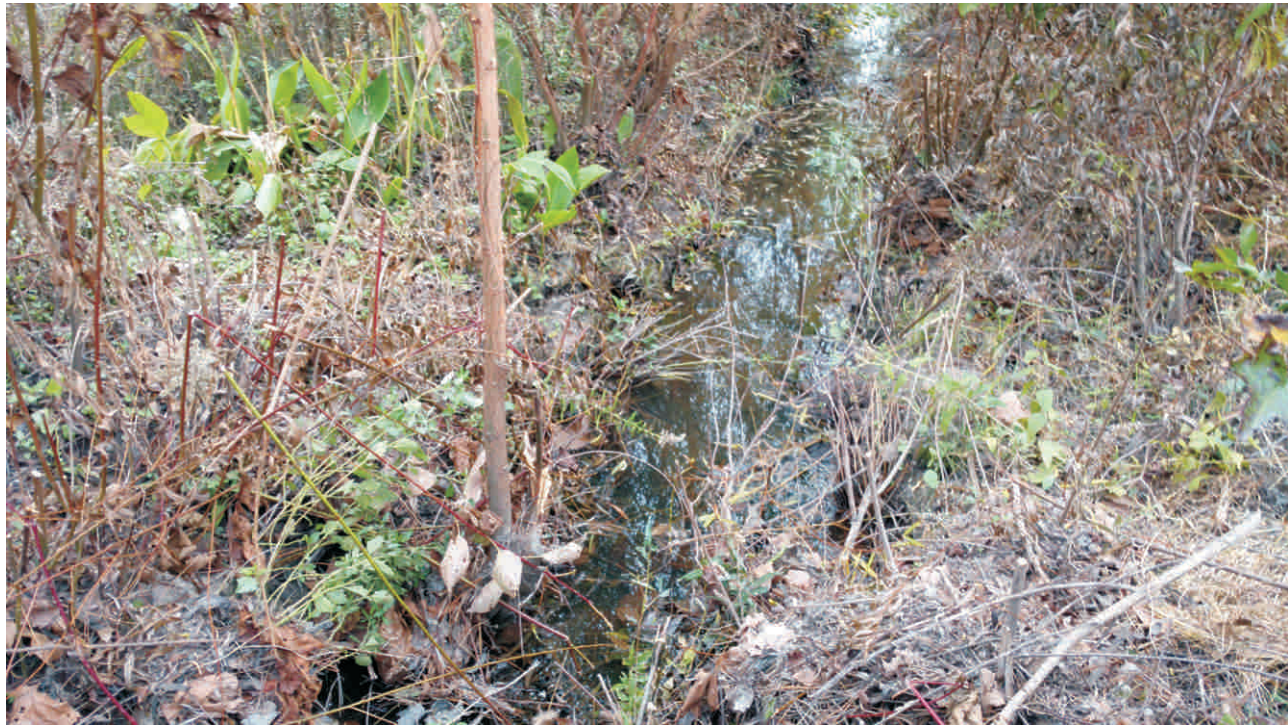
Reach 1A - Stream Problem Area #24; Degradation
