Jacksonville Country Club Stream Restoration and Enhancement Project

**SCO No. 070715501
DEQ Contract No. D08049S
DMS Project No. 194
Action ID# 2006-40325-067
Onslow County, North Carolina**

**Year 4 of 5 Monitoring Report
Data Collection: January through December 2017
Submission Date: March 9, 2018**

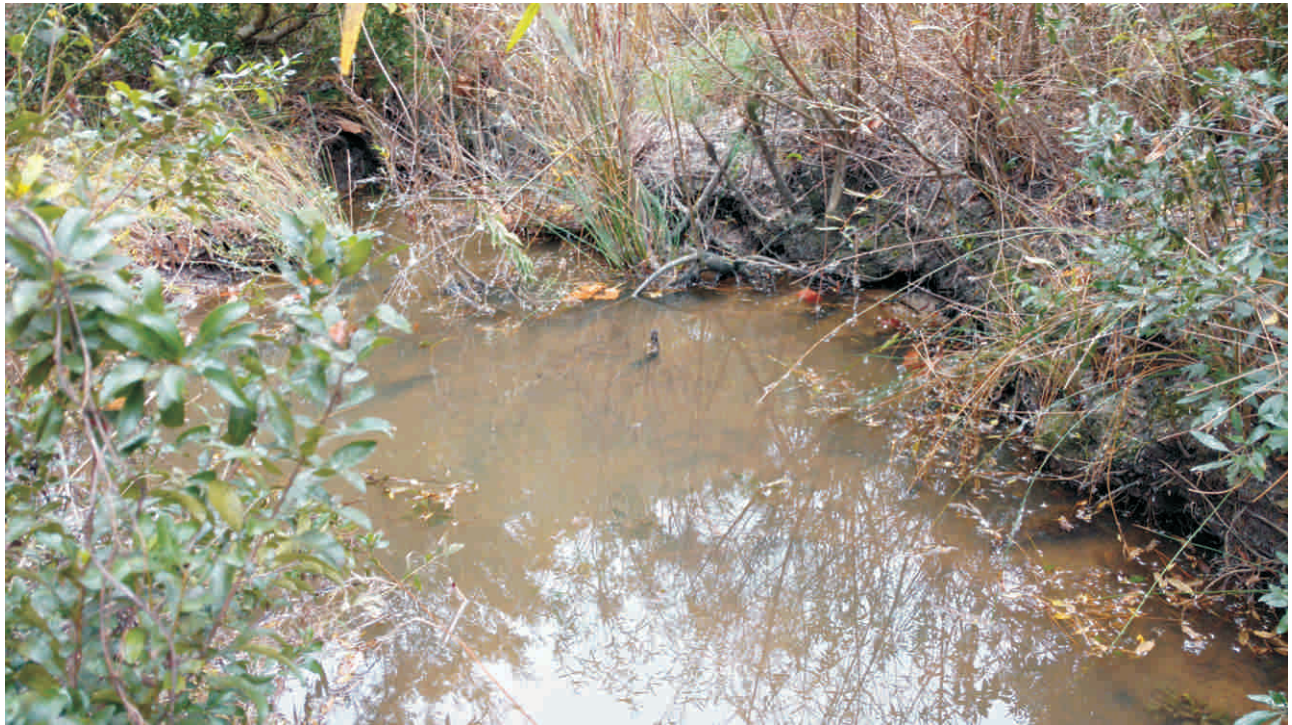
Reach 2A - Stream Problem Area #26; Mass Wasting

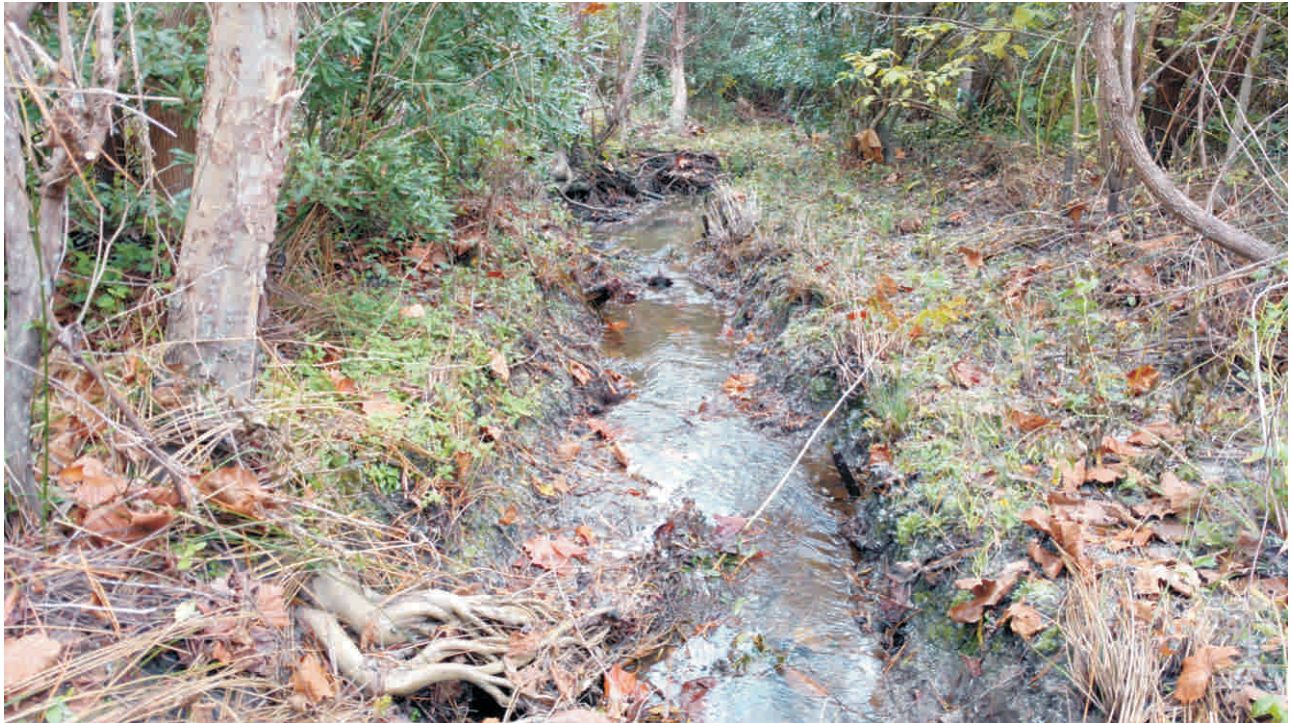
Reach 2A - Stream Problem Area #28; Degradation

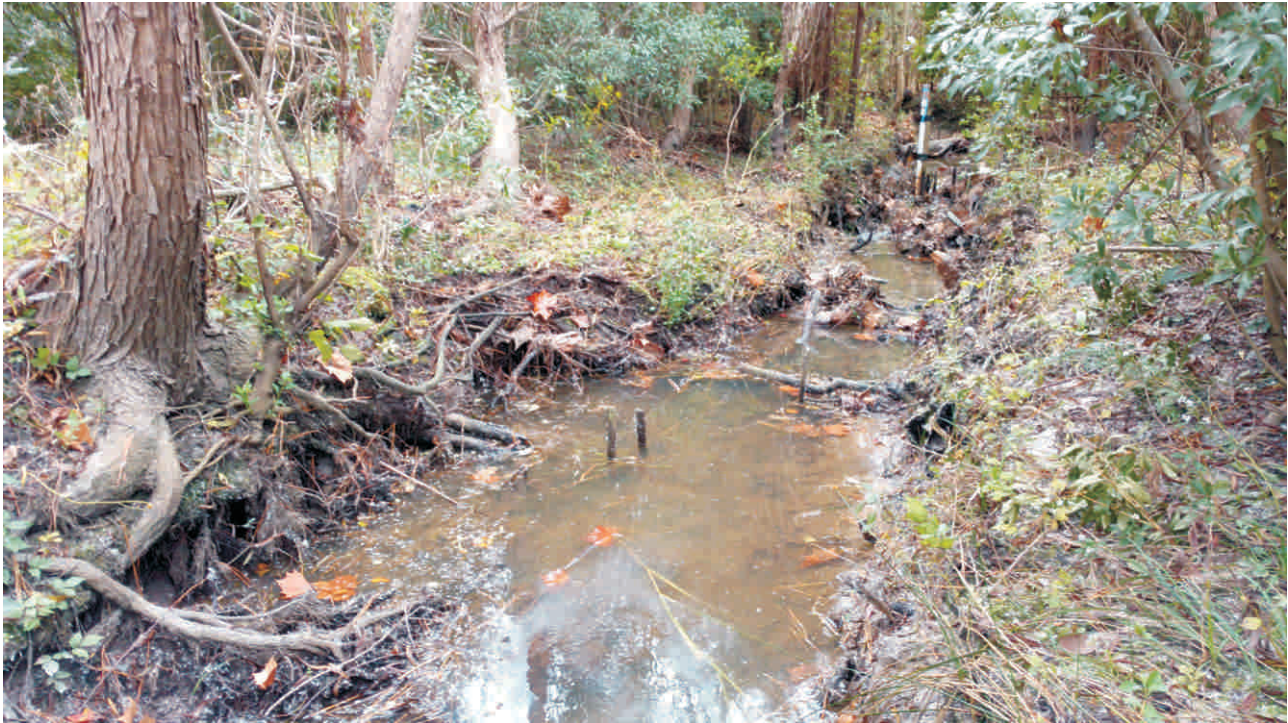
Reach 2A - Stream Problem Area #29; Scour

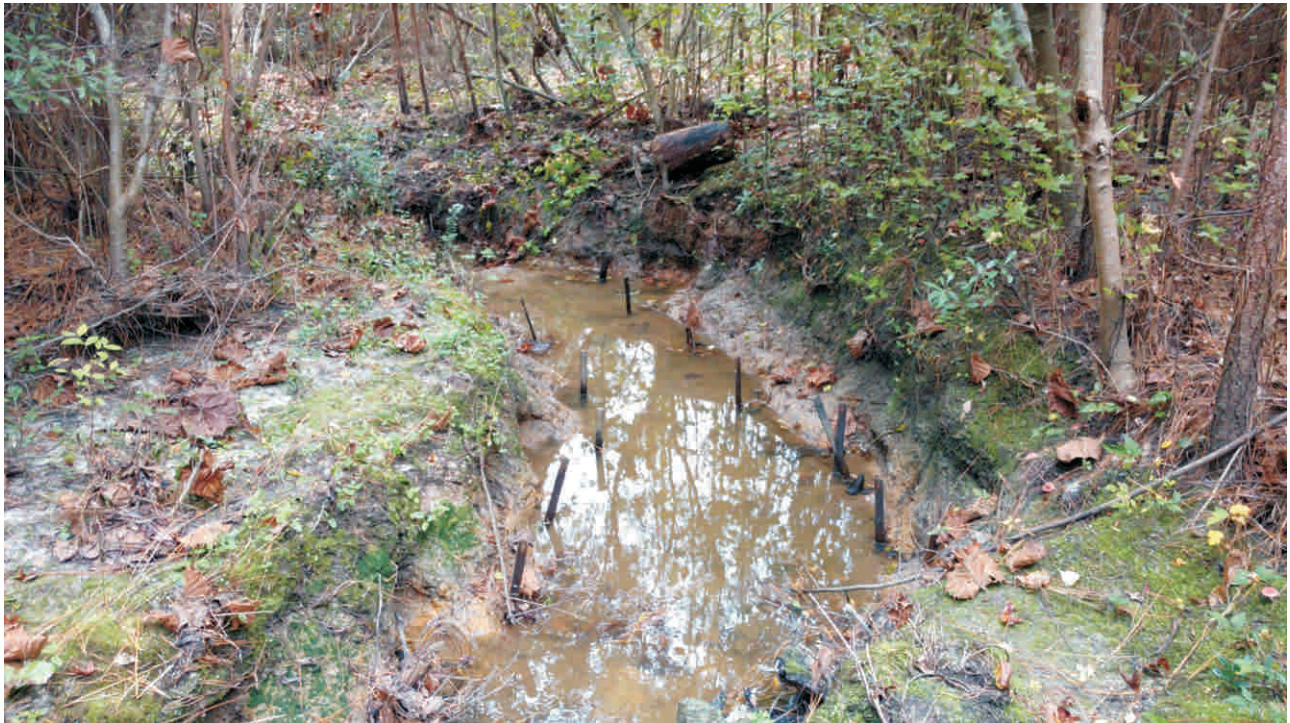
Reach 2A - Stream Problem Area #32; Degradation

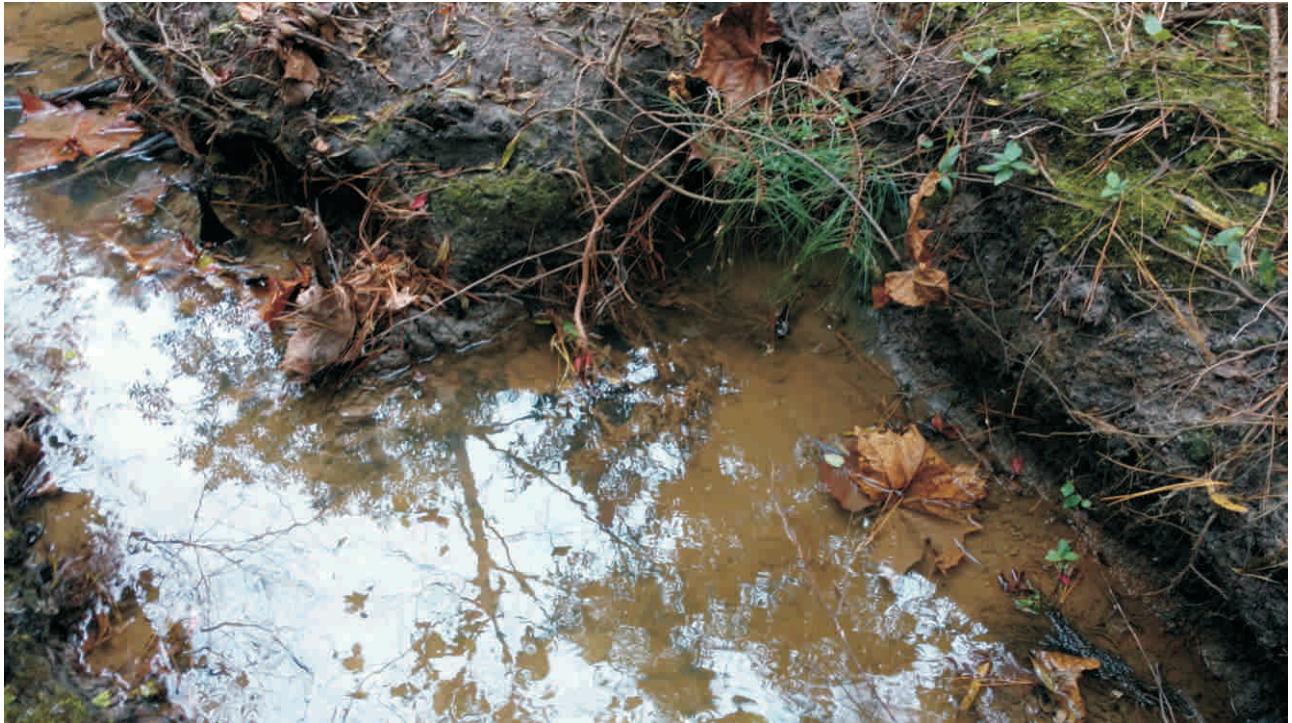
Reach 2A - Stream Problem Area #33; Scour

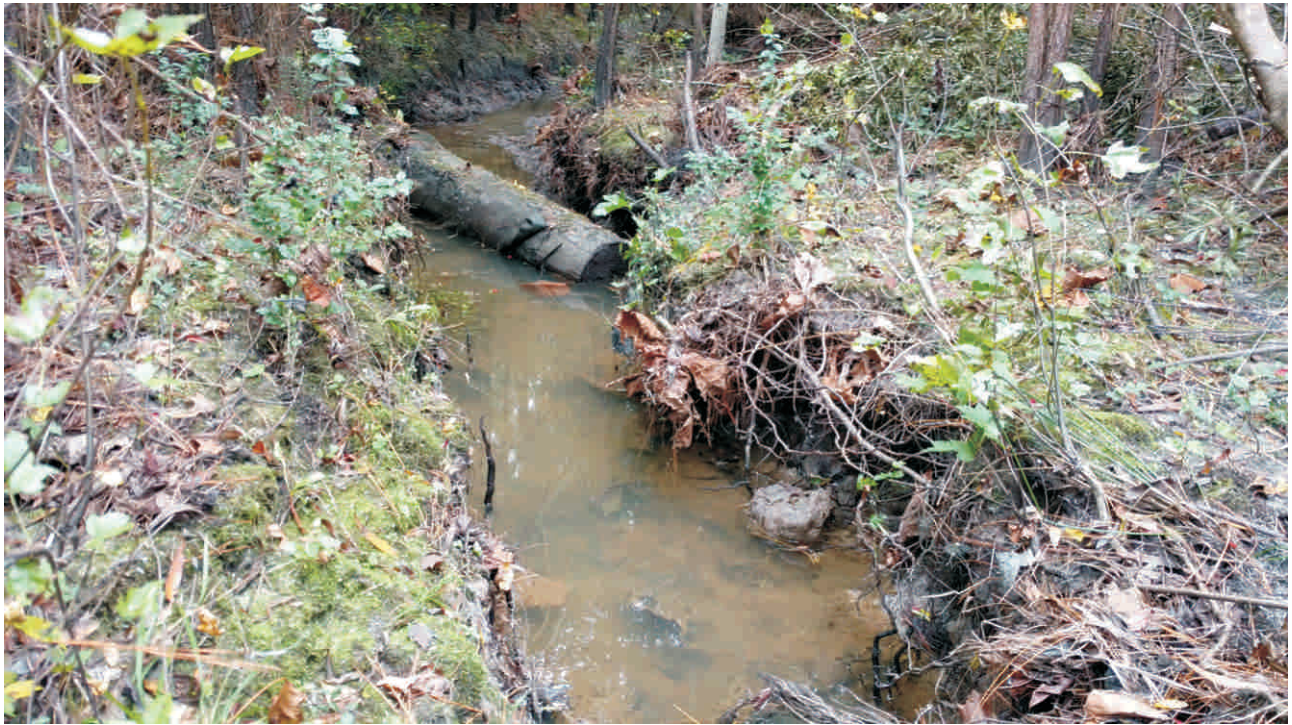
Reach 2A - Stream Problem Area #34; Log Vane Undercut

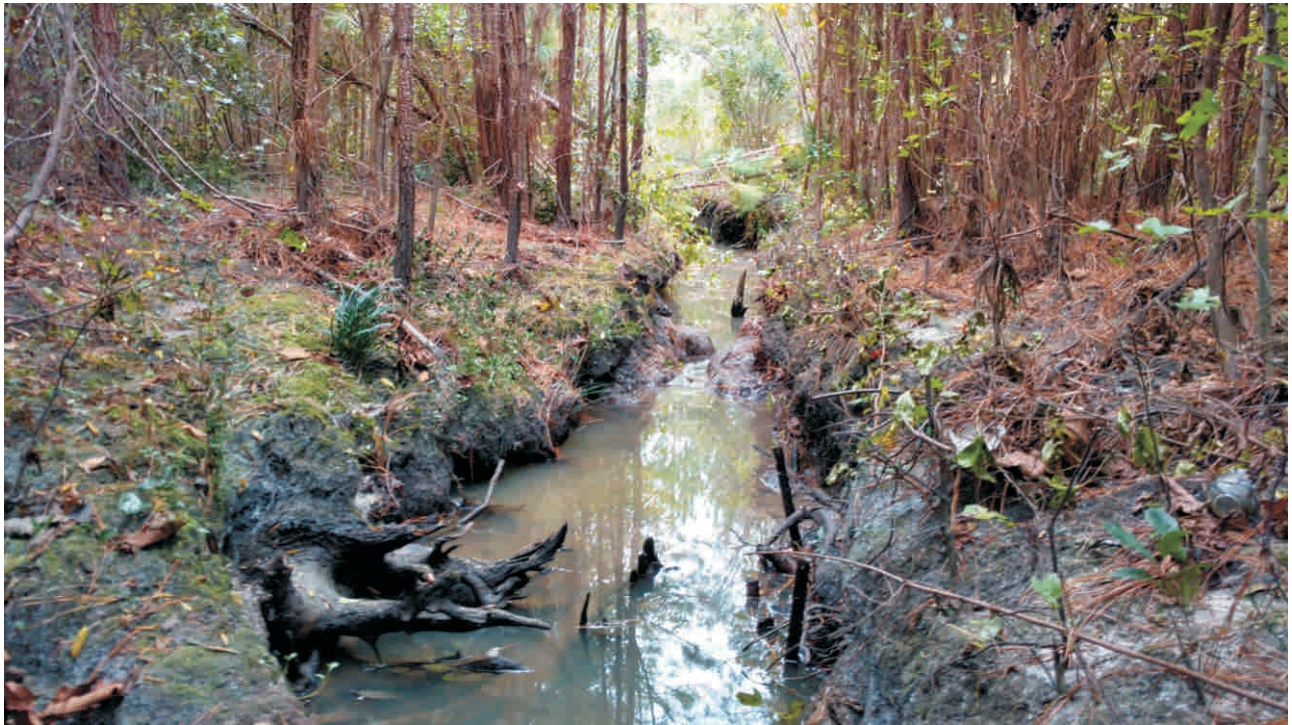
Reach 2A - Stream Problem Area #36; Degradation

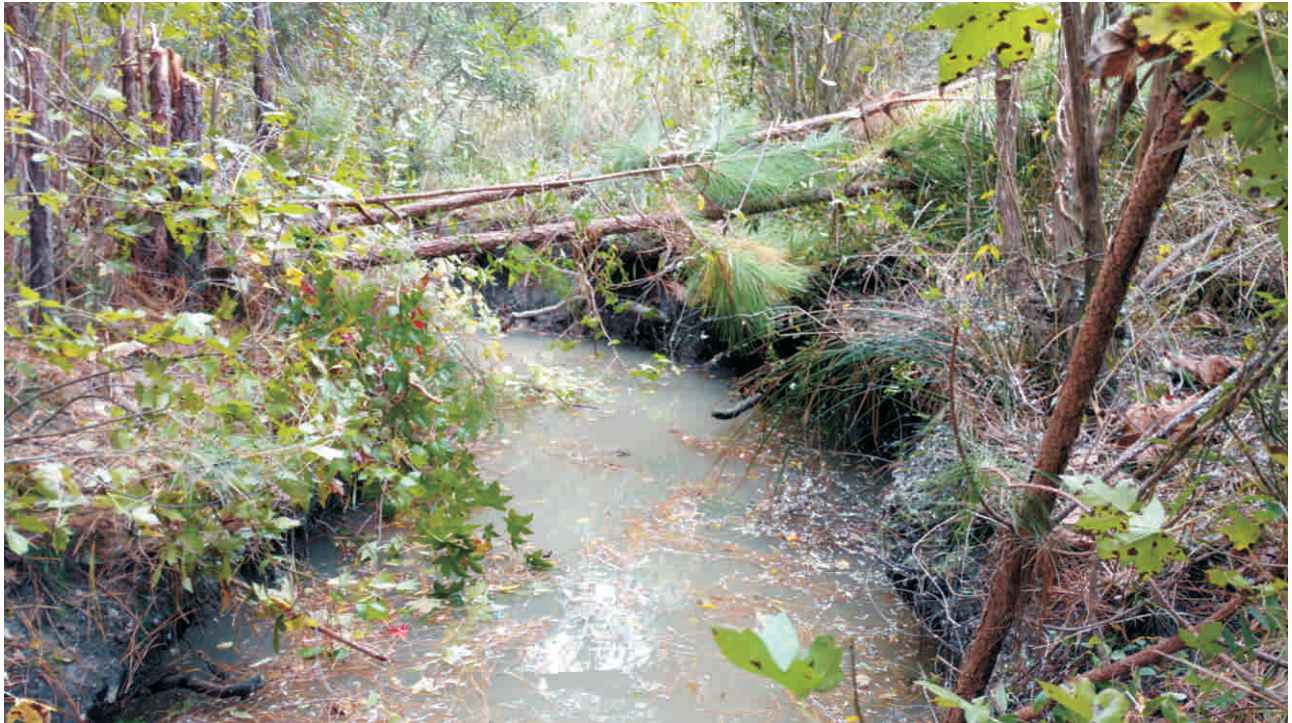
Reach 2A - Stream Problem Area #37; Undercut turning into Mass Wasting

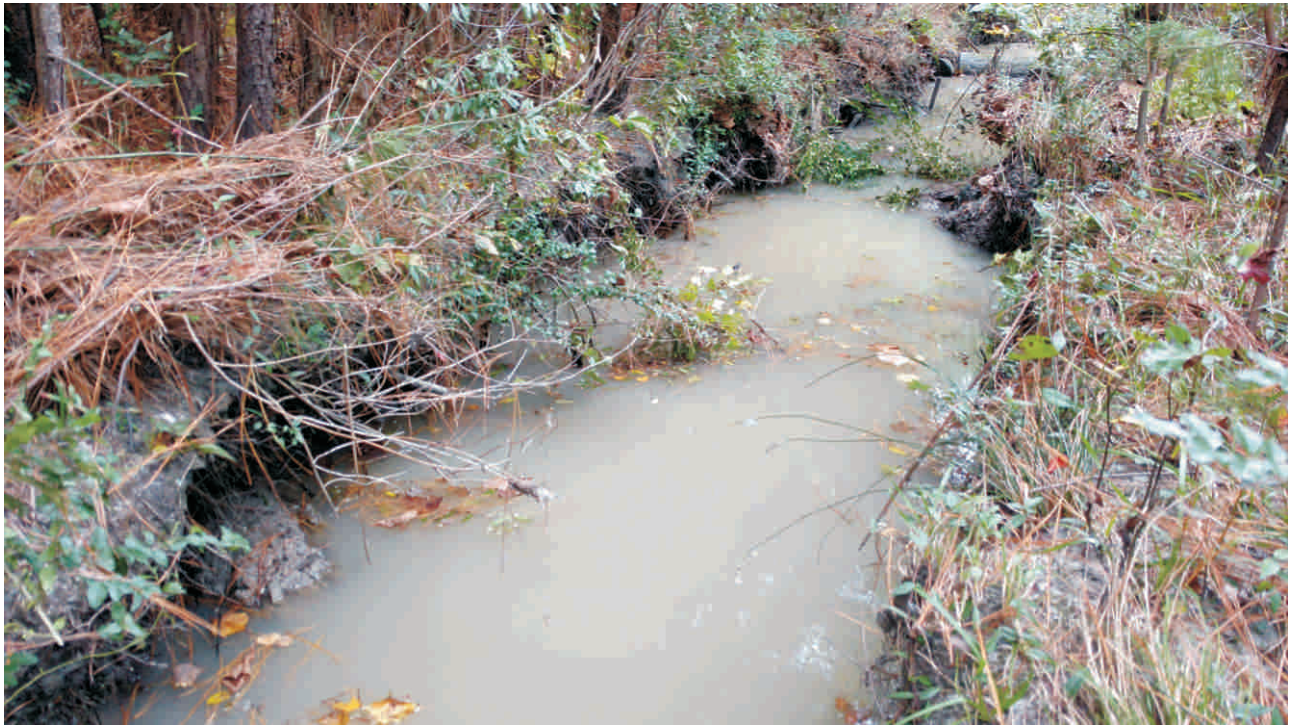
Reach 2A - Stream Problem Areas #38 & 39; Degradation and Undercut

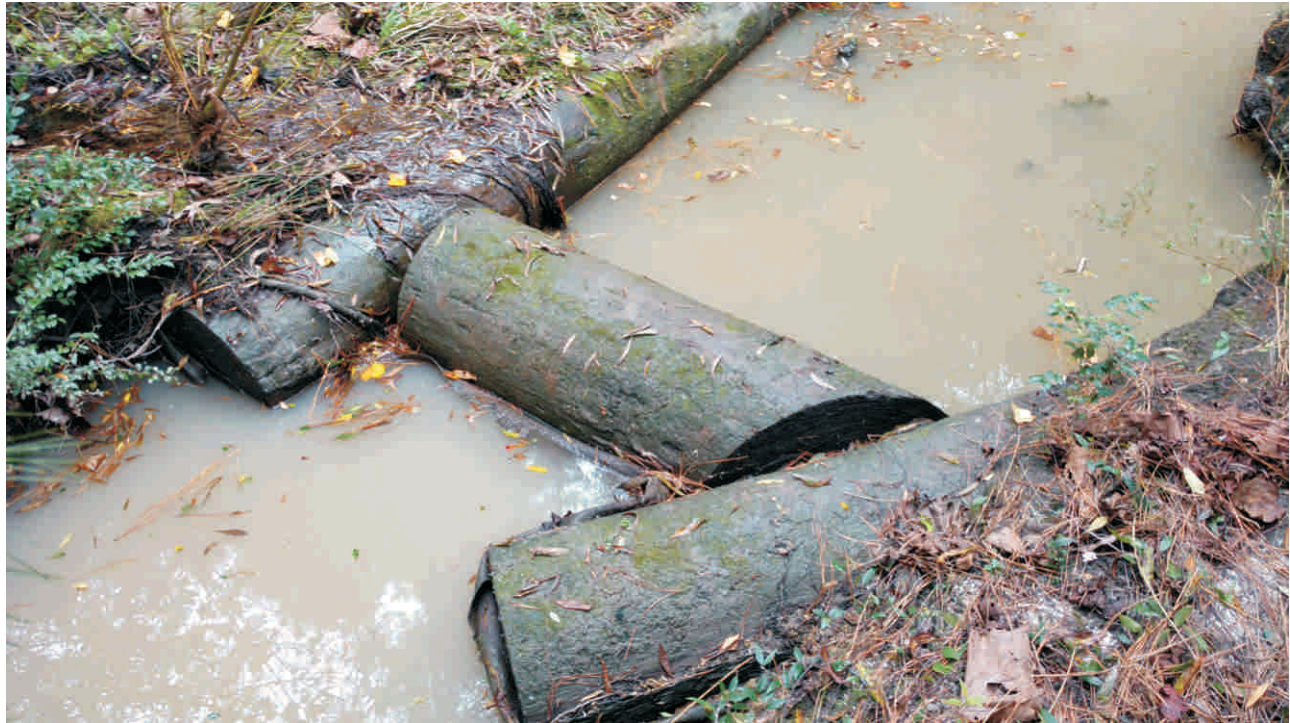
Reach 2A - Stream Problem Area #40; Log Vane Scour

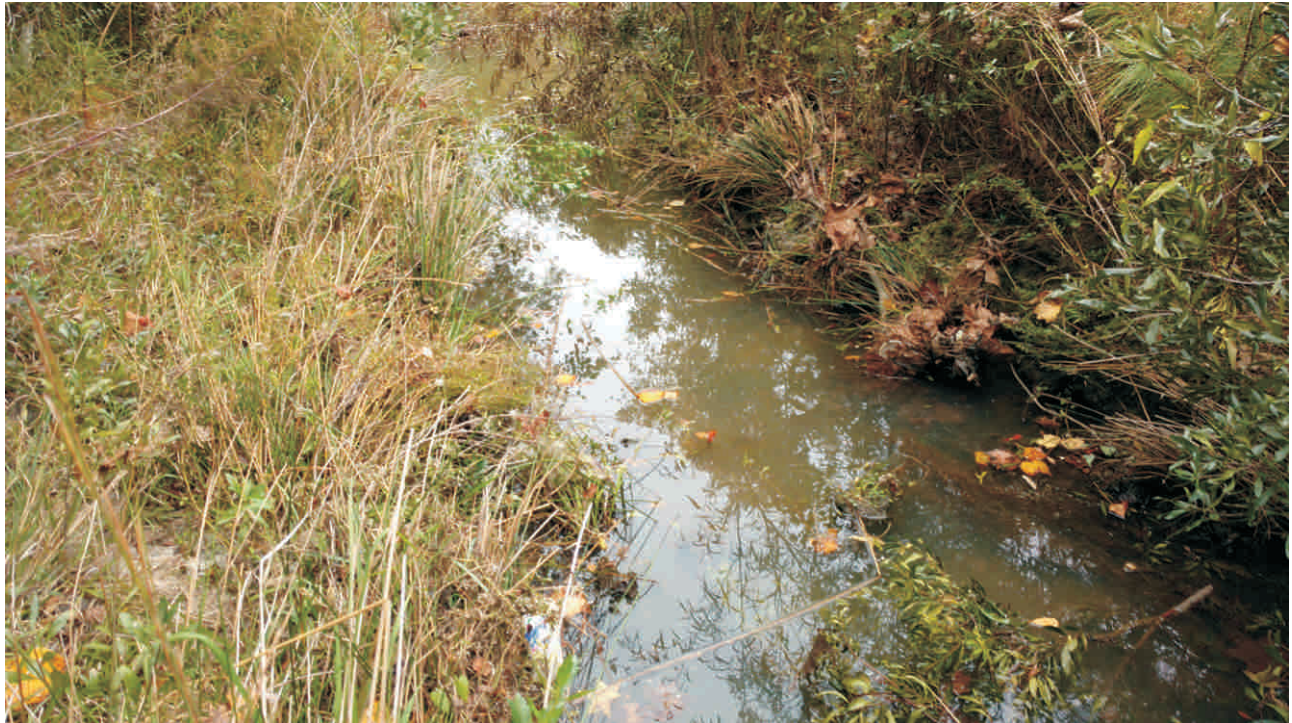
Reach 2A - Stream Problem Area #43; Degradation

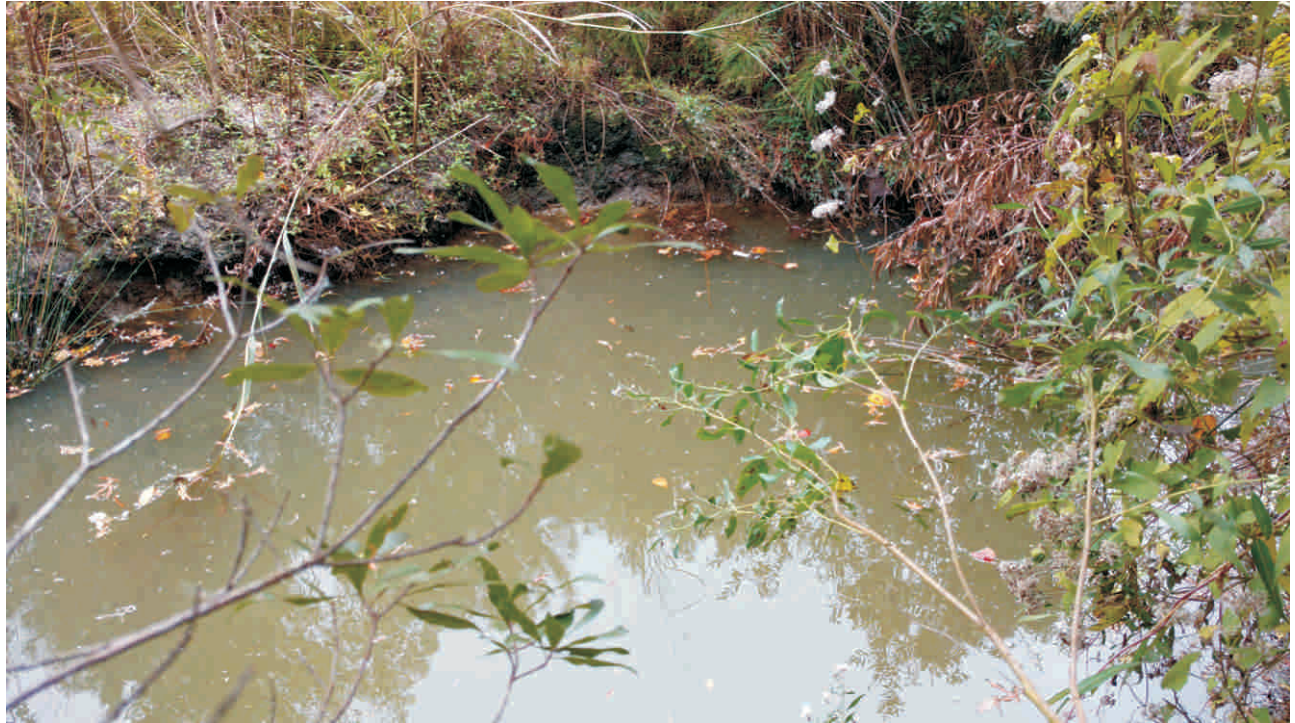
Reach 2A - Stream Problem Area #43a; Scour

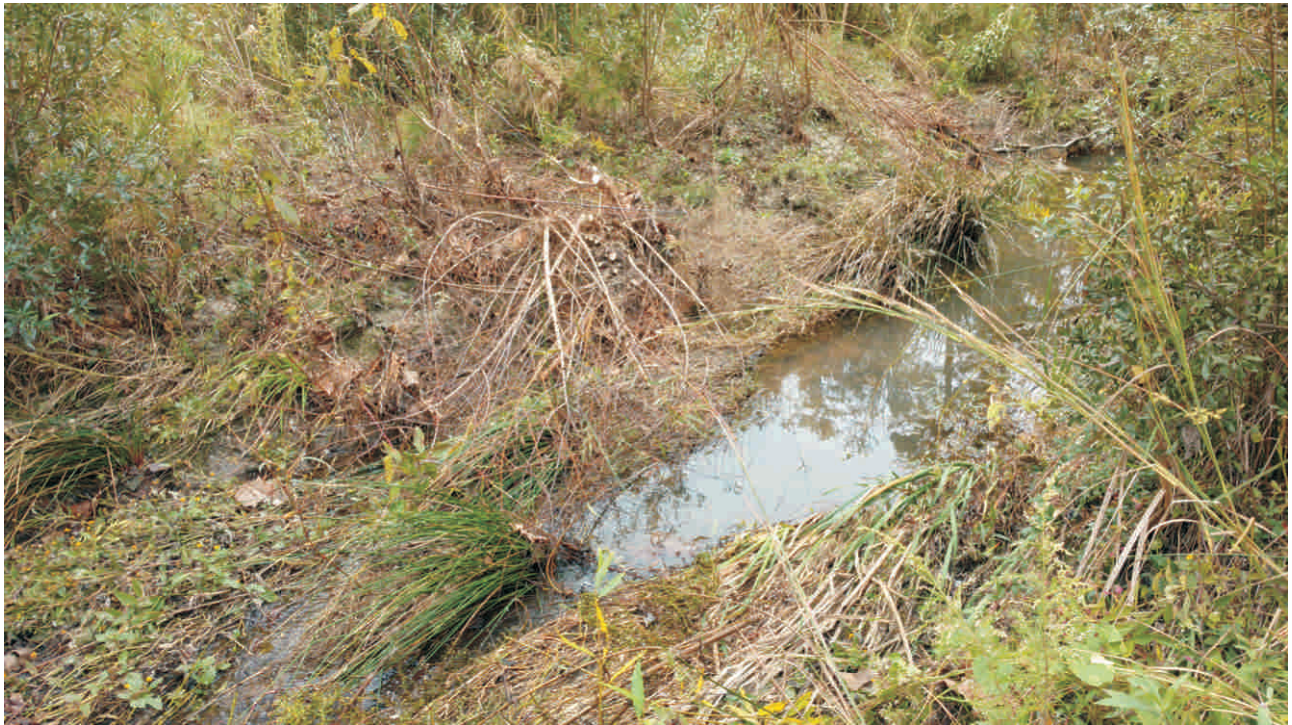
Reach 2A - Stream Problem Area #49; Mass Wasting

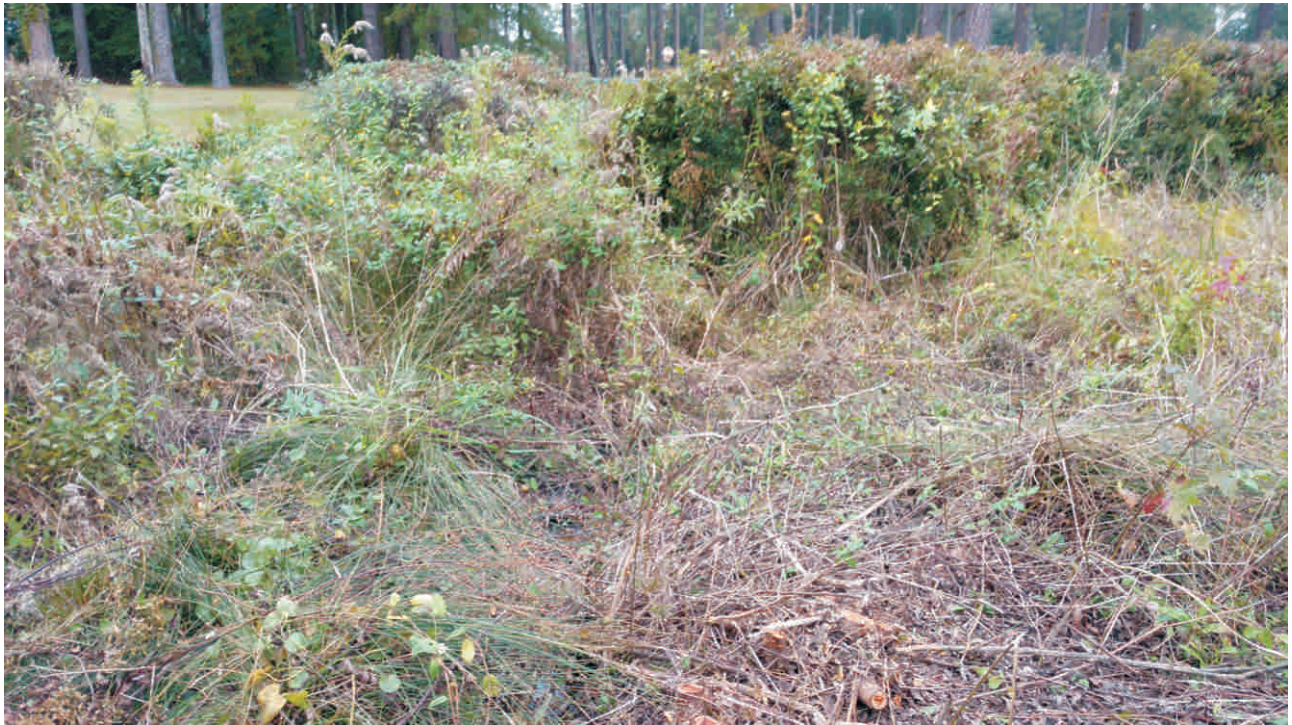
Enhancement Reach - Stream Problem Area #57; Aggradation

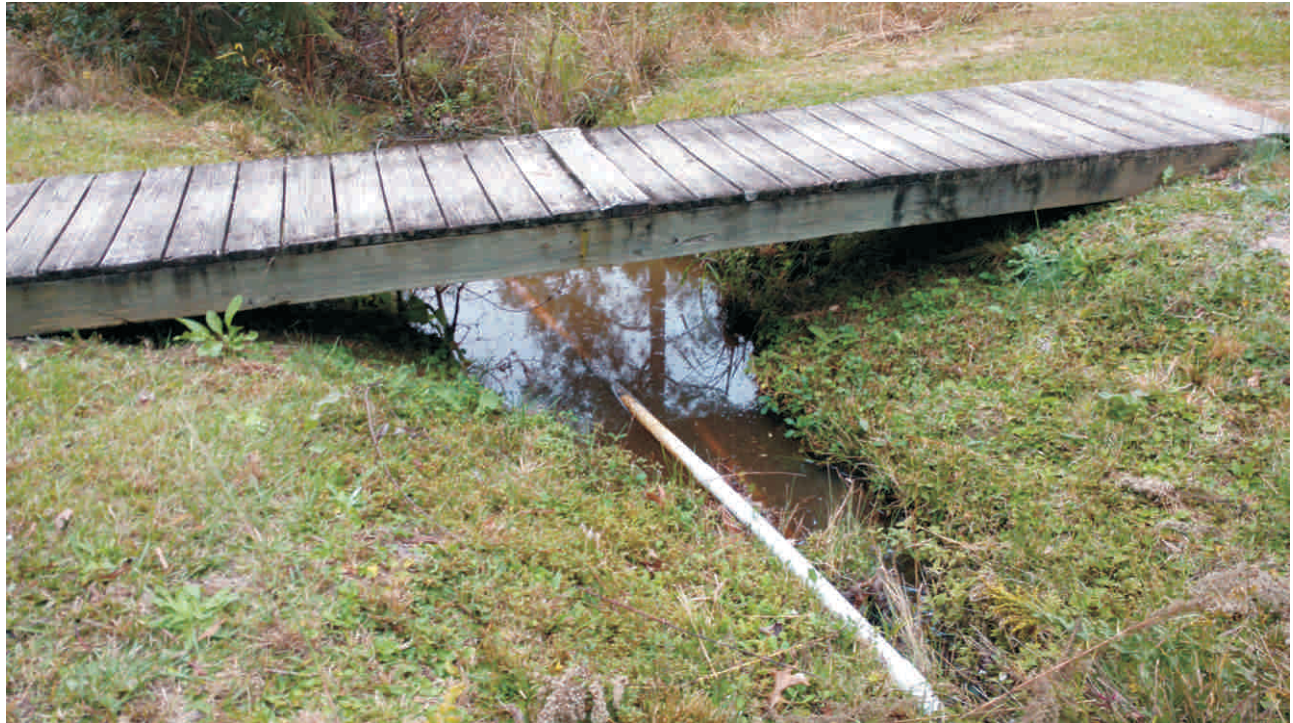
Enhancement Reach - Stream Problem Area #57a; Scour

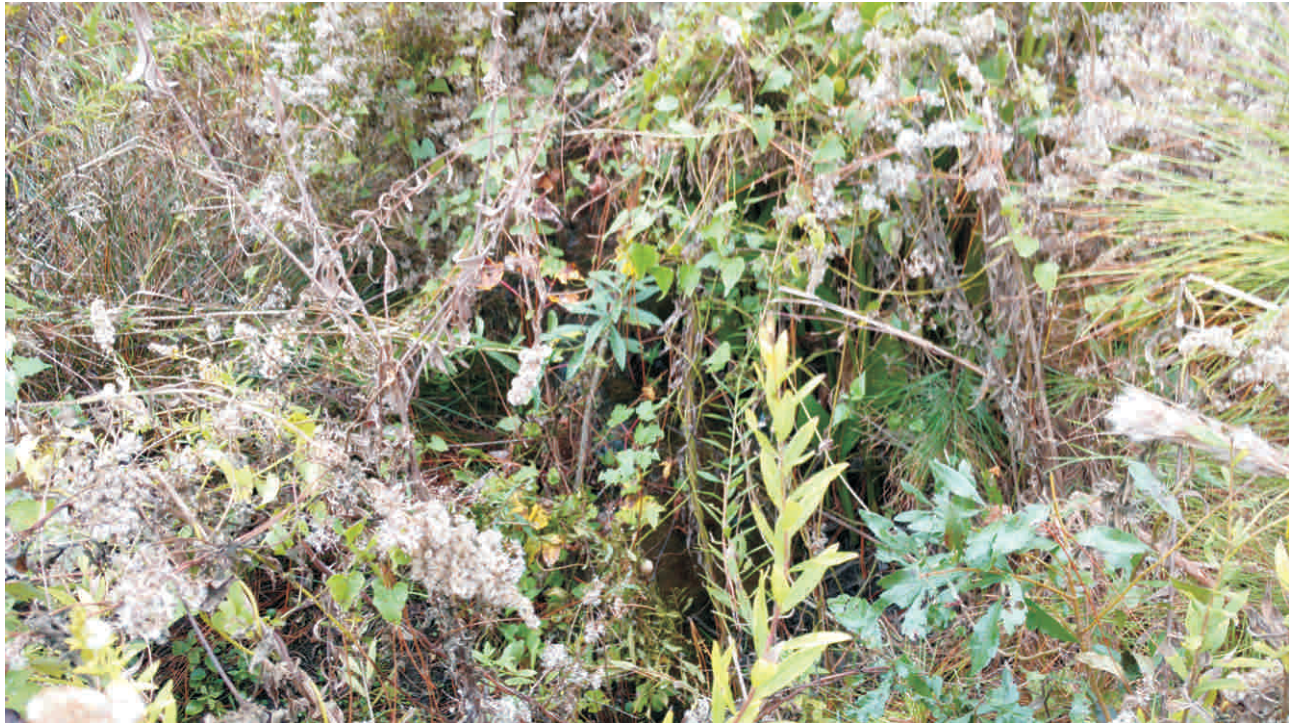
Enhancement Reach - Stream Problem Area #57c; Scour (difficult to see through vegetation)
