# **Jacksonville Country Club Stream Restoration and Enhancement Project**

**SCO No. 070715501  
DEQ Contract No. D08049S  
DMS Project No. 194  
Action ID# 2006-40325-067  
Onslow County, North Carolina**

**Year 5 of 5 Monitoring Report  
Data Collection: January through December 2018  
Submission Date: February 13, 2019**

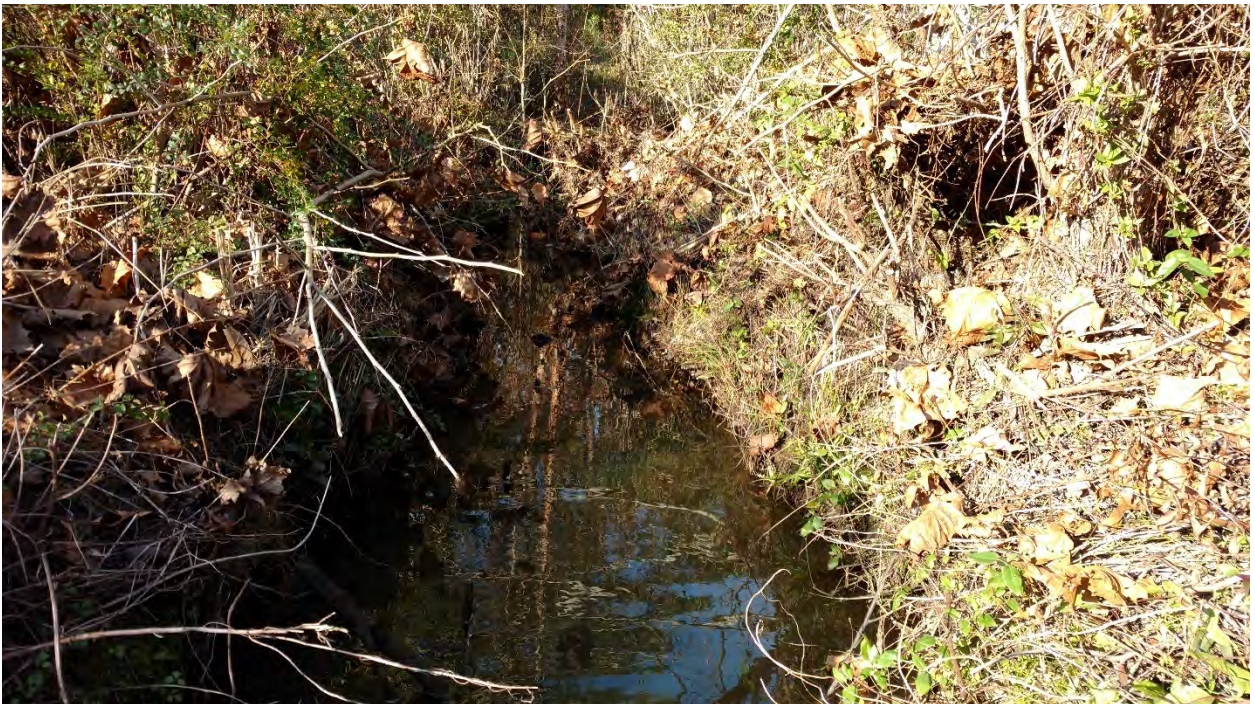
**Reach 1A: Stream Problem Area 5 – Scour**

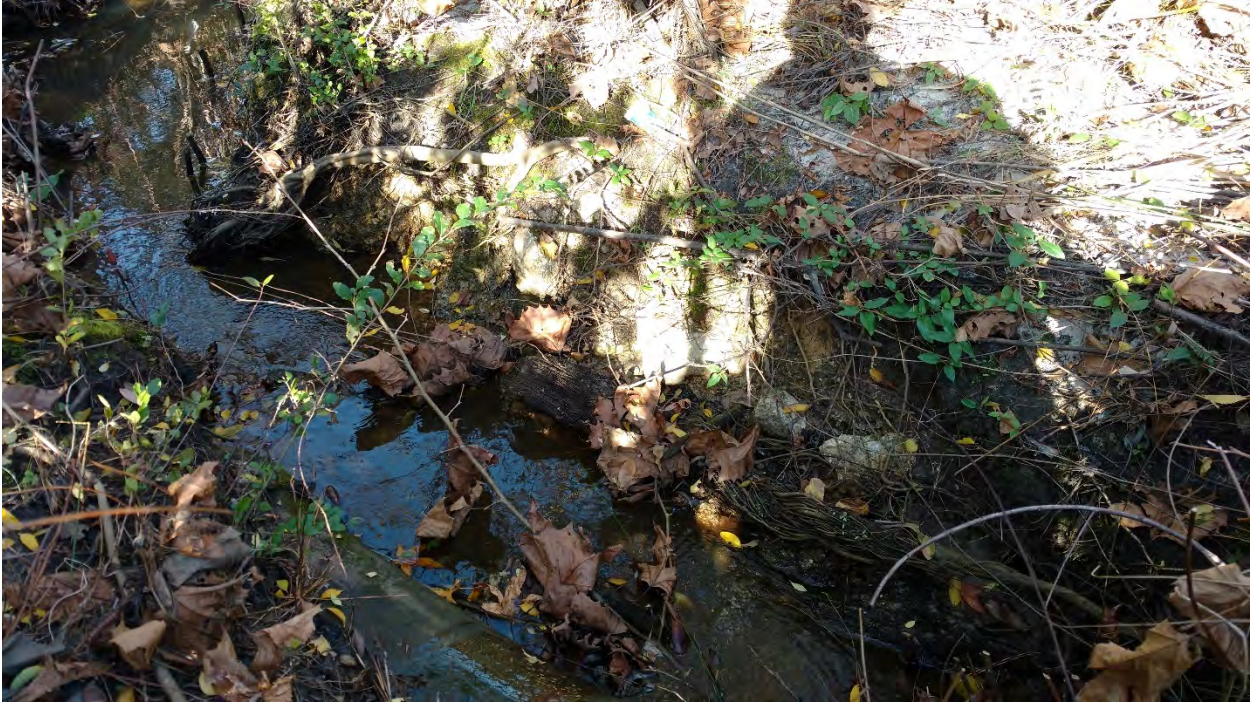
**Reach 1A: Stream Problem Area 6 – Degradation**

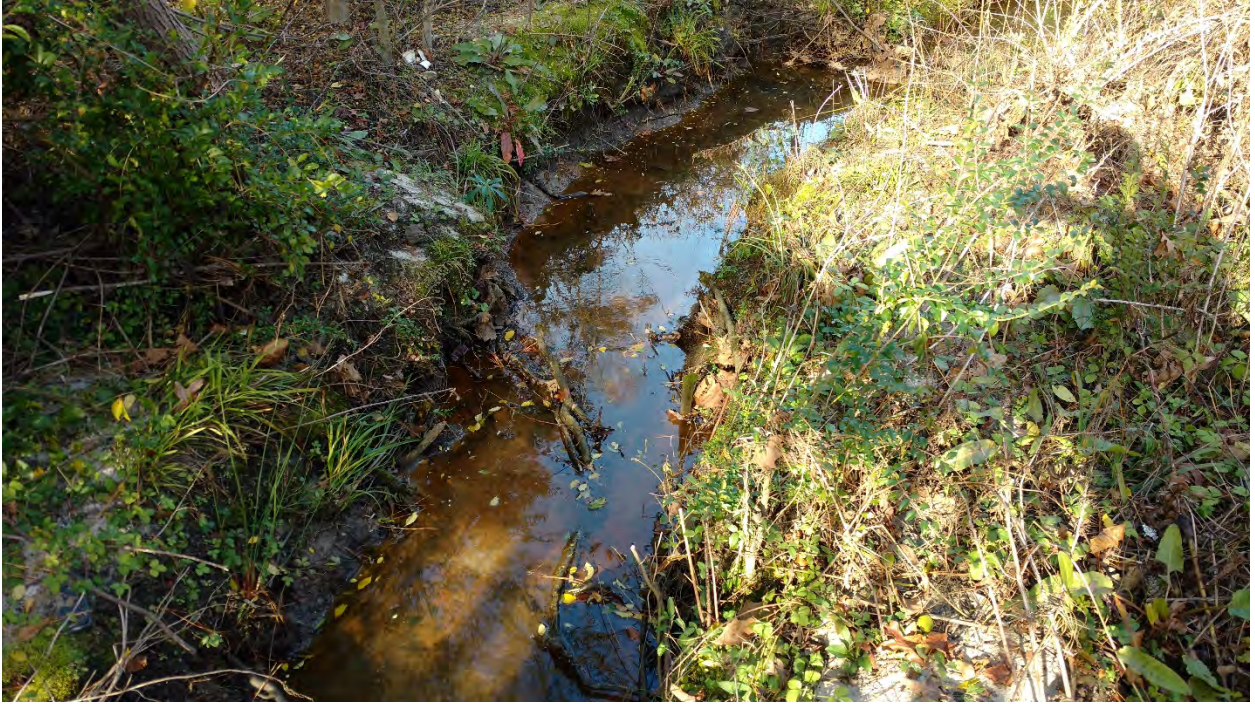
**Reach 1A: Stream Problem Area 7 – Degradation**

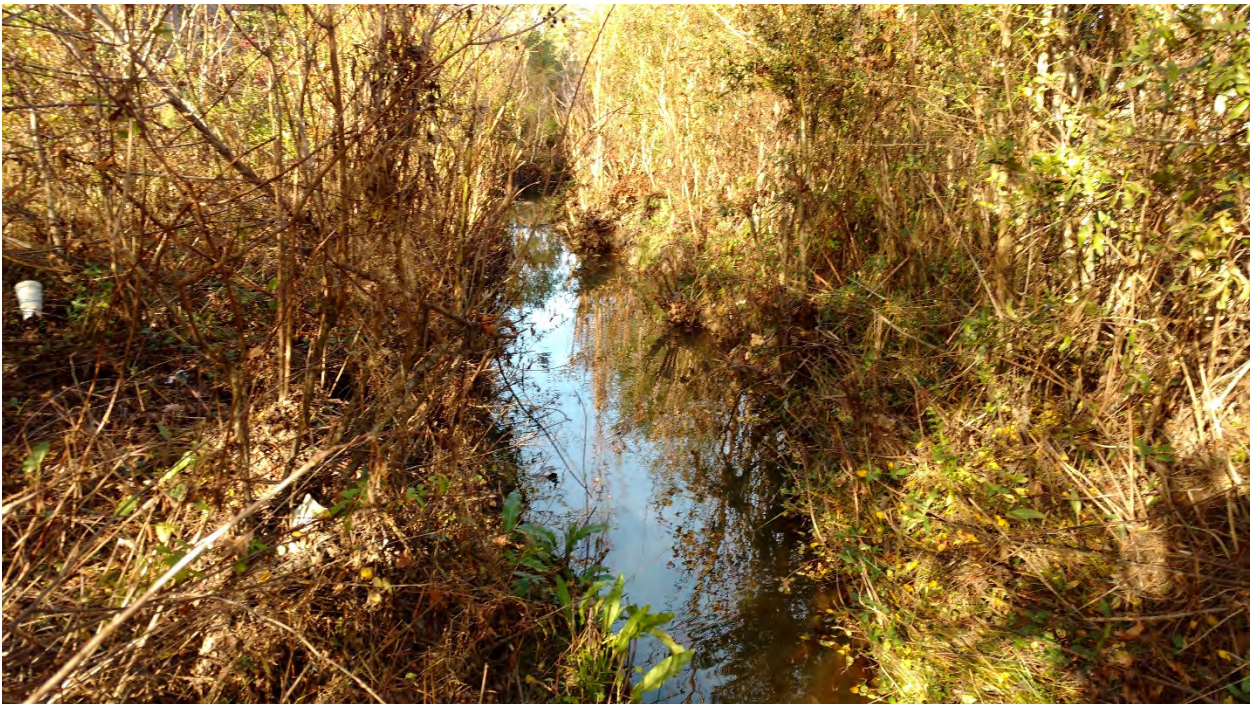
**Reach 1A: Stream Problem Area 8 – Degradation**

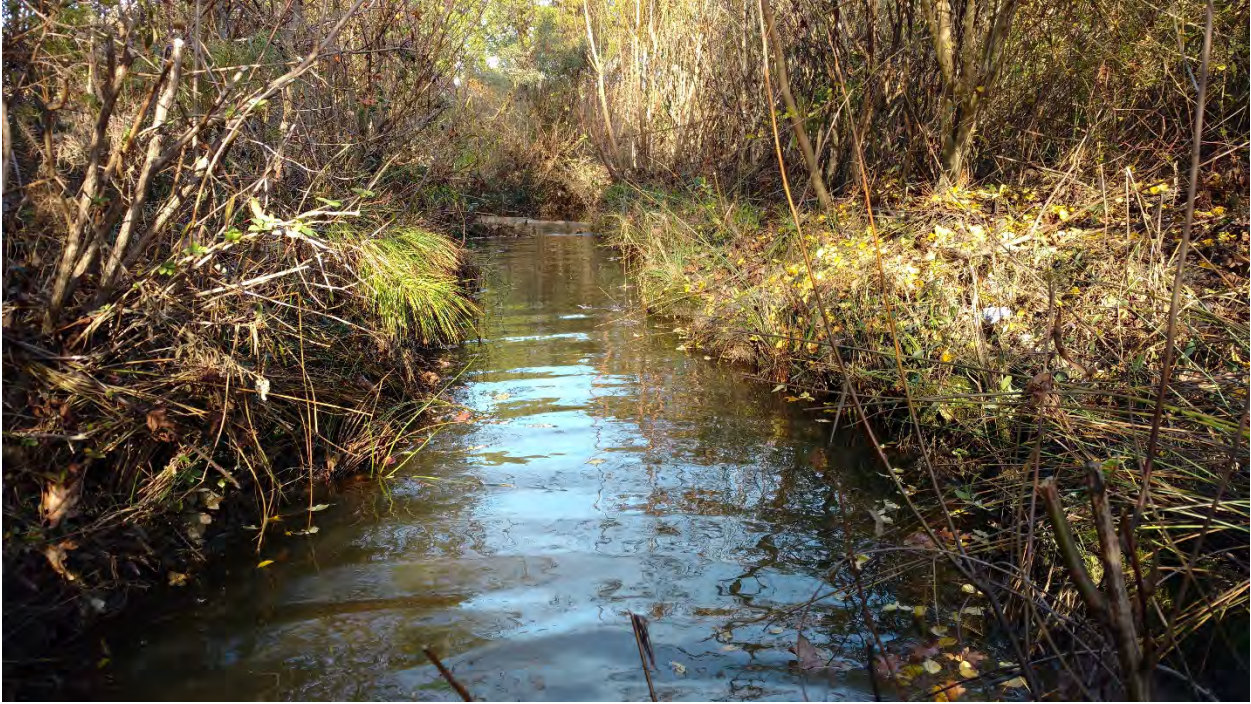
**Reach 1A: Stream Problem Area 9 – Degradation**

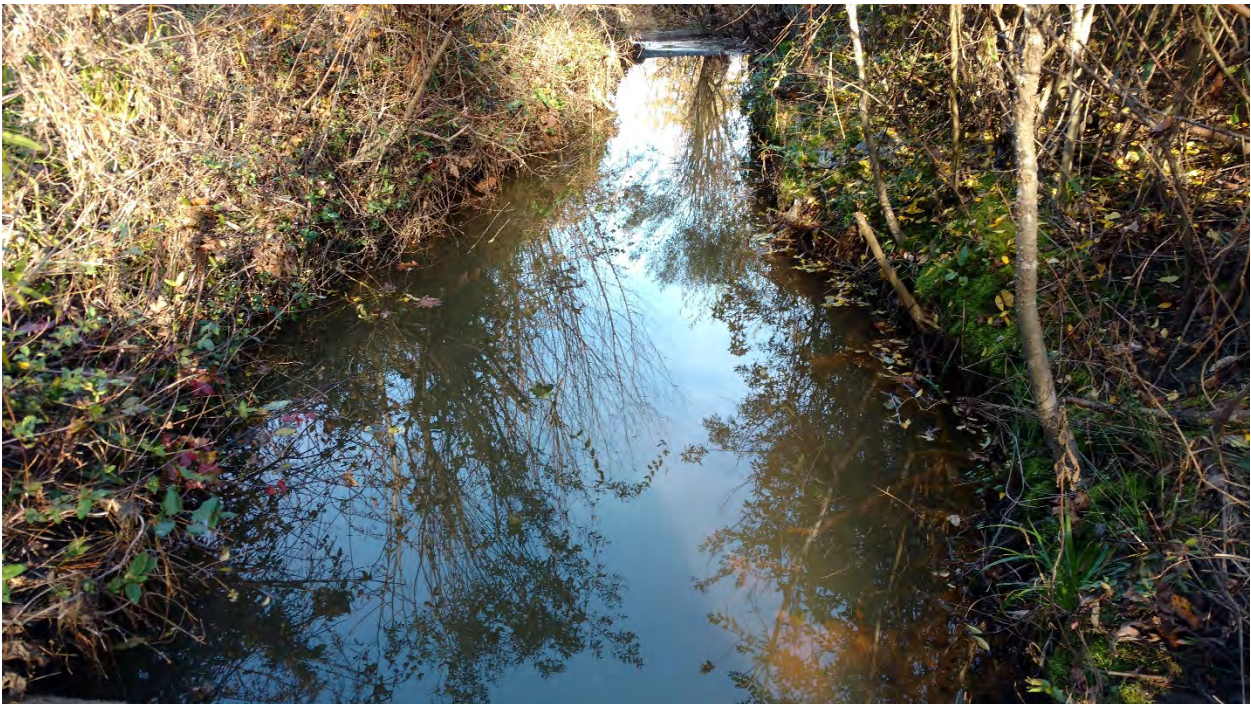
**Reach 1A: Stream Problem Area 10 – Scour**

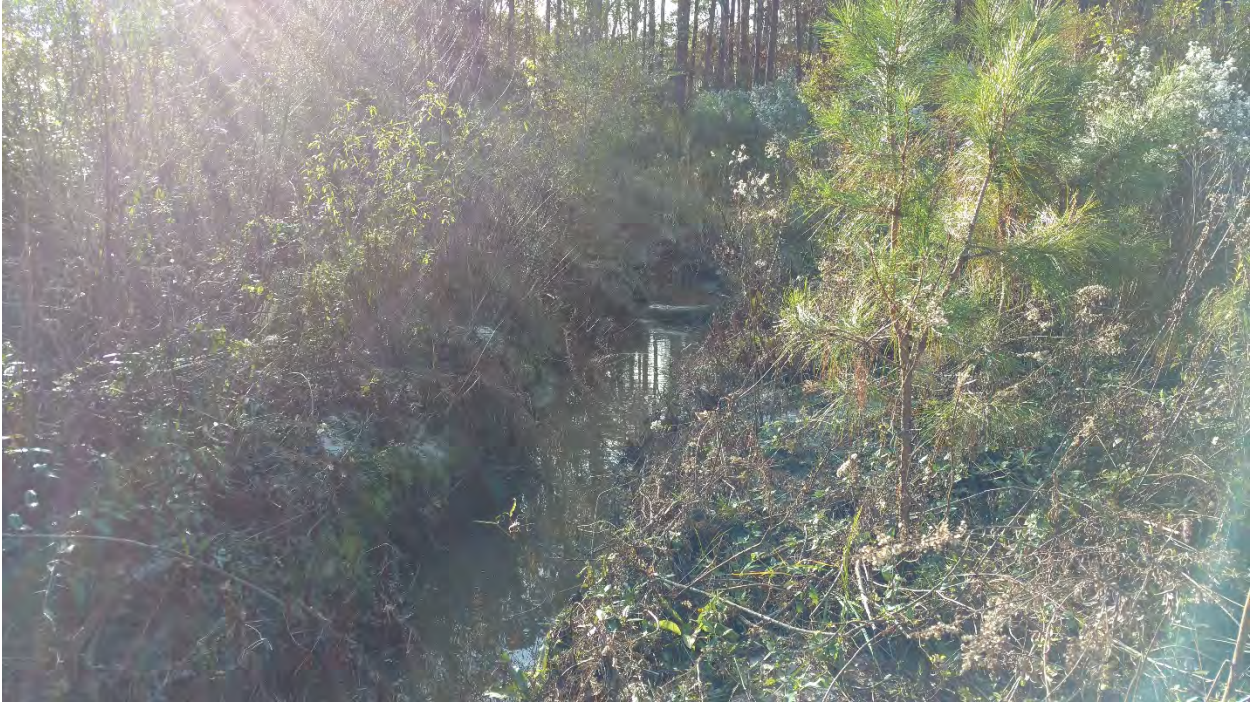
**Reach 1A: Stream Problem Area 12a – Degradation**

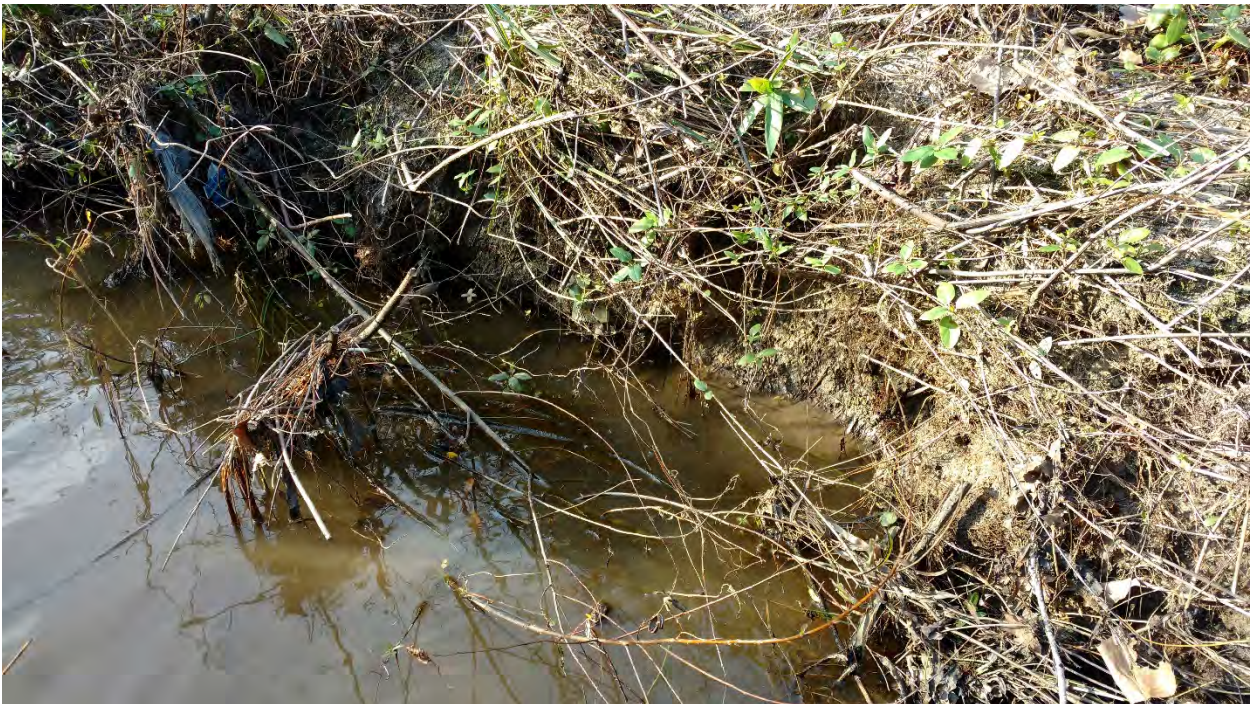
**Reach 1A: Stream Problem Area 13a – Scour**

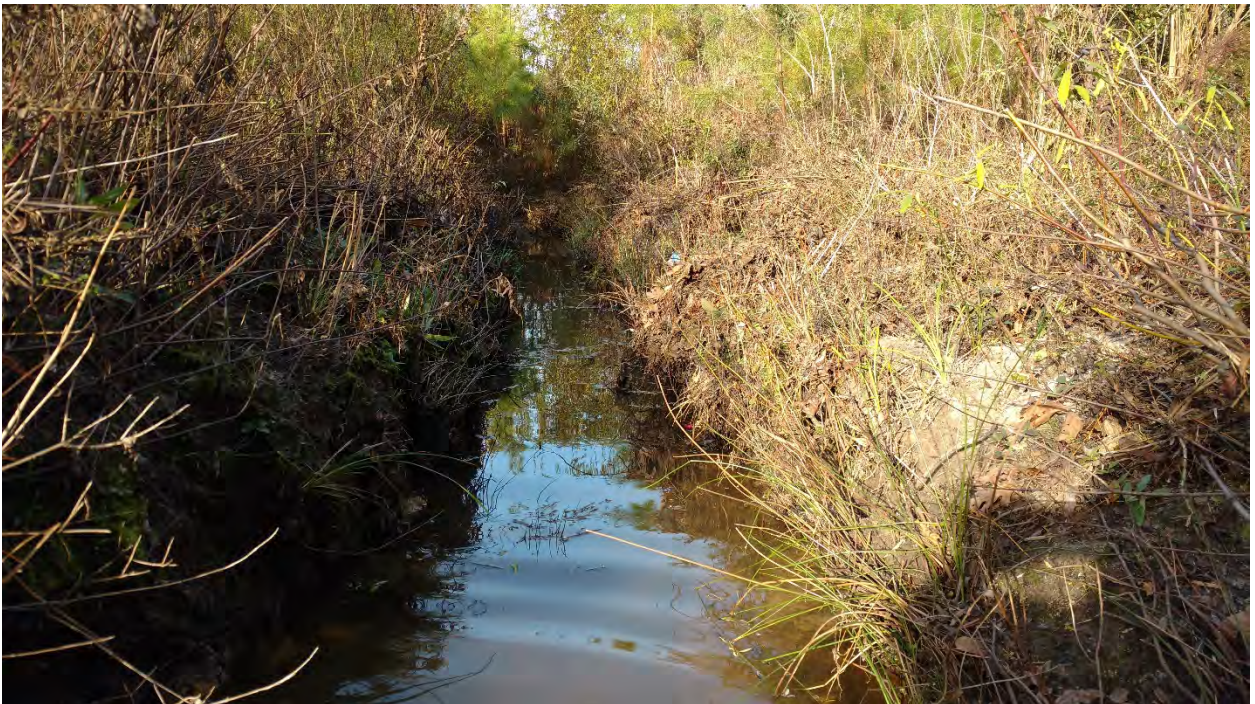
**Reach 1A: Stream Problem Area 13b – Degradation**

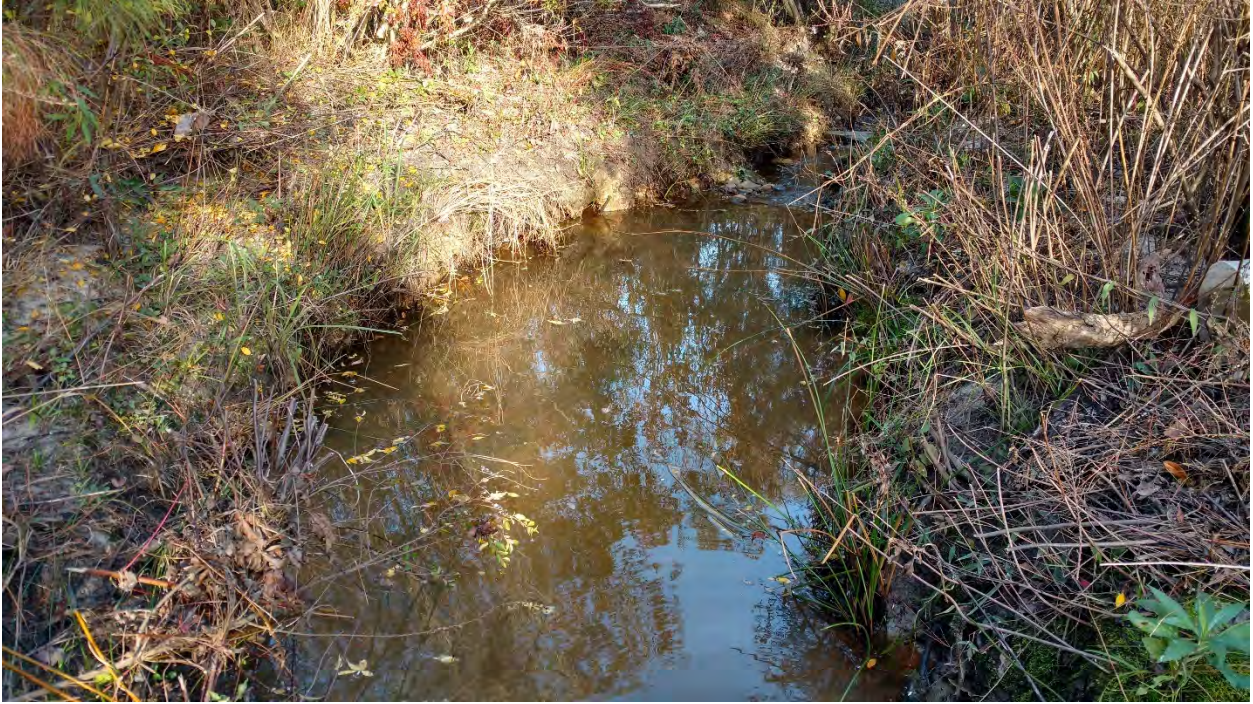
**Reach 1A: Stream Problem Area 14 – Scour**

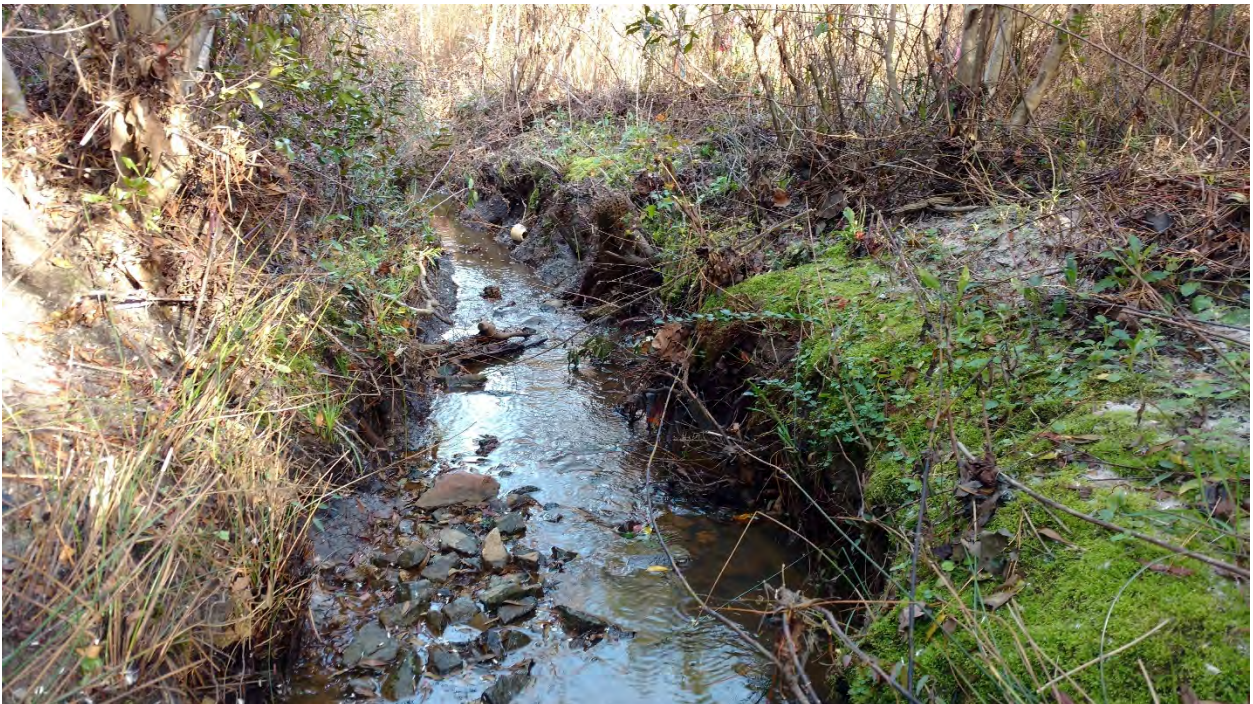
**Reach 1A: Stream Problem Area 14a – Degradation**

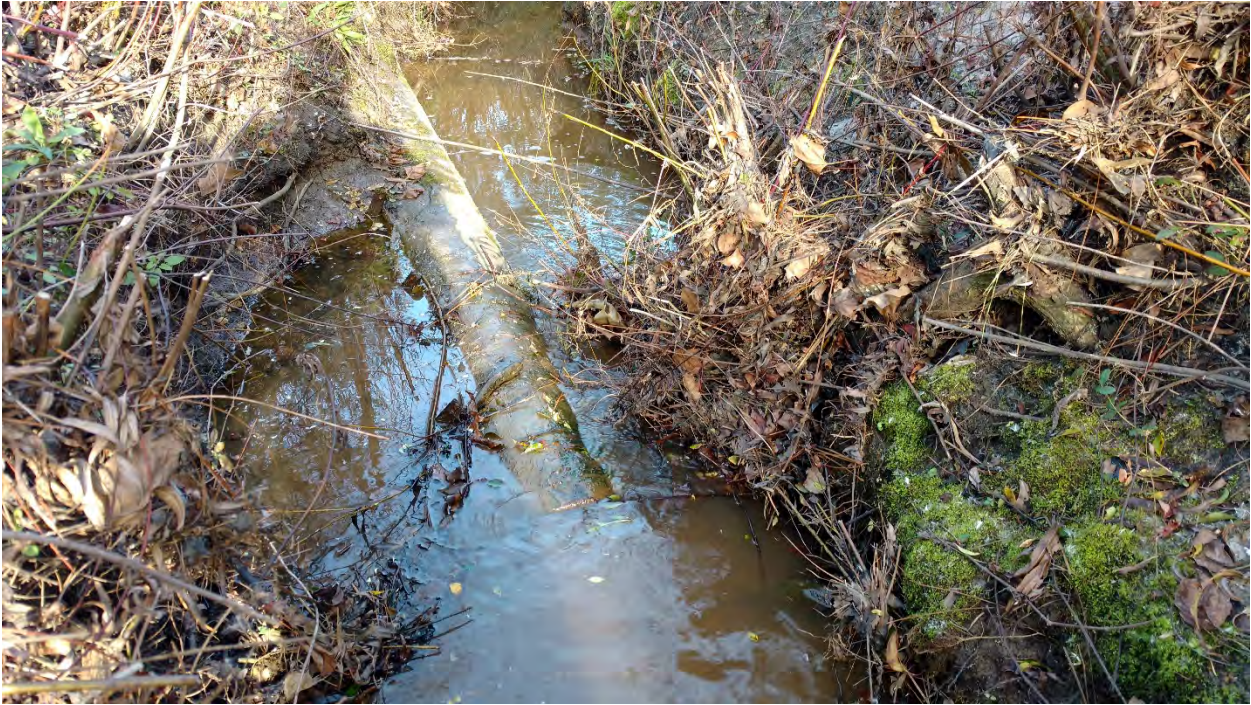
Reach 1A: Stream Problem Area 16 – Scour after log vane structure. Structure appears to be failing.

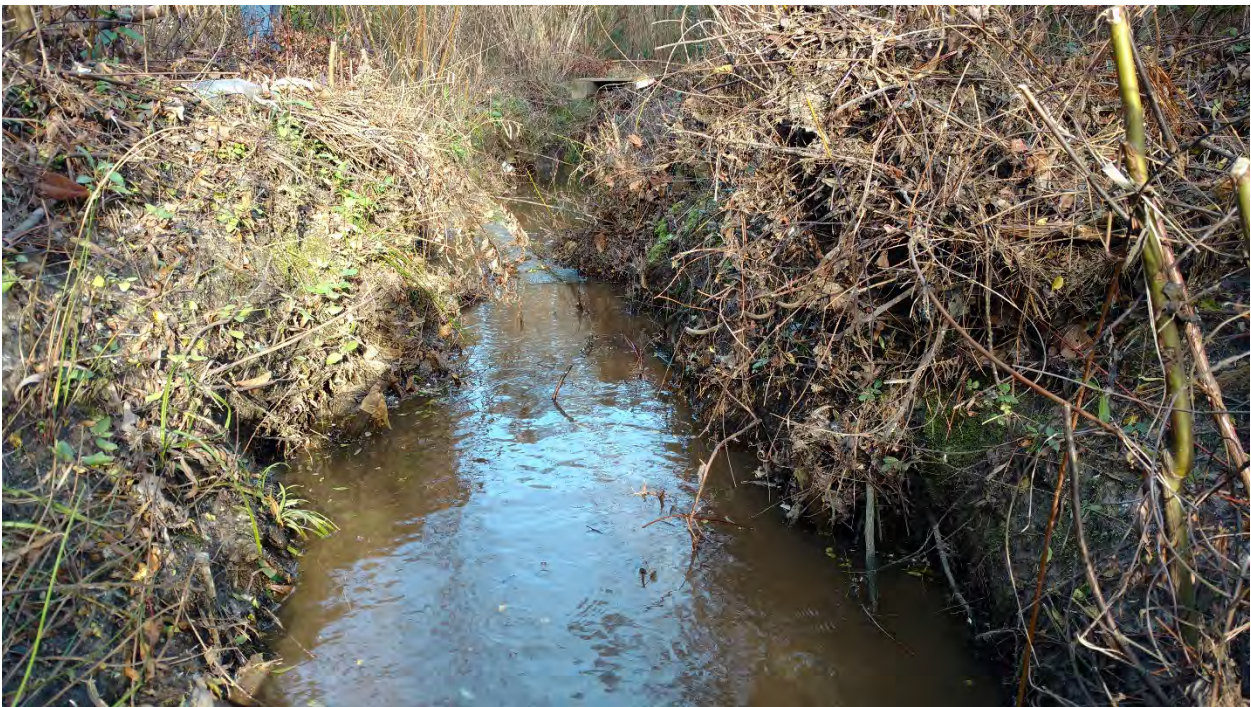
Reach 1A: Stream Problem Area 17 – Degradation

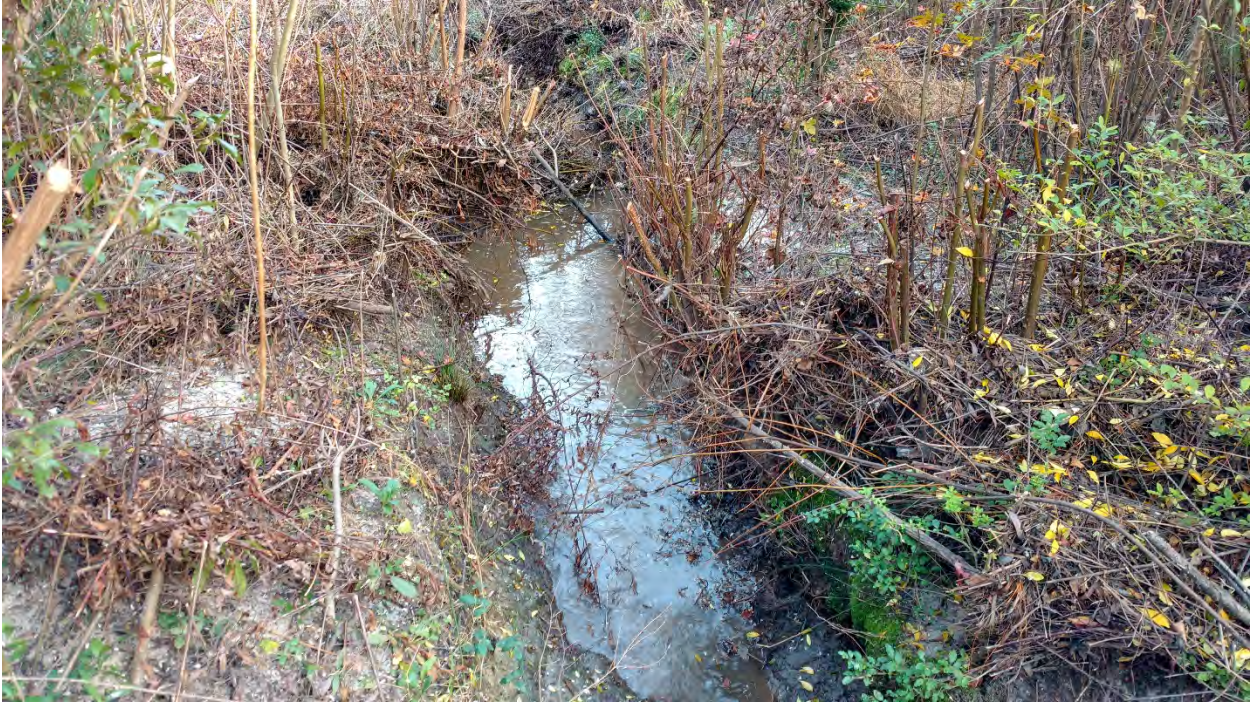
**Reach 1A: Stream Problem Area 18 – Degradation**

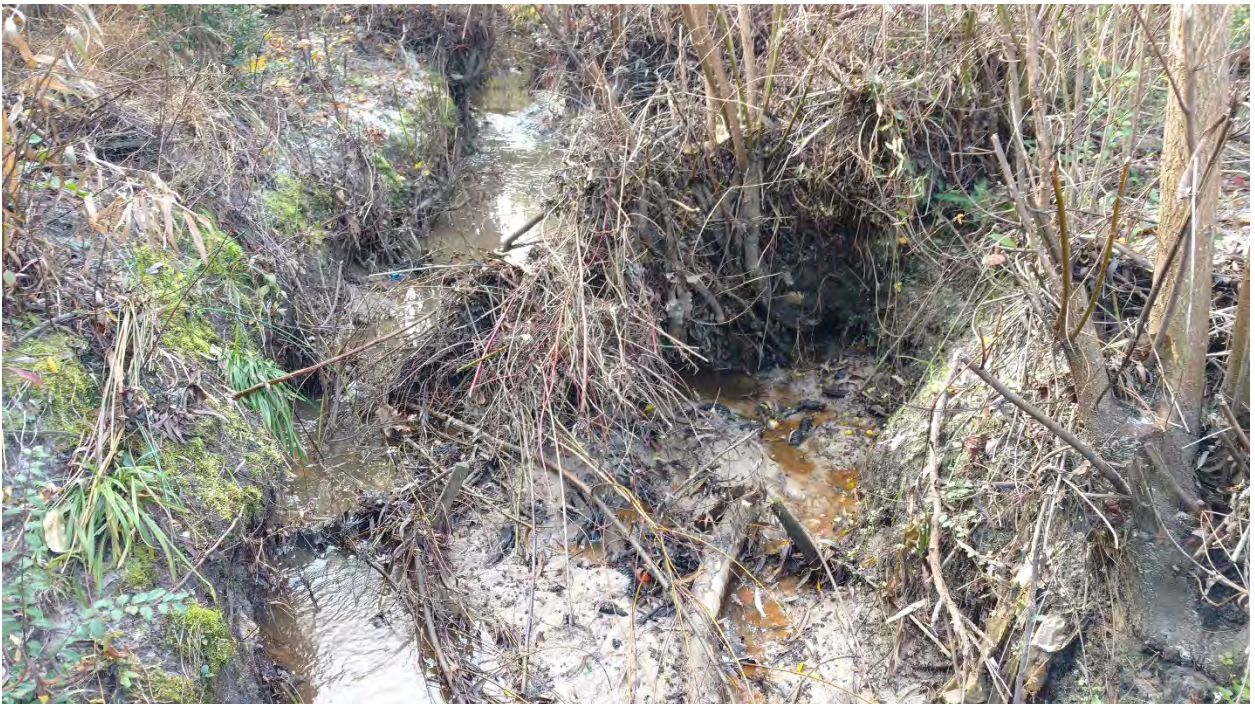
**Reach 1A: Stream Problem Area 19 – Aggradation caused by Mass Wasting**

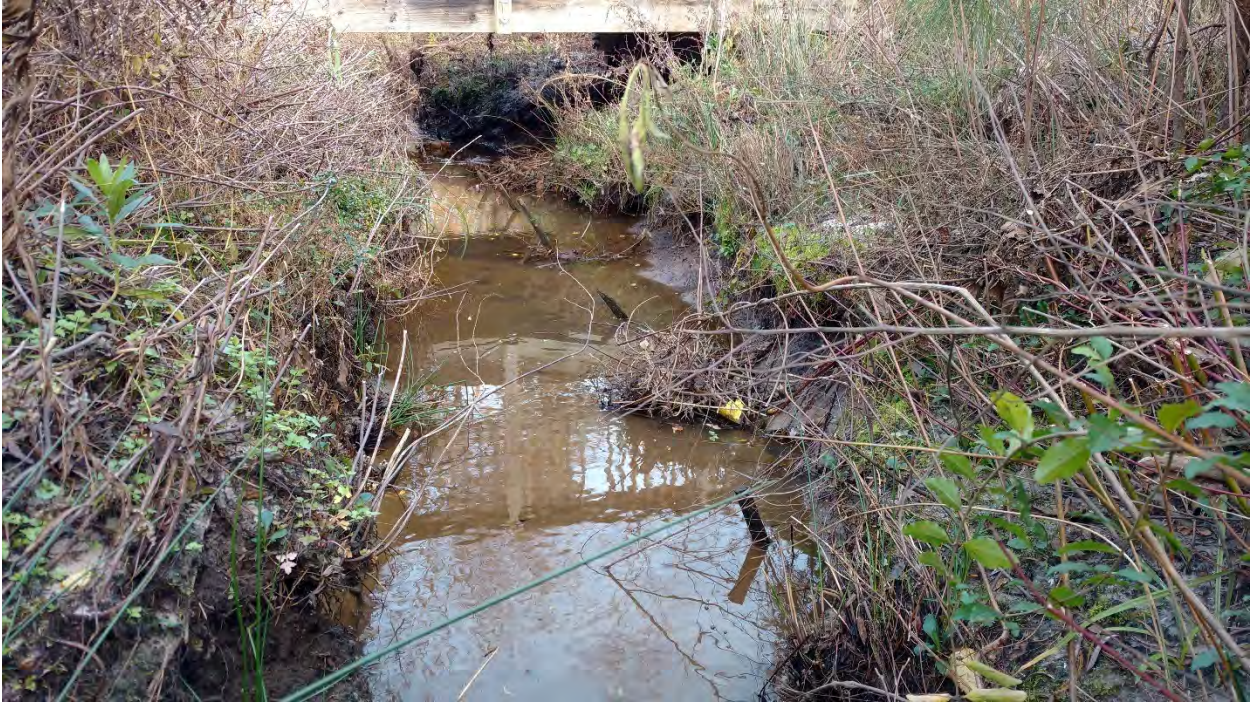
**Reach 1A: Stream Problem Area 20 – Degradation**

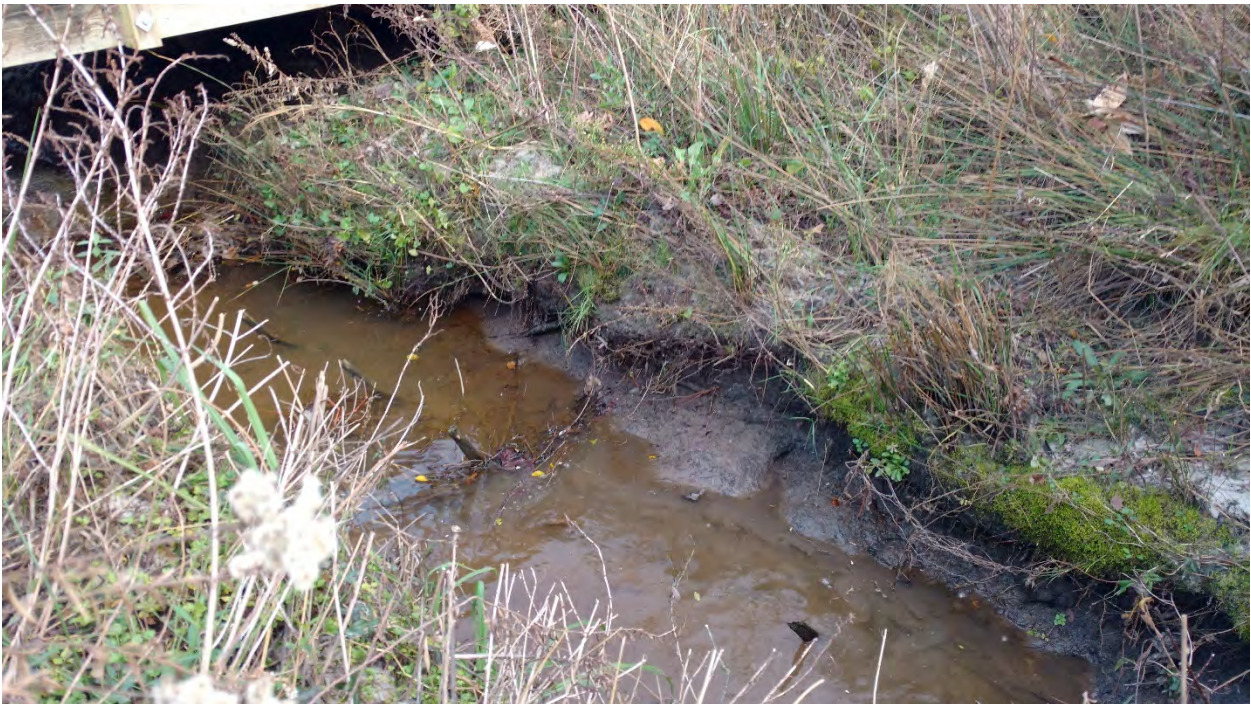
**Reach 1A: Stream Problem Area 20a – Scour**

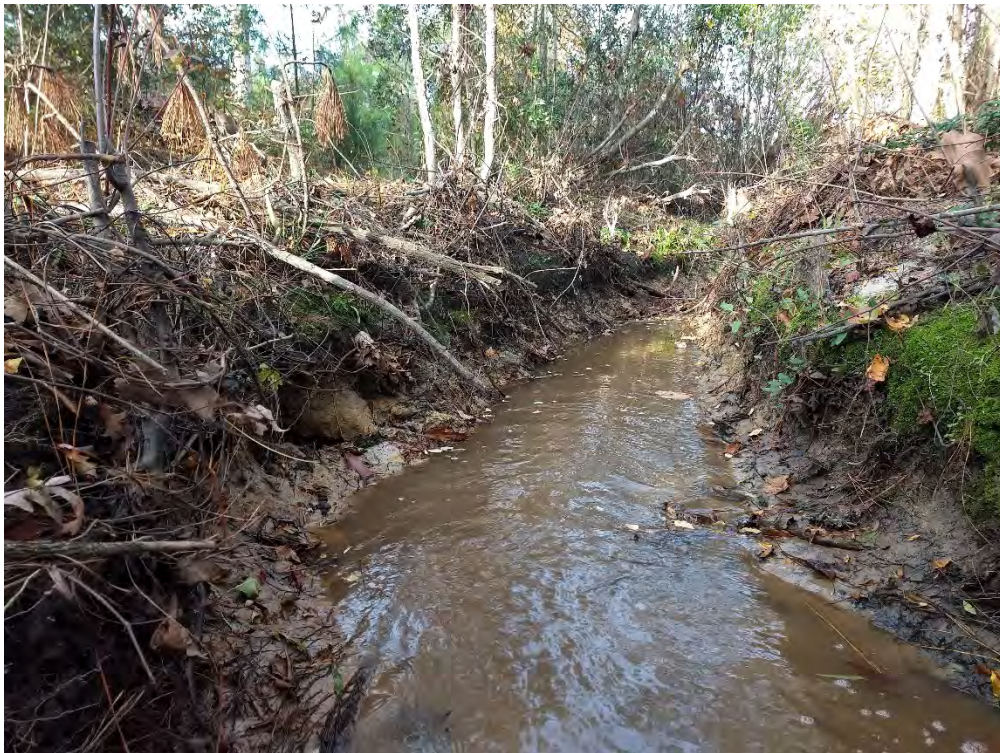
**Reach 1A: Stream Problem Area 22 – Degradation**

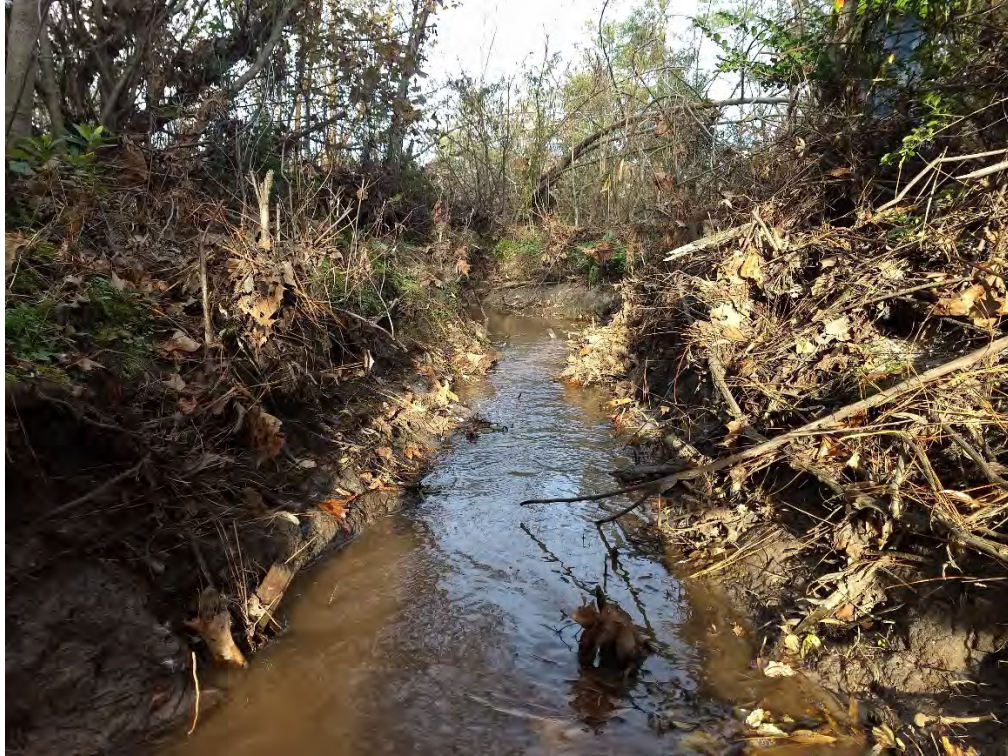
**Reach 1A: Stream Problem Area 23– Degradation**

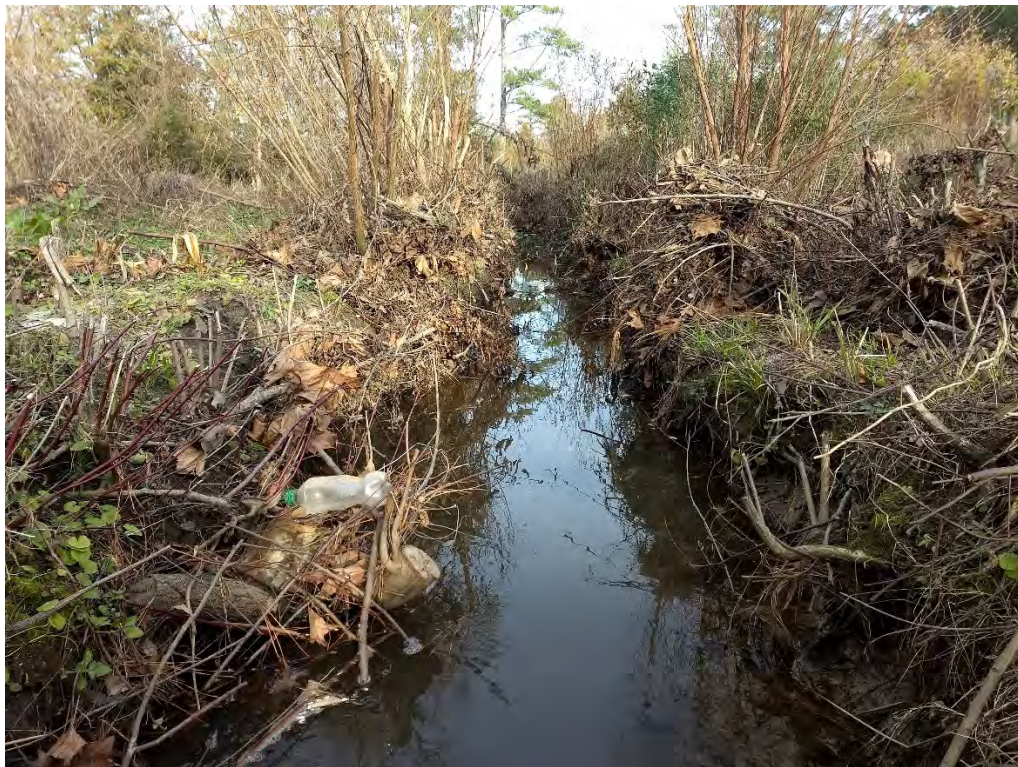
**Reach 1A: Stream Problem Area 24 – Degradation**

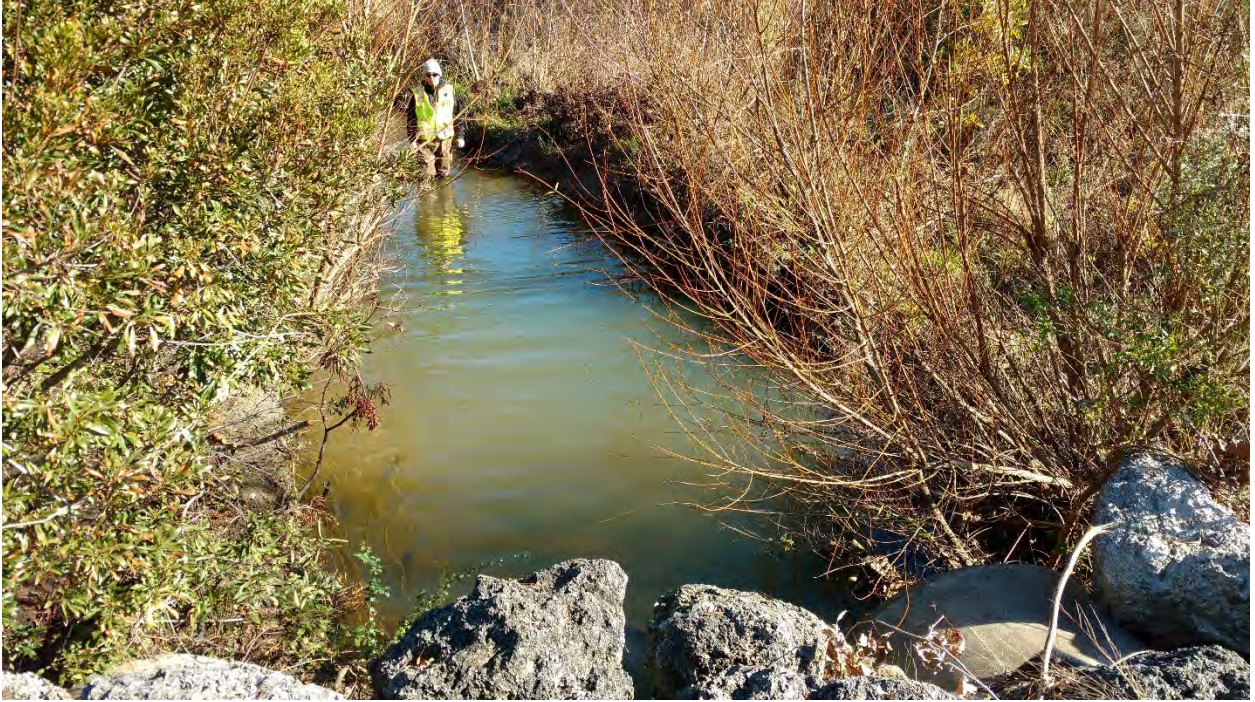
**Reach 2A: Stream Problem Area 25 – Scour off of road**

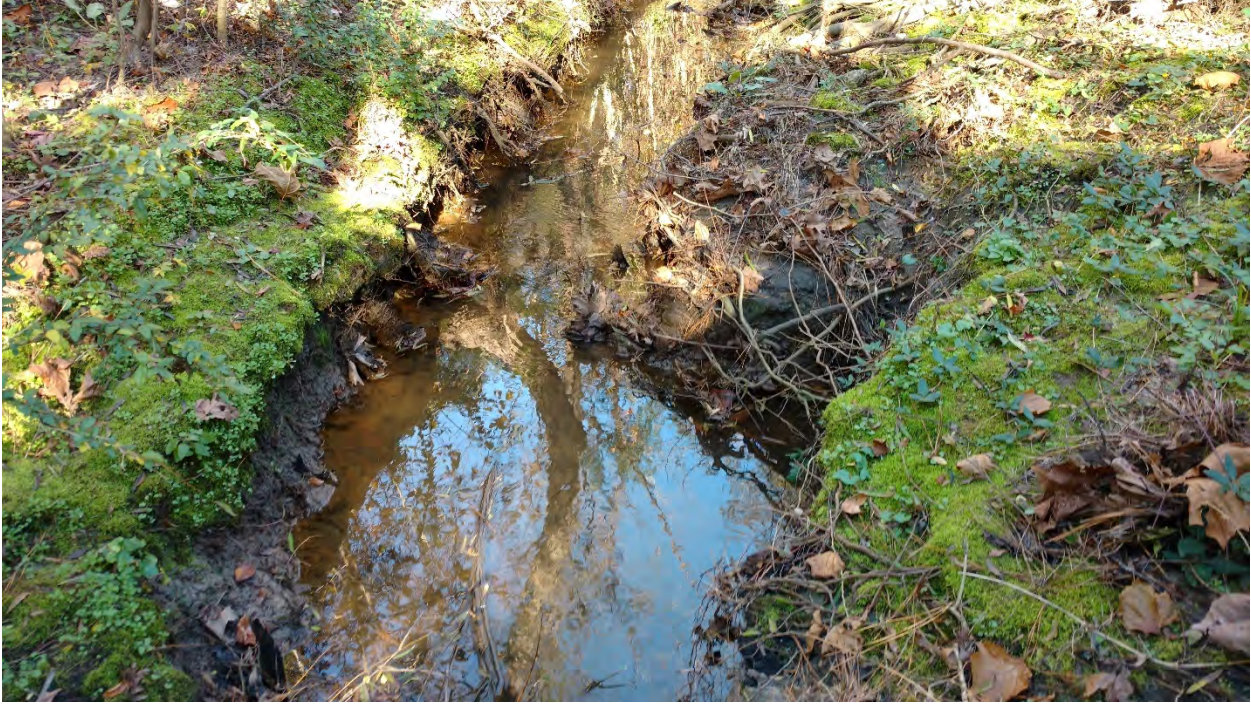
Reach 2A: Stream Problem Area 32 – Degradation and Mass Wasting

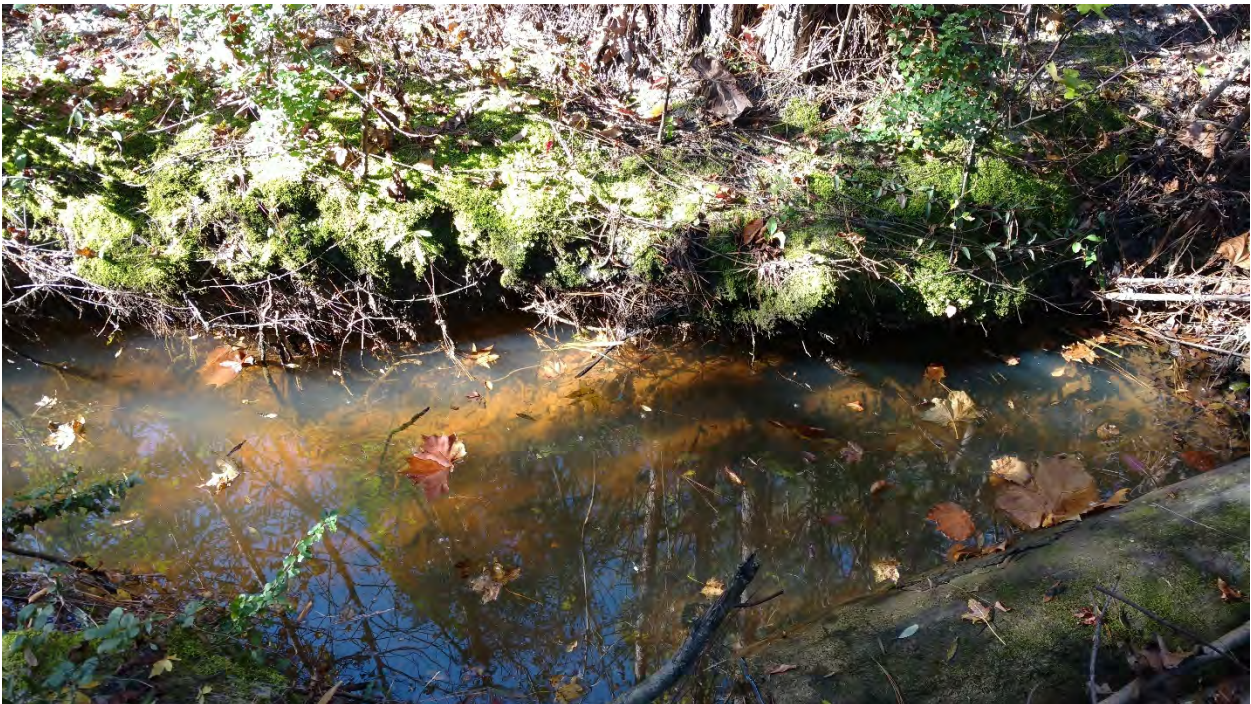
Reach 2A: Stream Problem Area 33 – Scour

Log Vane at this location not functioning

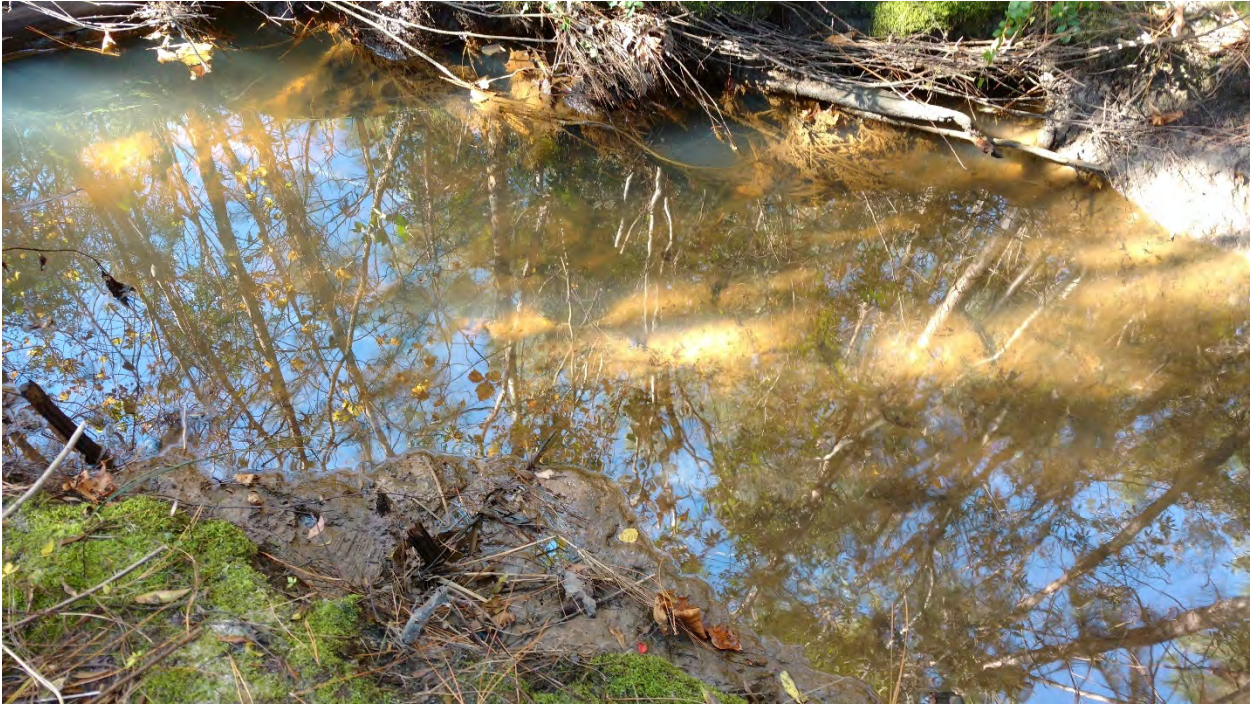
**Reach 2A: Stream Problem Area 36 – Degradation**

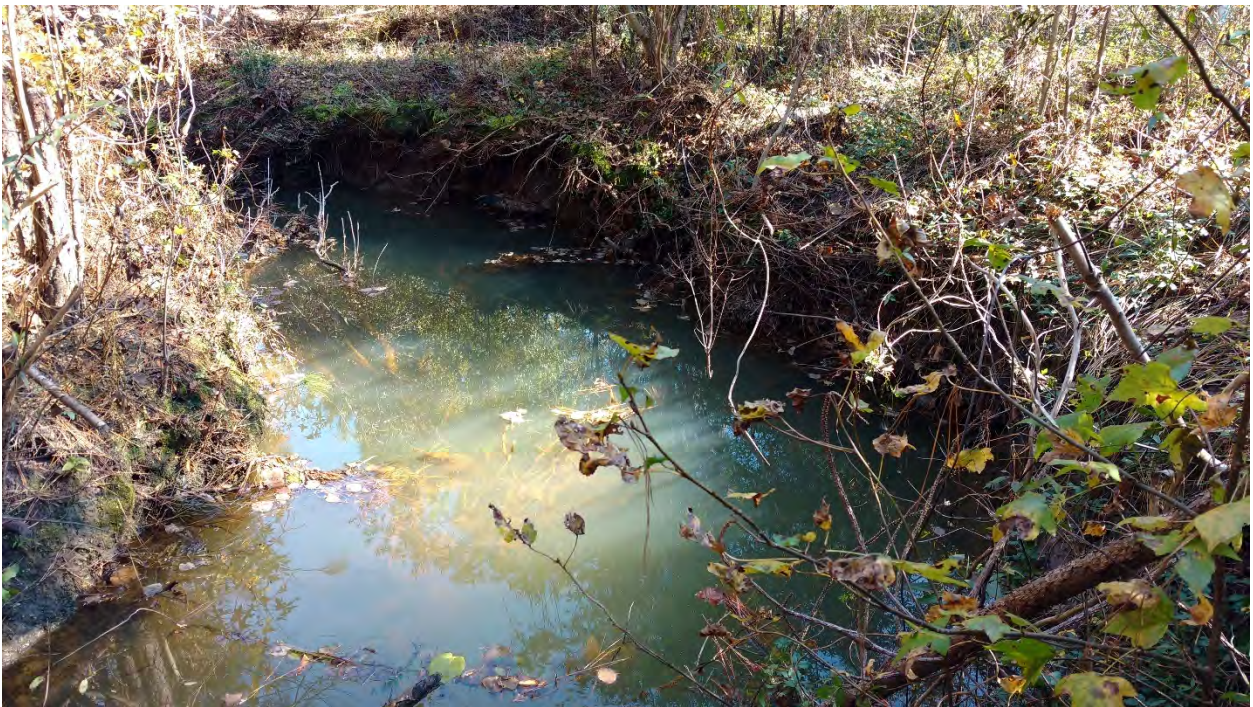
**Reach 2A: Stream Problem Area 37 – Mass Wasting**

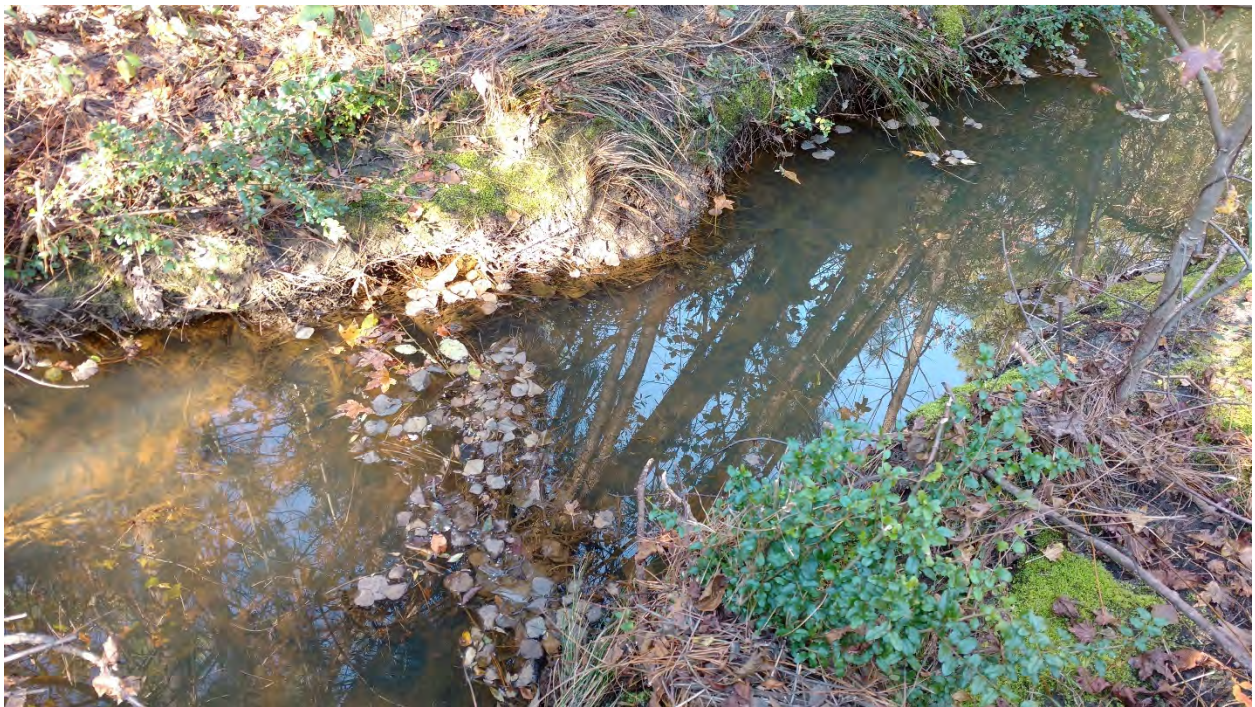
**Reach 2A: Stream Problem Area 38 – Degradation**
