# **Jacksonville Country Club Stream Restoration and Enhancement Project**

**SCO No. 070715501  
DEQ Contract No. D08049S  
DMS Project No. 194  
Action ID# 2006-40325-067  
Onslow County, North Carolina**

**Year 5 of 5 Monitoring Report  
Data Collection: January through December 2018  
Submission Date: February 13, 2019**

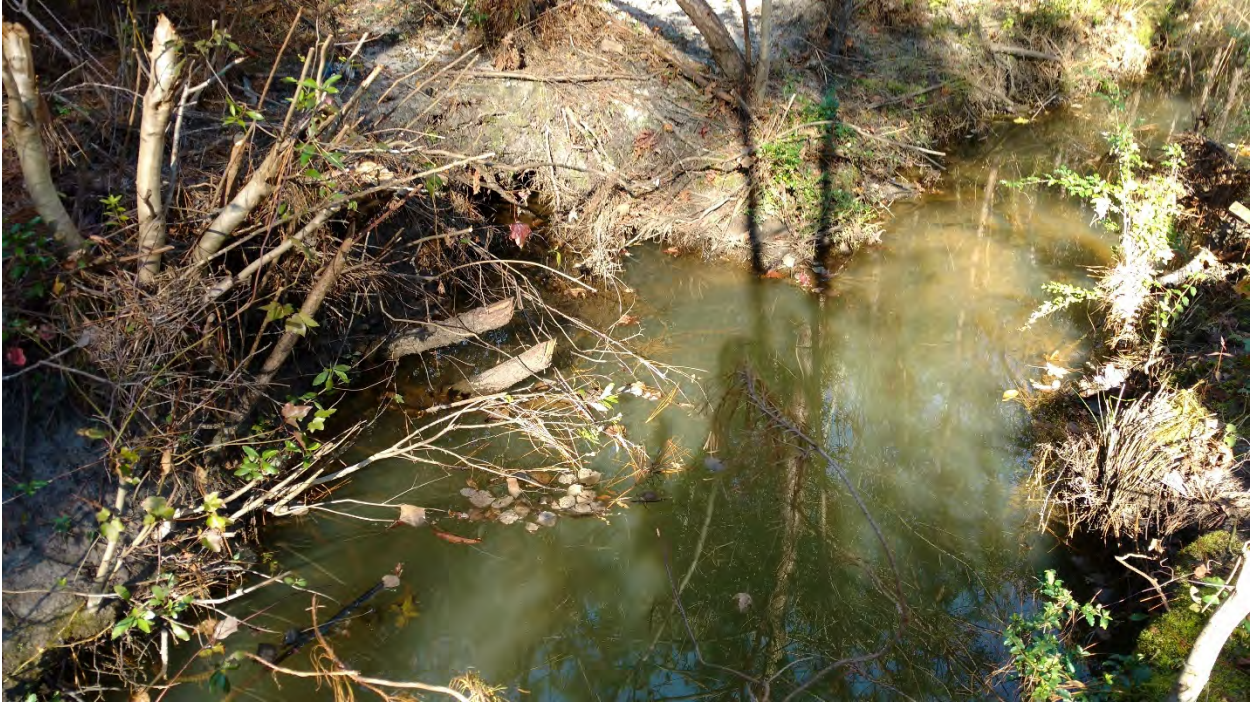
**Reach 2A: Stream Problem Area 39 – Mass Wasting**

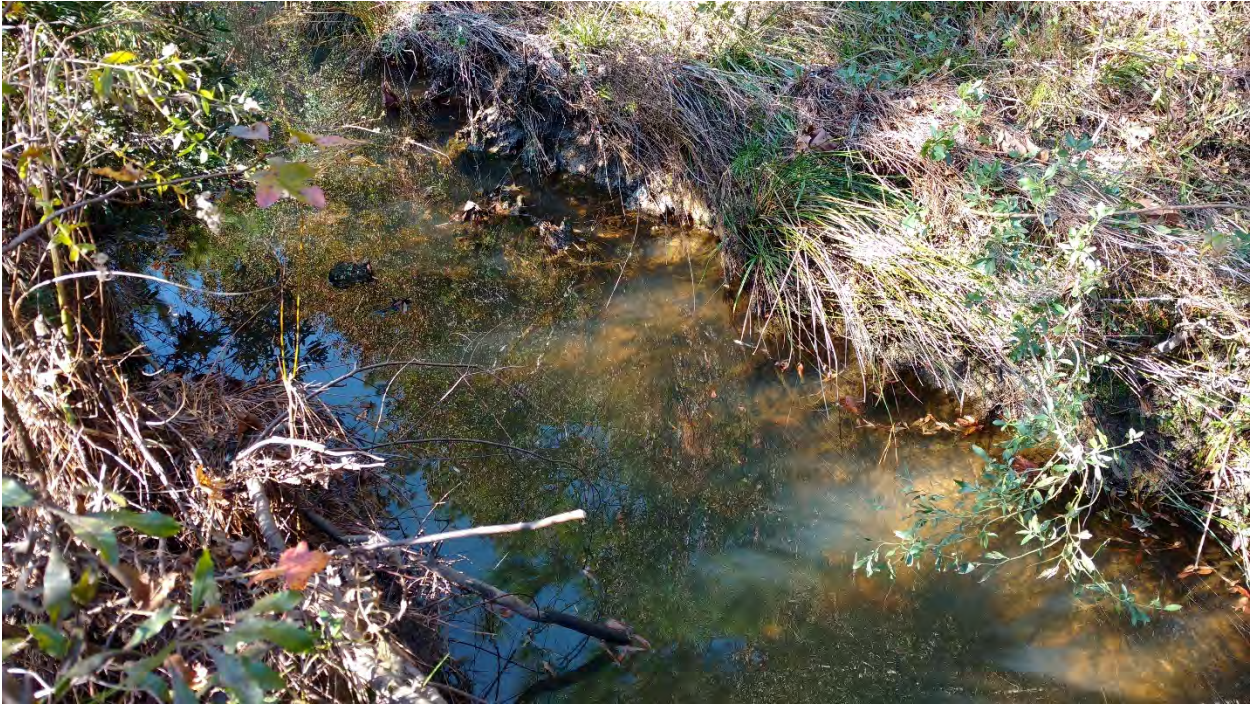
**Reach 2A: Stream Problem Area 43 – Degradation**

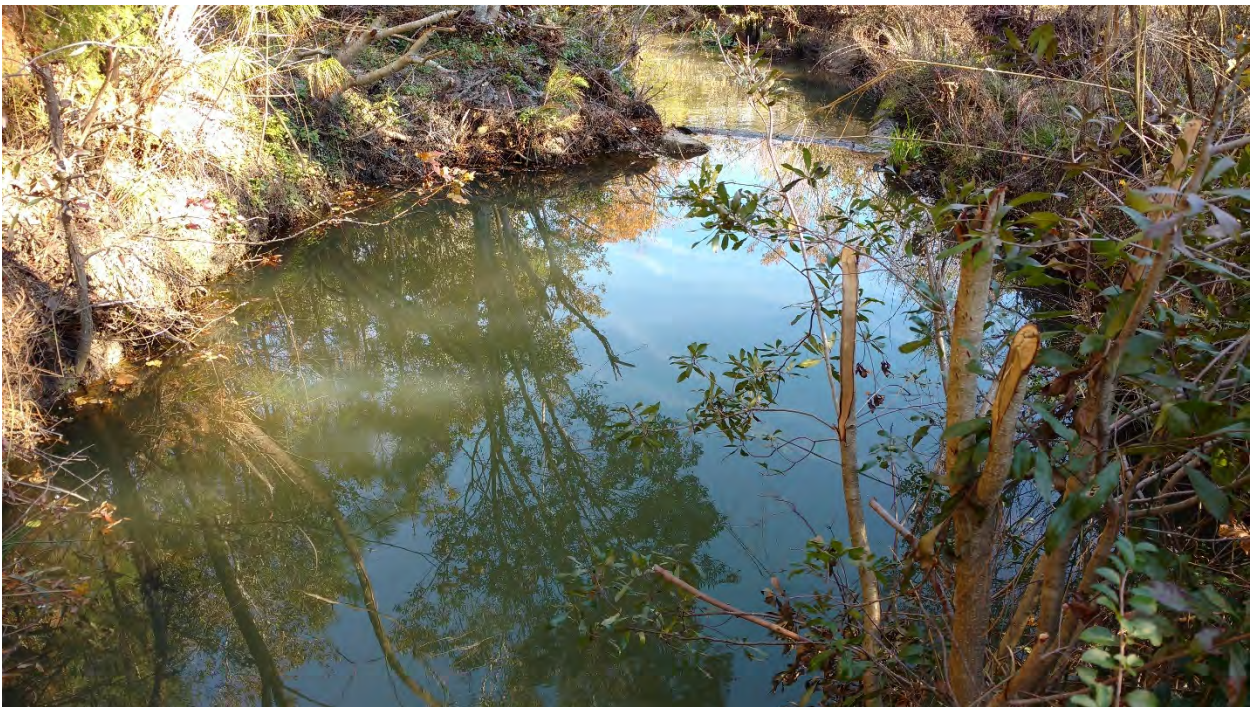
**Reach 2A: Stream Problem Area 43a – Scour**

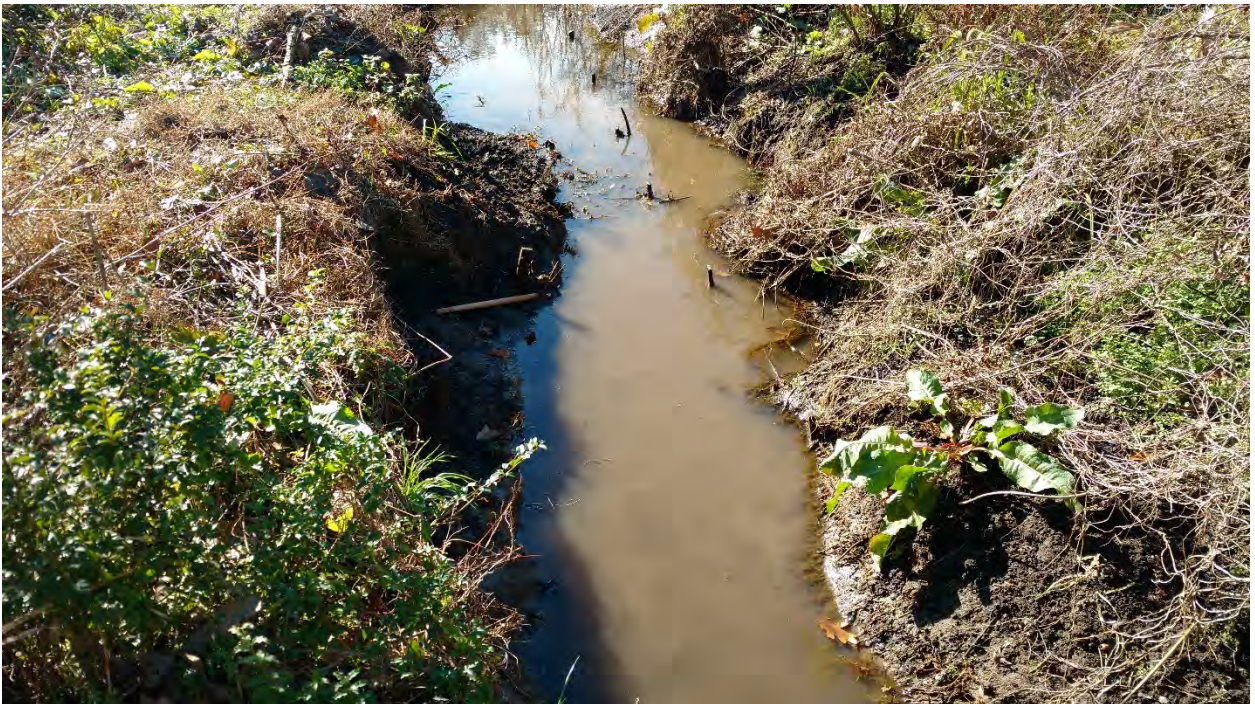
Reach C: Stream Problem Area 61 – Degradation

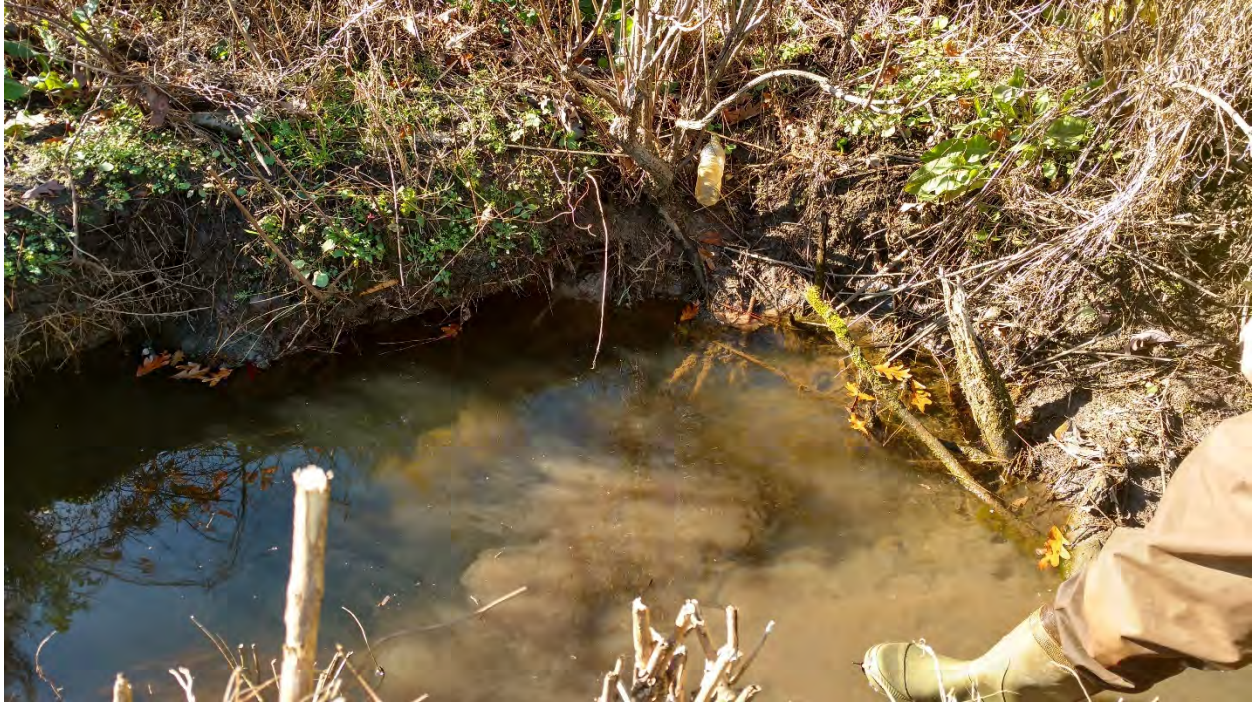
**Reach C: Stream Problem Area 62 – Under Cut**
