Jacob's Ladder
Stream Restoration Monitoring Report
DMS Project # 95023
DMS Contract # 003983
Monitoring Year 02

**JACOB'S LADDER
STREAM MITIGATION PROJECT
MONITORING YEAR 2**

CURRENT
CONDITION
PLAN VIEW

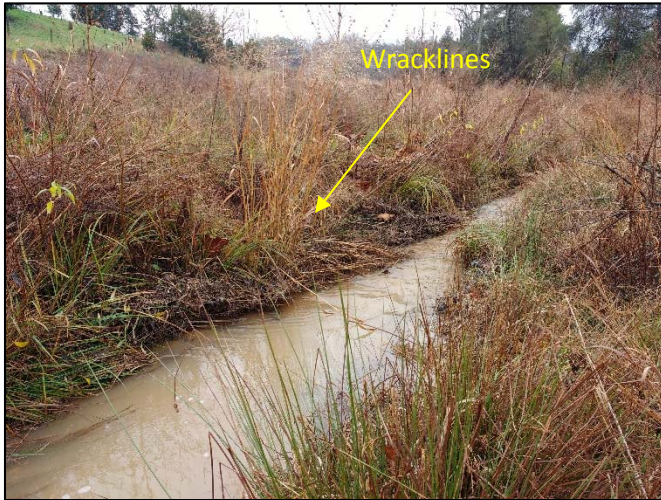
Photo 1. Bankfull indicators along T1, 12/17/15

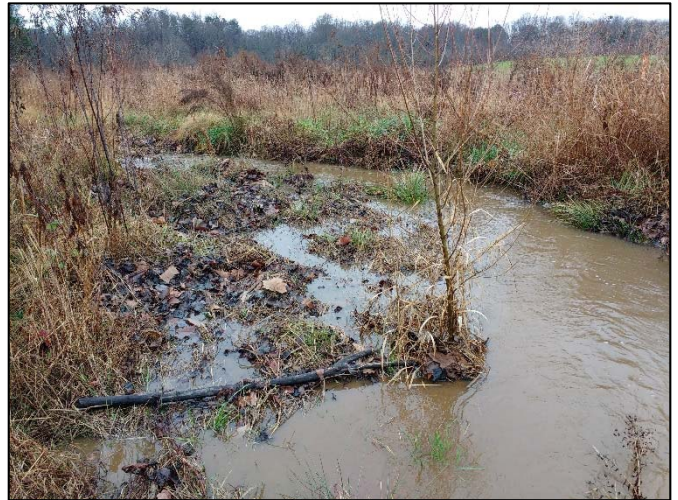
Photo 2. T2 at bankfull, 12/17/15
