Jacob's Ladder
Stream Restoration Monitoring Report
DMS Project # 95023
DMS Contract # 003983
Monitoring Year 03

**JACOB'S LADDER
STREAM MITIGATION PROJECT
MONITORING YEAR 3**
CHINA GROVE, ROWAN COUNTY, NORTH CAROLINA
REACH T1

DATE: DEC 2016
SCALE: GRAPHIC
**CURRENT
CONDITION
PLAN VIEW**
SHEET 1 OF 2

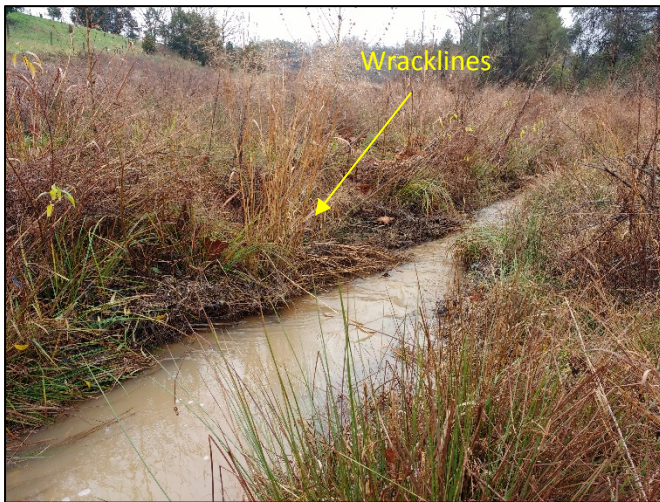
Photo 1. Bankfull indicators along T1, 12/17/15

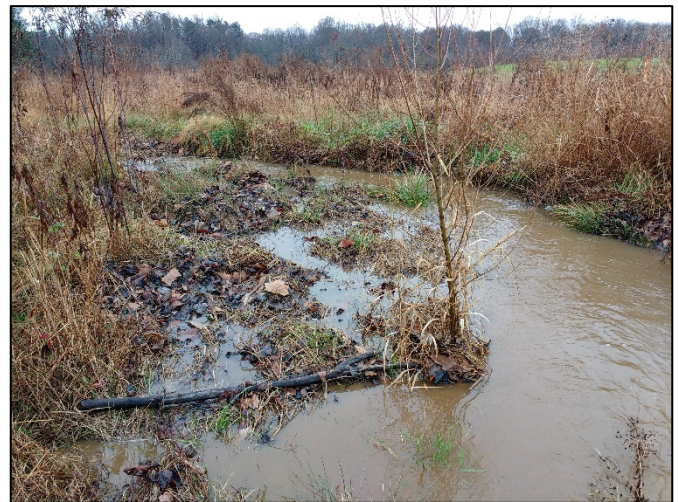
Photo 2. T2 at bankfull, 12/17/15
