**Jacob's Ladder**  
**Stream Restoration Monitoring Report**  
**DMS Project # 95023**  
**DMS Contract # 003983**  
**Monitoring Year 04**

**Construction Completed: January 2014**

**Data Collection: 2017**

**Submitted: January 2018**

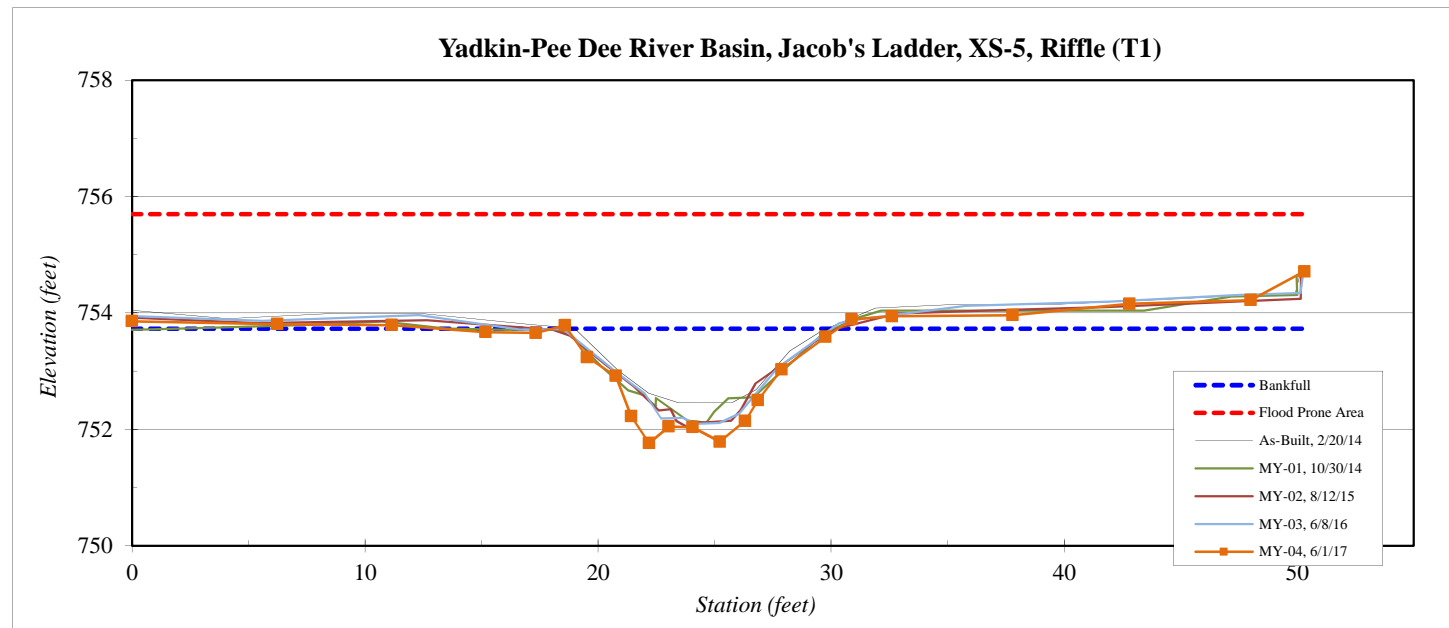
SUMMARY DATA	
<b>Bankfull Elevation (ft):</b>	753.7
<b>Bankfull Cross-Sectional Area (ft<sup>2</sup>):</b>	12.8
<b>Bankfull Width (ft):</b>	10.8
<b>Flood Prone Area Elevation (ft):</b>	755.7
<b>Flood Prone Width (ft):</b>	>50
<b>Max Depth at Bankfull (ft):</b>	2.0
<b>Mean Depth at Bankfull (ft):</b>	1.2
<b>W / D Ratio:</b>	9.1
<b>Entrenchment Ratio:</b>	4.6
<b>Bank Height Ratio:</b>	1.5

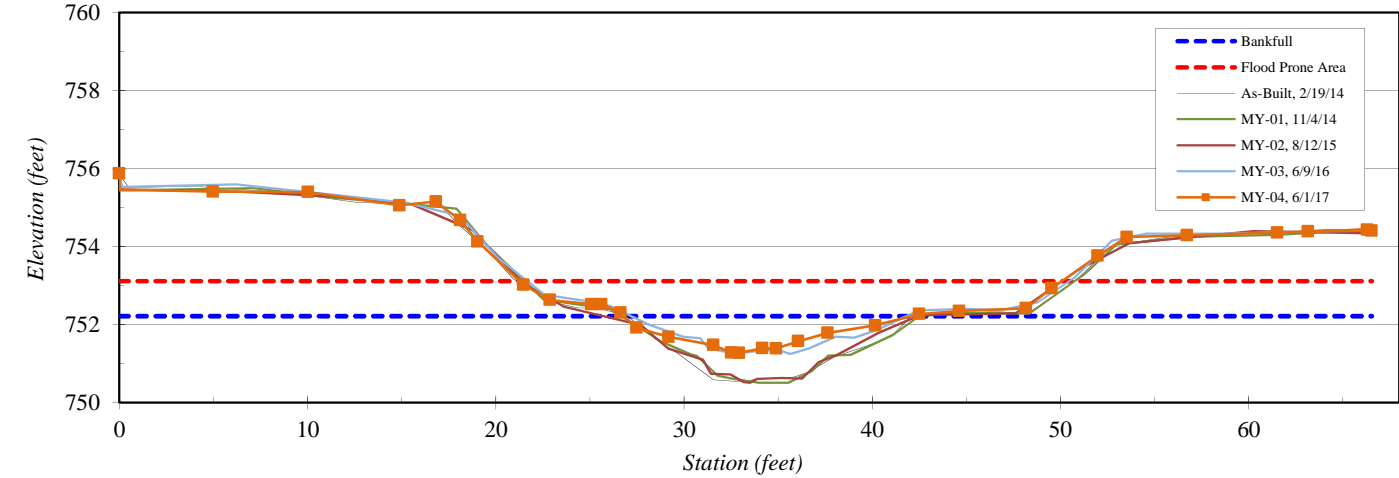
Yadkin-Pee Dee River Basin, Jacob's Ladder, XS-7, Riffle (T2)

SUMMARY DATA	
<b>Bankfull Elevation (ft):</b>	752.2
<b>Bankfull Cross-Sectional Area (ft<sup>2</sup>):</b>	8.0
<b>Bankfull Width (ft):</b>	15.3
<b>Flood Prone Area Elevation (ft):</b>	753.1
<b>Flood Prone Width (ft):</b>	29.1
<b>Max Depth at Bankfull (ft):</b>	0.9
<b>Mean Depth at Bankfull (ft):</b>	0.5
<b>W / D Ratio:</b>	29.0
<b>Entrenchment Ratio:</b>	2.2
<b>Bank Height Ratio:</b>	0.5

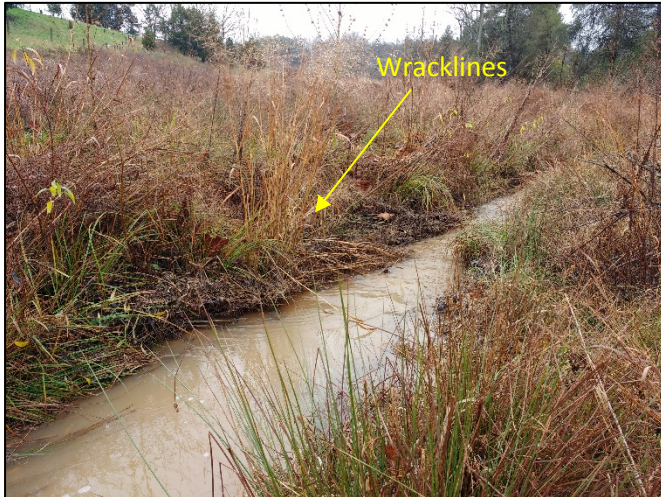
Photo 1. Bankfull indicators along T1, 12/17/15

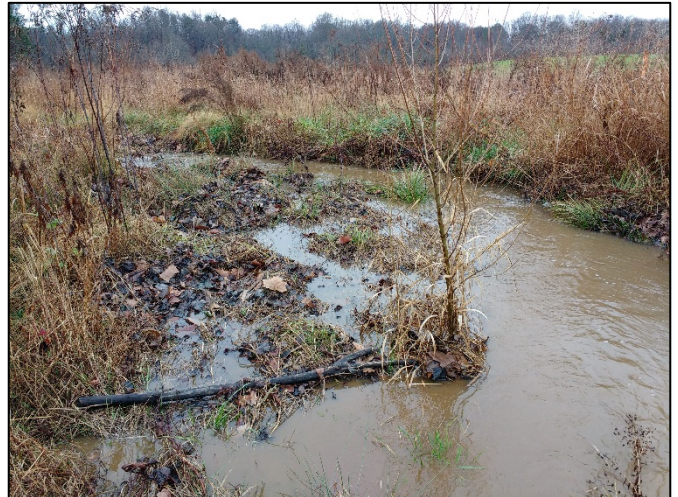
Photo 2. T2 at bankfull, 12/17/15
