Mitigation Project Name Jacobs Ladder
 DMS ID 95023
 River Basin Yadkin
 Cataloging Unit 03040105

Jacob's Ladder
Stream Restoration Monitoring Report
DMS Project # 95023
DMS Contract # 003983
Monitoring Year 05

Subject: Jacob's Ladder Stream Restoration Site
MY-05 Monitoring Report Comments
Yadkin River Basin CU 03040105
Rowan County, North Carolina
NCDMS Project # 95023
Contract # 003983

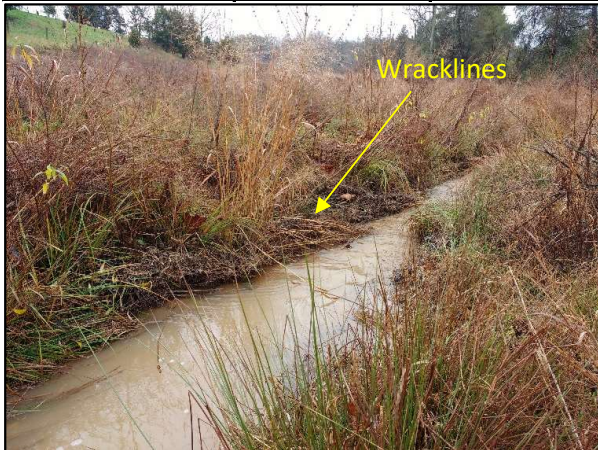
Photo 1. Bankfull indicators along T1, 12/17/15

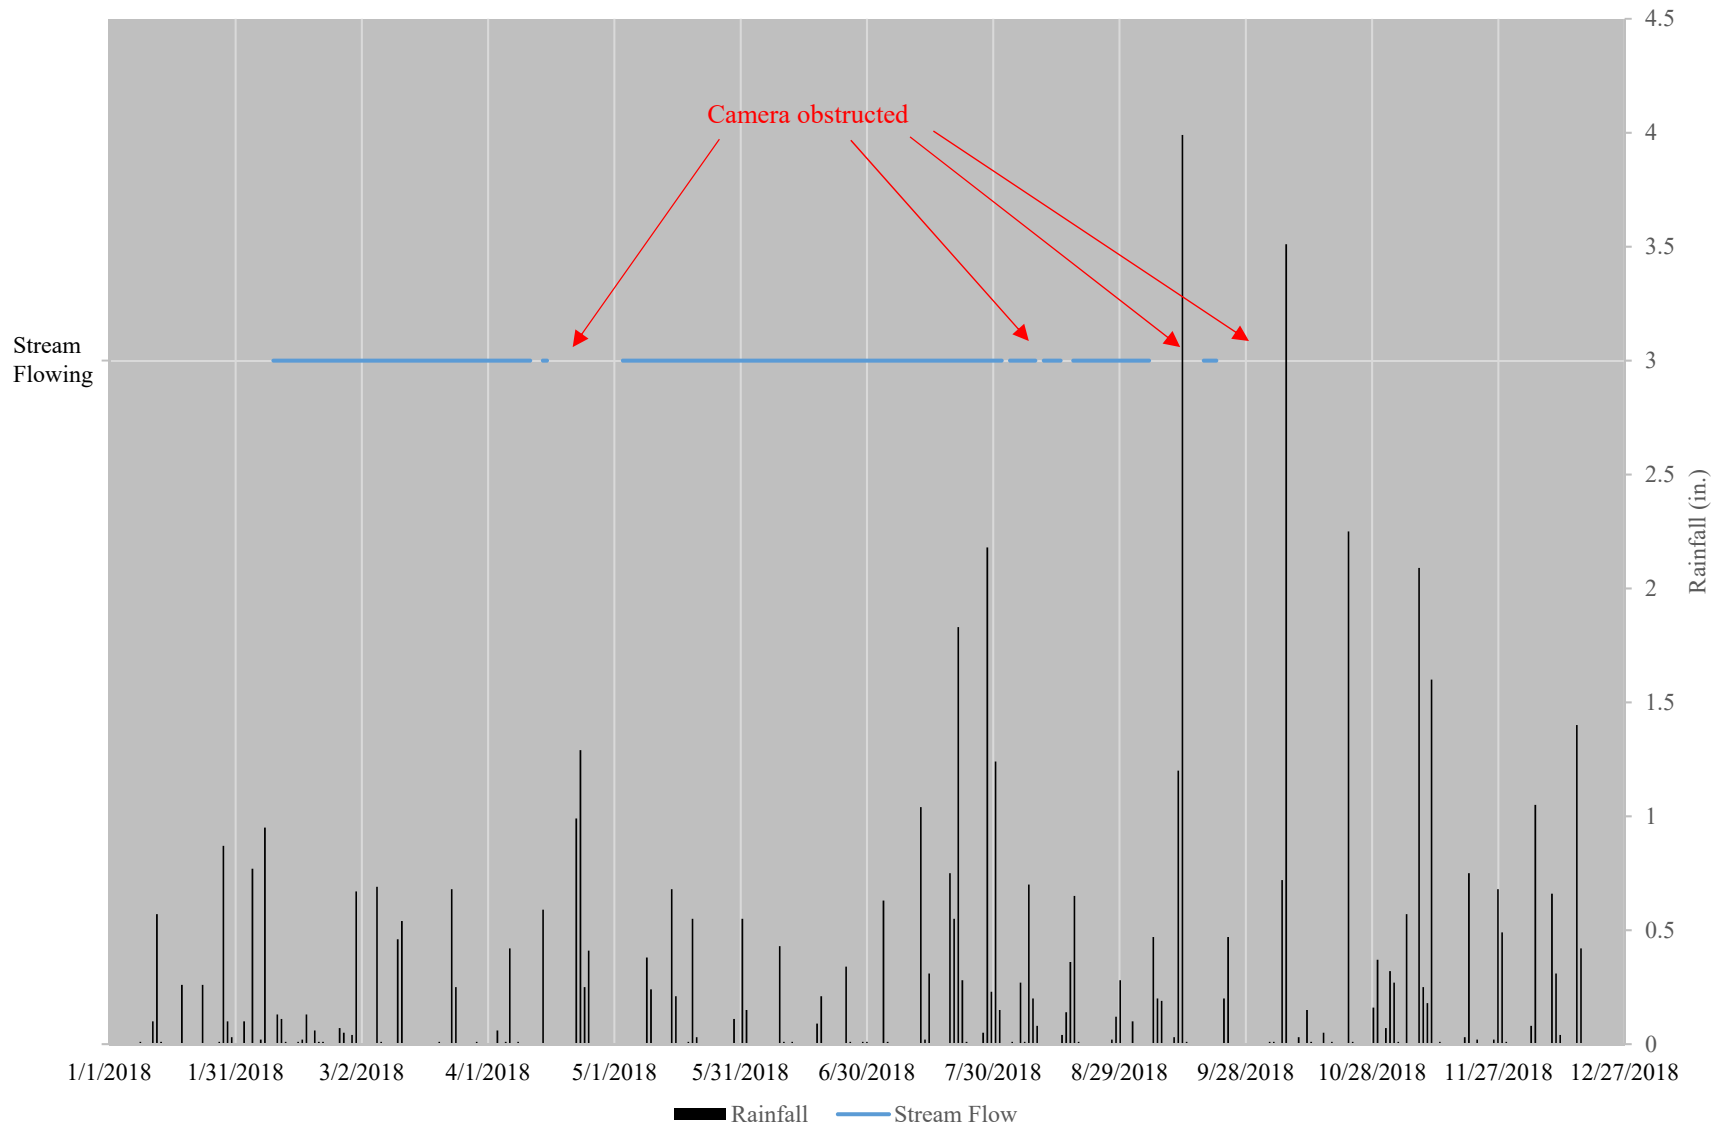
Jacob's Ladder Flow Camera T1A-1

On October 26, 2017, DMS met KCI on site to conduct a site walk and Reach T1A was determined to be a reach of concern due to the inconsistent flow in portions of the reach. A camera was installed on this reach at approximately Station 51+50 and set to record once a day starting February 9, 2018. The videos from this camera documented stream flow for most of the year. Some portion of the year the stream was obscured by vegetation growing in front of it or moisture accumulating on the camera lens. The periods of flow include a 62 day stretch from February 9 to April 11, and a 91 day stretch from May 3 to August 1, both of which ended because of vegetation growing in front of the camera.
