**Jacob's Landing  
Stream Restoration Monitoring Report  
DMS Project # 95024  
DMS Contract # 003984  
Monitoring Year 02**

**Construction Completed: January 2014**

**Data Collection: 2015**

**Submitted: January 2016**

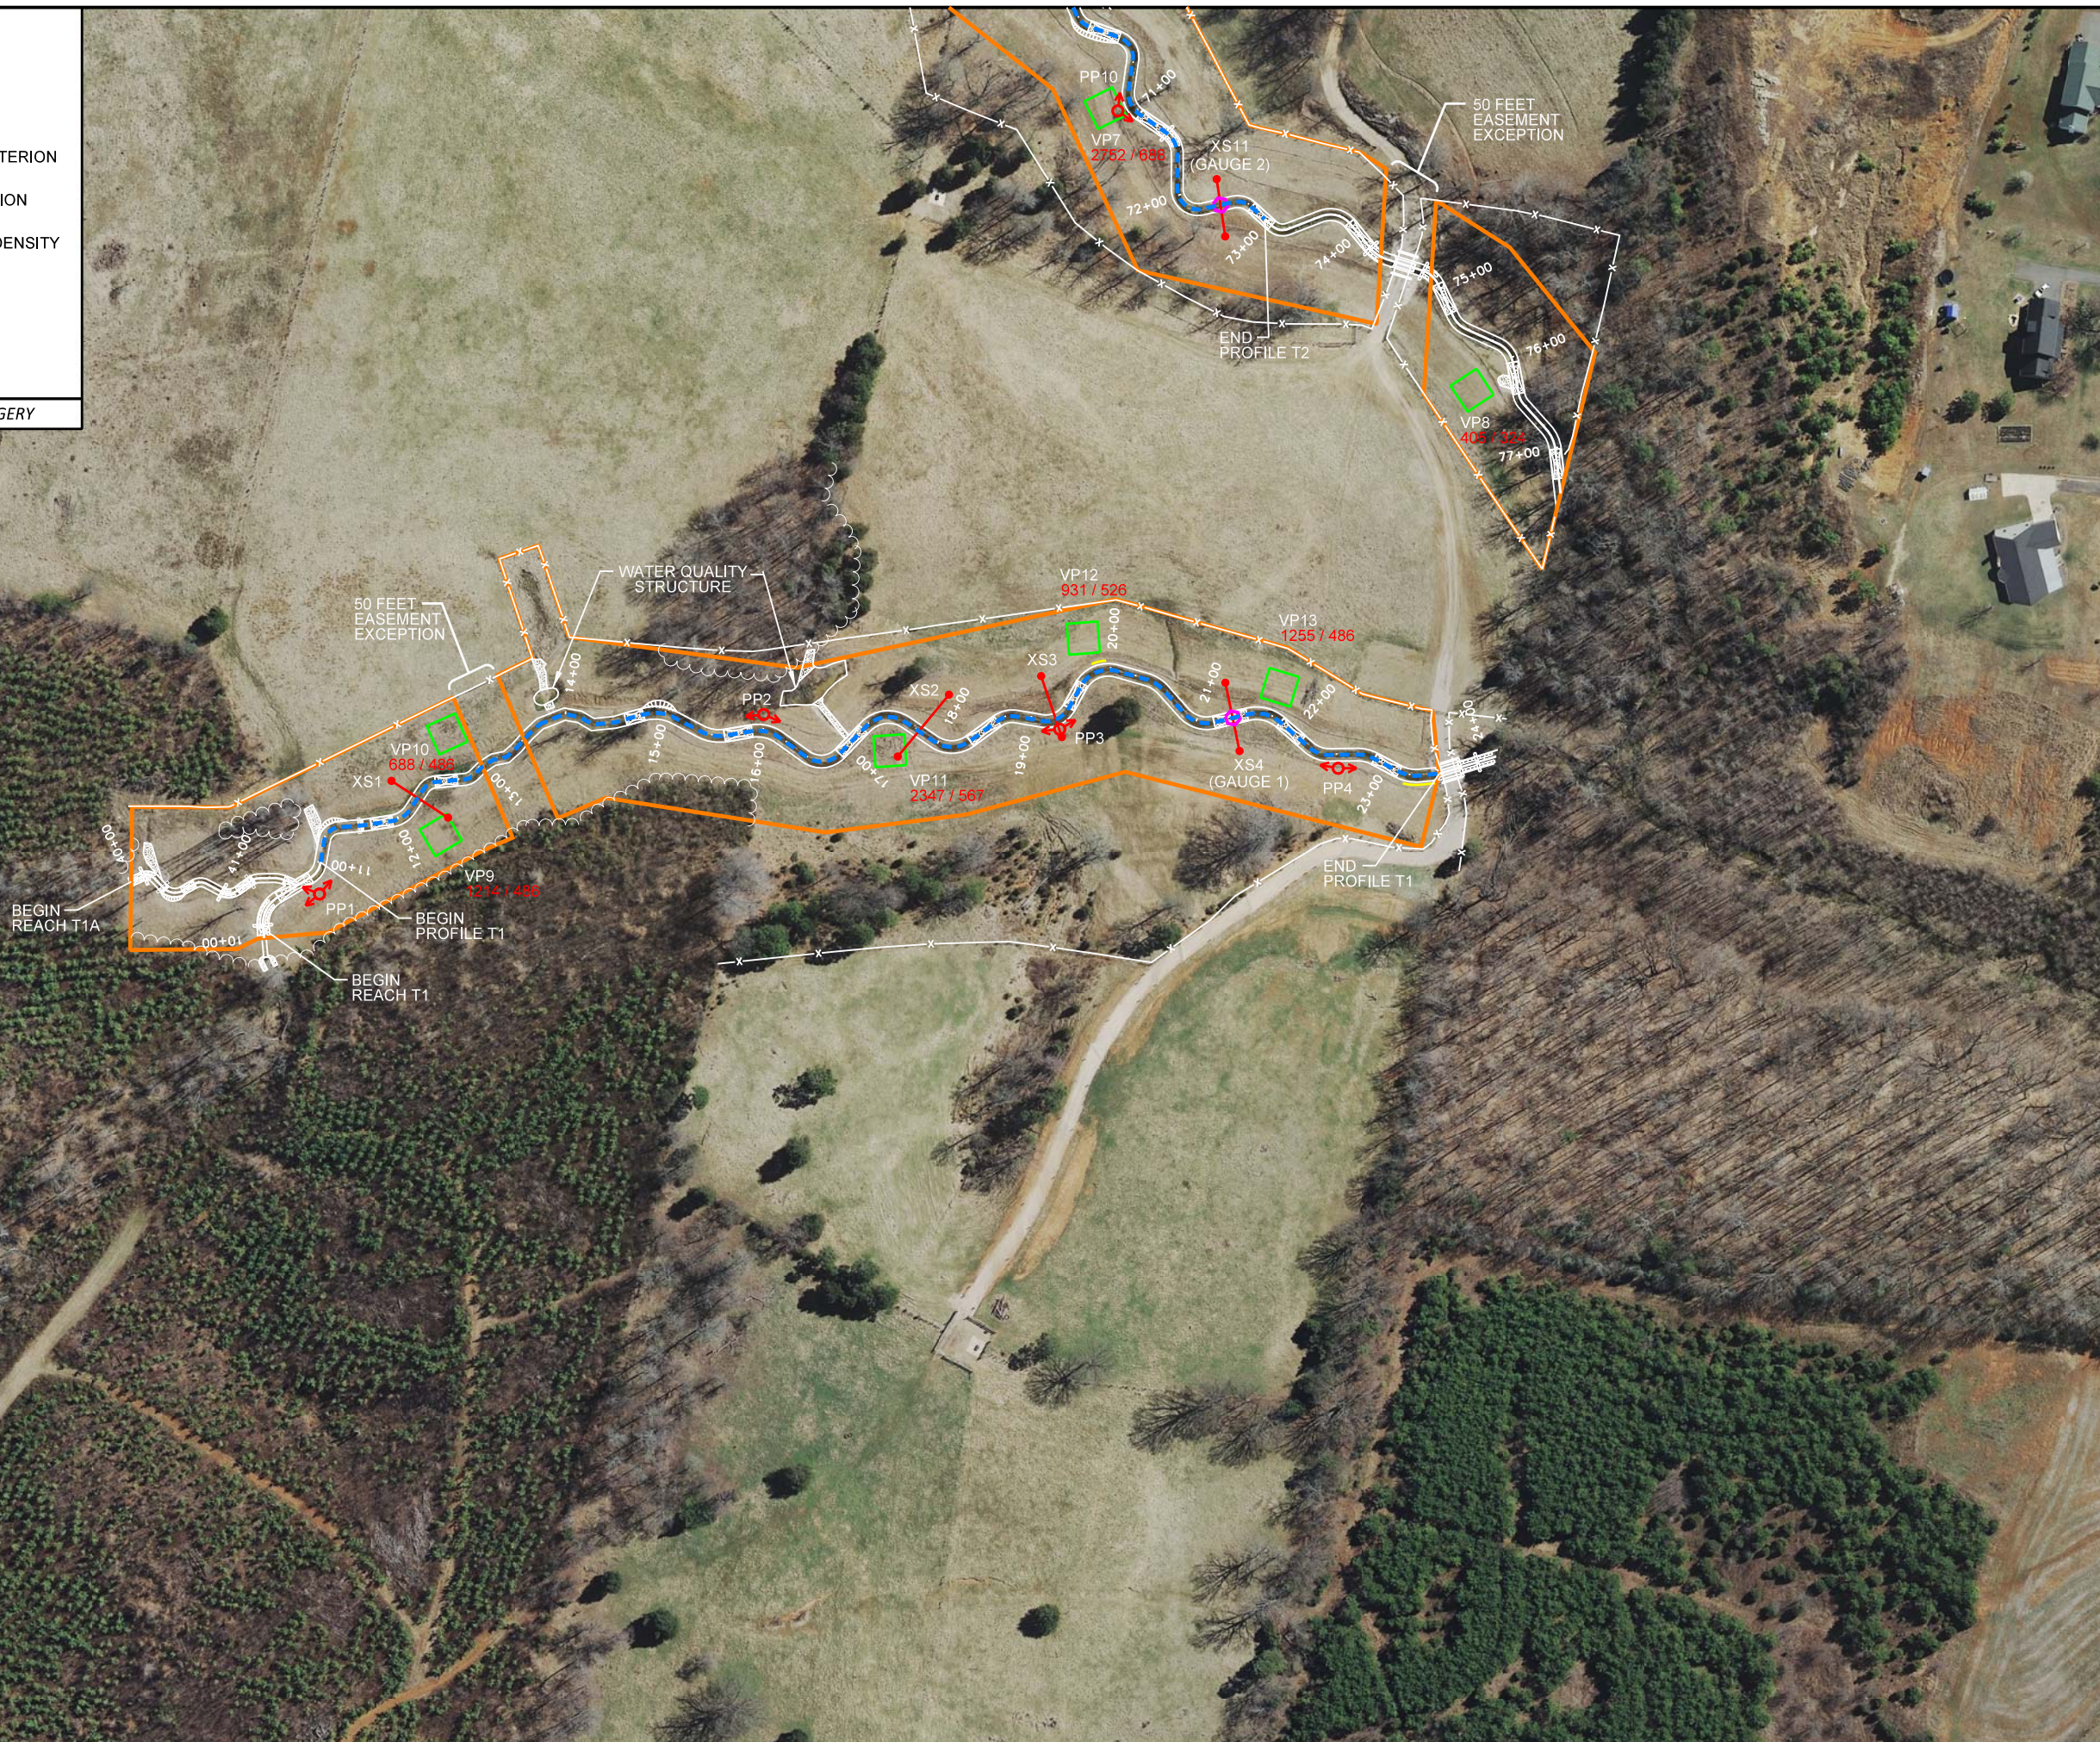
DATE: DEC 2015  
SCALE: GRAPHIC  
**CURRENT  
CONDITION  
PLAN VIEW**  
SHEET 1 OF 2

Second-year monitoring found the Jacob's Landing Site to be stable, with only minor changes from the as-built conditions. Two small areas of bank erosion are present on T1, but these areas appear to be isolated instances of erosion and do not represent a systematic problem. The monitoring components were installed in February/March 2014. Two automatic recording gauges have been installed along T1 and T2. The stream gauge on T1 recorded several bankfull events during 2015, and although the gauge on T2 did not record any, there was clear evidence of

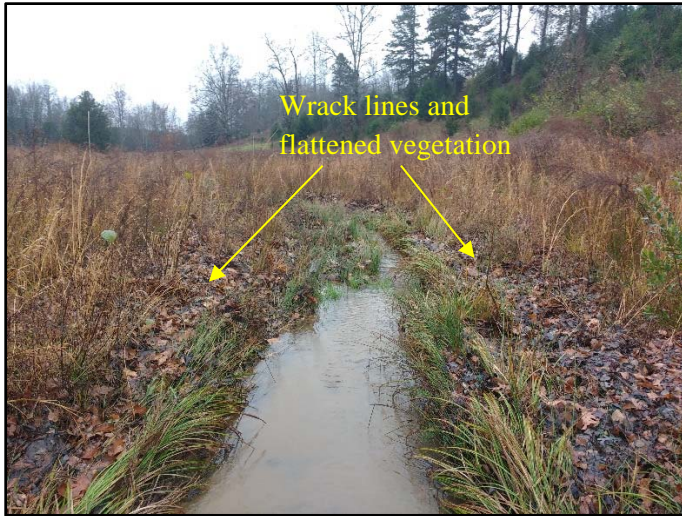
Photo 1. Bankfull indicators T1, 12/17/2015

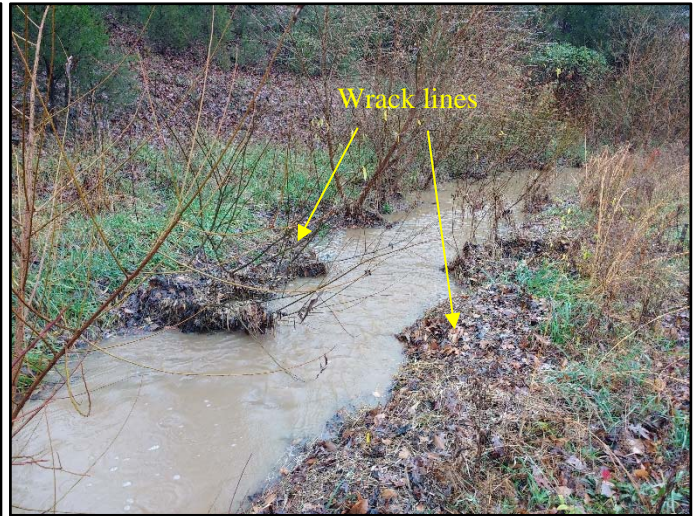
Photo 2. Bankfull indicators T2, 12/17/2015
