**Jacob's Landing  
Stream Restoration Monitoring Report  
DMS Project # 95024  
DMS Contract # 003984  
Monitoring Year 03**

**Construction Completed: January 2014**

**Data Collection: 2016**

**Submitted: December 2016**

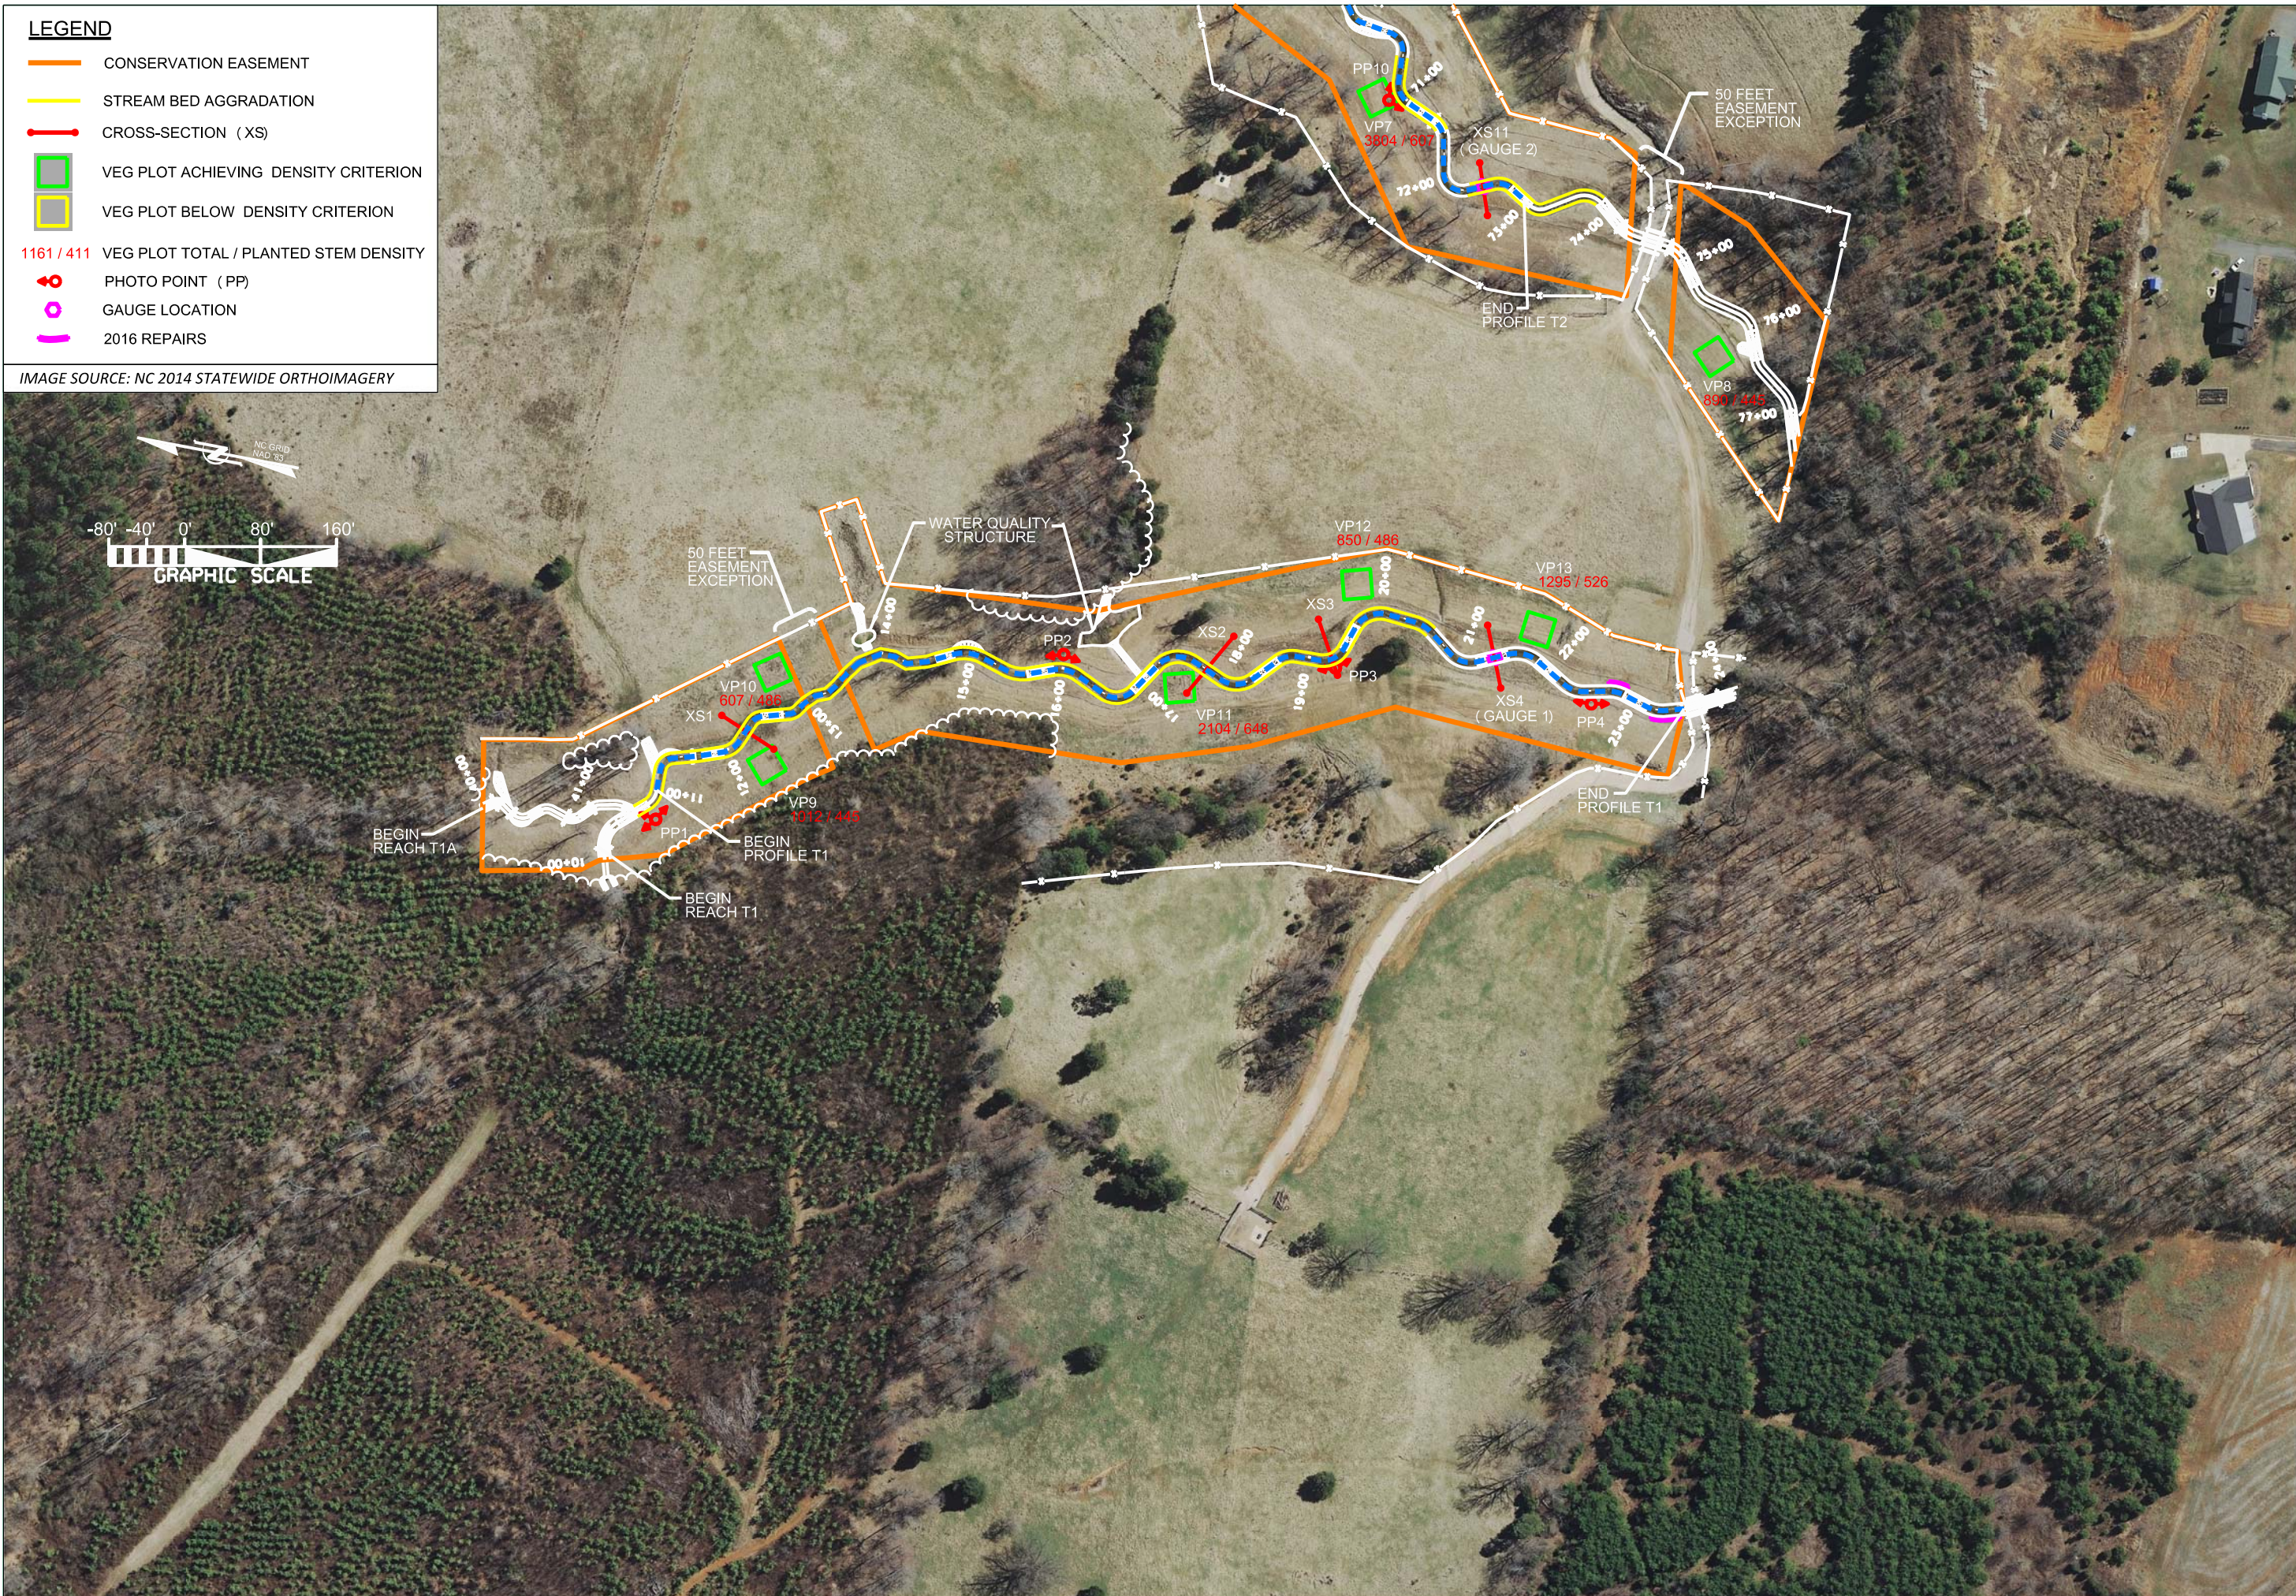
CURRENT  
 CONDITION  
 PLAN VIEW

Third-year monitoring found the Jacob's Landing Site to be stable, with only minor changes from the as-built conditions. Two small areas of bank erosion that were reported on T1 in last year's report were repaired with soil lifts in the beginning of 2016. The monitoring components were installed in February/March 2014. Two automatic recording gauges have been installed along T1 and T2. Both stream gauges recorded several bankfull events during 2016. The monitoring plan for each tributary is as follows: T1 has a 1,500 foot longitudinal profile,

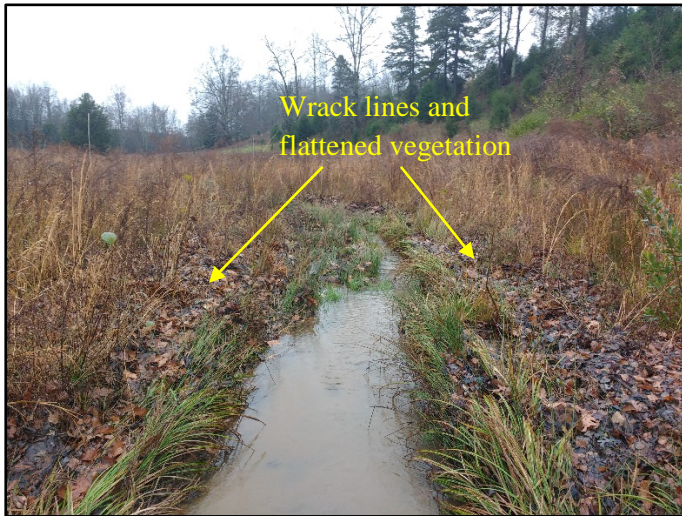
Photo 1. Bankfull indicators T1, 12/17/2015

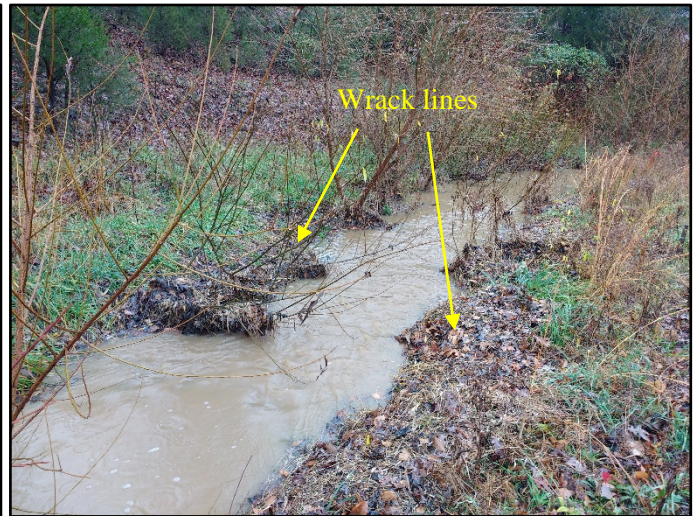
Photo 2. Bankfull indicators T2, 12/17/2015
