**Jacob's Landing
Stream Restoration Monitoring Report
DMS Project # 95024
DMS Contract # 003984
Monitoring Year 04**

Subject: Jacob's Landing Stream Restoration Site
MY-04 Monitoring Report Comments
Yadkin River Basin CU 03040105
Rowan County, North Carolina
NCDMS Project # 95024
Contract # 003984

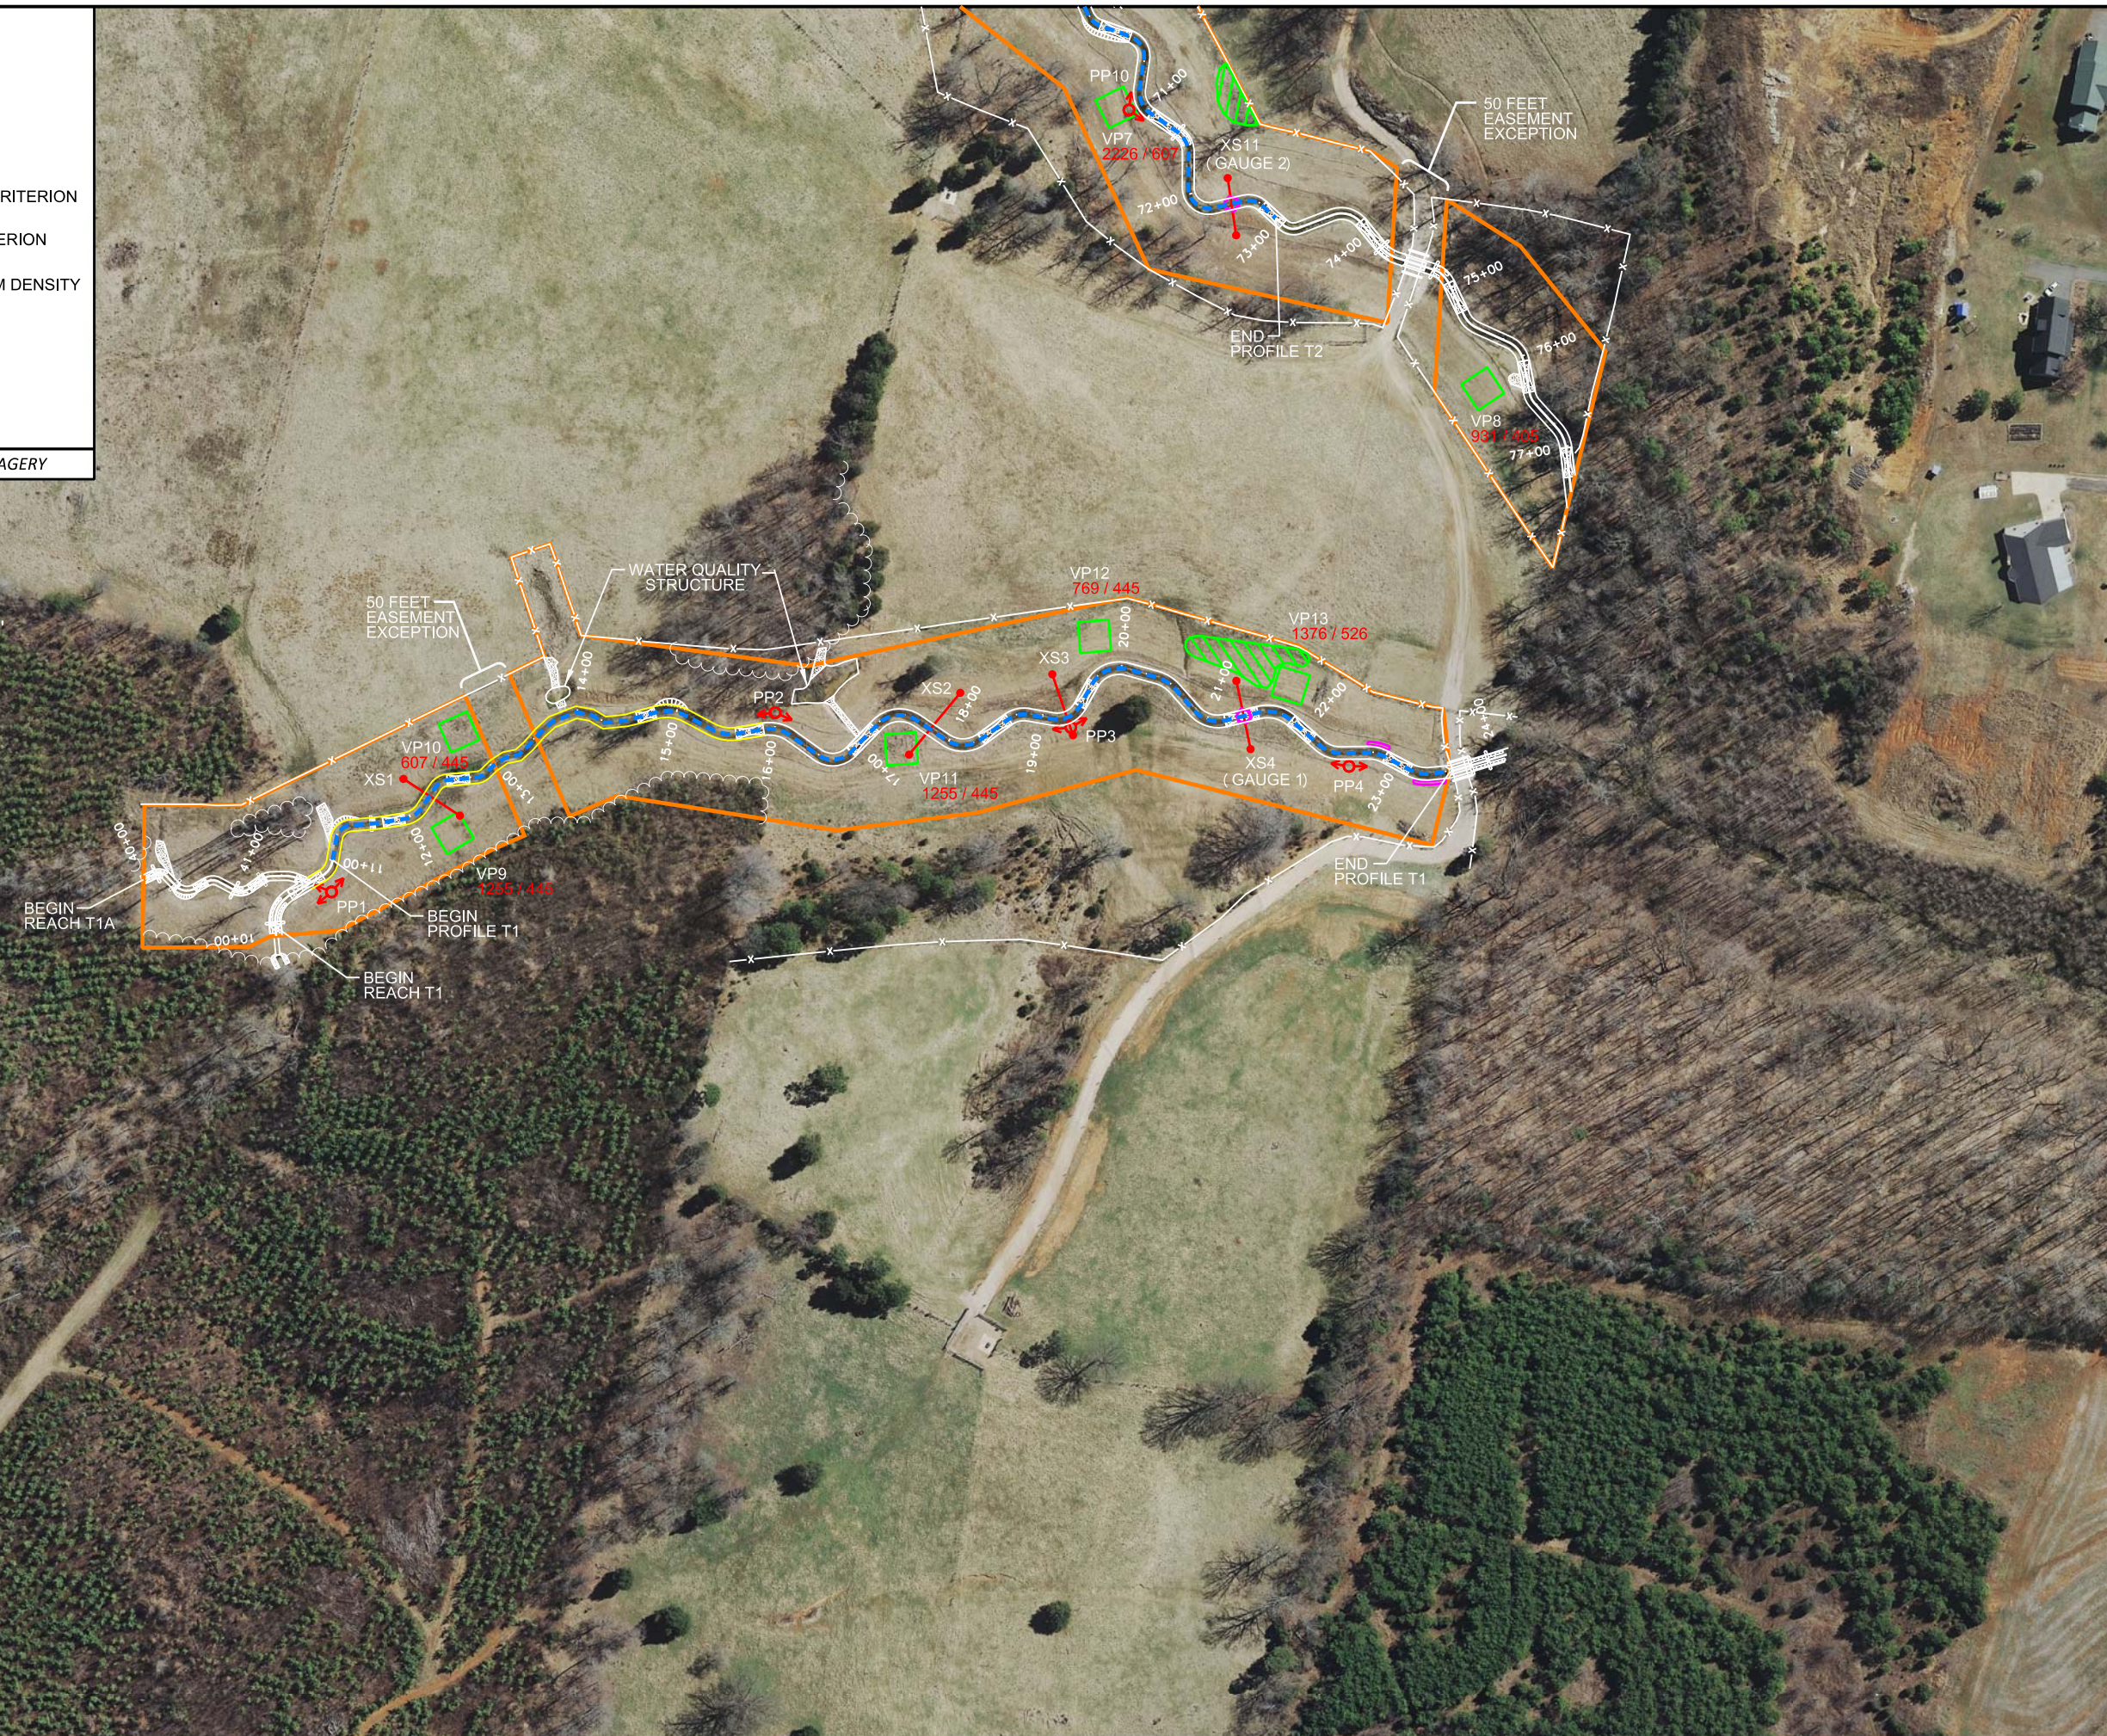
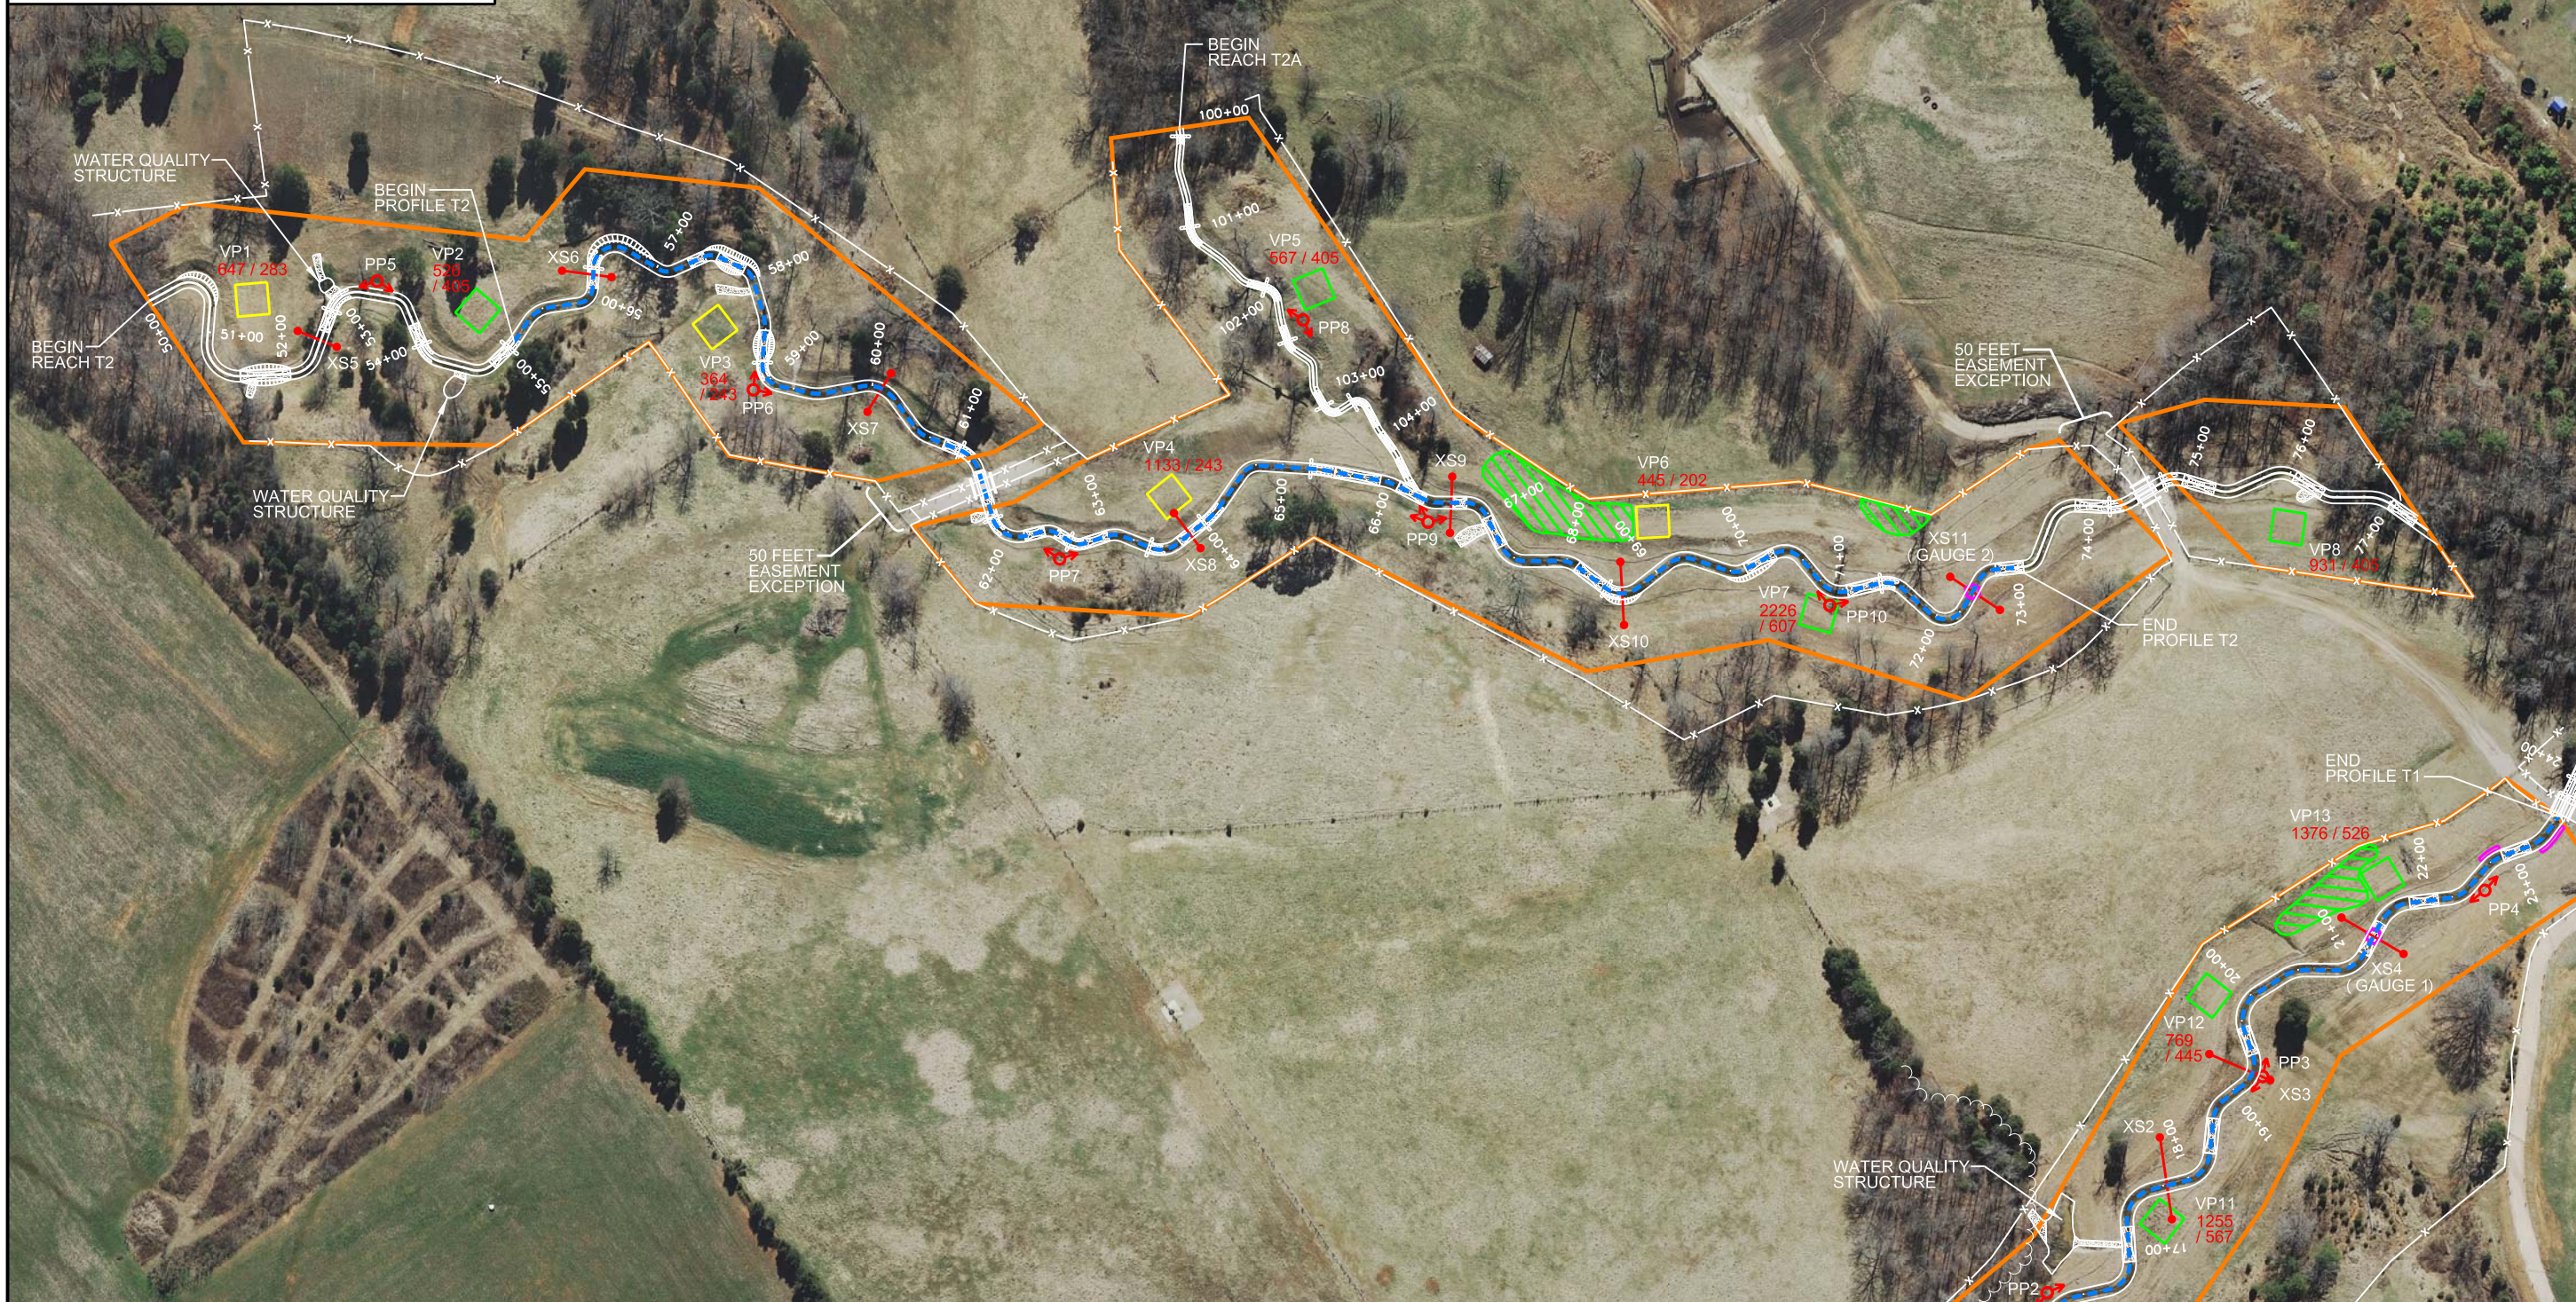
CURRENT
CONDITION
PLAN VIEW

Fourth-year monitoring found the Jacob's Landing Site to be stable, with only minor changes from the as-built conditions. Two small areas of bank erosion that were reported on T1 during MY02 were repaired with soil lifts in the beginning of 2016 and these have shown no signs of instability since. The monitoring components were installed in February/March 2014. Two automatic recording gauges have been installed along T1 and T2. Both stream gauges recorded several bankfull events during 2017. The monitoring plan for each tributary is as follows: T1 has a 1,500 foot longitudinal profile, 3 riffle cross-sections, and 1 pool cross-section; T2 has a 1,500 foot longitudinal profile, 5 riffle cross-sections and 2 pool cross-sections; T1A and T2A are being monitored visually since they are short reaches and small channels. Pebble counts were conducted at all eleven cross-sections. Ten permanent photo reference points have been established with a total of twenty-two photos to be taken annually. The fourth year of monitoring found the site to be functioning and T2 shows little change from the baseline conditions. The two areas of deposition mentioned in last year's report have since washed out and are more closely aligned with the baseline condition. This is representative of the natural cycle of sediment transport within the restored system, which receives a high volume of sediment input upstream of the restored reach. Similarly, although there are several areas of aggradation still present on T1, much of the aggradation reported last year has washed out and the remaining instances are confined to the upper quarter of the reach. As with T2, this is not seen as an indicator of instability in the reach, but will be monitored to ensure it does not become a problem for the site.

- *KCI is currently planning a supplemental planting at the site to address areas of low stem density/majority sweetgum areas before the beginning of the next growing season. Three of the 4 failing plots have a significant number of high quality volunteers and it is not believed that overall the site is lacking in woody vegetation.*

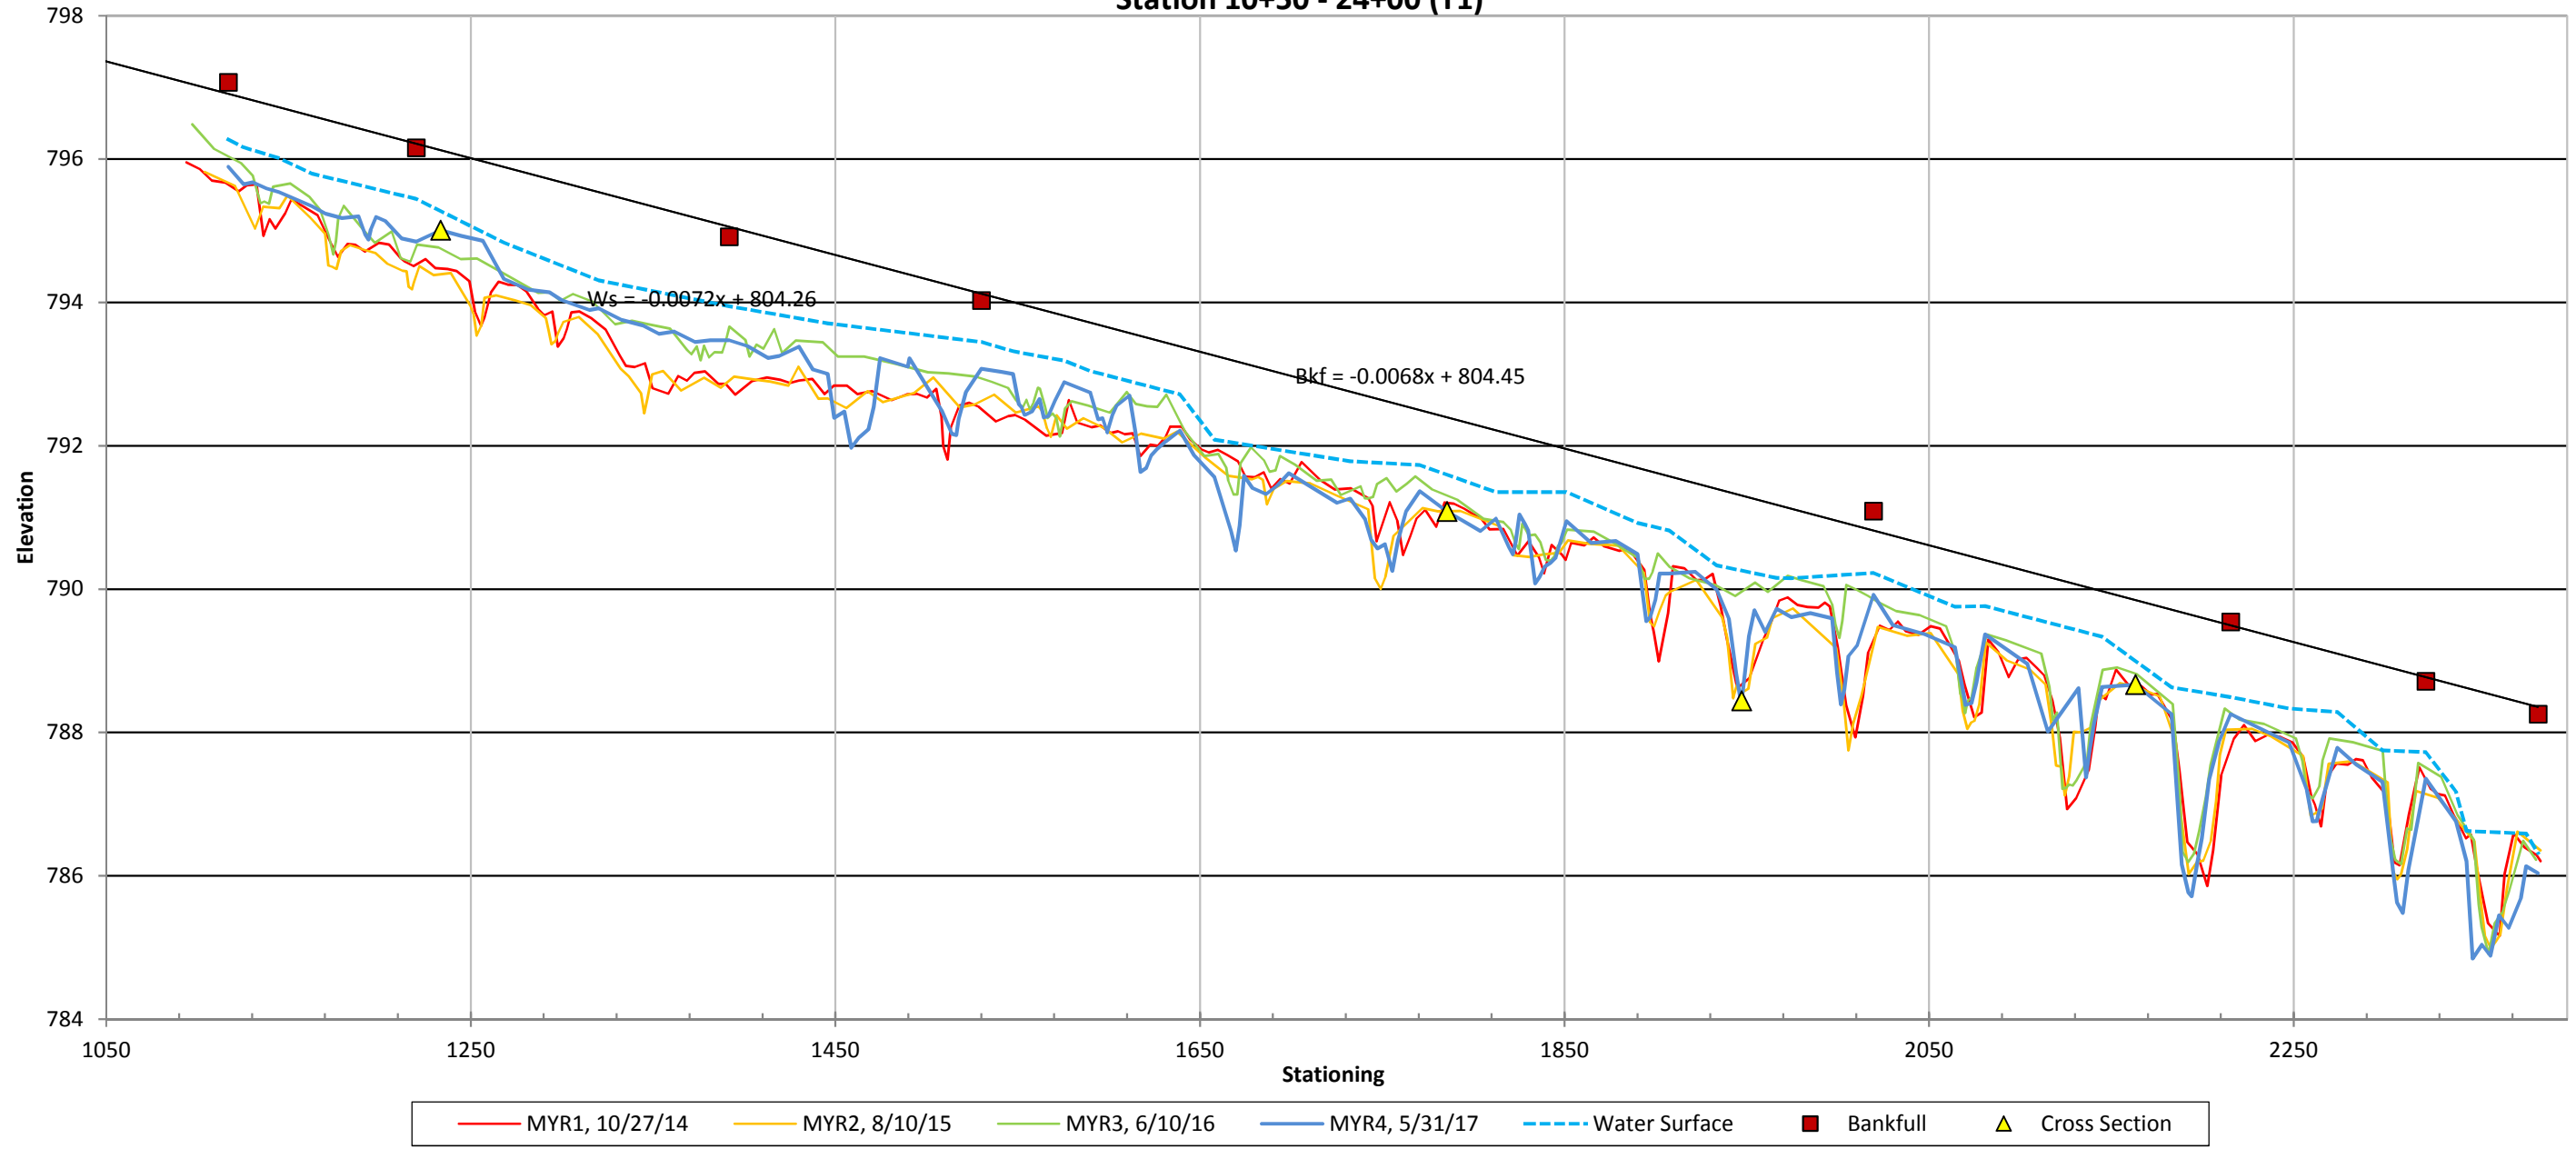
Longitudinal Profile
Jacob's Landing
DMS Project Number - 95024
Station 10+50 - 24+00 (T1)

- Executive summary discusses aggradation on T1. According to the profile and Table 5, there appears to be approximately 550' of aggradation at the upstream section of T1. Please be aware that if a stream fills in and is not functioning as designed, the IRT may deny credit for this section. DMS recommends requesting site visit with IRT to discuss and develop an adaptive management plan if necessary.

- *KCI will request a site visit with the IRT.*
- All four of the failing vegetation plots are on Reach T2. Does KCI plan to replant portions of this reach?
