**Jacob's Landing
Stream Restoration Monitoring Report
DMS Project # 95024
DMS Contract # 003984
Monitoring Year 05**

Subject: Jacob's Landing Stream Restoration Site
MY-05 Monitoring Report Comments
Yadkin River Basin CU 03040105
Rowan County, North Carolina
NCDMS Project # 95024
Contract # 003984

DATE: JAN 2019
 SCALE: GRAPHIC
 CURRENT CONDITION
 PLAN VIEW
 SHEET 1 OF 2

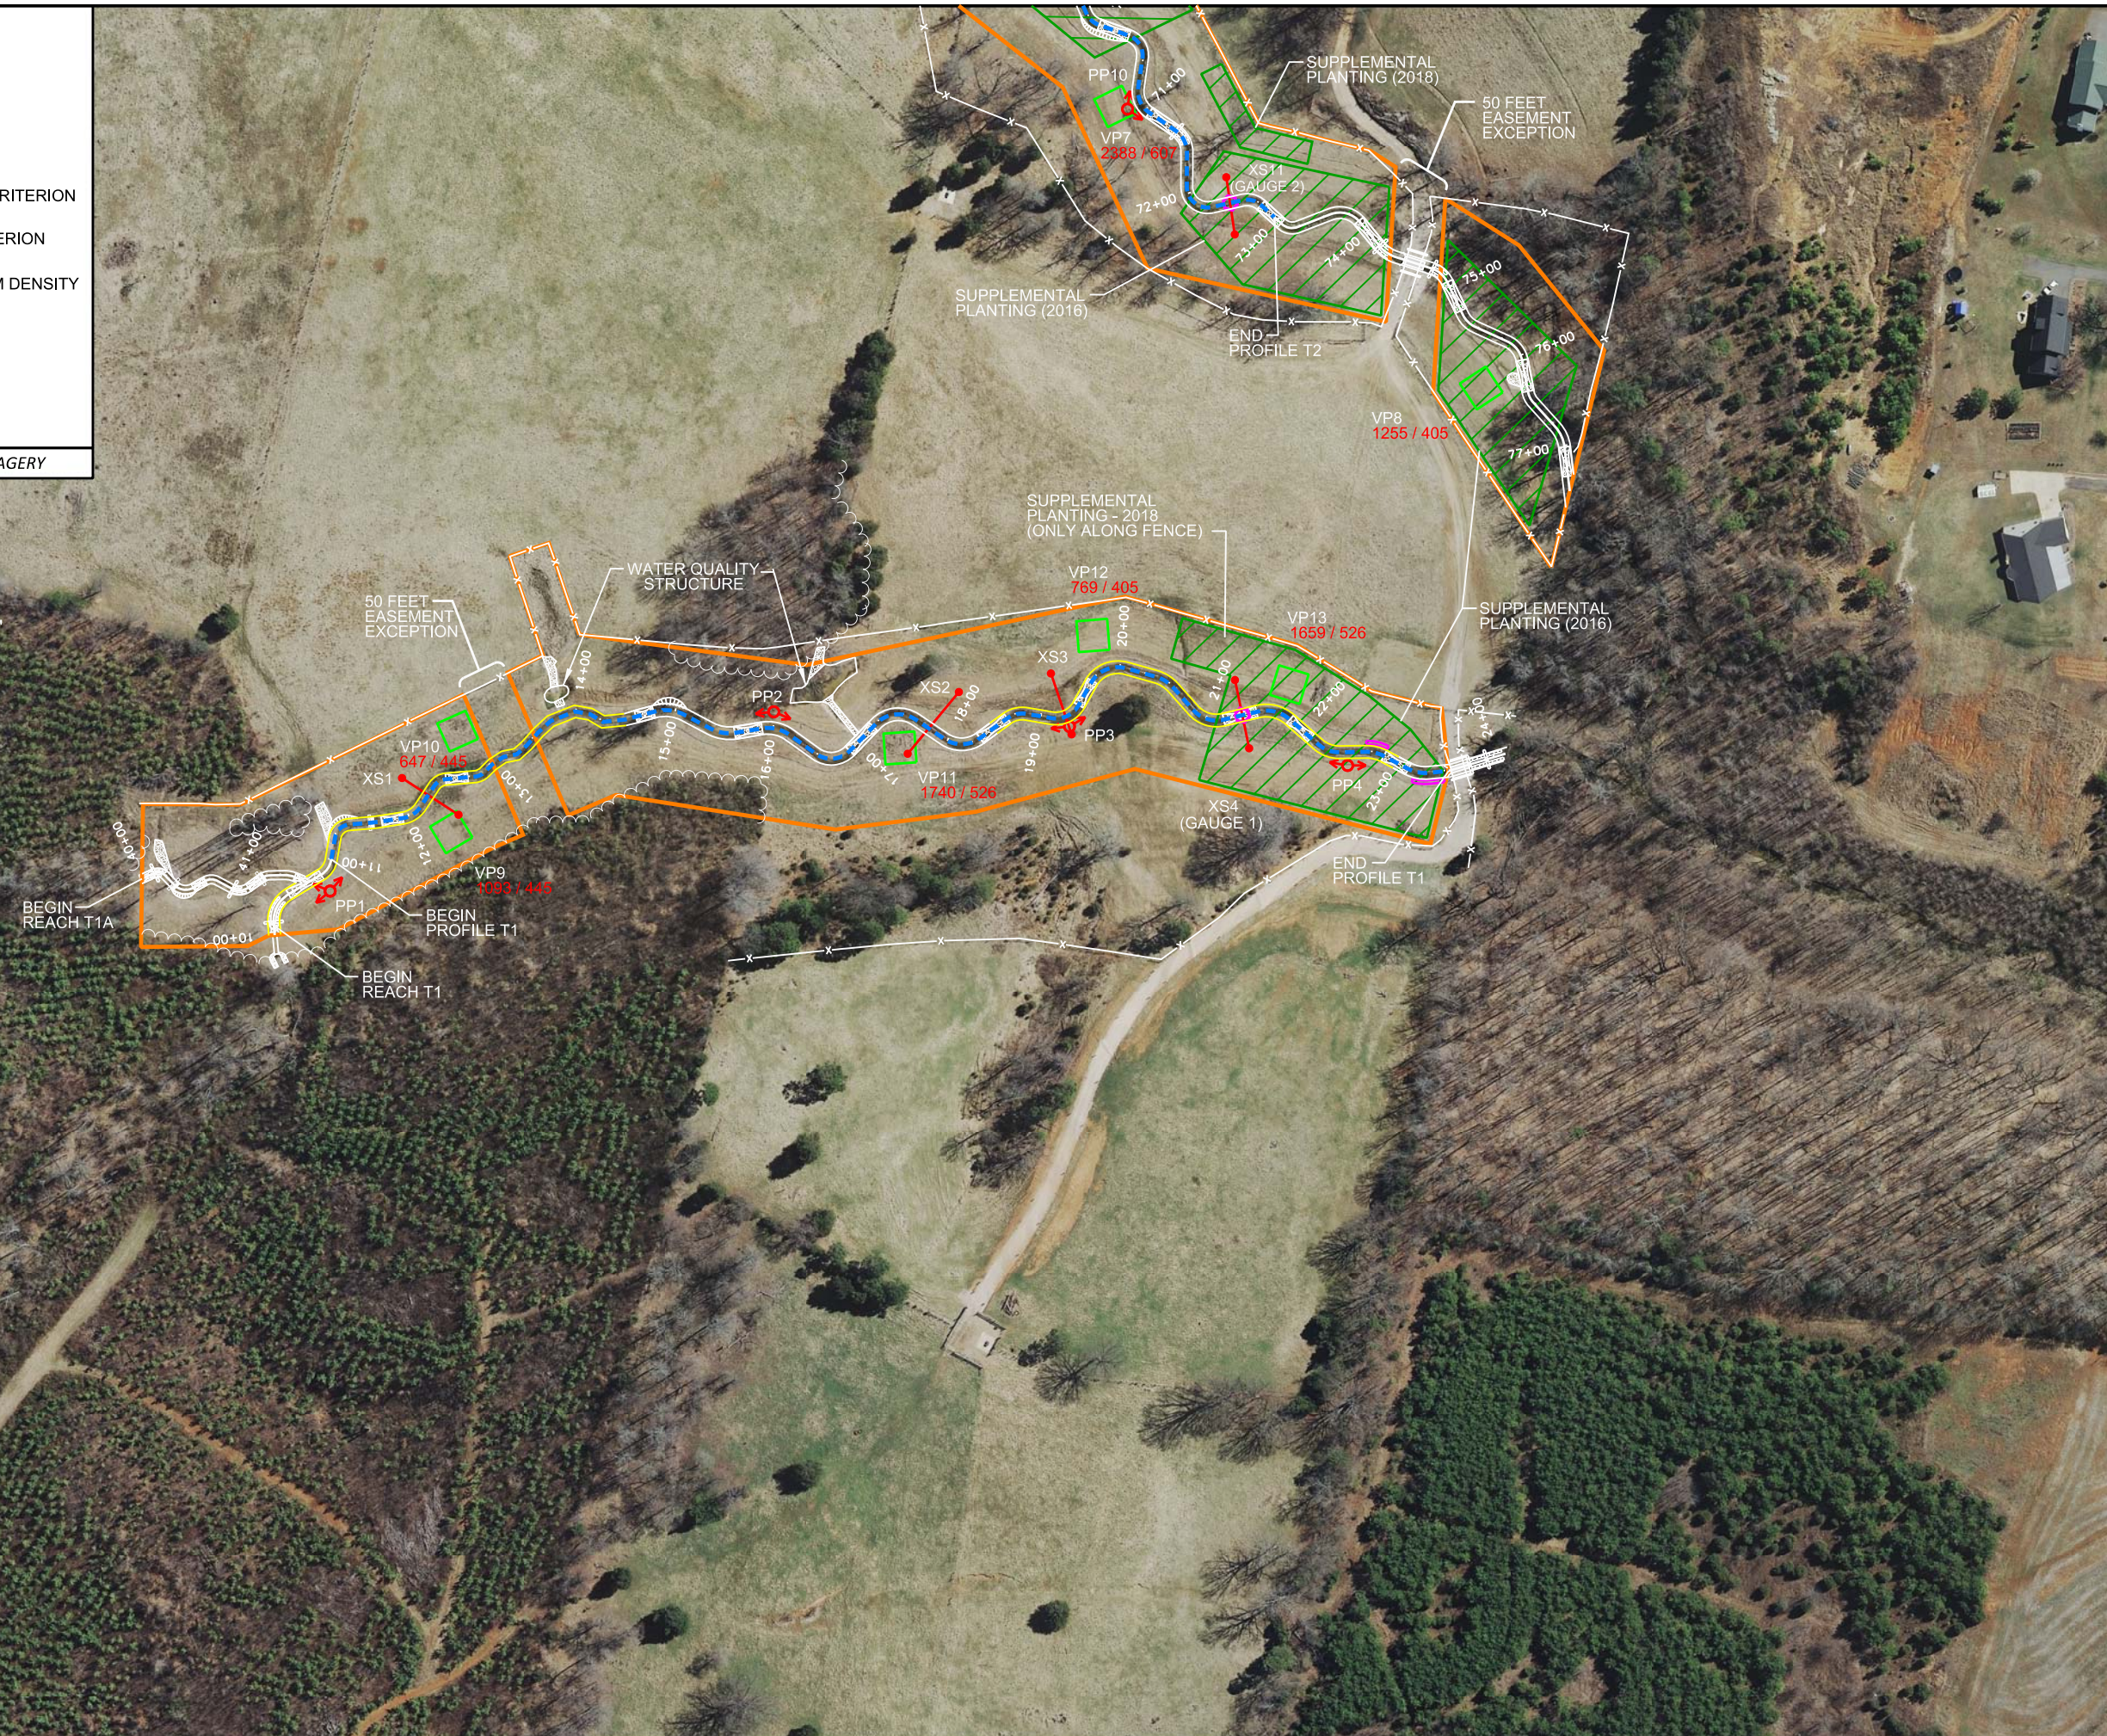
- DMS met with KCI on December 4, 2018 to view the Jacob Landing site. Dense privet was observed on Reach T2A. Please show this area on the CCPV and include the treatment date if it has occurred on Table 2.
 - *This area of privet was treated on December 13, 2018. This date has been added to Table 2 and the area has been added to the CCPV.*

- A large tree fell and damaged portion of the fence on T2. Has this tree been removed and the fence repaired?
 - *The area around the tree is currently too wet to access and so the tree has not been removed. Once the area dries out, KCI will remove the tree and repair the fence. The landowner does not have his cows in this area of his pasture and has said he will keep the cows away from this area until the fence is repaired.*

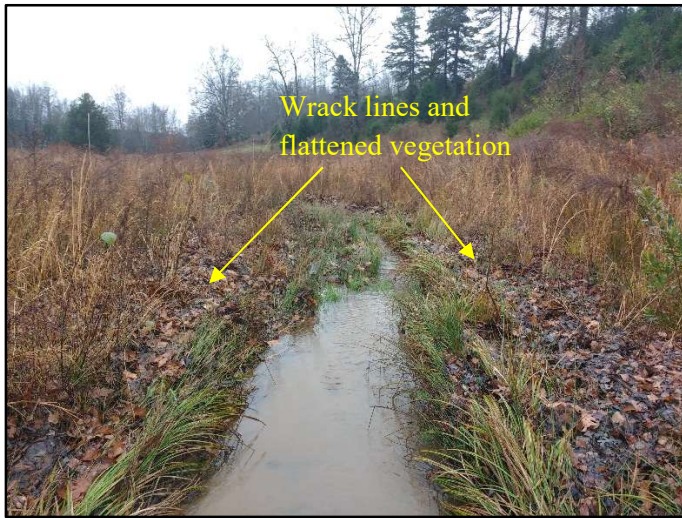
Photo 1. Bankfull indicators T1, 12/17/2015

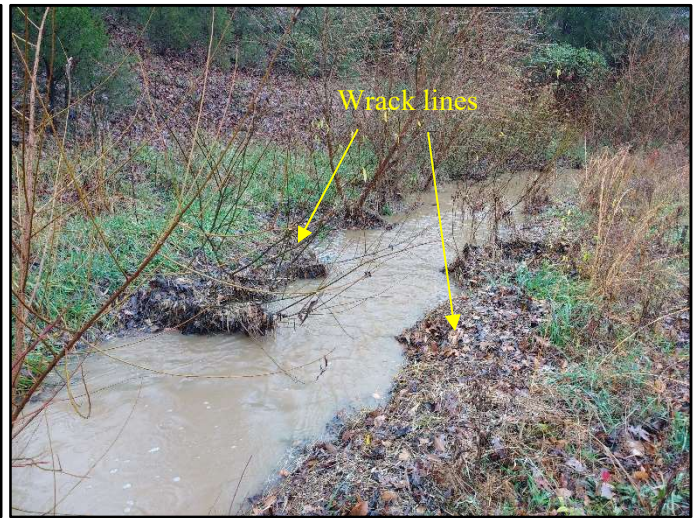
Photo 2. Bankfull indicators T2, 12/17/2015
