YEAR 3 (2010)
ANNUAL MONITORING REPORT
JARMANS OAK RESTORATION SITE
ONslow COUNTY, NORTH CAROLINA

(CONTRACT D06069-A)
FULL DELIVERY PROJECT
WHITE OAK RIVER BASIN
CATALOGING UNIT 03030001

August 2010

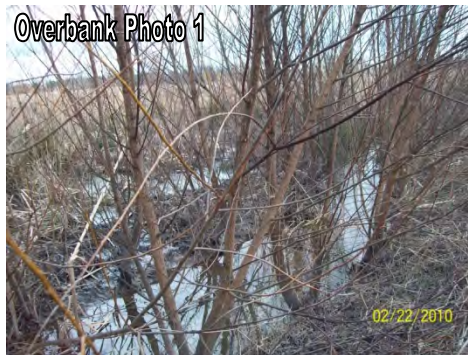
Date of Data Collection	Date of Occurrence	Method	Photo (if available)
March 2009	February 28-March 2, 2009	Total of 2.28 inches of rain documented between February 28-March 2, 2009 at an onsite rain gauge	--
April 2009	April 14, 2009	Total of 3.01 inches of rain documented on April 14, 2009 at an onsite rain gauge	--
May 2009	May 16-18, 2009	Total of 3.05 inches of rain documented between May 16-18, 2009 at an onsite rain gauge	--
April 2010	November 11, 2009	Greater than 5 inches of rain documented between November 10-12, 2009 as the result of Tropical Storm Ida.*	--
April 2010	February 5, 2010	Visual observations of overbank resulting from a 1.65 inch rainfall event on February 5, 2010 that occurred after numerous rainfall events, within the 3 weeks prior, that totaled 4.32 inches*.	Photo 1

One potential stream problem area was documented within the Site during the last monitoring period. An area of reduced bed and bank integrity, located on the Main Tributary, immediately upstream of Monitoring Reach 2, was noted and should continue to be watched throughout the monitoring period. This area consists of one pool that has scoured; however, erosion does not appear to be progressing. In addition, beaver management was initiated at the Site in the winter of 2009 and will continue as necessary. No additional stream problem areas were noted within the Site during the Year 3 (2010) monitoring year.

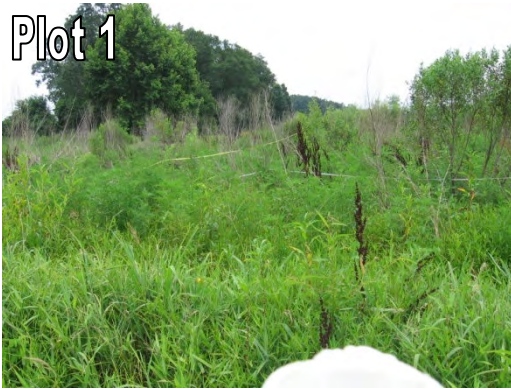
Plot 1

Vegetation sampling across the Site was above the required average density with an overall average of 494 planted stems per acre. One of the fourteen plots had a low density (plot 1) with 162 planted stems per acre; however, this is not considered to be a problem at this time. The establishment of natural recruits such as dogwood (*Cornus* sp.) has started and is expected to continue over the next few years. No vegetation problem areas were noted during the Year 3 (2010) monitoring season.

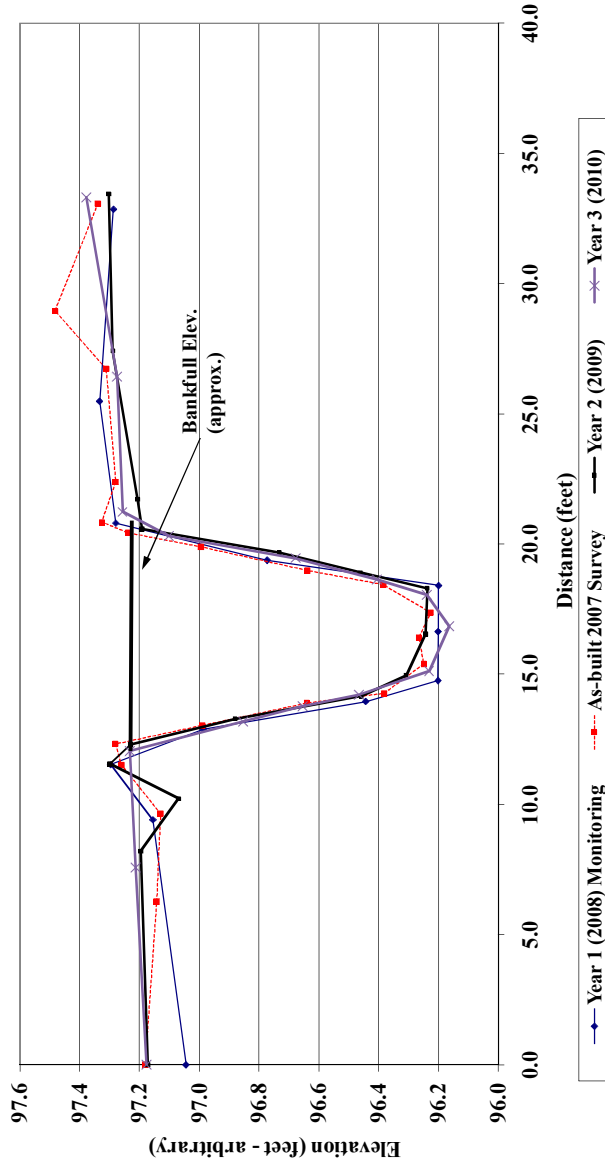
Jarman's Oak Reach 1 - XS1 Riffle

As-built	2008	2009	2010
Area	5.9	6.4	5.6	5.8
Width	9.1	9.0	8.9	8.8
Mean Depth	0.6	0.7	0.6	0.7
Max Depth	1.1	1.1	1.0	1.0
W/D Ratio	14.1	12.7	14.0	13.3

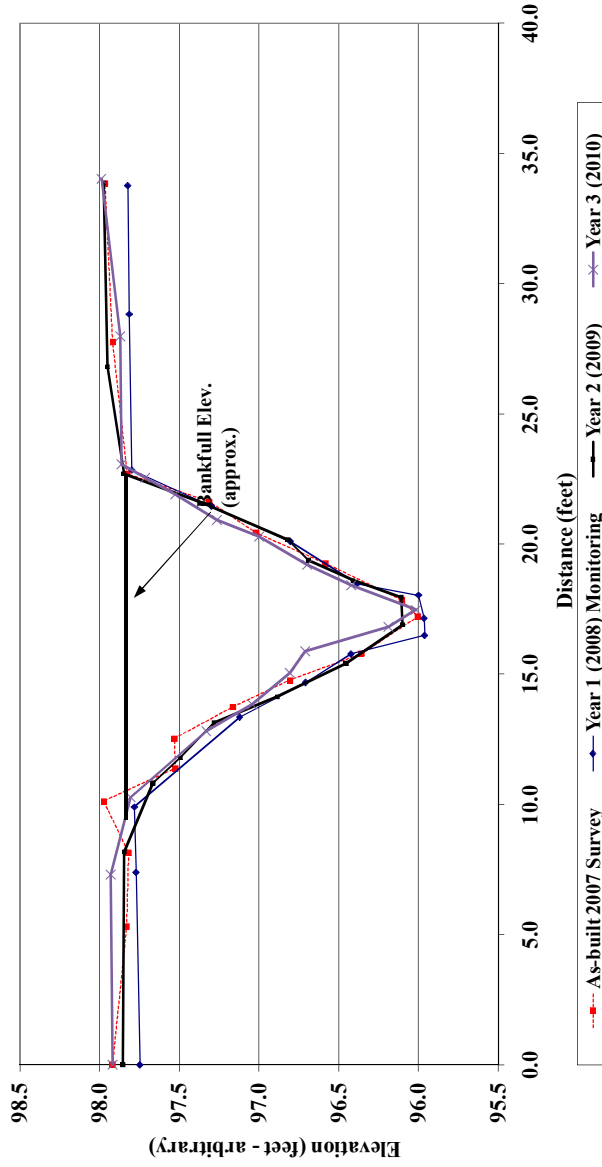
Jarman's Oak Reach 1 - XS2 Pool

As-built	2008	2009	2010
Area	7.6	11.4	11.9	10.6
Width	9.5	12.8	14.6	13.8
Mean Depth	0.8	0.9	0.8	0.8
Max Depth	1.5	1.8	1.8	1.8
W/D Ratio	N/A	N/A	N/A	N/A

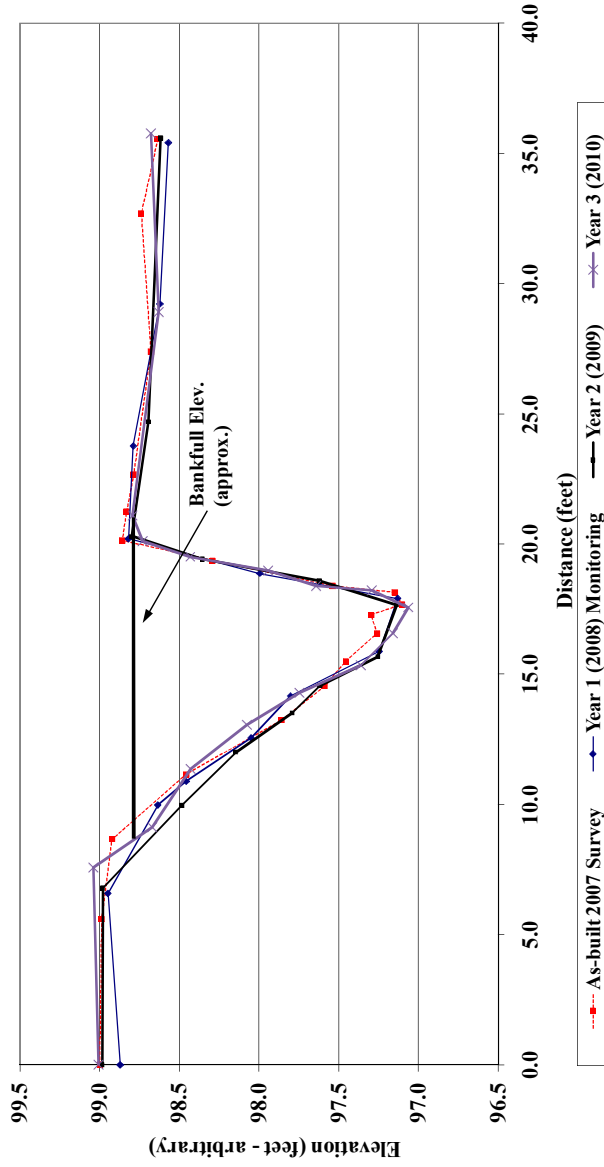
Jarman's Oak Reach 1 - XS3 Pool

As-built	2008	2009	2010
Area	10.4	10.0	10.6	9.8
Width	12.3	12.1	12.4	12.5
Mean Depth	0.8	0.8	0.9	0.8
Max Depth	1.8	1.7	1.7	1.7
W/D Ratio	N/A	N/A	N/A	N/A

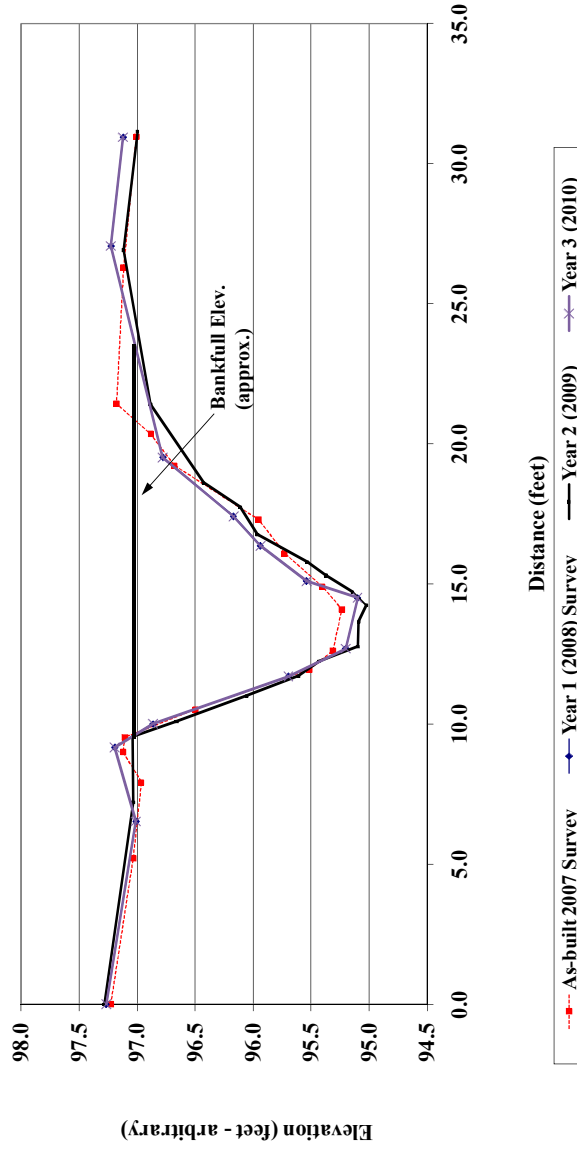
Jarman's Oak Reach 2 - XS1 Pool

As-built	2008	2009	2010
Area	12.7	11.3	13.2	11.3
Width	11.7	13.6	15.5	13.6
Mean Depth	1.1	0.8	0.9	0.8
Max Depth	1.9	1.9	2.0	1.9
W/D Ratio	N/A	N/A	N/A	N/A

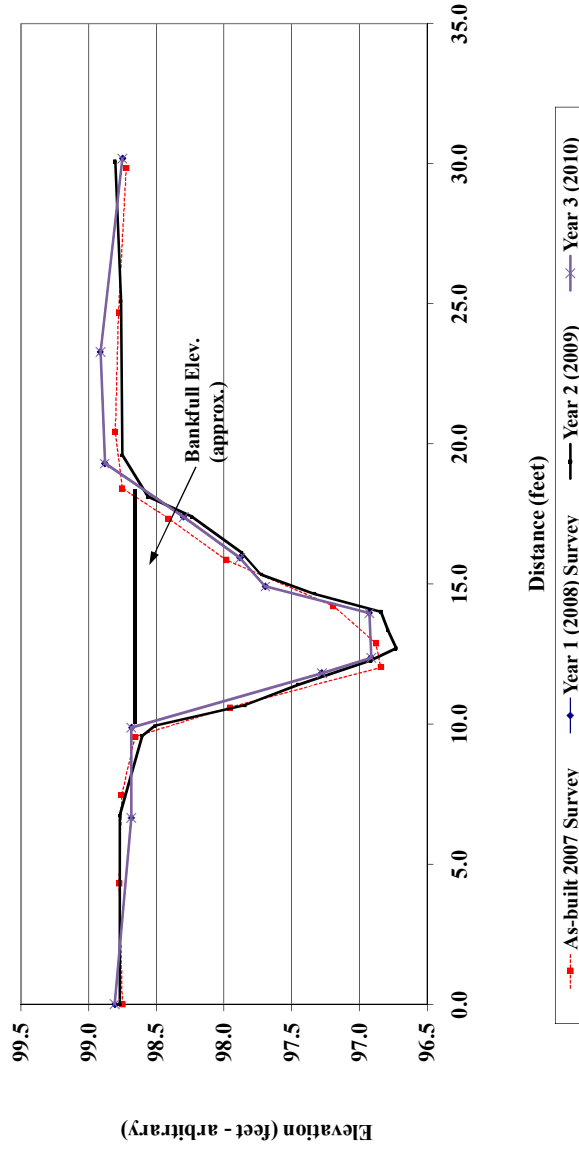
Jarman's Oak Reach 2 - XS3 Pool

As-built	2008	2009	2010
Area	8.4	8.3	8.7	8.3
Width	8.7	8.8	9.0	8.8
Mean Depth	1.0	1.0	1.0	1.0
Max Depth	1.8	1.8	1.9	1.8
W/D Ratio	N/A	N/A	N/A	N/A

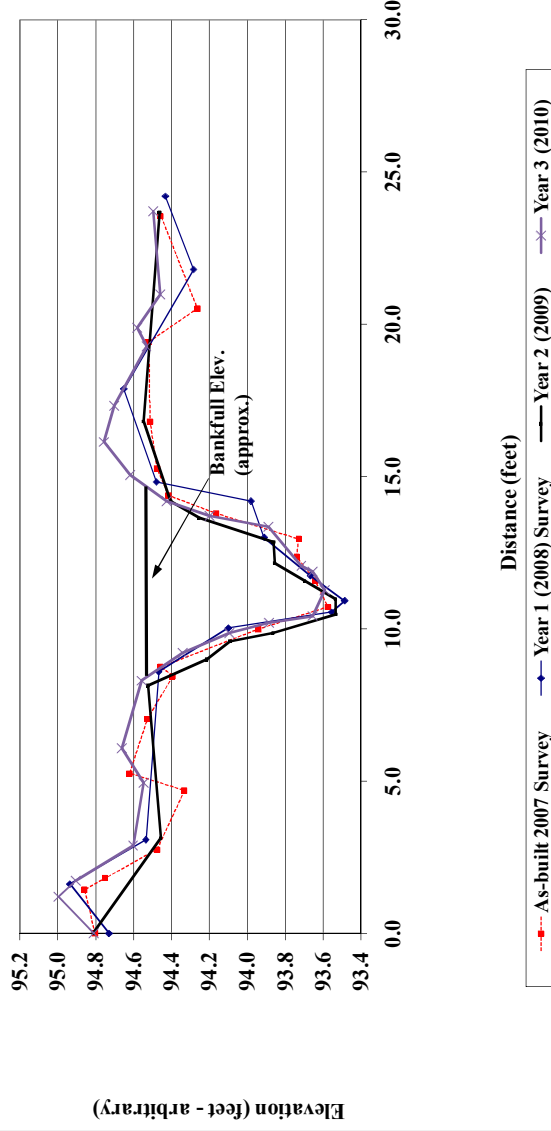
Jarman's Oak Reach 3 - XS1 Pool

As-built	2008	2009	2010
Area	2.9	3.3	3.5	3.5
Width	5.6	6.2	8.1	6.4
Mean Depth	0.5	0.5	0.4	0.5
Max Depth	0.8	1.0	1.0	1.0
W/D Ratio	N/A	N/A	N/A	N/A

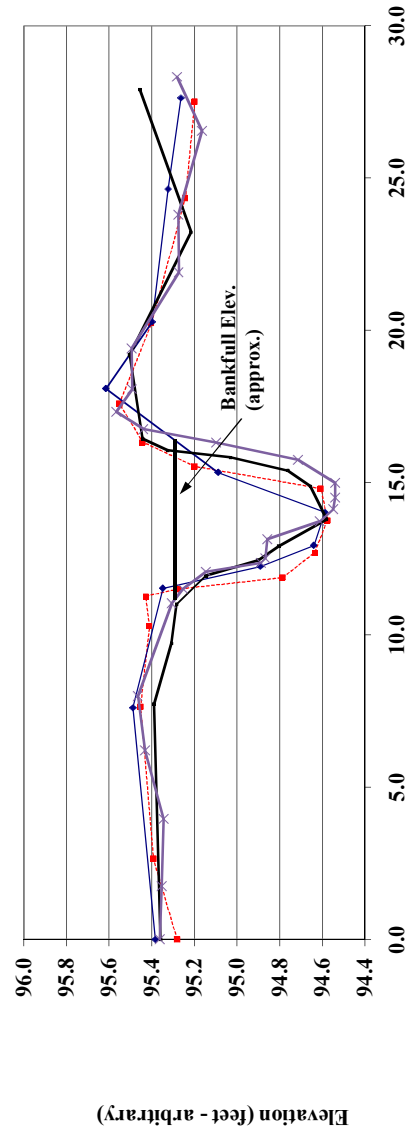
Jarman's Oak Reach 3 - XS3 Riffle

As-built	2008	2009	2010
Area	3.0	2.2	2.1	2.5
Width	5.0	5.2	5.0	5.5
Mean Depth	0.6	0.4	0.4	0.5
Max Depth	0.9	0.8	0.7	0.8
W/D Ratio	8.5	12.3	11.8	11.9

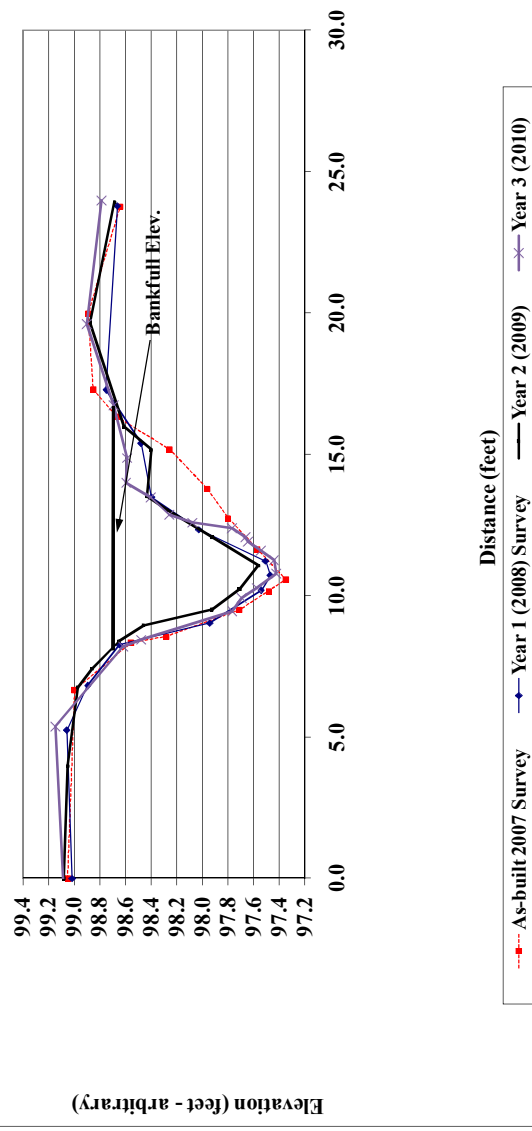
Jarman's Oak Reach 4 - XS3 Pool

As-built	2008	2009	2010
Area	7.8	5.3	5.3	4.8
Width	10.1	9.5	10.9	9.1
Mean Depth	0.8	0.6	0.5	0.5
Max Depth	1.5	1.3	1.2	1.3
W/D Ratio	N/A	N/A	N/A	N/A

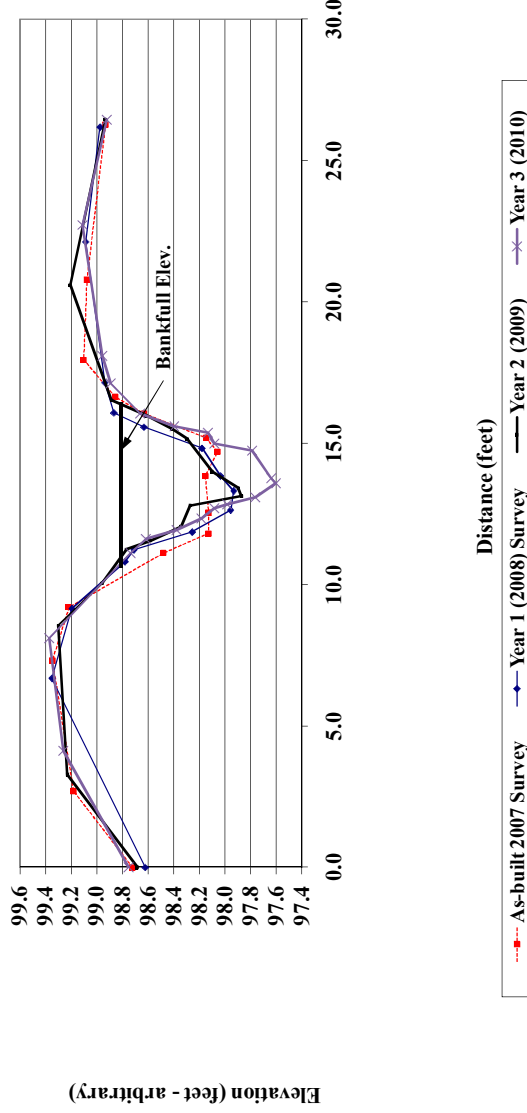
Jarman's Oak Reach 4 - XS4 Riffle

As-built	2008	2009	2010
Area	5.3	3.1	3.1	3.3
Width	8.4	5.6	6.4	5.5
Mean Depth	0.6	0.6	0.5	0.6
Max Depth	1.0	0.9	1.0	1.2
W/D Ratio	13.3	10.0	12.1	9.1

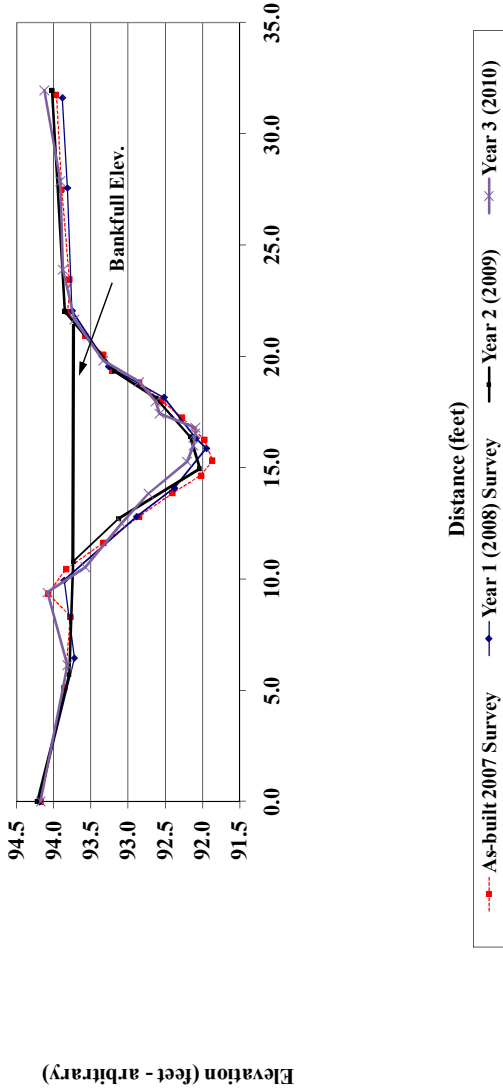
Jarman's Oak Reach 5 - XS3 Pool

As-built	2008	2009	2010
Area	11.5	10.6	9.4	9.4
Width	11.5	11.8	10.7	11.4
Mean Depth	1.0	0.9	0.9	0.8
Max Depth	1.9	1.8	1.7	1.6
W/D Ratio	N/A	N/A	N/A	N/A
